CLEANUP ACTION PLAN

Texaco February 22, 1991 Oil Spill
Anacortes, Washington

Washington Department of Ecology

May 25, 1993

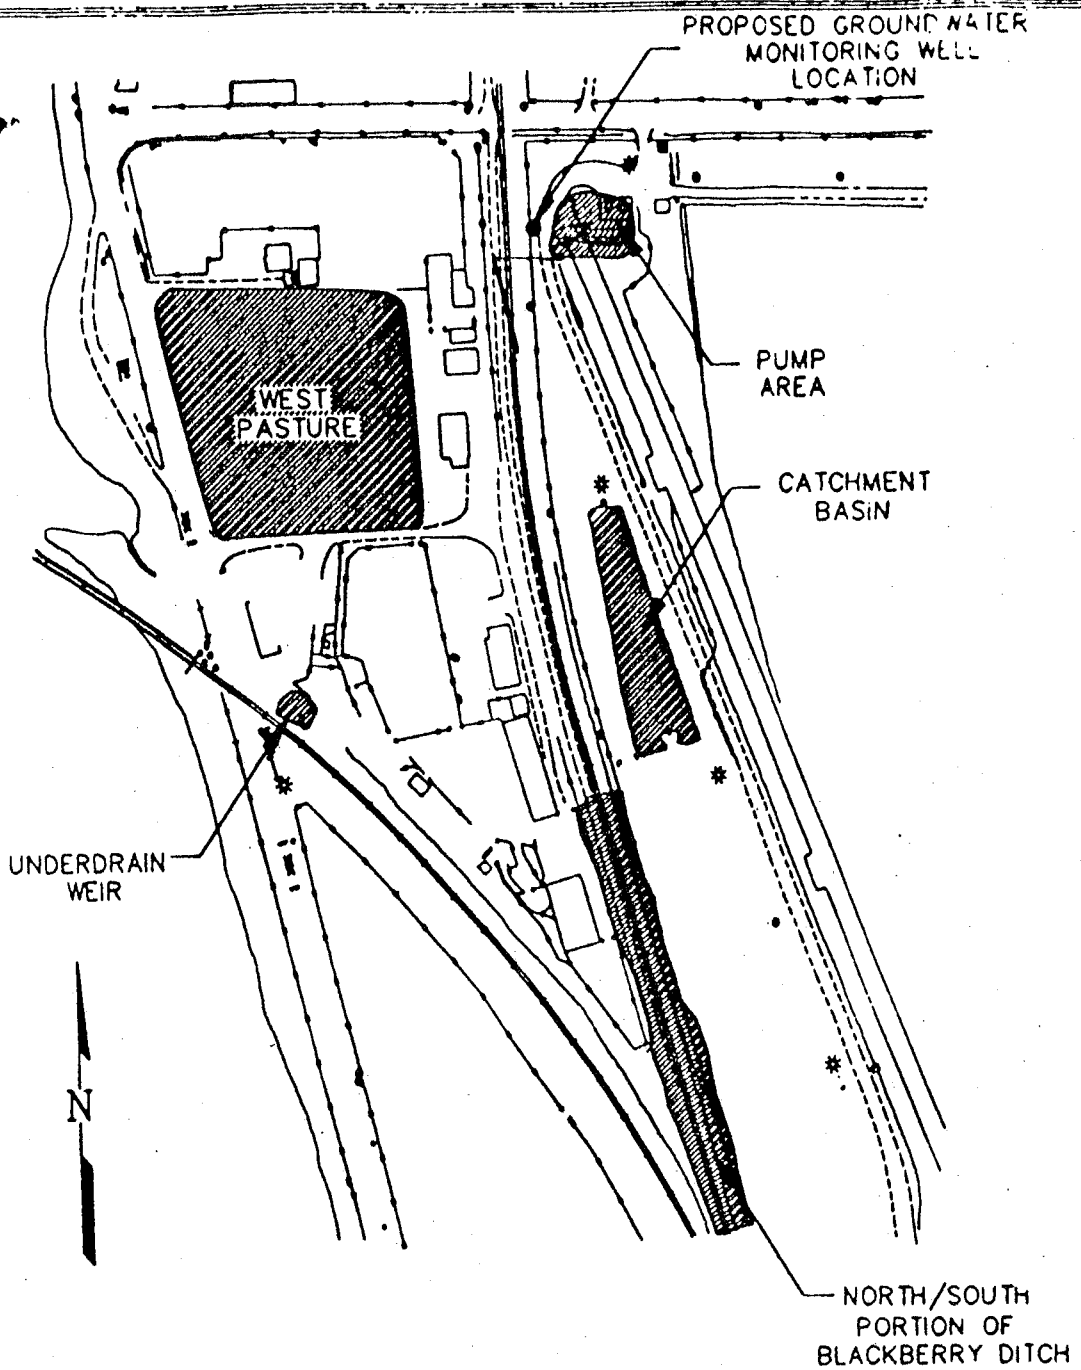
FIGURE: 1

This document presents the Cleanup Action Plan for the Texaco February 22, 1991 oil spill on-land site. The Cleanup Action Plan documents the site-specific factors and analysis that led to the selection of the cleanup remedy for the site. The upland site is located on March Point at the Texaco refinery approximately three miles east of the city of Anacortes, Washington. The oil spill site resulted from the failure of a booster pump located in the northwest corner of the refinery. The pump failed during the offloading of Alaska North Slope crude oil from an offshore oil tanker. An estimated 210,000 gallons of crude oil were released at the site. Soils were impacted on Texaco property as well as adjacent property owned by Leonard Munks family, and Shell Oil Company. The southern portion of Fidalgo Bay was also affected by the spill. The cleanup decisions in this Cleanup Action Plan are based on data presented in remedial investigation and feasibility studies and interim action studies conducted by K. W. Brown Environmental Services and initial investigations carried out by Texaco Environmental Services. Much of the cleanup was completed as either an emergency action or interim action under an Agreed Order signed by Texaco and the Department of Ecology in July of 1991. Figure one shows areas of the site which still are impacted by the spill.

Oil spill areas of concern.

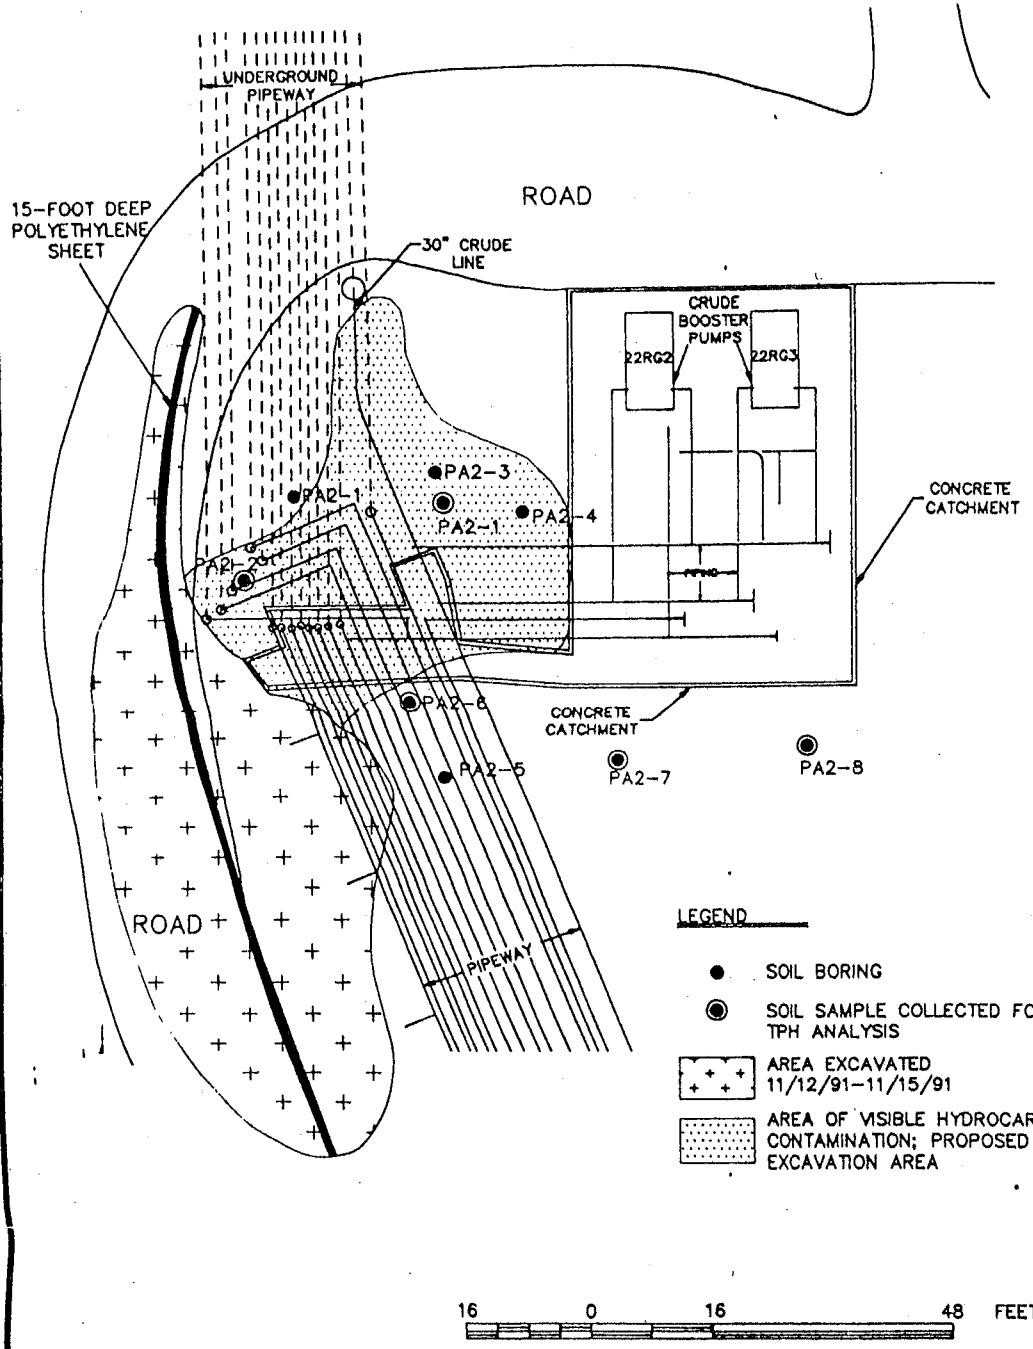
The pump area was heavily oiled during the spill. The oily piping and support structures were pressure washed during the emergency action. The upper 6 inches of oily soil, or approximately 925 cubic yards, were removed near the station and land farmed at the Texaco refinery. Soil removal was not attempted below the pipeway west of the pump station. During the interim action Texaco placed a 120 foot HDPE sheet pile west of the pipeway. The plastic barrier was designed to prevent oil present under the pipeway and buried pipeline from migrating west into the clean railroad ballast bed. Based on analytical results and field observations of soils in the pump area, there appears to still be hydrocarbon contamination in soils directly west of the pump station (Figure 6).

Soil boring locations, proposed and completed excavations at crude booster pump area.	
	PROJECT: 701091008-237 (BOOSTPMP) LOCATION: ANACORTES, WASHINGTON APPR: _____ DATE: 2/12/92 DRAWN BY: SSA SCALE: AS SHOWN DATE: 1/28/92 FIGURE: 6

The preferred alternative in the pump station area is further excavation in the vicinity of the contamination. If contaminated soils remain after the excavation, then a Method B cleanup standards can be used in the area. If the soil remains above the Method B standard then a deed restriction will be placed on the pump station area and a ground water monitoring program will be initiated at the site. The monitoring well will be located downgradient from the pump station contamination. The well would also be located on the downgradient side of the barrier wall found on the western side of the pump station contamination.

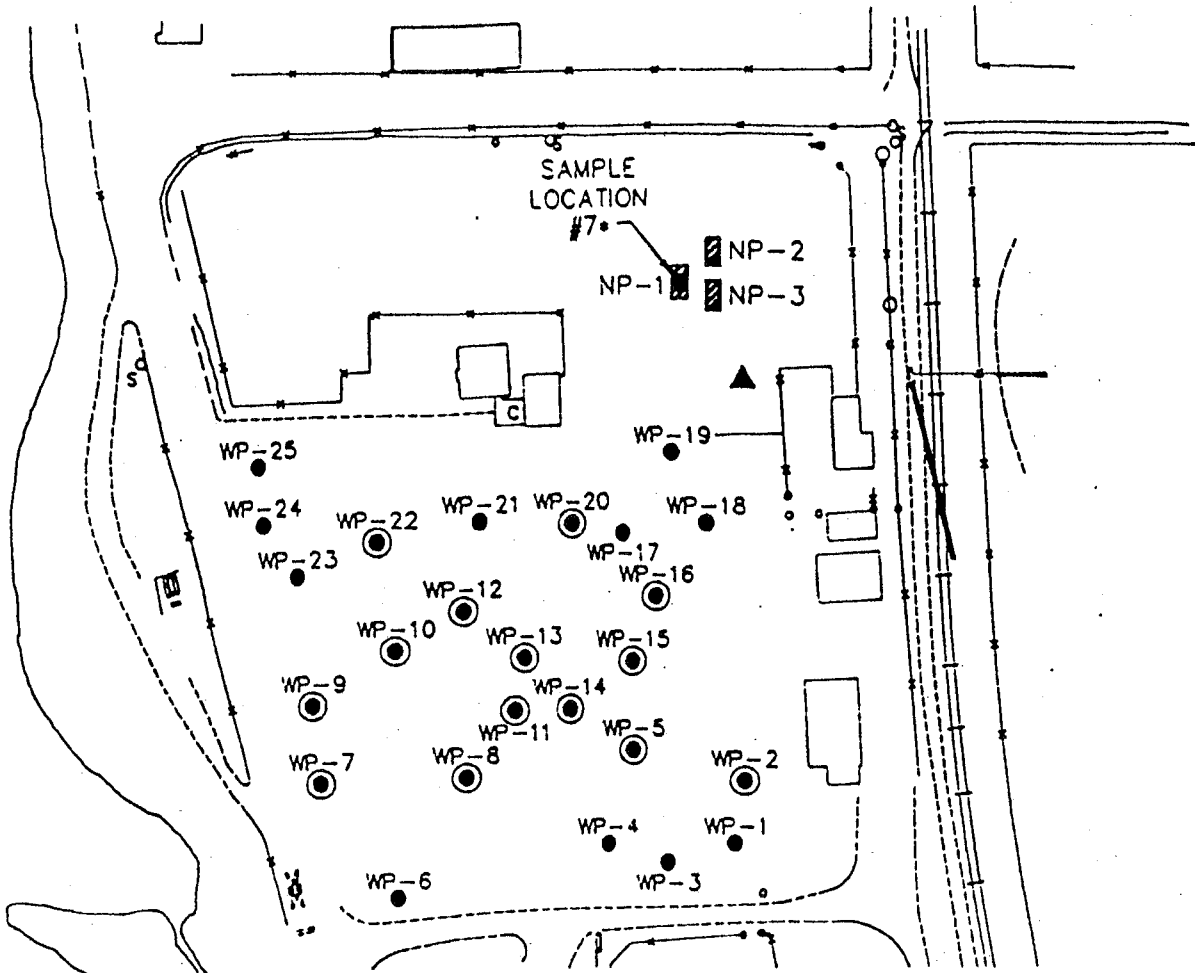
DATE: 10/23/91 | FIGURE: 8

A preliminary sample (location 7 - Figure 8) indicated hydrocarbon contamination in the center of the pasture (Figure 8). During the remedial investigation three trenches were excavated in the vicinity of the high sample. No oil was observed or measured using photoionization detectors (PID) during the investigation. Total petroleum hydrocarbon (TPH) and benzene analysis did not repeat the high sample results. The analytes were not present above method detection limits.

Soil sampling locations at the north and west pastures (WP and NP sampling events).

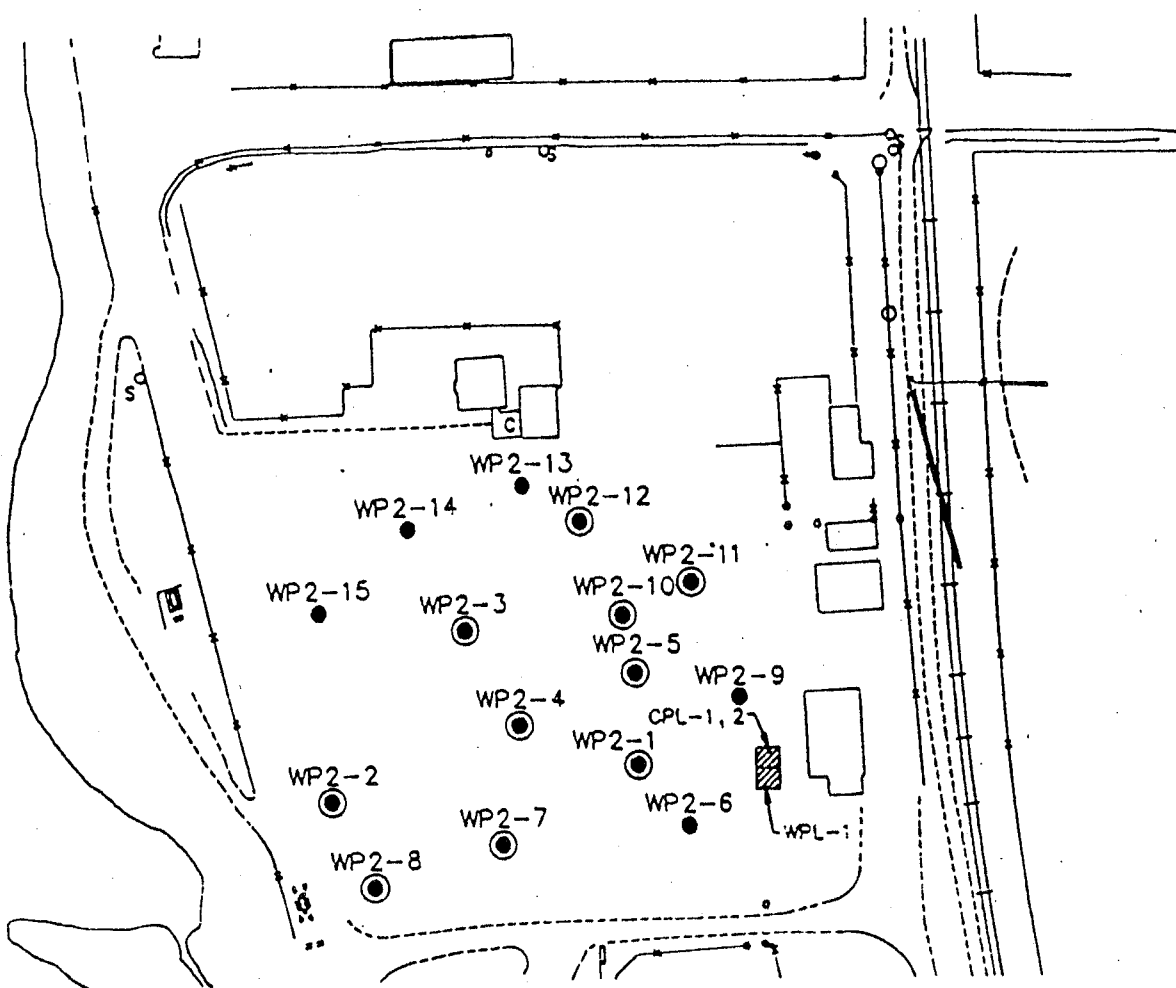
DATE: 10/23/91 | FIGURE: 9

Texaco began an *in situ* land farming program on Munks west pasture in the fall of 1991. A third sampling event occurred in October of 1991 (Figure 9). Once again TPH concentrations in the west pasture were above the 200 mg/kg cleanup standard. Texaco continued to landfarm the material throughout the winter and spring season. The area was re-sampled in August of 1992. The results of the 1992 sampling indicated that two samples were above the 200 mg/kg MTCA standard and that the oil concentrations in all cases were continuing to degrade. In September of 1992, Texaco choose to re-sample around the two high samples and

West pasture soil sampling locations (WP2, WP3, sampling events).

remove soils above the MTCA cleanup standard. Texaco removed soils around the two hot spots using techniques described in Exhibit A of the consent decree. The west pasture was covered with new clean top soil in October of 1992. The area around the drain tile was removed and landfarmed on the refinery site.

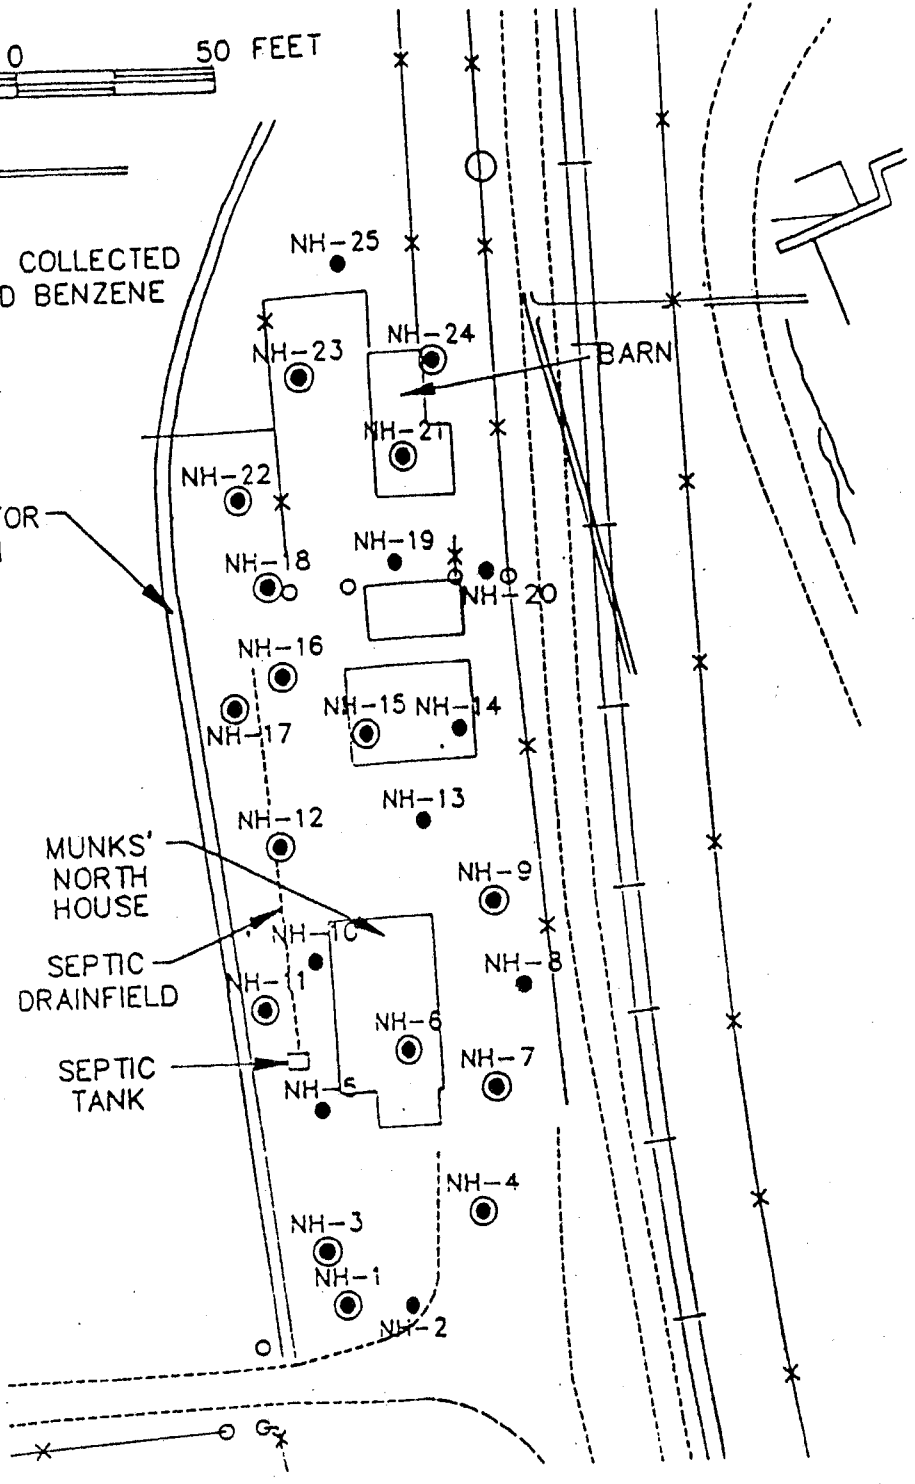
DATE: 01/21/92 FIGURE: 10

Approximately 11,000 cubic yards of contaminated soil was removed from the area and landfarmed in the Texaco flare landfarms. The deepest contamination was observed beneath the Munks barn where crude oil had pooled under the flooring. This resulted in hydrocarbon contamination to depths of 15 feet in the fractured clay. Soil analysis was completed in the bottom of the pit after removal of contaminated soils. None of the samples from the North house area yielded results above the 200 mg/kg cleanup standard (Figure 10).

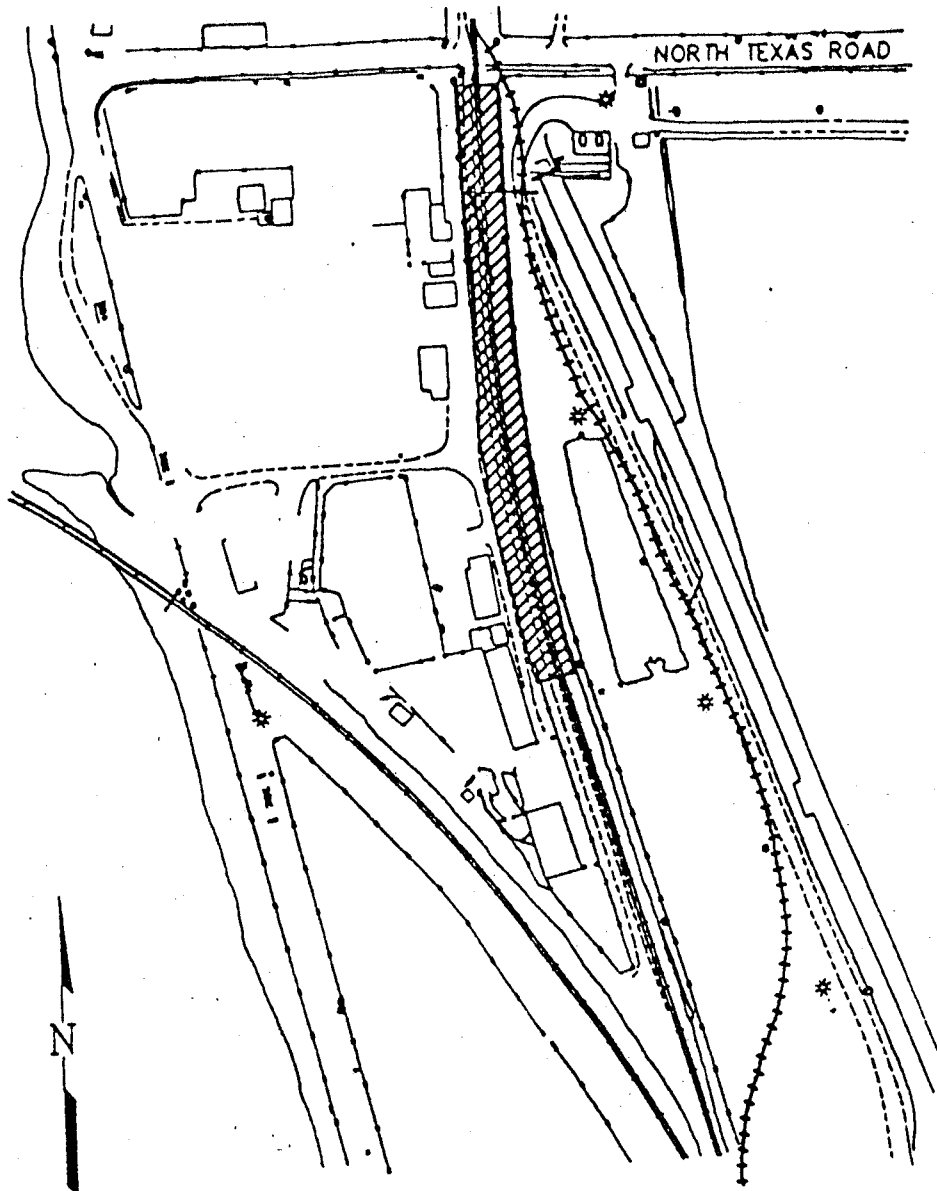
A temporary railroad spur was constructed through the spill site east of the original railroad right of way. The construction of the temporary spur resulted in the excavation of soils and the backfilling of the excavation with ballast to provide a firm roadbed and achieve proper grade. During the excavation the soils in the trench were examined for evidence of hydrocarbon contamination. South of the catchment basin no contaminated soils were observed. Oil was observed north of the basin in the road bed ballast that was found beneath the service road that runs between the catchment basin and pipeline (Figure 13). All oily soils and ballast were removed to the Texaco refinery staging areas. The depth of excavation was directed by visual observation and with the aid of a PID. The nine confirmational samples after the excavation indicated TPH concentrations below the method detection limits (Figure 13). Oily soils were left in place next to the pump area. A 12 foot high, 100 foot long HDPE barrier was placed next to the oily soils found near the pump station (Figure 14). The barrier will prevent oil from moving west through the new fill and into the Munks property.

Location of temporary railroad spur and excavated portion of railroad roadbed.

pockets of oil were found in the ballast at this location. A total of 7,100 cubic yards of soil were removed from the 700 feet of railroad bed that was remediated. Confirmational samples were taken at a depth interval of 0-10 inches, every 75 feet linear feet along the excavation. The analytical results indicated that the TPH concentrations were below method detection limits in all nine samples collected (Figure 13). Backfilling of the area began immediately following the receipt of the analytical results. Clean fill materials were moved by truck from offsite. The railroad bed was reconstructed using clean materials.
