## **Remedial Investigation Report**

**DeBock's Main Street Texaco (aka Debock's Auto Repair)  
100 W., 101 W., and 101 E. Wine Country Road  
Grandview, WA  
Facility Site No. 94369212  
Cleanup Site ID No. 6910**

**Prepared by AECOM for:  
Resource Environmental, LLC**

**February 15, 2022**

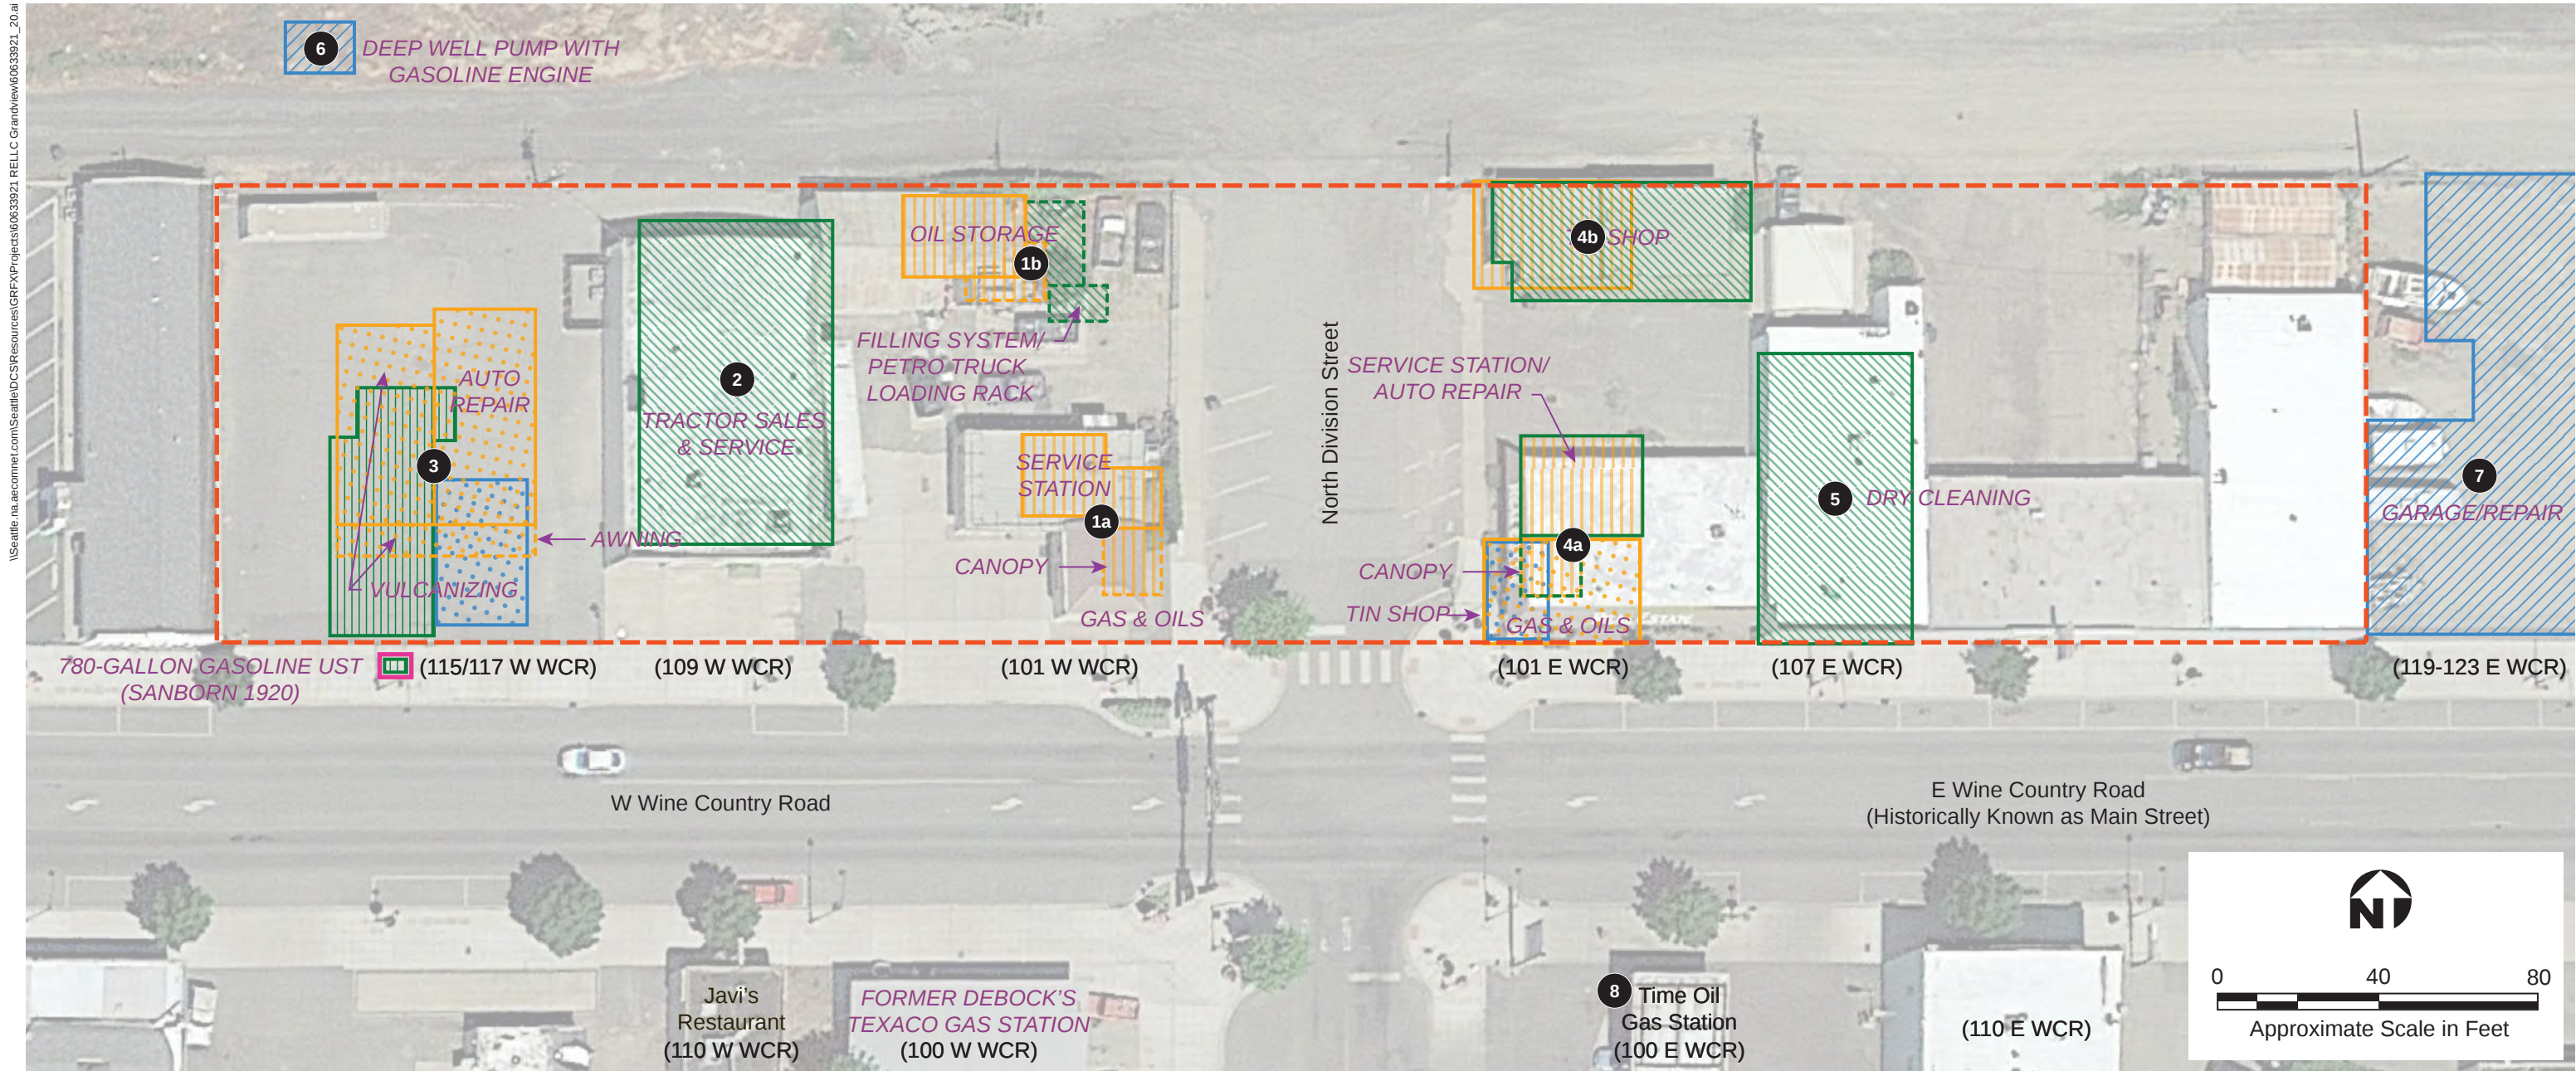
Figure 5

The 101 E. Wine Country Road historical service station and fueling operations (Location ID 4a on **Figure 5**) were situated in the southwestern portion of this property. These operations were noted between the 1920s and the early 1950s. The office building was constructed in 1979 and appears to cover the majority of the footprint of the historical service station building.

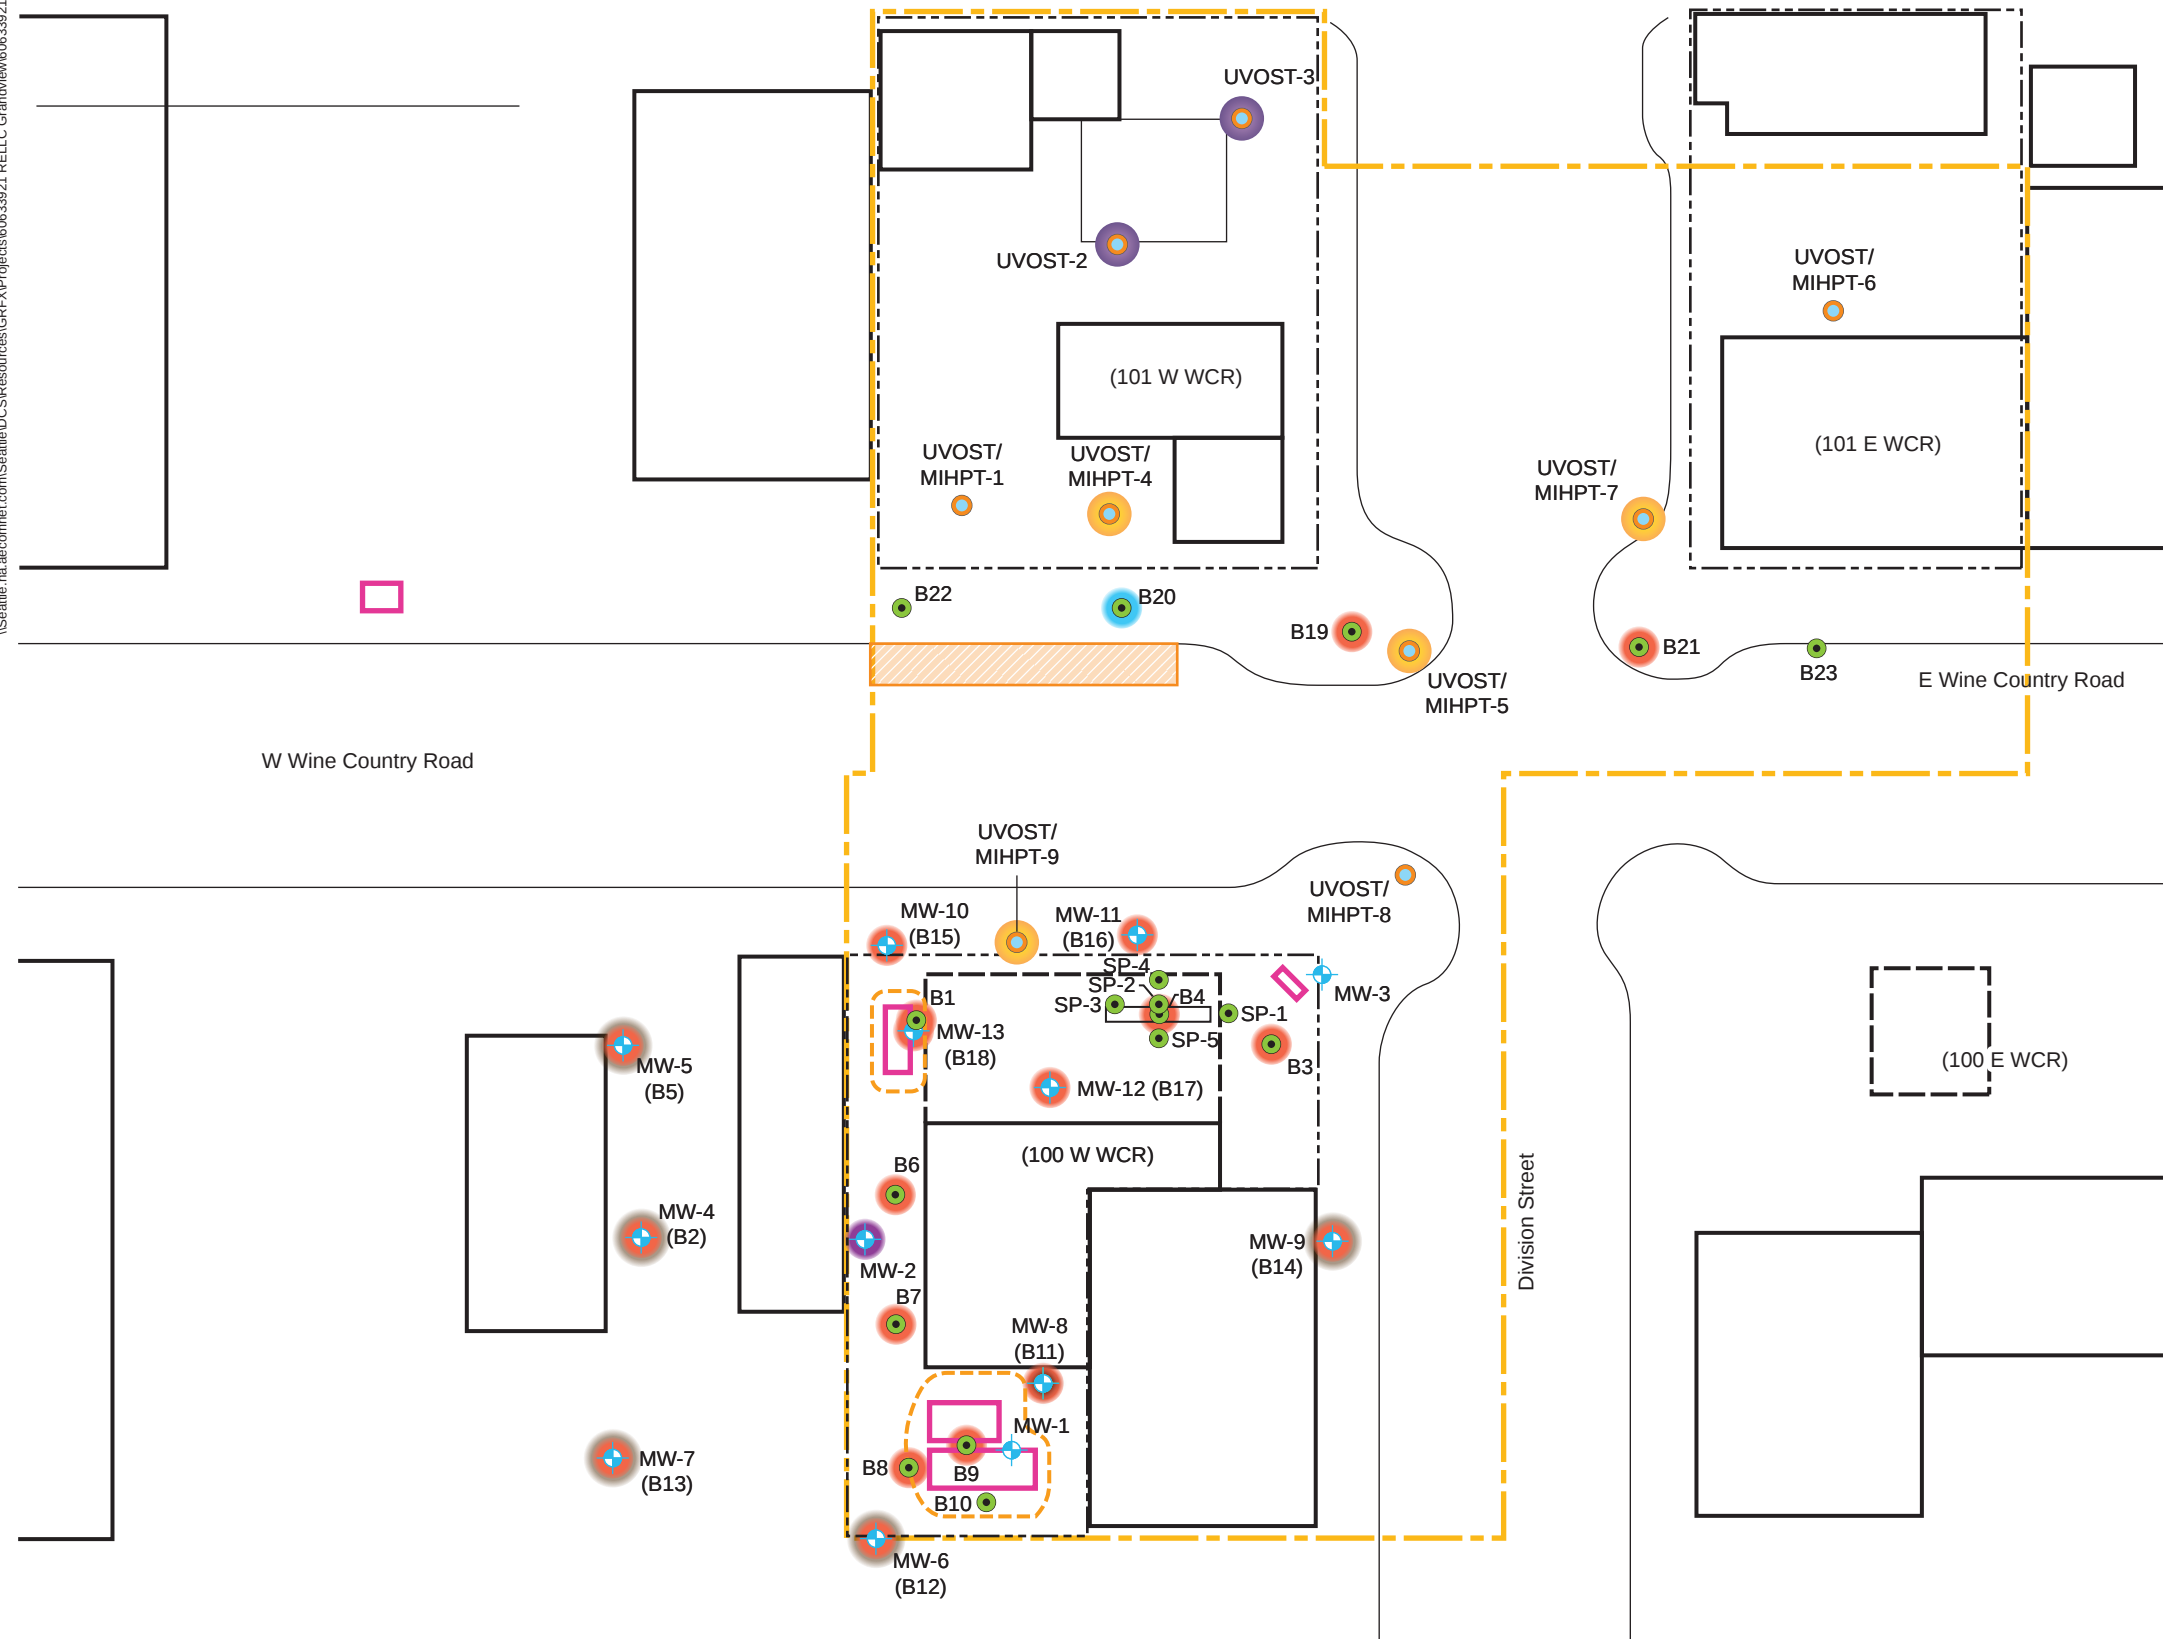
Figure 6  
**Distribution of Petroleum-Related Contamination**

Elevated concentrations of TPH-g were noted in the soil samples collected within the saturated zone soils near the southern boundaries of both the 101 W. and 101 E. Wine Country Road properties (**Figure 6**).

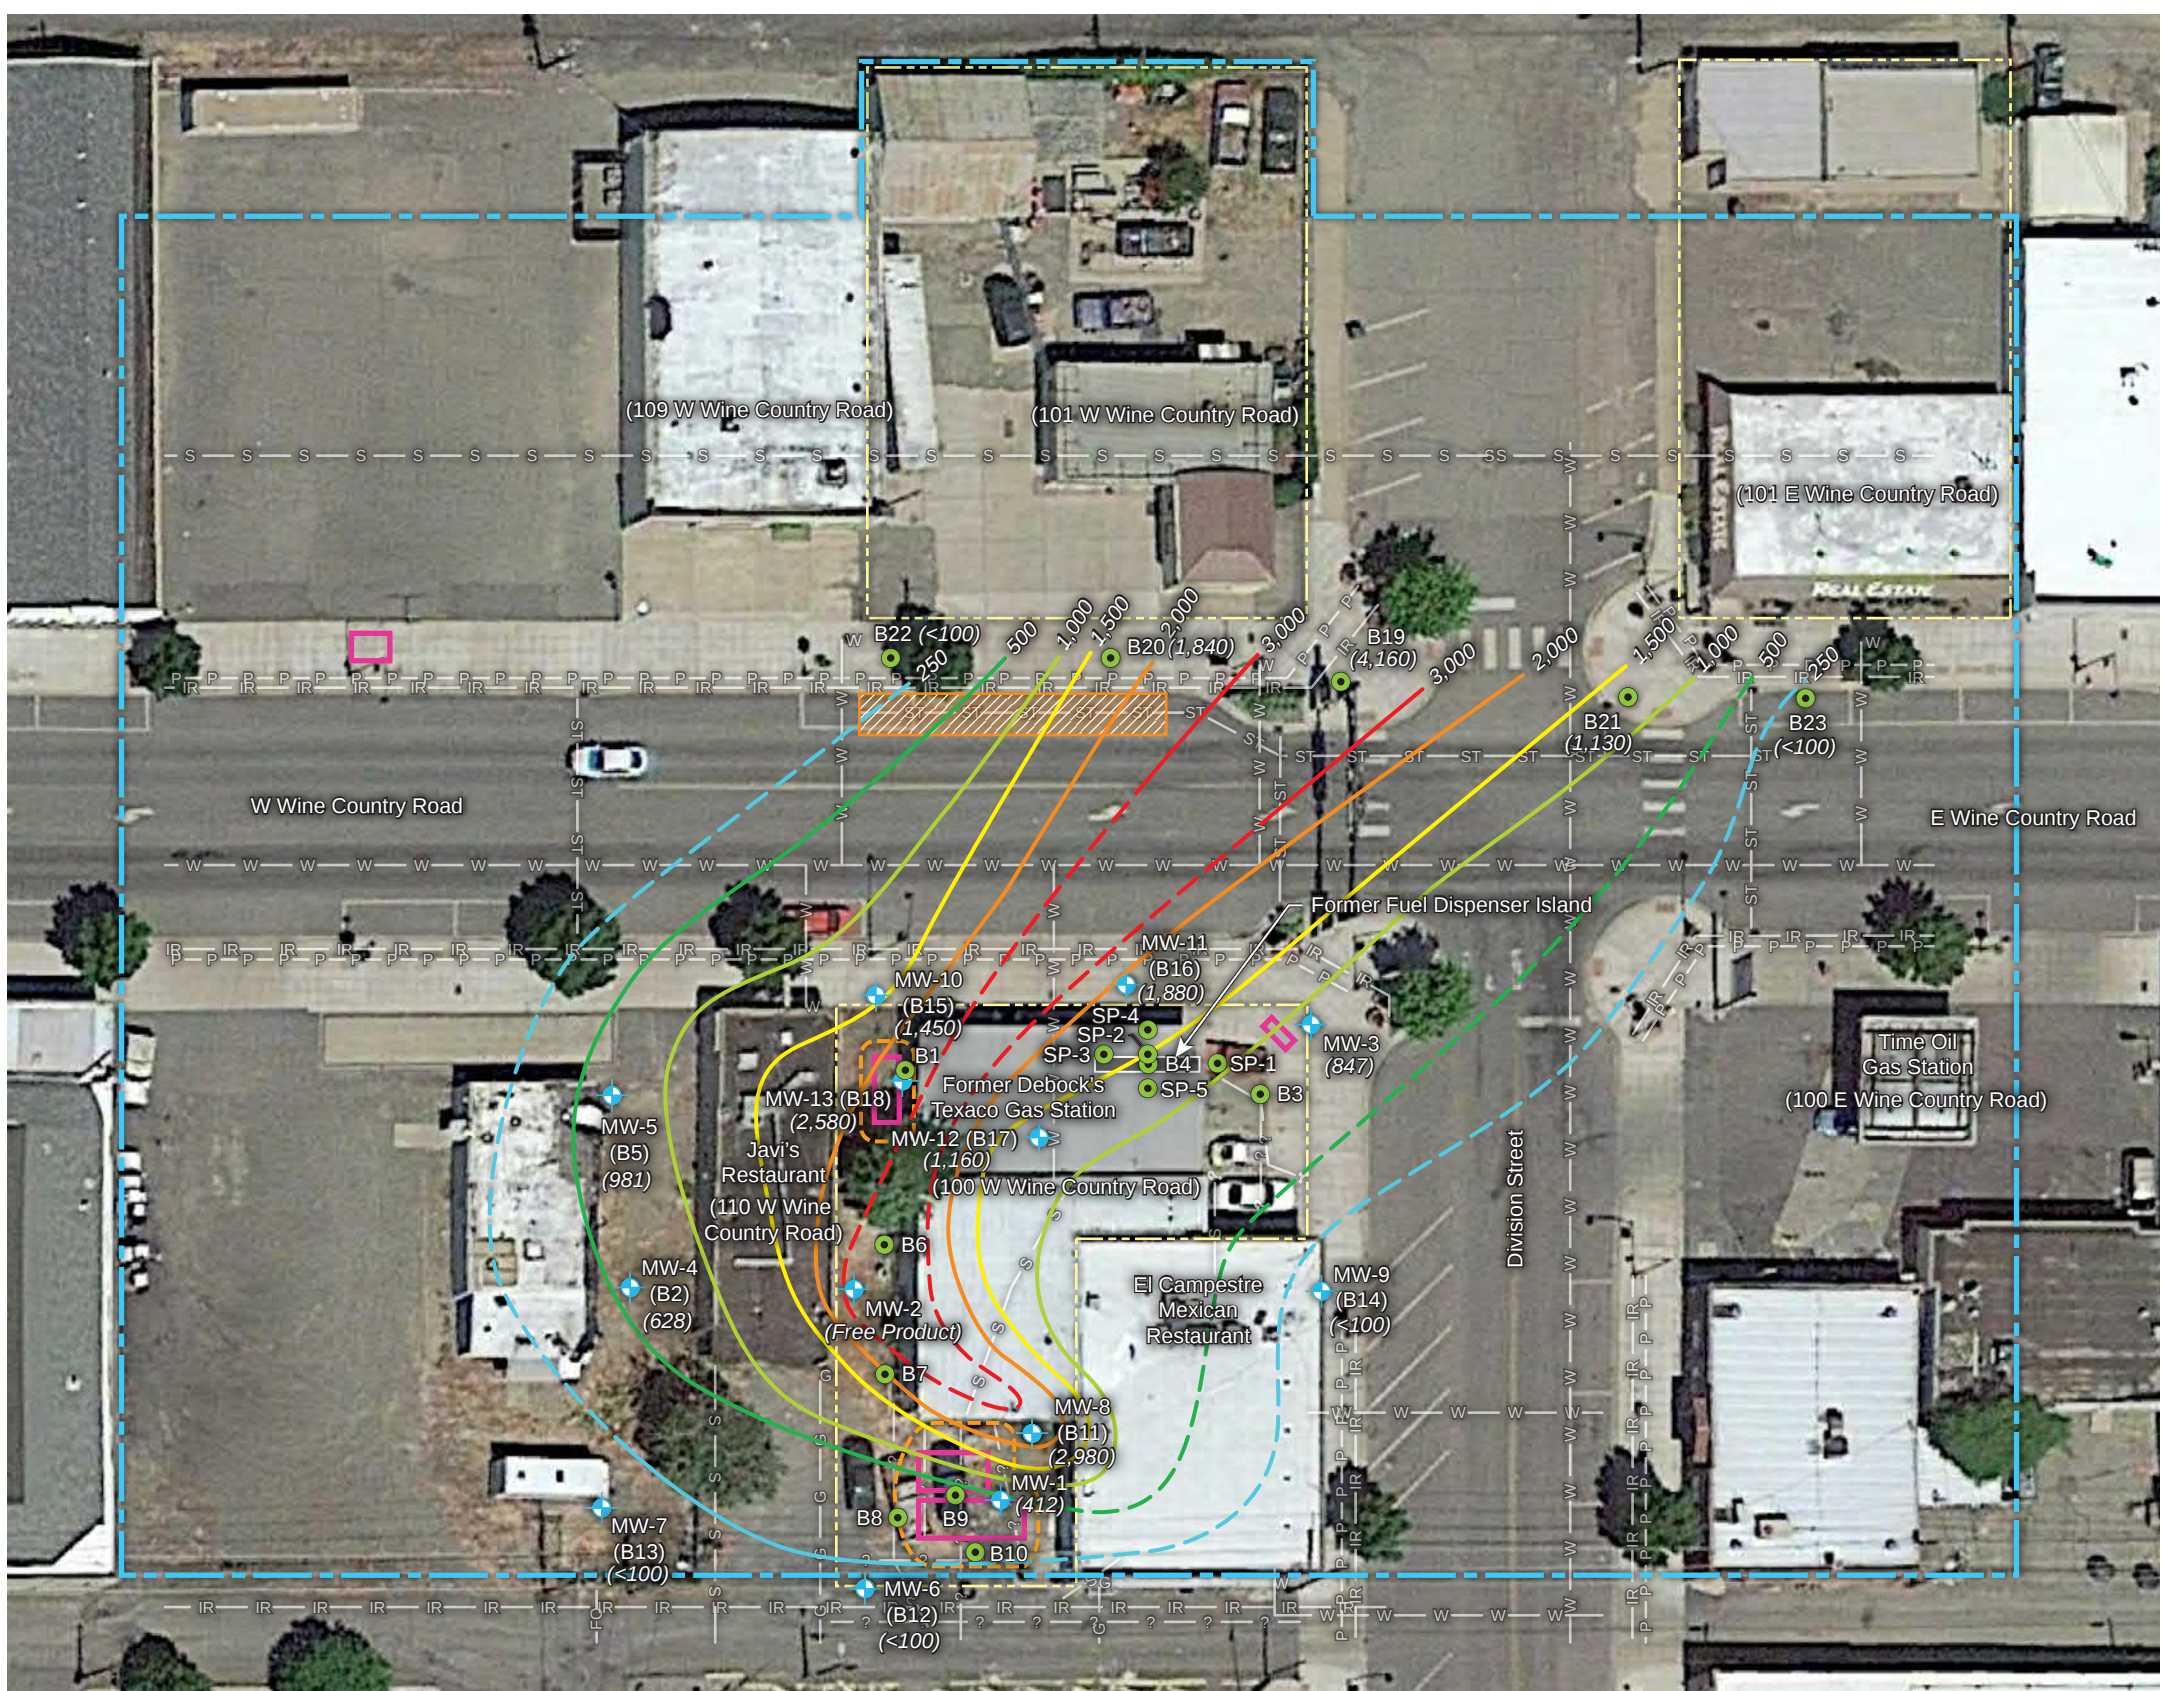
Figure 7  
**Groundwater Gasoline-Range Petroleum Hydrocarbon Concentrations (2019)**

LNAPL has been measured in one monitoring well, well MW-2, which is located west of the service station building (**Figure 7**). LNAPL measurements between 2017 and 2021 have ranged from a film to 1.14 feet in thickness (in April 2021, the LNAPL thickness was 0.08 feet). The extent of the LNAPL to the west and east of well MW-2 is not defined. However, LNAPL was not encountered in borings completed north (boring B6) and south (boring B7) of well MW-2, although a slight sheen was noted in the soil samples from these borings within the capillary fringe above the saturated zone. The LNAPL thickness in well MW-2 has decreased since initiation of periodic LNAPL skimming in early 2018 (EES, 2020).
