# UNDERGROUND TANK INVESTIGATION

SUMMARY REPORT WESTLAKE AVENUE CITY OF SEATTLE

## CITY OF SEATTLE UNDERGROUND TANK INVESTIGATION WESTLAKE AVENUE UST SITE SITE INVESTIGATION AND TANK REMOVAL SUMMARY REPORT

June 18, 1990 File No. 48921

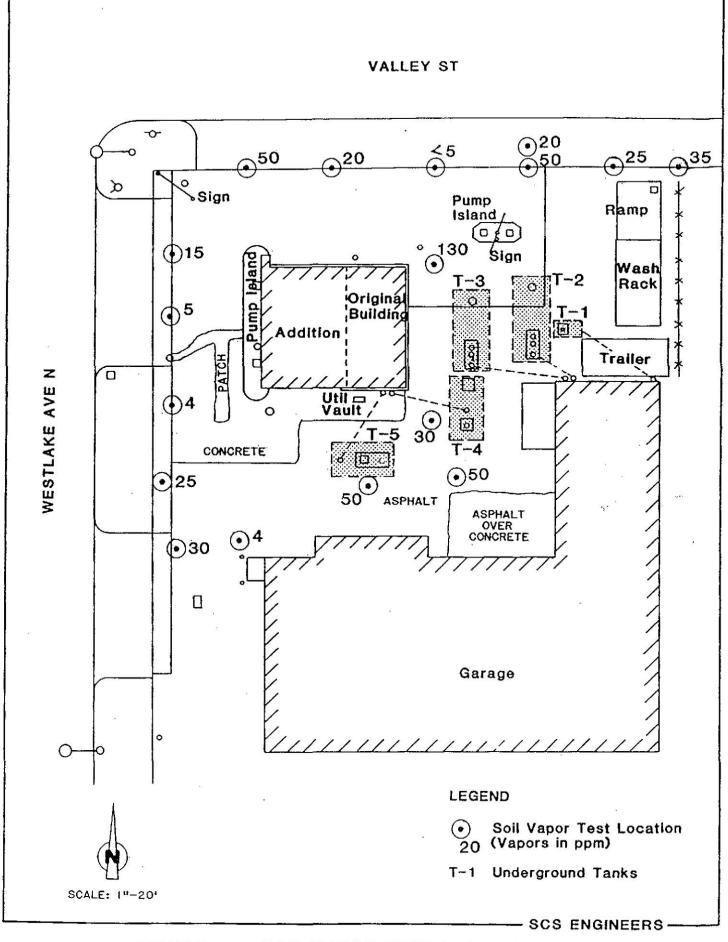
FIGURE 9 SOIL VAPOR TEST RESULTS

Based on the results of the soil vapor survey, SCS Engineers and Centrac concluded that the site was most likely contaminated with petroleum fuel product and that there was a likely possibility of off-site migration. Potential sources of volatile organic vapors in the soil at the site include previously leaking underground tanks or fuel lines, surface drainage, old surface spills, or migration of contamination from upgradient sources.

Additional investigatory work is recommended to determine the extent of contamination based on the findings of the soil vapor survey conducted during Phase I and analytical laboratory testing of soil and groundwater samples conducted during Phase II. An evaluation of Phase II analytical test results as well as recommendations for additional work is provided in Sections 5 and 7, respectively.

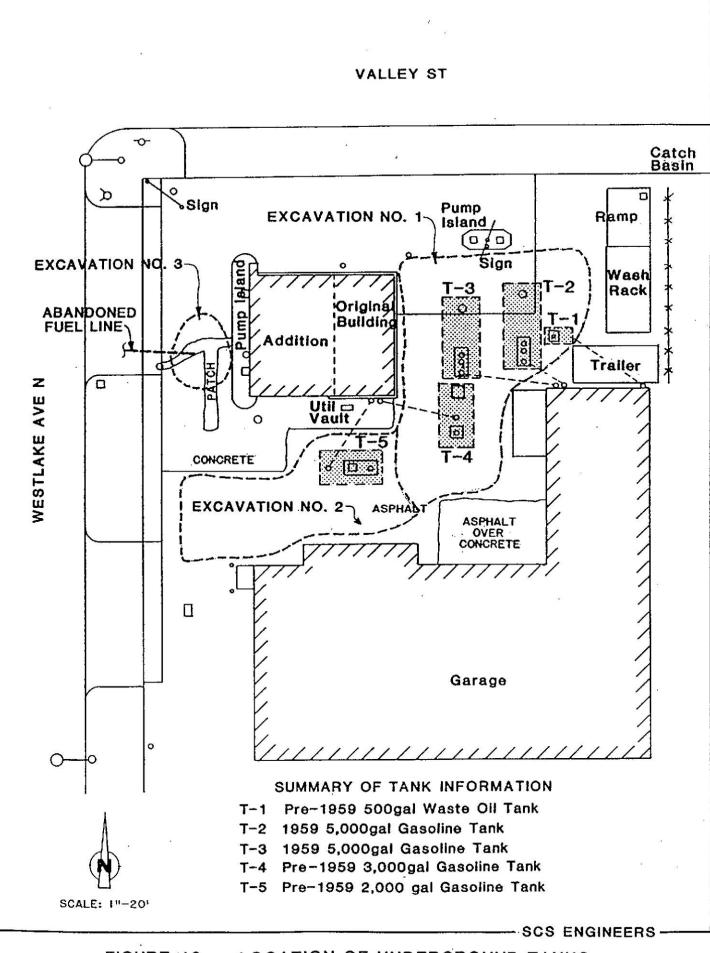
FIGURE 10 LOCATION OF UNDERGROUND TANKS

Approximately 800 cubic yards of contaminated soil was removed from two large tank excavations (Excavation No. 1 and 2) at the site. The approximate location of the excavations are shown in Figure 10. The excavations covered nearly the entire driveway area between the two buildings to a depth of about 10 to 14 feet. No additional contaminated soil could be removed from the site without undermining the foundation of the buildings. Remedial alternatives are currently under investigation for the contaminated soil that remains below the buildings at the site.

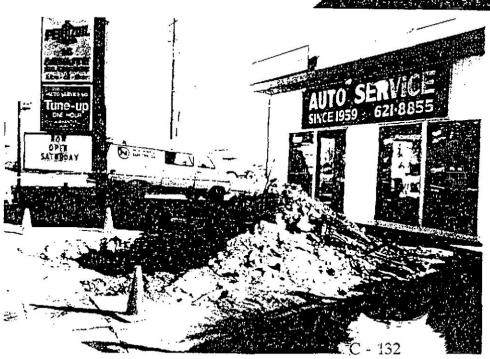
An area on the west side of the office building was excavated (Excavation No. 3) to a depth of about four feet to investigate for the presence of a tank (see Figure 10). No tank was found at this location; however, an abandoned two-inch fuel line was discovered at a depth of about two feet. The line lies east to west, and using a steel tape measure, was determined to end at a distance of 20 feet from the excavation, under Westlake Avenue. The line contained fuel vapors but no free product. After determining that the line was previously abandoned and did not present a hazard, it was capped and buried. Analytical laboratory testing indicated that the soil in the northeast corner of Excavation No. 3 was contaminated with TPH above cleanup levels.

Flate 16. Exploratory hole adjacent to Westlake Avenue. Discovered an abandoned fuel line, but no tank

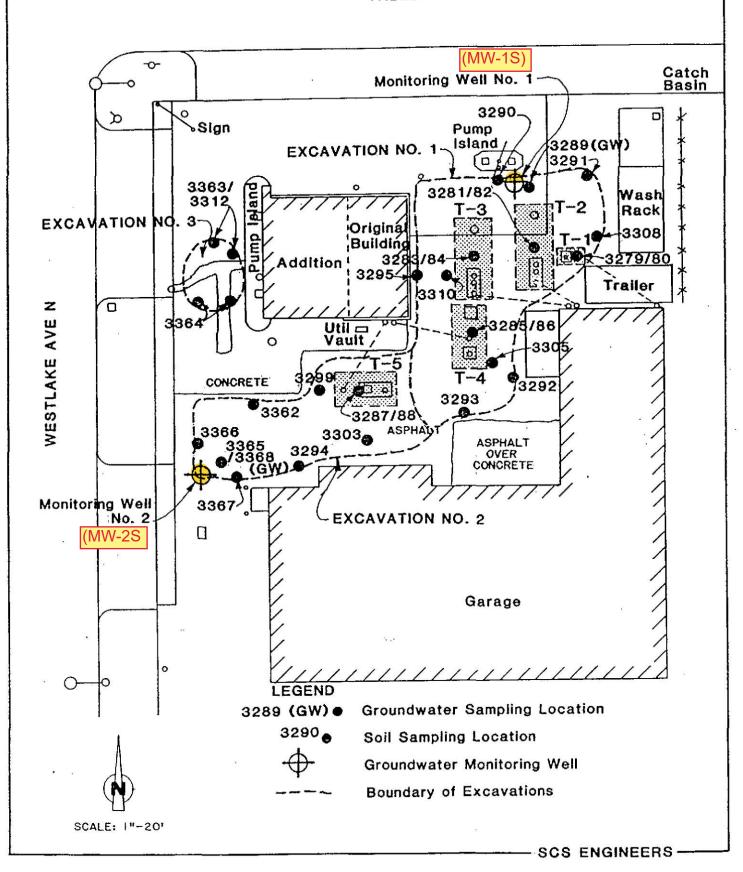
FIGURE 11 SOIL AND GROUNDWATER SAMPLING LOCATIONS

Analytical test results indicated that 14 out of 16 soil samples tested for TPH exceeded WDOE's recommended clean up level of 200 ppm for TPH. The detected level of TPH contamination in soil at the site ranged from 2.9 ppm (Sample No. 3364) to 13,000 ppm (Sample No. 3367). The average level of TPH contamination in soil samples exceeding cleanup levels was about 2,000 ppm and the median level was 920 ppm.

Analytical test results indicated that 4 out of 10 soil samples tested for benzene exceeded WDOE's recommended clean up level of 0.66 ppm for benzene. The maximum level of benzene contamination was detected at 47 ppm (Sample No. 3367) in the soil on the southwest side of the site. Toluene was detected slightly above WDOE's recommended cleanup level of 143 ppm at this same location. Ethylbenzene was detected above its cleanup level of 14 ppm in three soil samples collected from the site. The maximum detected level of ethylbenzene contamination was 93 ppm (Sample No. 3367). The maximum detected level of total xylene was 440 ppm (Sample No. 3367); however, no cleanup levels have been established for xylene at the present time.

Maximum TPH in the groundwater was detected at 700 ppm (Sample No. 3365). WDOE's recommended cleanup level for TPH contamination in groundwater is 15 ppm. One groundwater sample (Sample No. 3289) was tested for BTEX levels. Benzene and ethylbenzene exceeded WDOE's recommended cleanup level in this sample by 112 and 2 times, respectively. A summary of the analytical test results exceeding recommended WDOE cleanup levels for TPH and BTEX in groundwater is provided in Table 4.
