Updated Phase I Environmental Site Assessment Superblock Site

(Washington Square Project Site)

**UPDATED PHASE I
ENVIRONMENTAL SITE ASSESSMENT**

**SUPERBLOCK SITE
(WASHINGTON SQUARE PROJECT)
BELLEVUE, WASHINGTON**

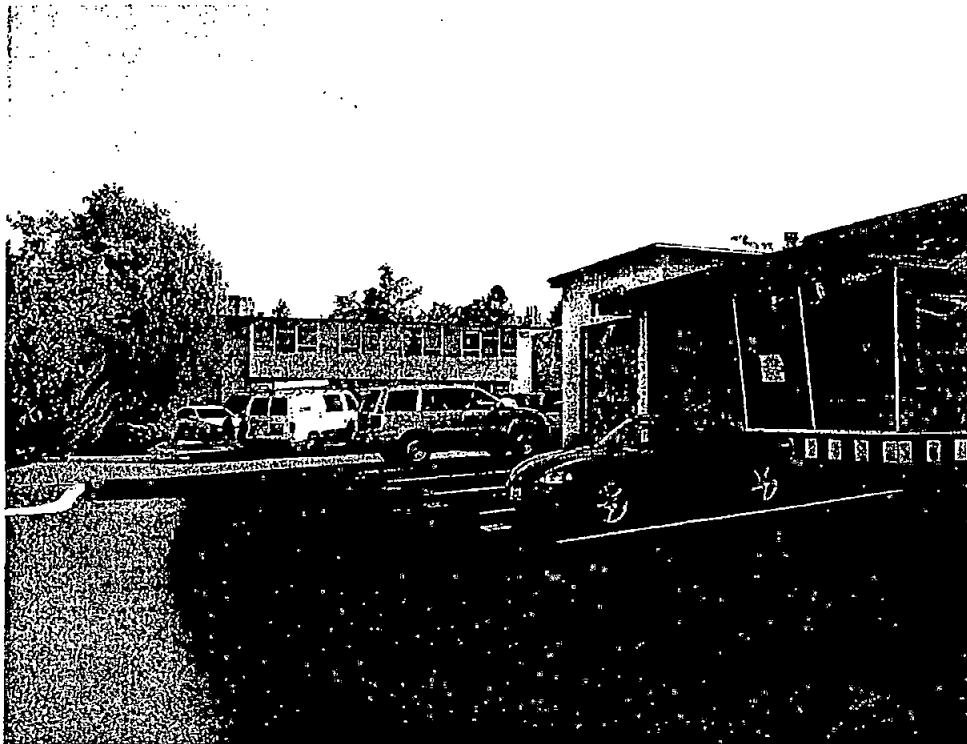
Photo 1. View of the Superblock Site from the Southwest corner, view looking North.

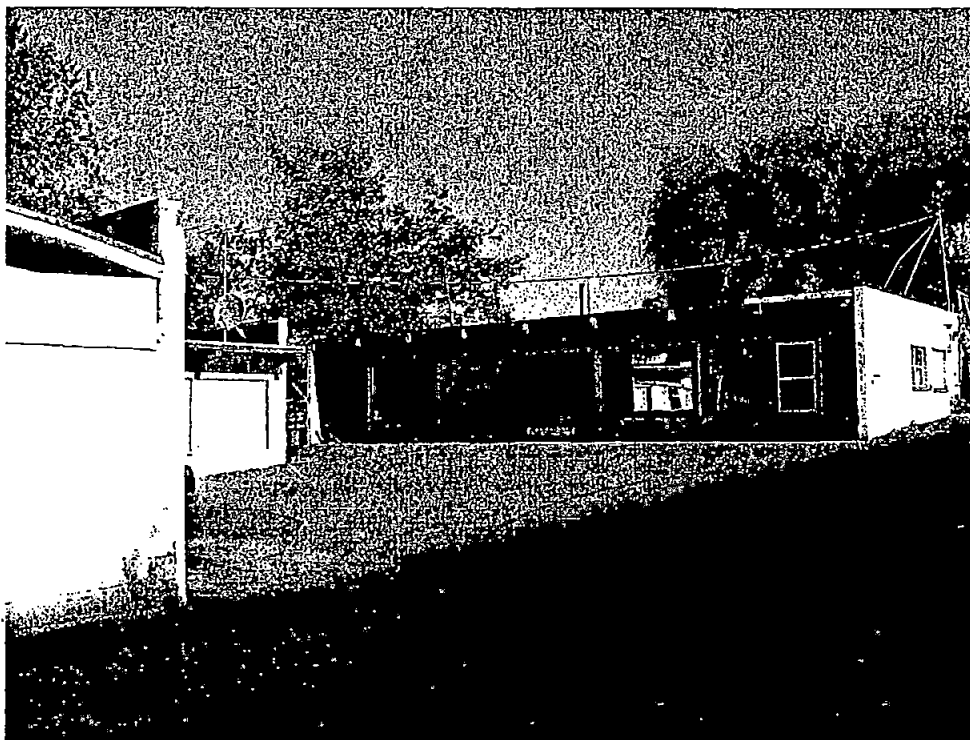
- The proximity of Greg's Auto Body shop to the Site was identified in the 1999 Phase I ESA, since this facility was suspected of using, storing and potentially disposing of hazardous materials. The possible impact from a petroleum release found at this location (parking lot between 10640 and 10650 NE 8th Street) was identified in the Updated Phase I ESA report (Golder 2005). In addition, the Updated Phase I ESA identified the low levels of PCE found in the two soil gas samples from this location during the Phase II ESA. The report states that this may indicate a wider release of PCE to soils in this area, since a dry cleaner operation was formerly located at 10640 NE 8th Street.

Greg's Auto Body shop appears to be vacant, and the drums stored on the southwest corner of this site were removed by the client during a recent drum removal conducted by the Waste Management Company. The potential home heating oil USTs identified in the 1998 Phase I ESA were not found during subsequent Phase II activities onsite (Golder 2003). However, the Phase II ESA (Golder 2003) indicated it is possible that releases from former heating oil USTs in this area exist but that the releases were not readily discernible at that time.

Photo 2. View of the former Greg's Auto Body shop (10650 NE 8th Street), view looking North.

- Conducting additional soil and potentially groundwater testing at the former Greg's Auto Body shop and the current Carpet shop located at 10640 and 10650 NE 8th Street (King County Tax Parcel No. 1544600152). The additional testing would be done to determine the potential extent of diesel range contaminated soil, and to determine if PCE found in soil gas is present in soil and potentially groundwater in other areas around this parcel. This should be done prior to the commencement of Site development on this parcel so that handling these materials can be efficiently planned and managed.

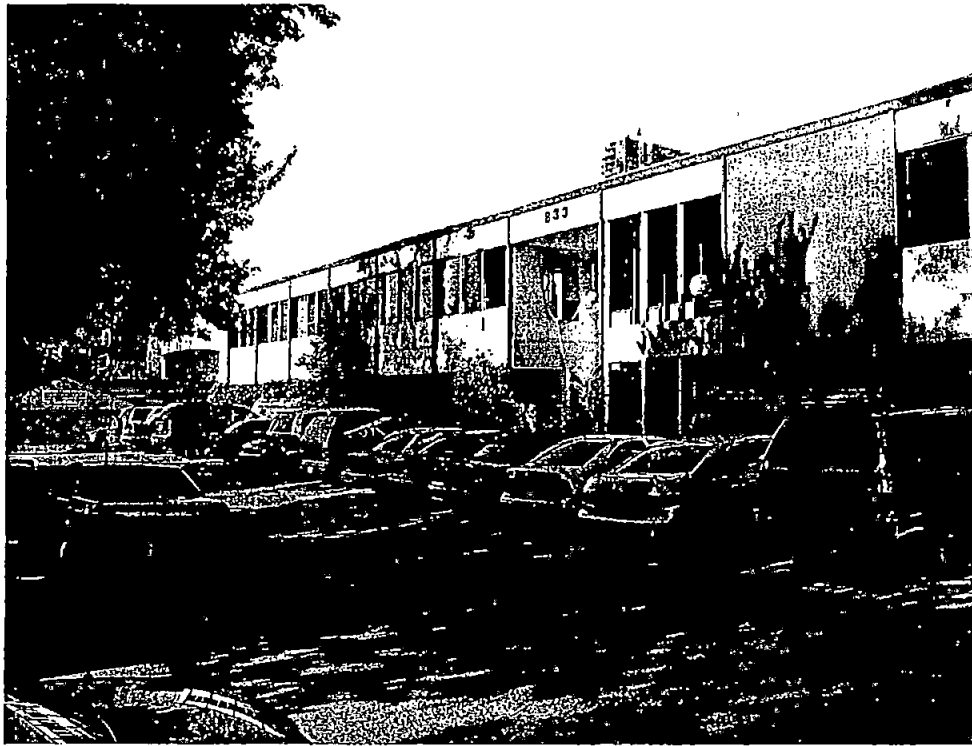
- The 833 108th Avenue NE building is currently vacant and being readied for asbestos abatement and demolition. Based on a Site visit conducted during the Phase I ESA update of this parcel (Golder 2005), this building was occasionally used by the Bellevue Police Department for training drills. Wallboard, glass and other building materials were broken and damages were extensive inside the building. The damage was apparently done during police training. In addition, evidence was found of vagrants using the building for shelter, although the building was locked and empty during the site visit.

Photo 3. Eastern side of the Superblock Site, view looking Southwest at the office building at 833 108th Avenue NE.

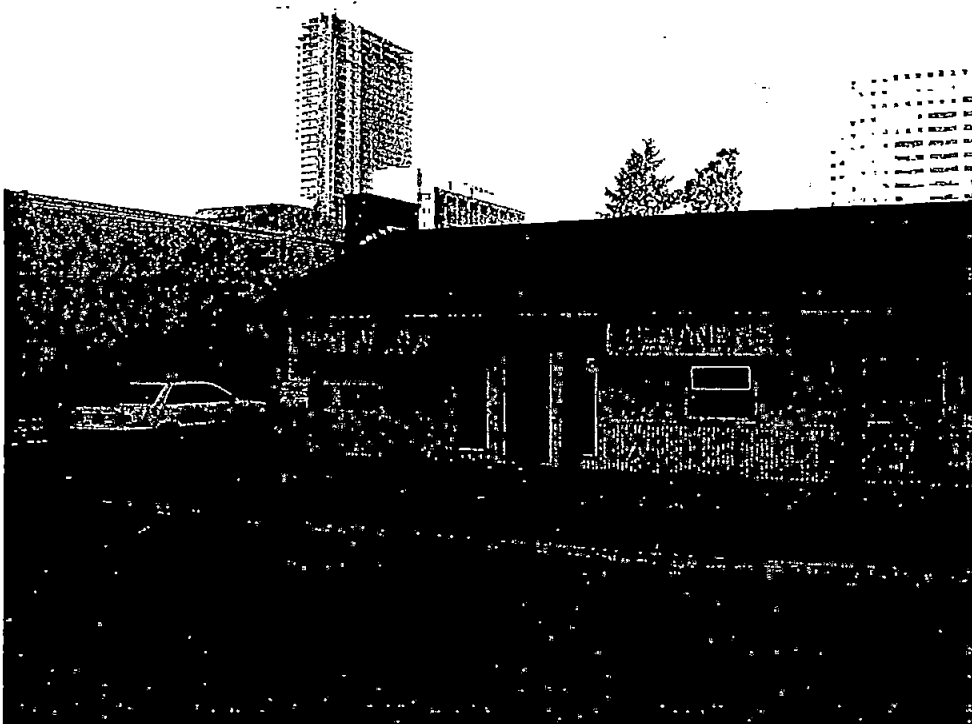
Photo 4. Eastern side of the Superblock Site, view looking West at the retail building at 827 108th Avenue NE (Village Cleaners).
