### MEMORANDUM

## 2018 Parcel 15 Cap Maintenance

**From:** Randy Pratt, GSI Water Solutions, Inc.

**Date:** May 28, 2019

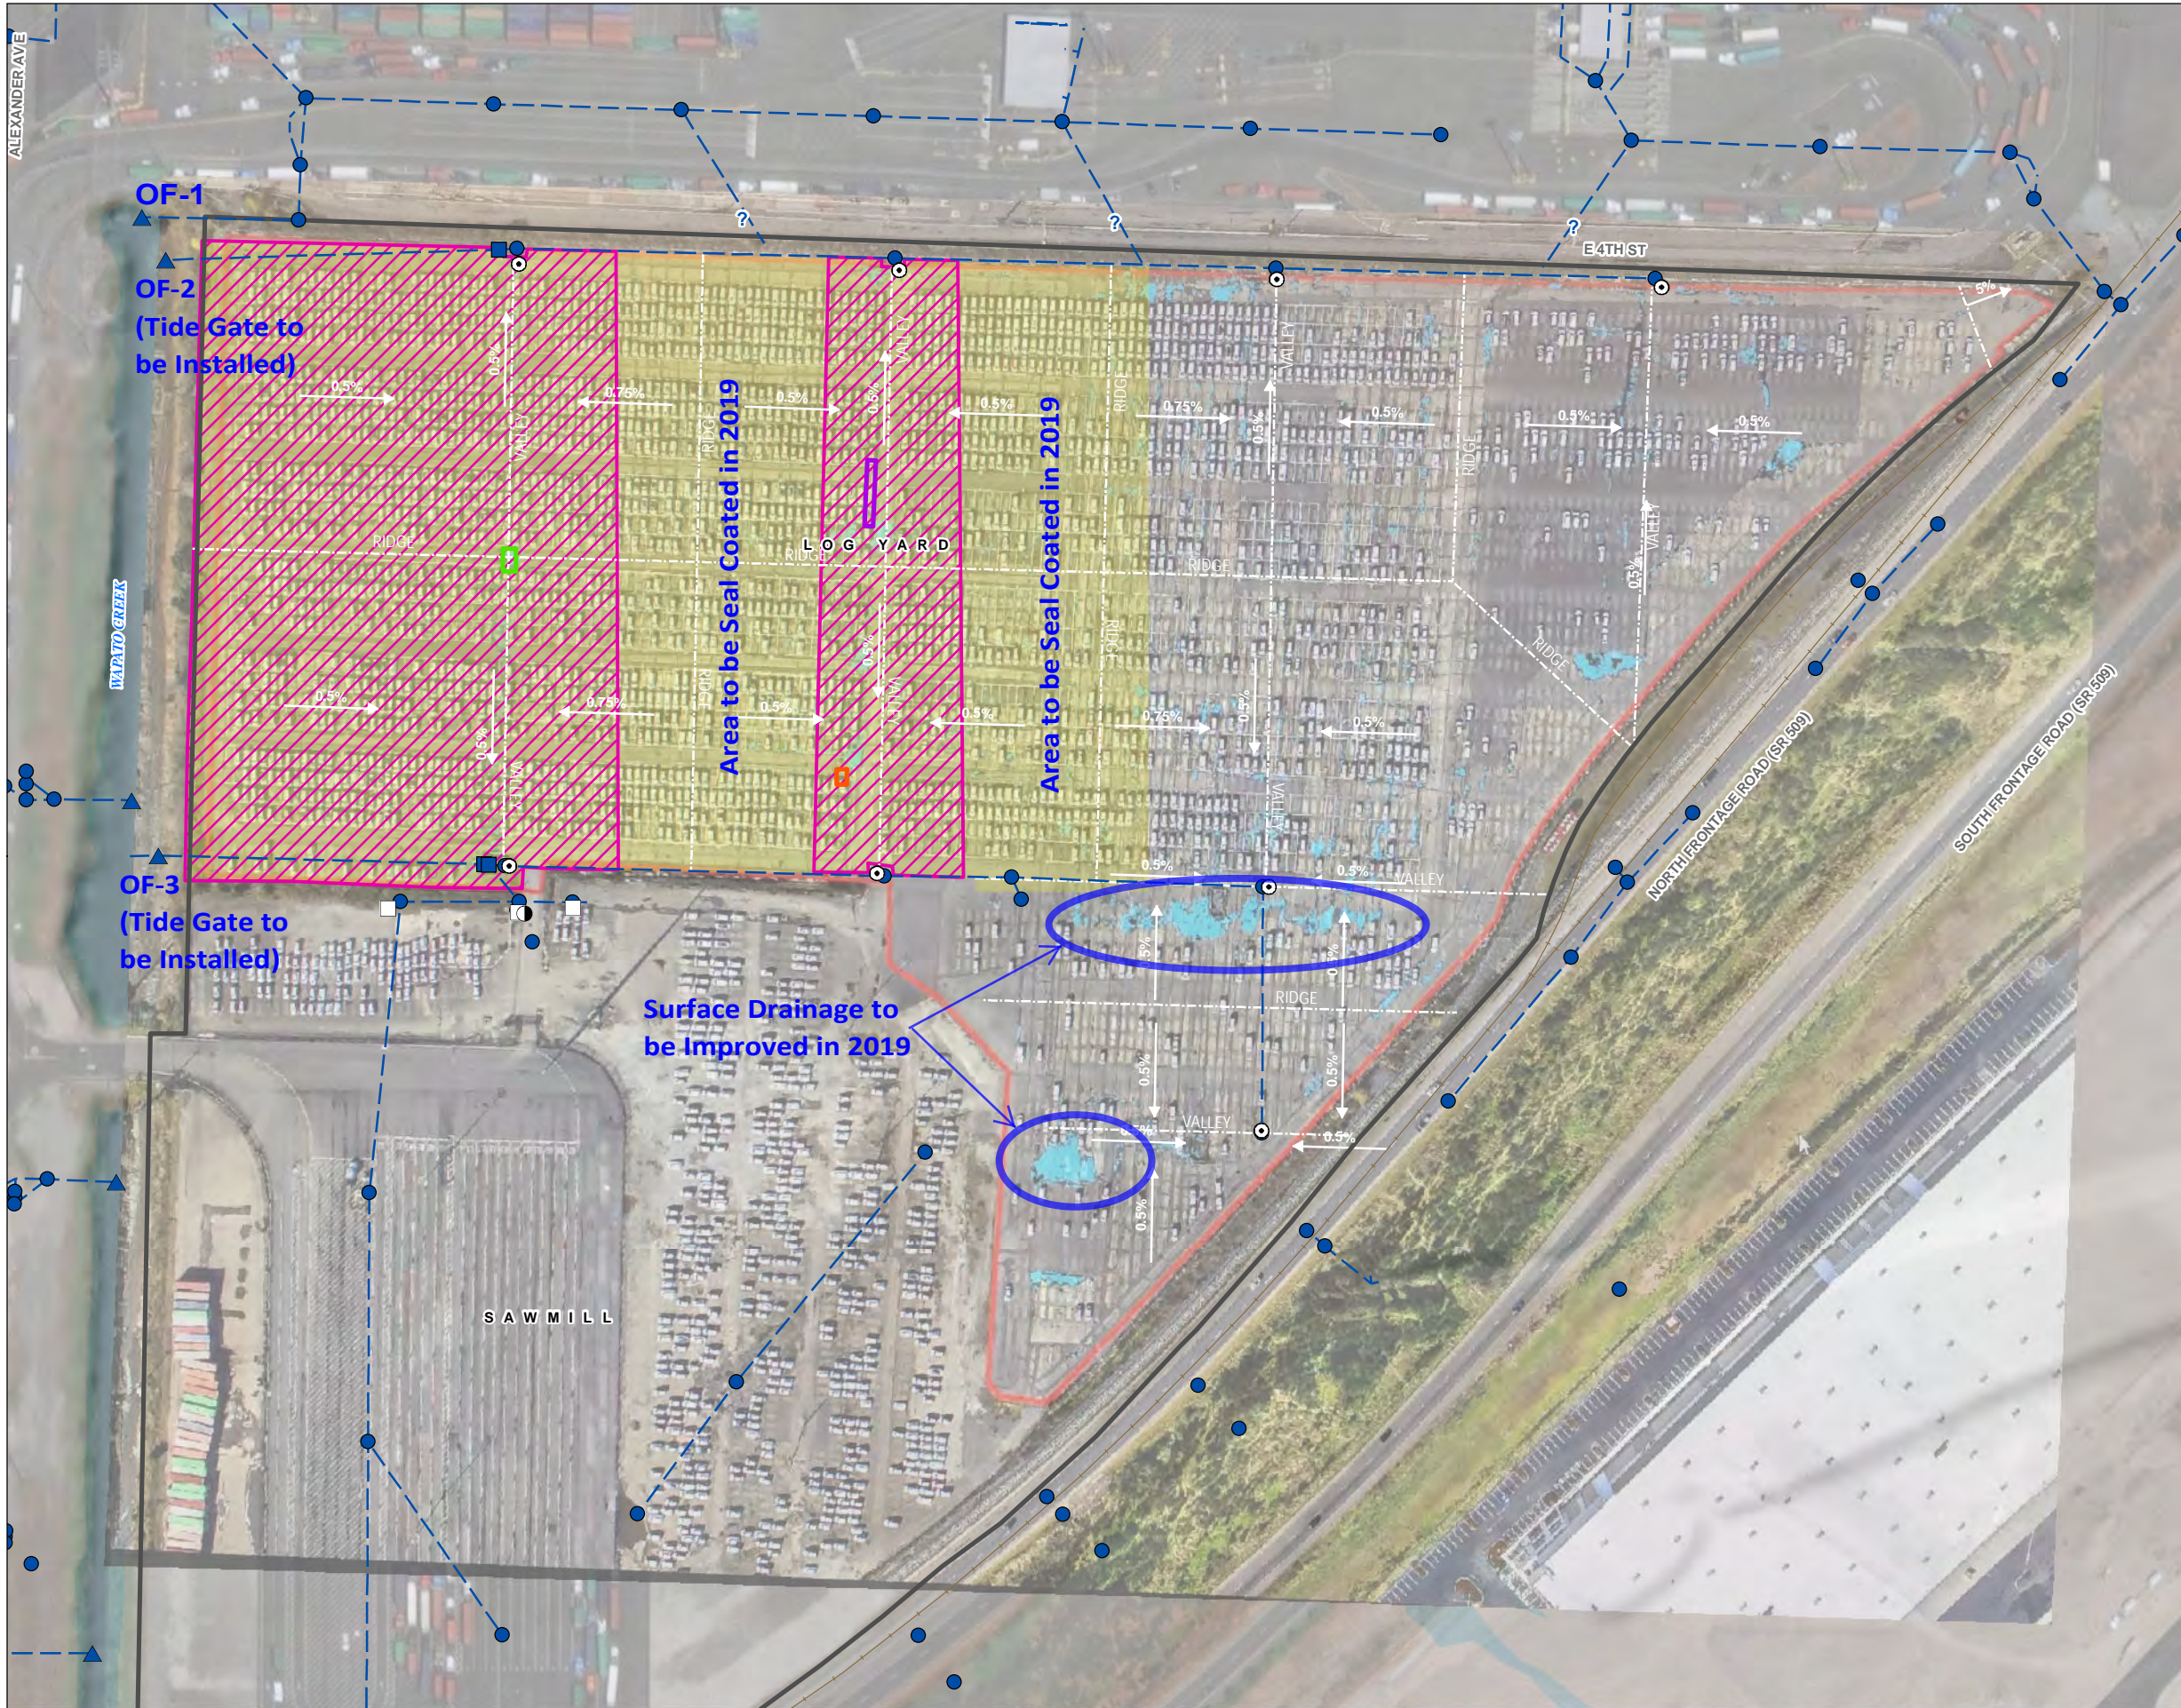
**FIGURE 2**  
**2018 - 19 Interim Cap**  
**Repair and**  
**Maintenance**  
Parcel 15  
Tacoma, Washington

Cap maintenance in 2018 focused on the west side based primarily on proximity to the known perched water zones, and proximity to Wapato Creek (Figure 2). Two cap maintenance activities will be completed in 2019: (1) apply seal coating in areas where crack sealing was completed but no seal coating was applied in 2018, and (2) improve drainage in areas of ponding found in the middle and eastern portions of the cap (shown in Figure 2). In addition, tide gates will be installed in outfalls OF-2 and OF-3 at Wapato Creek to prevent periodic backflow into the stormwater lines located beneath the cap.

Maintenance for the cap focuses on actions that reduce surface water infiltration through the cap. Reducing infiltration through the cap is expected to reduce the amount of perched water in the slag-containing-fill where higher concentrations of arsenic have been observed. The focus of the work will be in the two drainage swales nearest to Wapato Creek as well as spot improvements in surface drainage areas as shown on Figure 2. Cap maintenance actions planned to be completed during the 2019 construction season

- **Sweep Cap:** Areas of the cap shown on Figure 2 where cap maintenance is planned will be swept free of debris prior to completing actions described below.
- **Seal Cap:** After sweeping, the target areas will be sealed to reduce the overall leakage through the cap and to protect the underlying repaired cracks. The seal coat will consist of a thin layer of asphalt emulsion sprayed onto the cap (fog seal). The area targeted for cap sealing is shown on Figure 2.
- **Drainage Improvements:** Surface grinding of the pavement will be completed to improve drainage in areas where there is persistent ponding of surface water. Where there are existing drainage channels, they will be cleaned and additional grinding completed to improve functionality, if needed. The areas targeted for drainage improvements are shown on Figure 2.

Tide gates will be installed in outfalls OF-2 and OF-3, as shown on Figure 2. The type and model of the tide gates will be selected and installed by the Port of Tacoma operations staff. The tide gates will be installed in-line near the end of the outfall pipes at Wapato Creek. Specifics of the type and model of tide gate used will be provided in a construction report after the cap maintenance and tide gate work is completed.
