October 27, 2016

Subject: Engineering and Institutional Controls Monitoring Report – Year 2
Cap Sante Marine Site
Anacortes, Washington
Ecology Consent Decree No. 9917
GEI File No. 5147-005-10

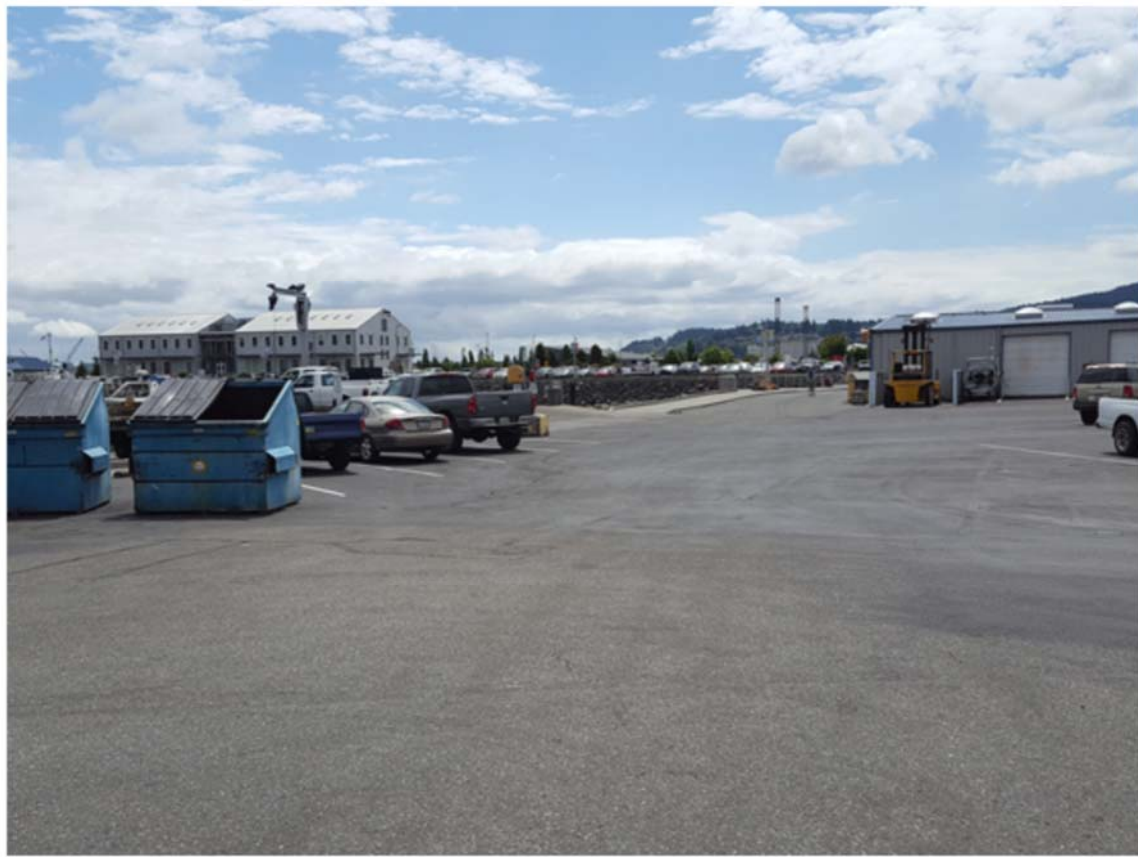
Photo A1: Protective asphalt barrier looking southeast from Control Point A1 (See Figure 1).

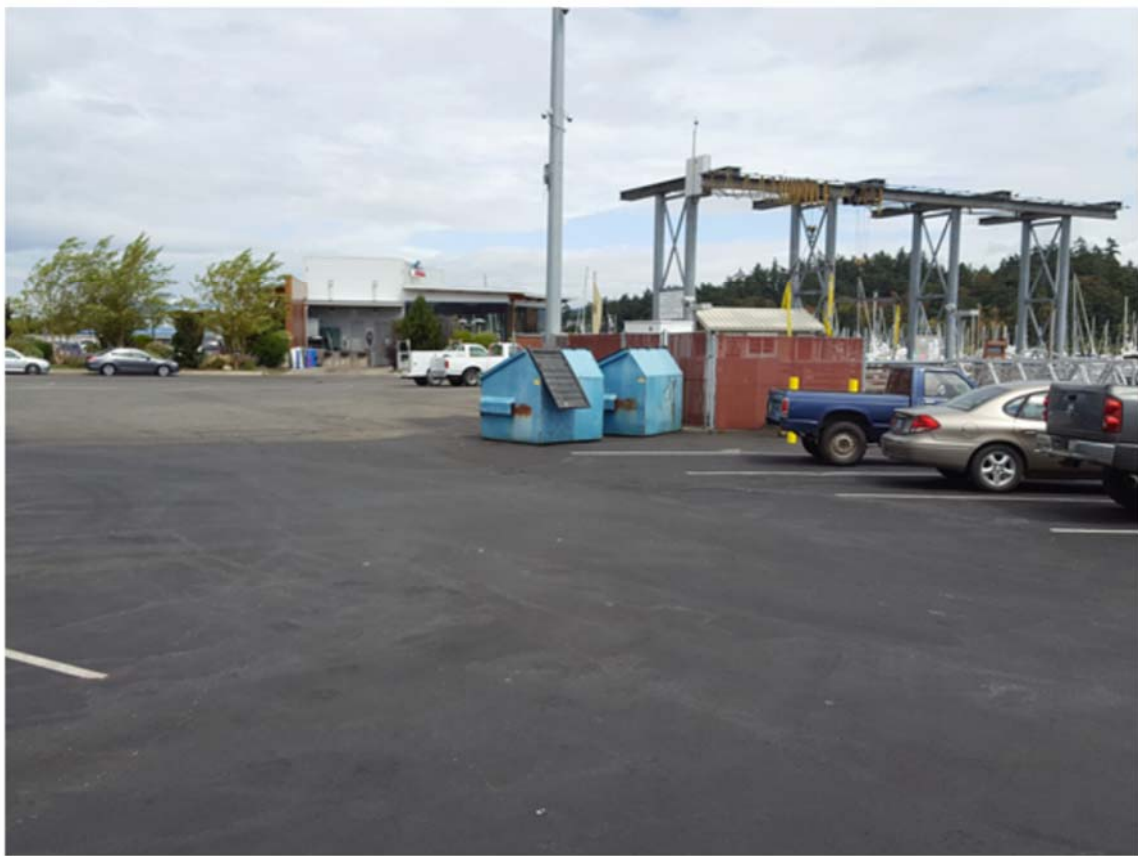
Photo A2: Protective asphalt barrier looking northeast from Control Point A2 (see Figure 1).

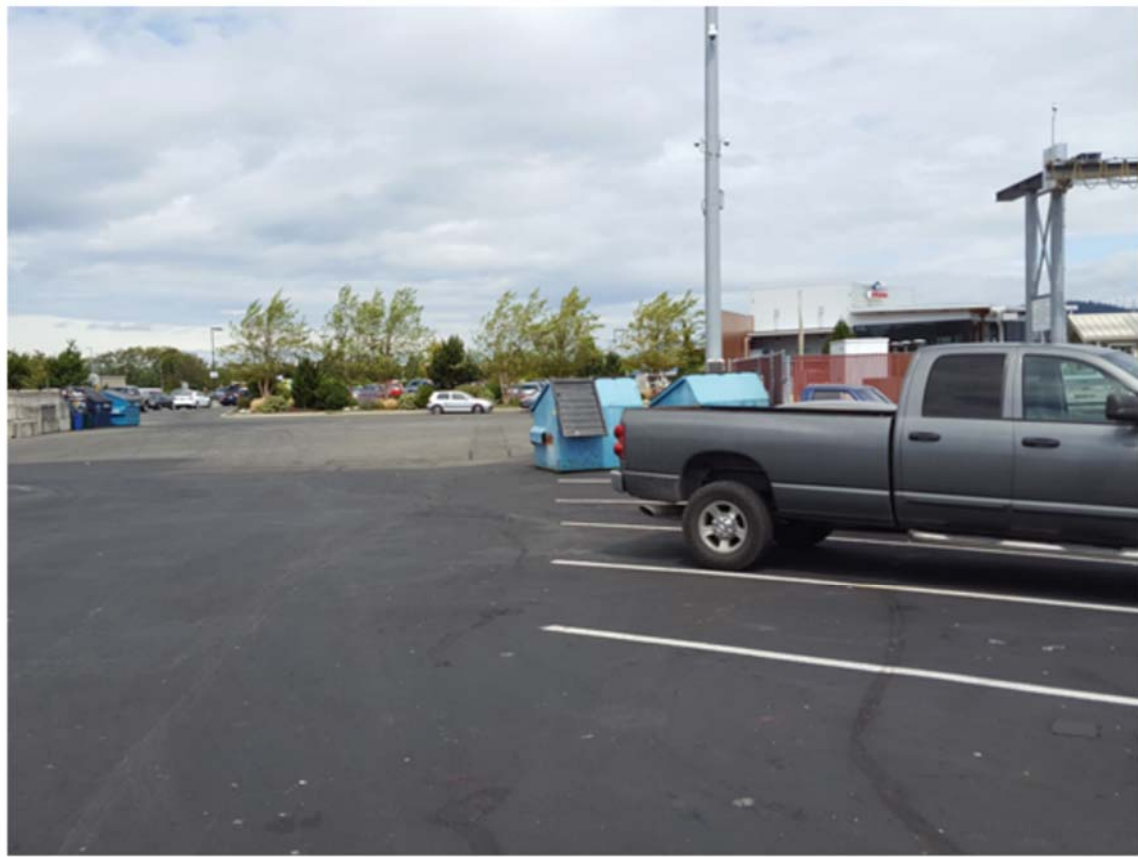
Photo A3: Protective asphalt barrier looking north (see Figure 1).

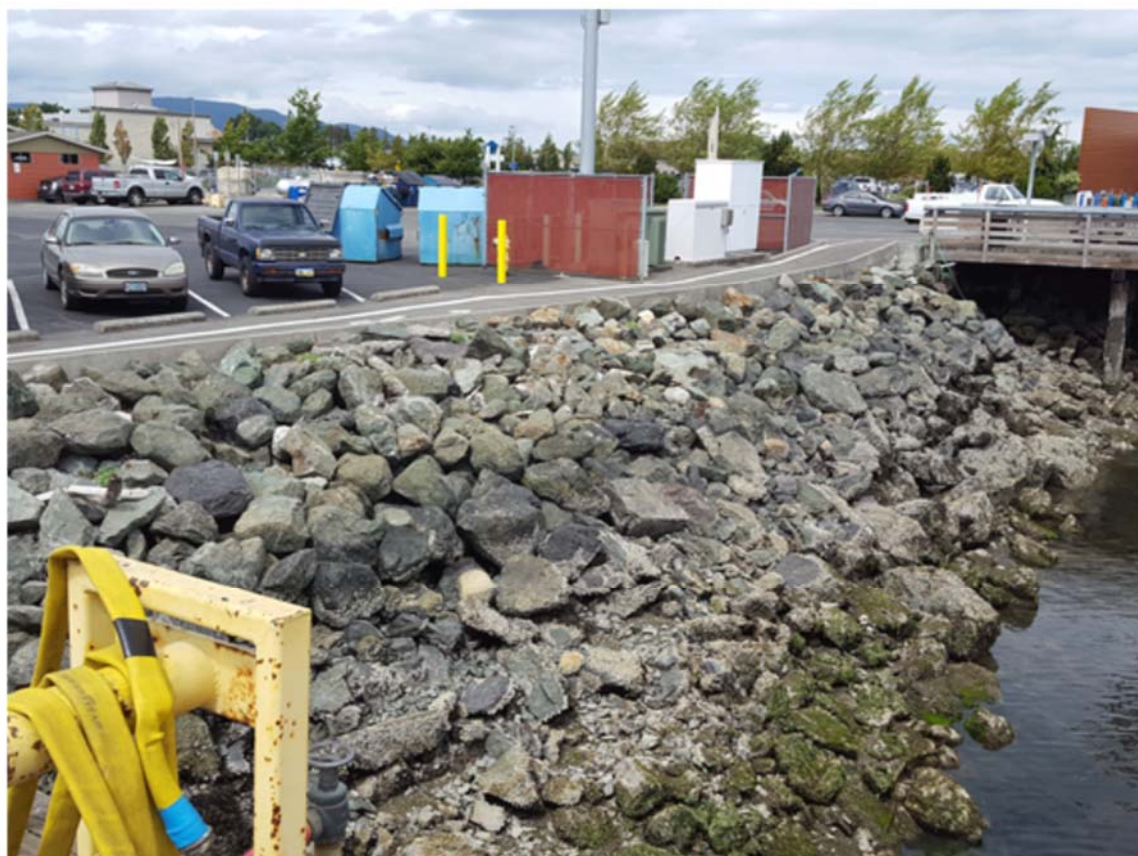
Photo A4: Protective stone revetment barrier looking northwest (see Figure 1).

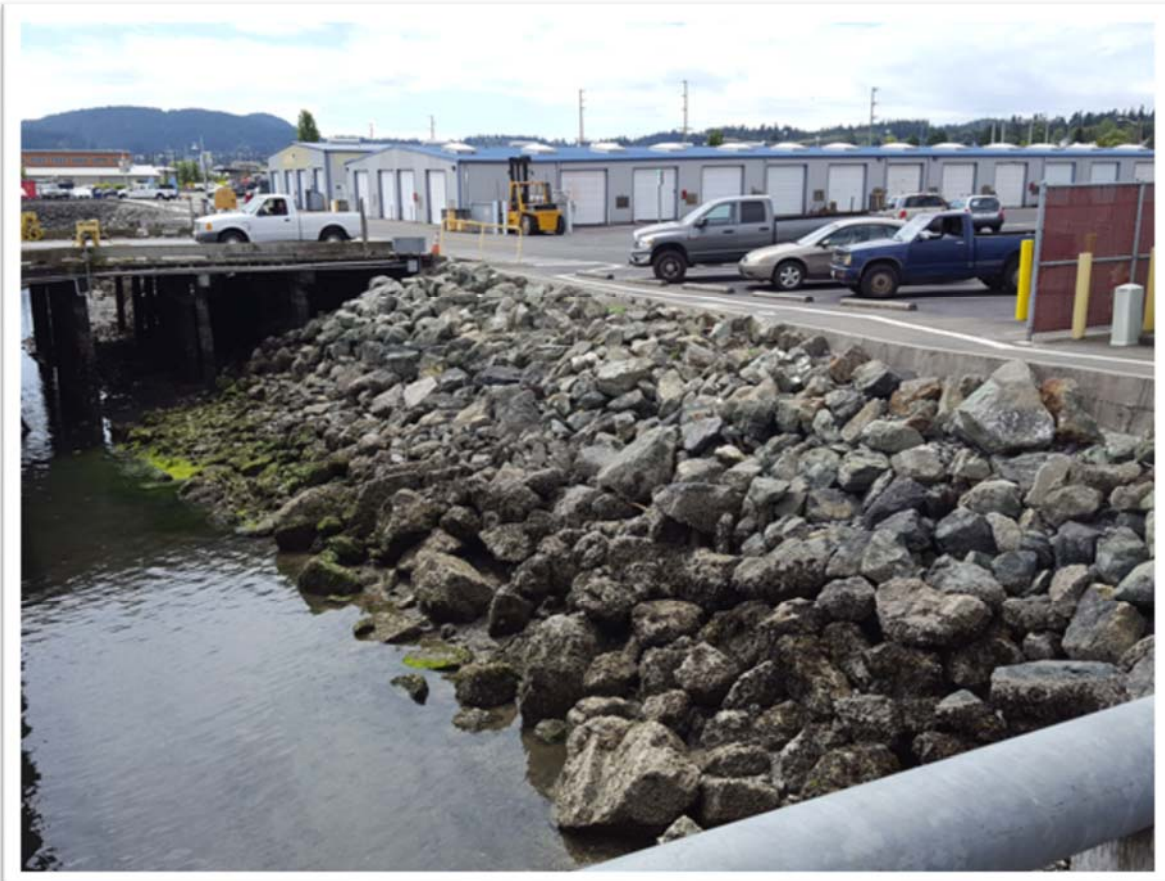
Photo A5: Protective stone revetment barrier looking southwest (see Figure 1).

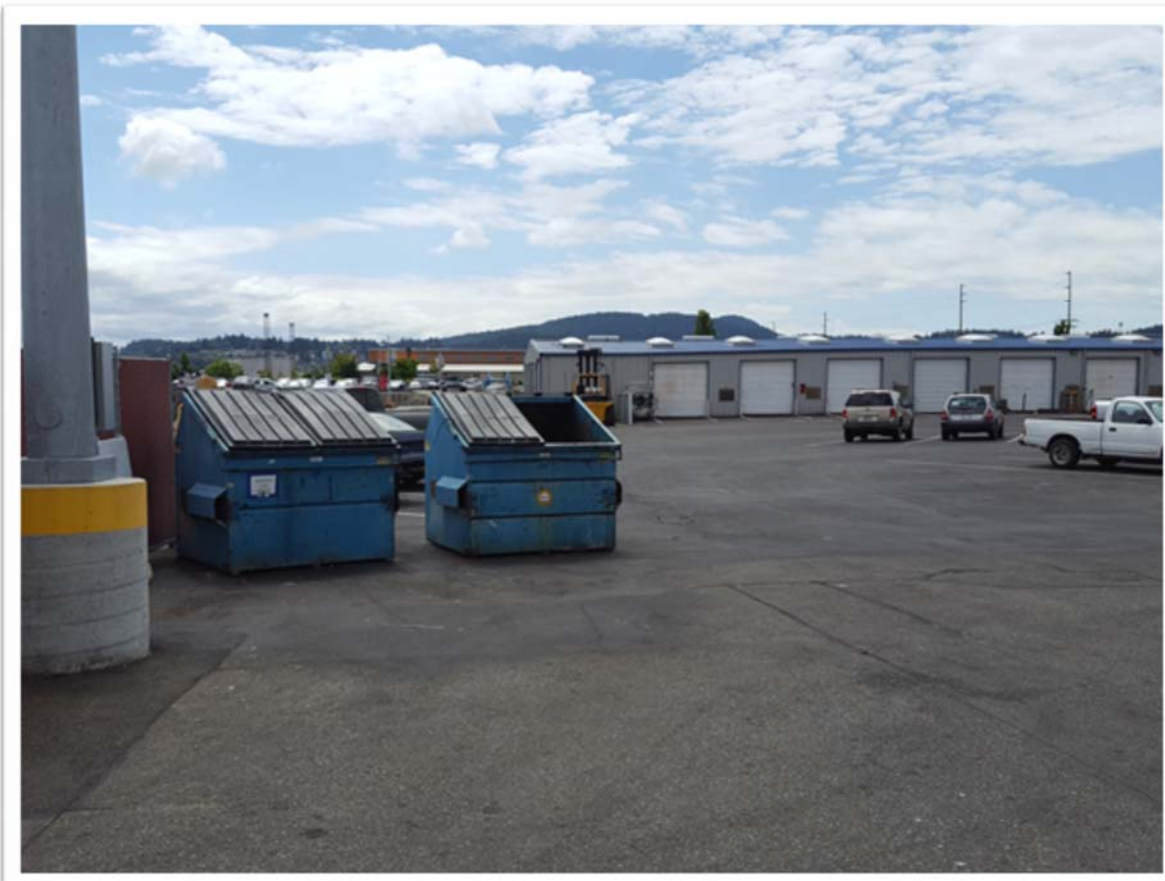
Photo A6: Protective asphalt barrier looking south (see Figure 1).

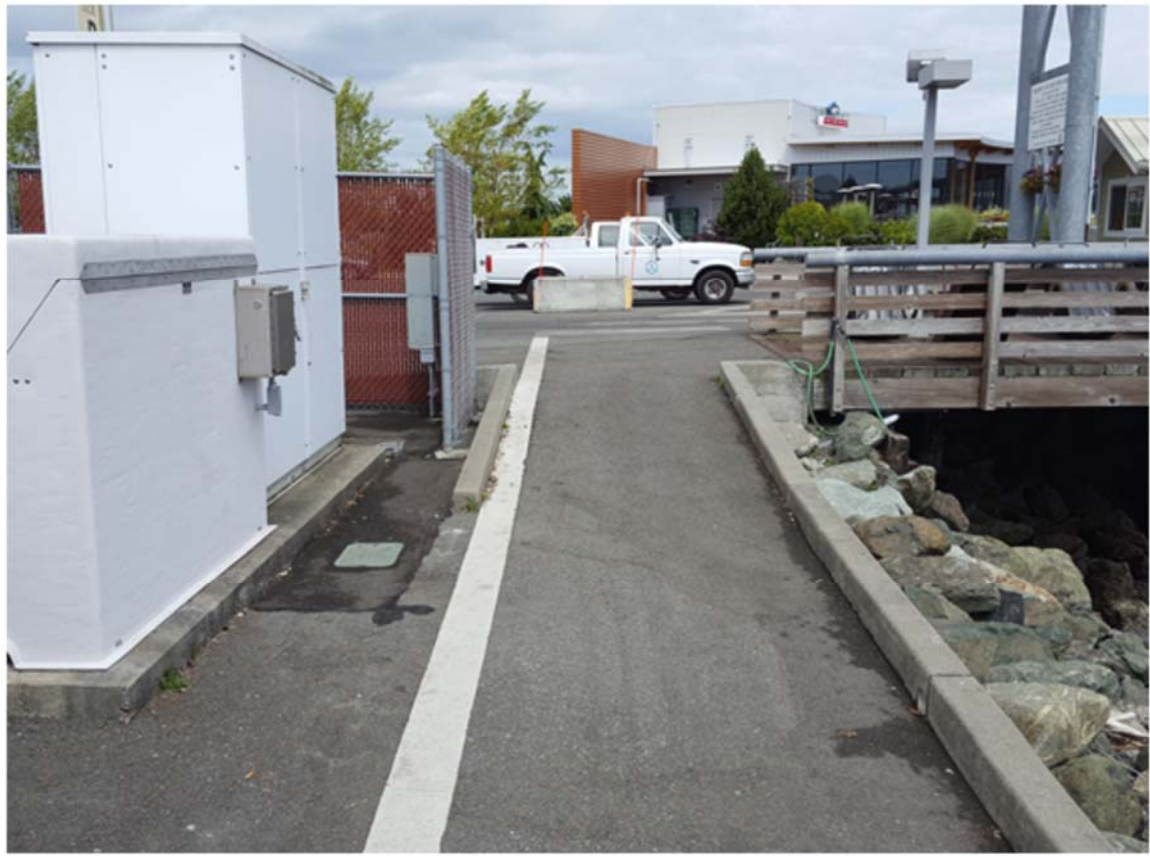
Photo A7: Protective asphalt barrier east of the utilities looking north (see Figure 1).

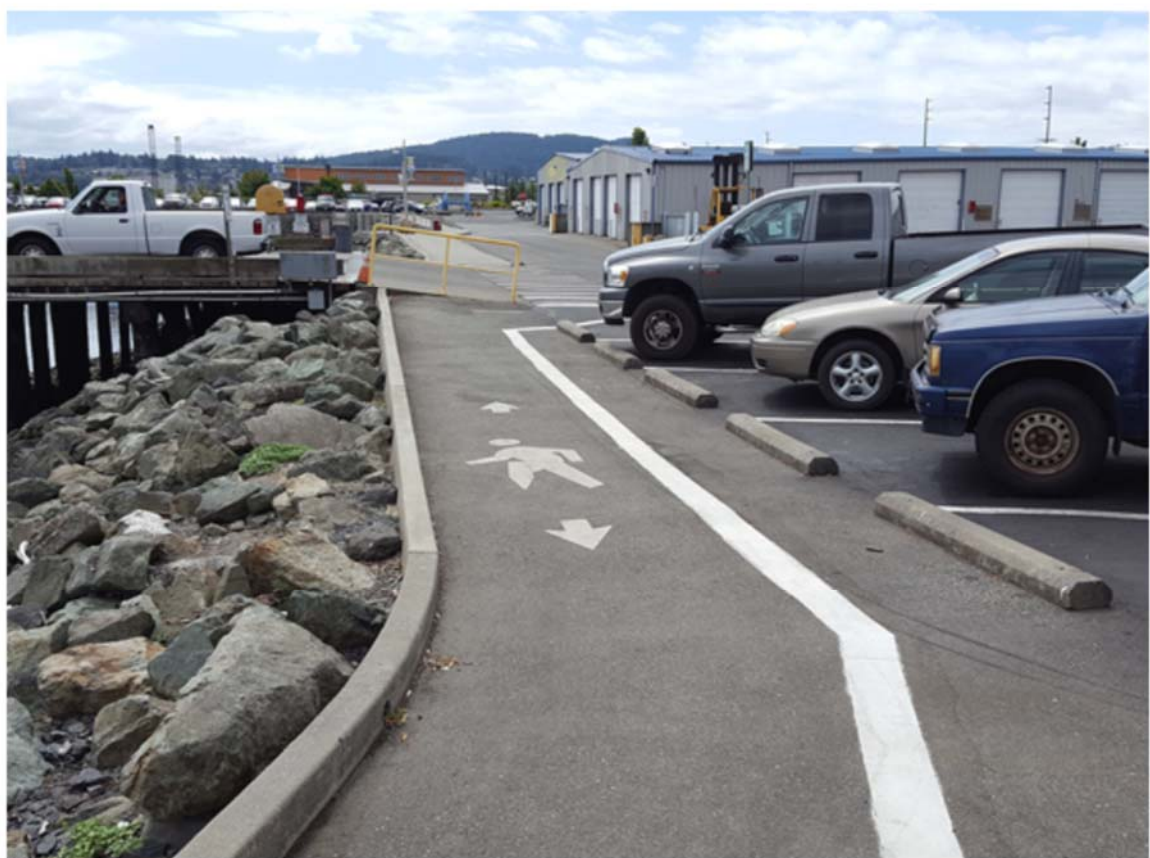
Photo A8: Protective asphalt barrier east of the utilities looking south (see Figure 1).

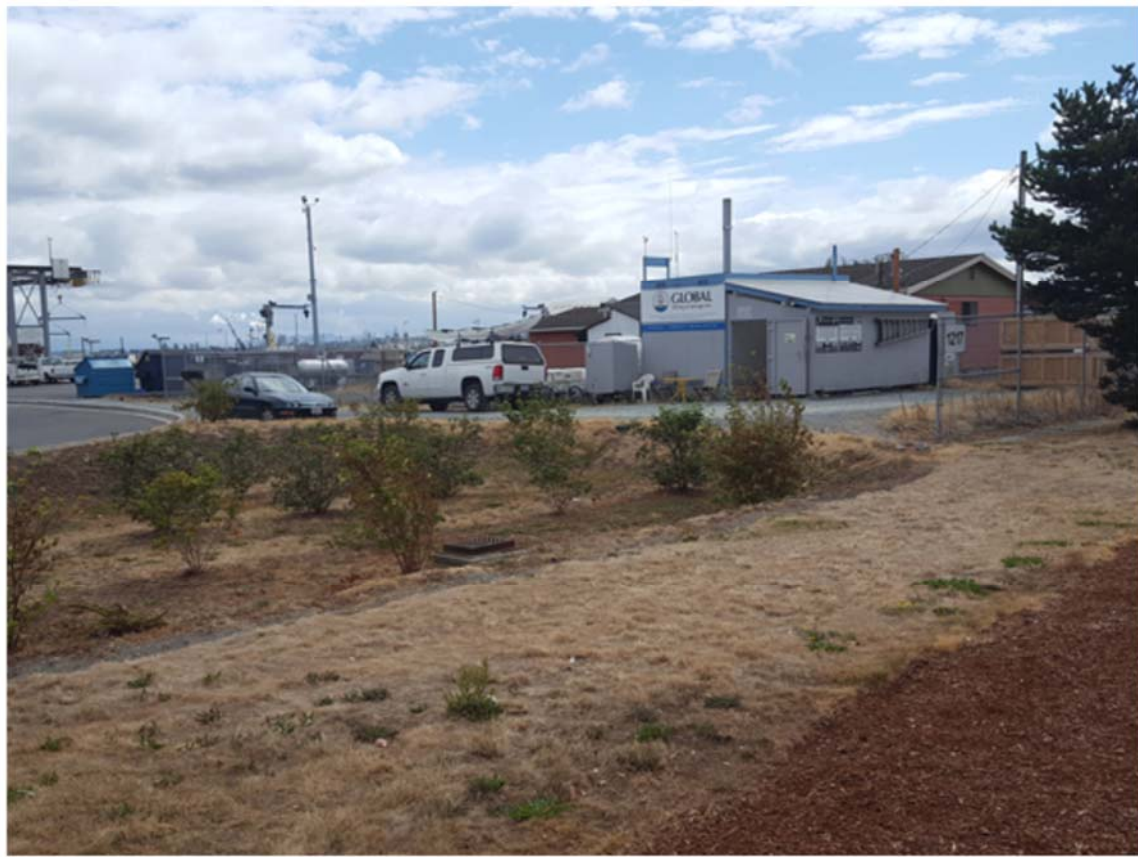
Photo B1: Protective vegetated topsoil barrier looking southeast (see Figure 2)

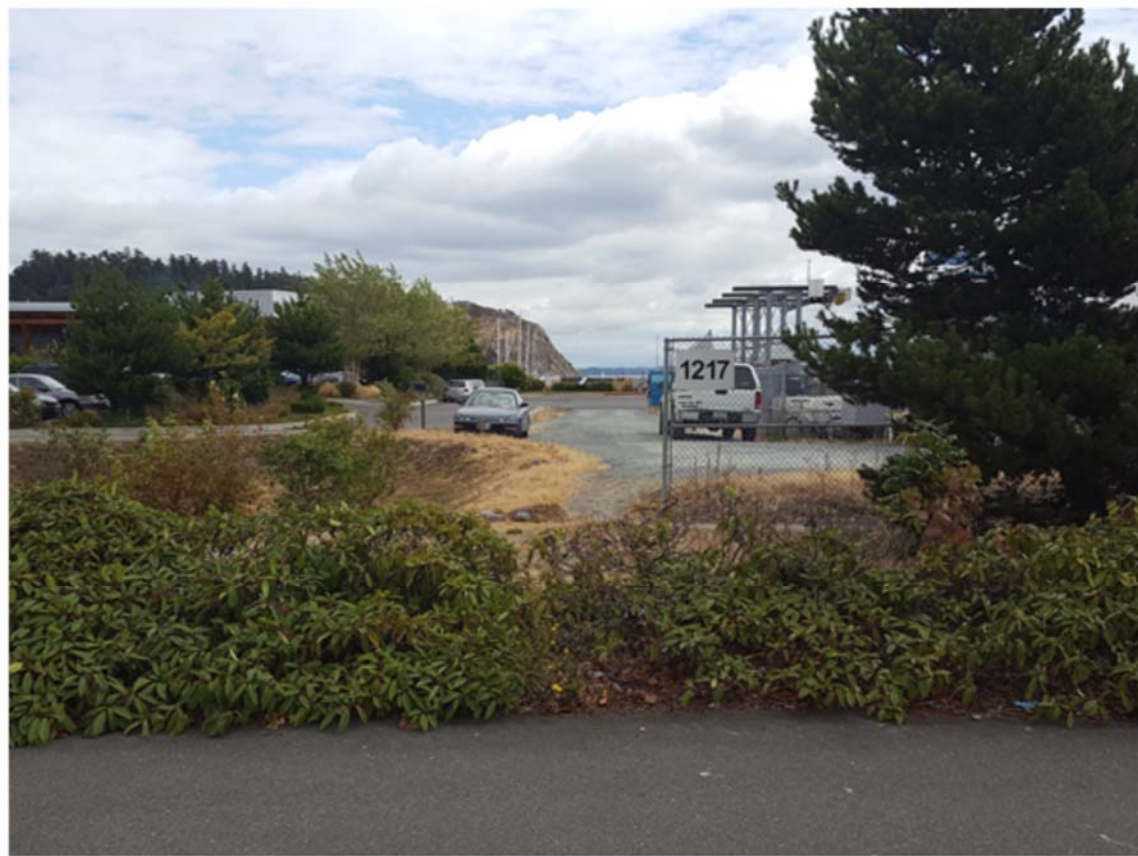
Photo B2: Protective vegetated topsoil and crushed gravel barriers looking north (see Figure 2)

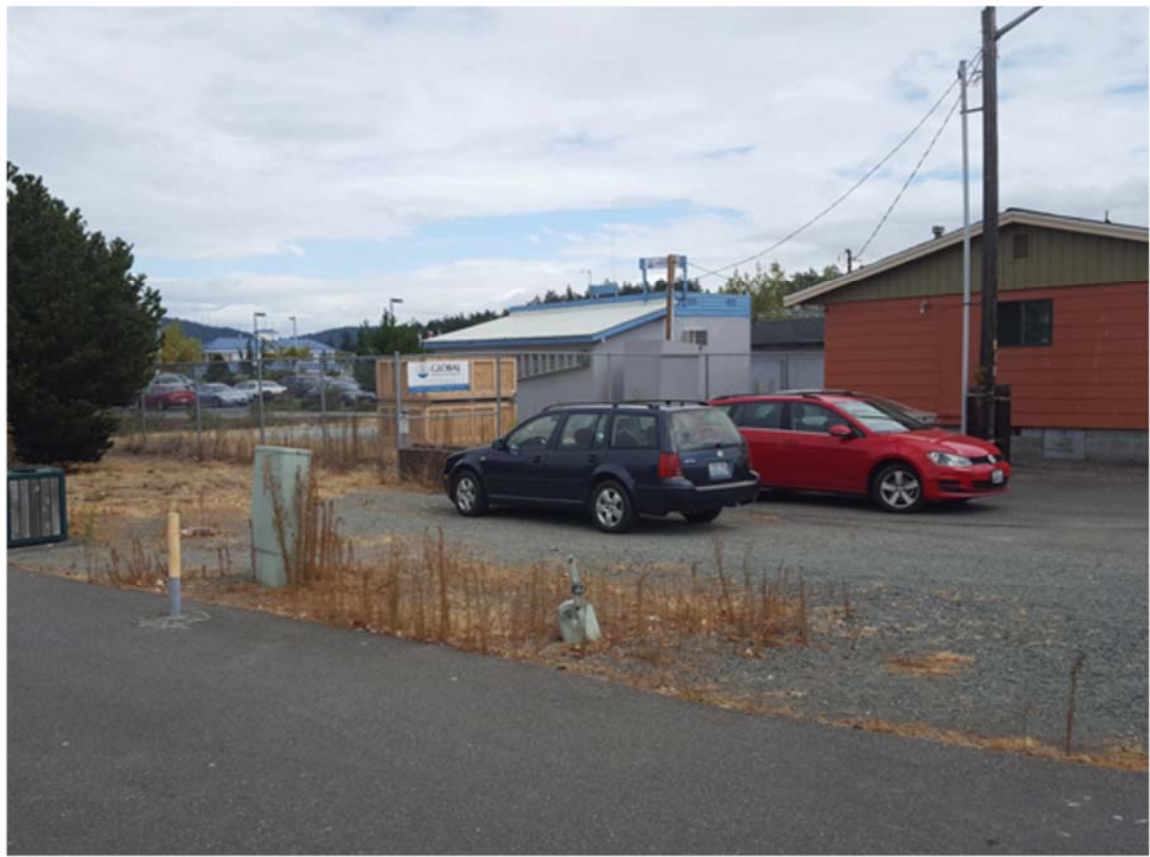
Photo B3: Protective asphalt and crushed gravel barriers looking northeast (see Figure 2)

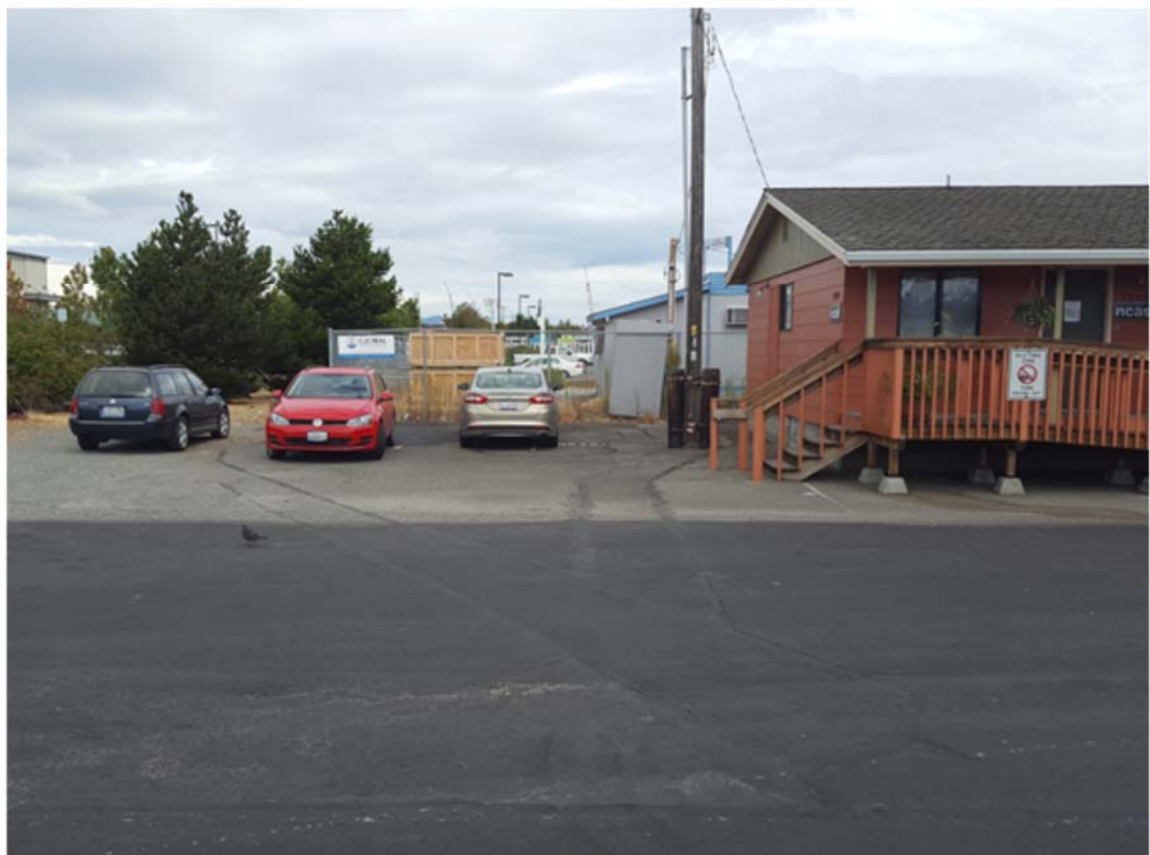
Photo B4: Protective asphalt barrier south of the office building (see Figure 2)

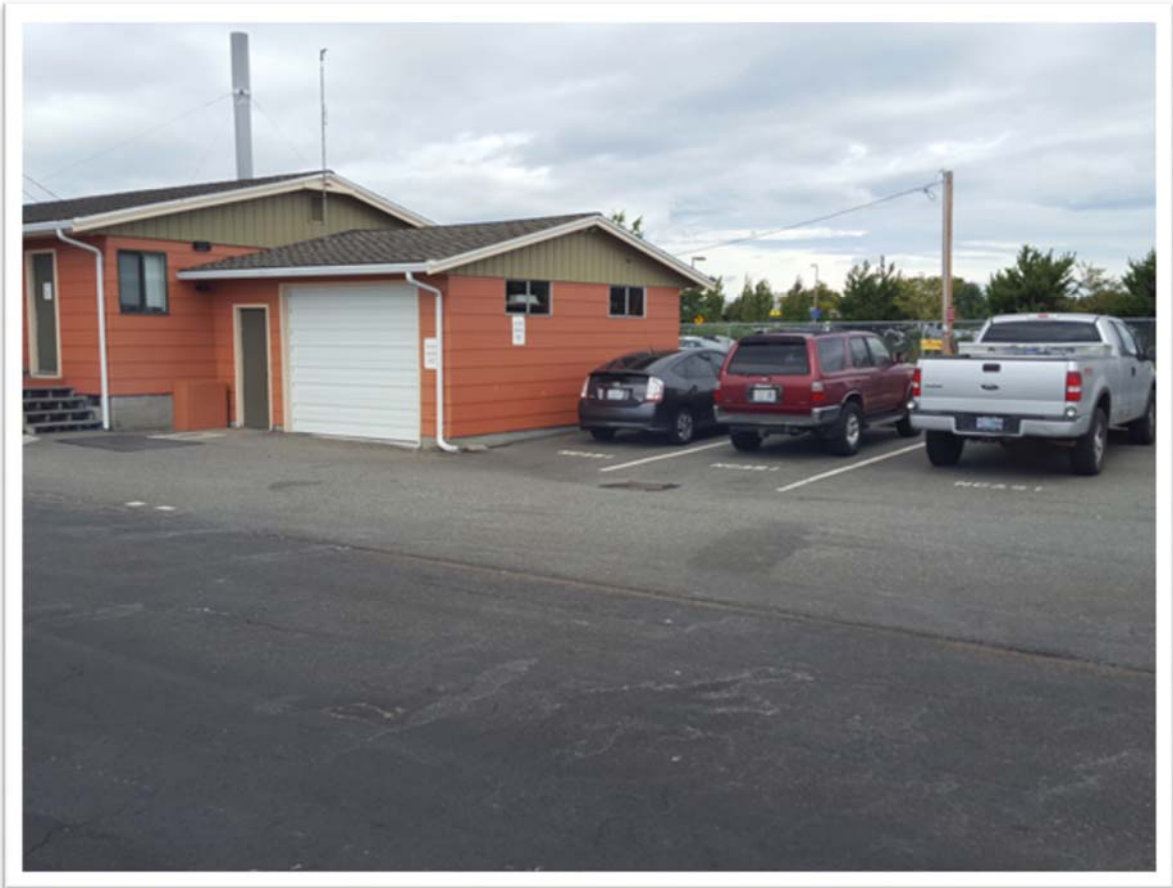
Photo B5: Protective asphalt barrier looking northwest from Control Point B1 (see Figure 2)

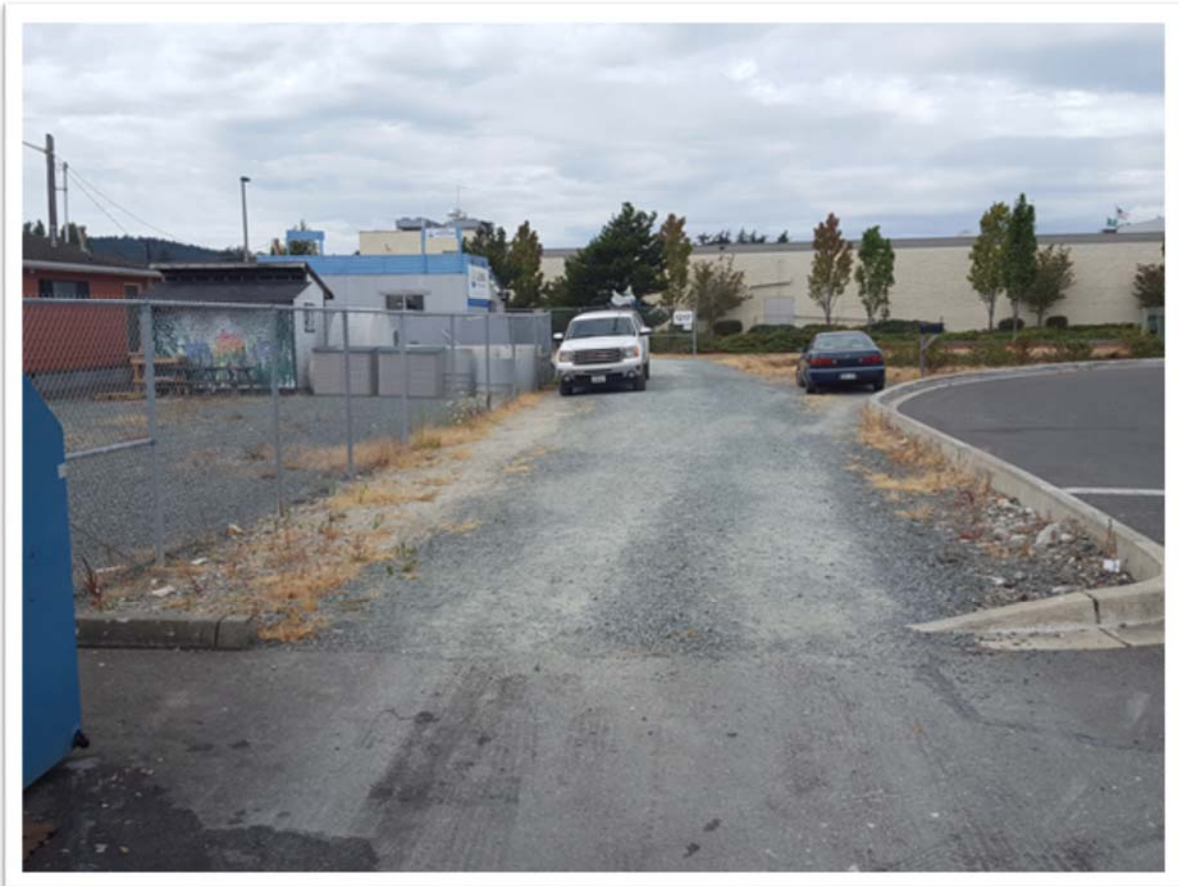
Photo B6: Protective crush gravel and topsoil barriers with fenced enclosure north of the office building (see Figure 2)

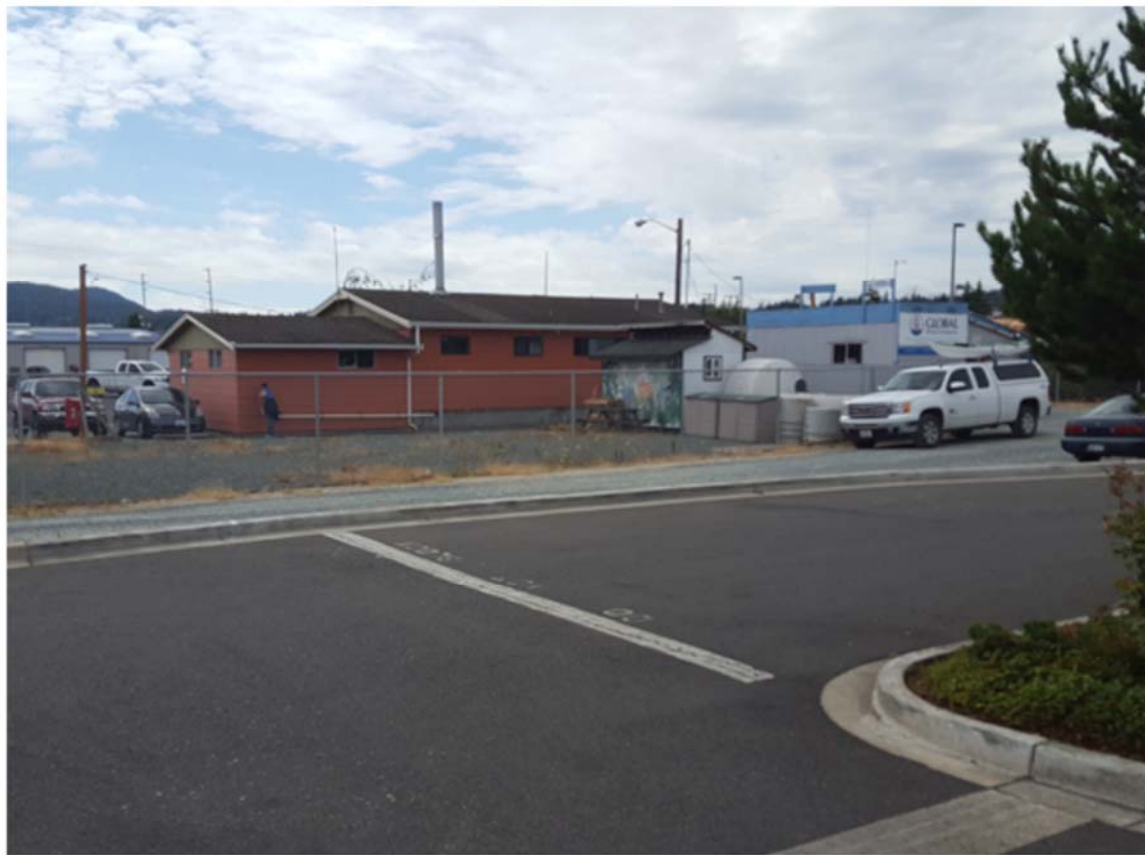
Photo B7: Protective crush gravel, topsoil and asphalt barriers north of the office building (see Figure 2)

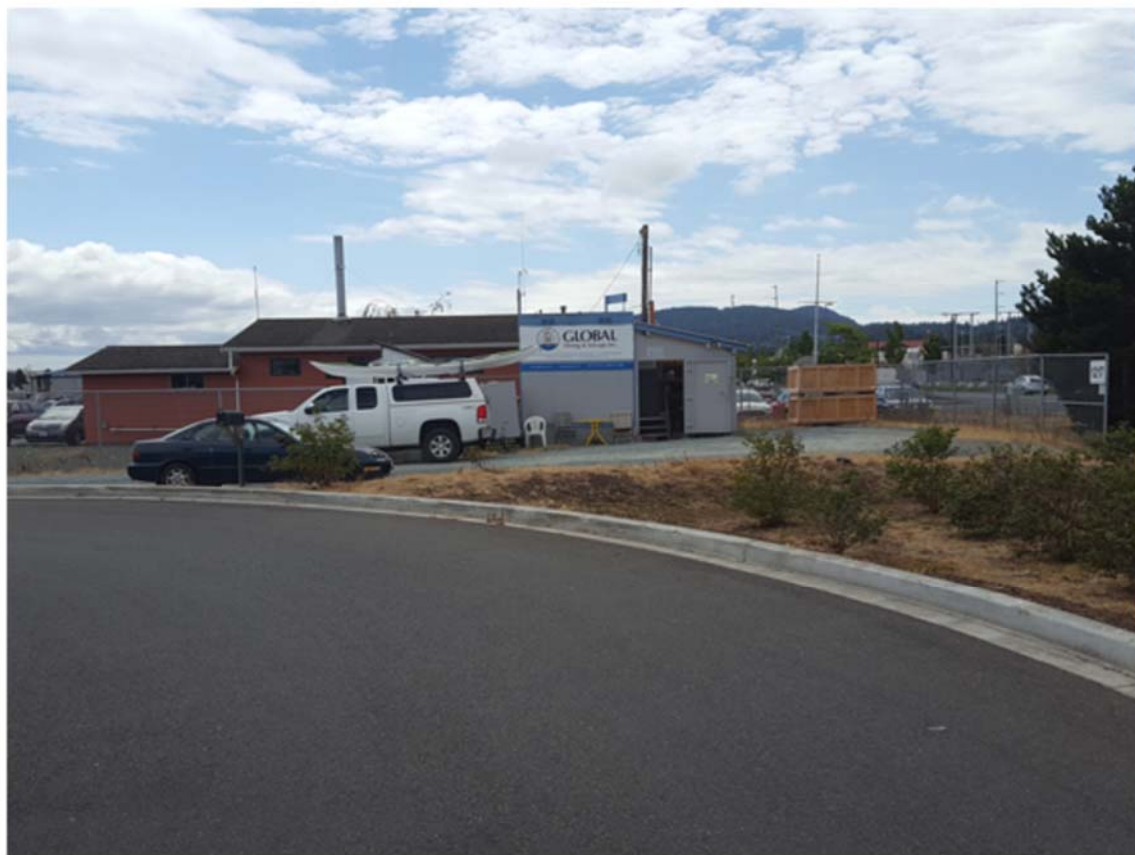
Photo B8: Protective crush gravel and topsoil barriers with fenced enclosure north of the office building (see Figure 2)
