Port of Anacortes
Engineering and Institutional Controls Report
Year 5 – 2019

Cap Sante Marine Site
Anacortes, WA
Ecology Consent Decree No. 9917

Subject: Engineering and Institutional Controls Monitoring Report – Year 5 – 2019
Cap Sante Marine Site
Anacortes, Washington
Ecology Consent Decree No. 9917

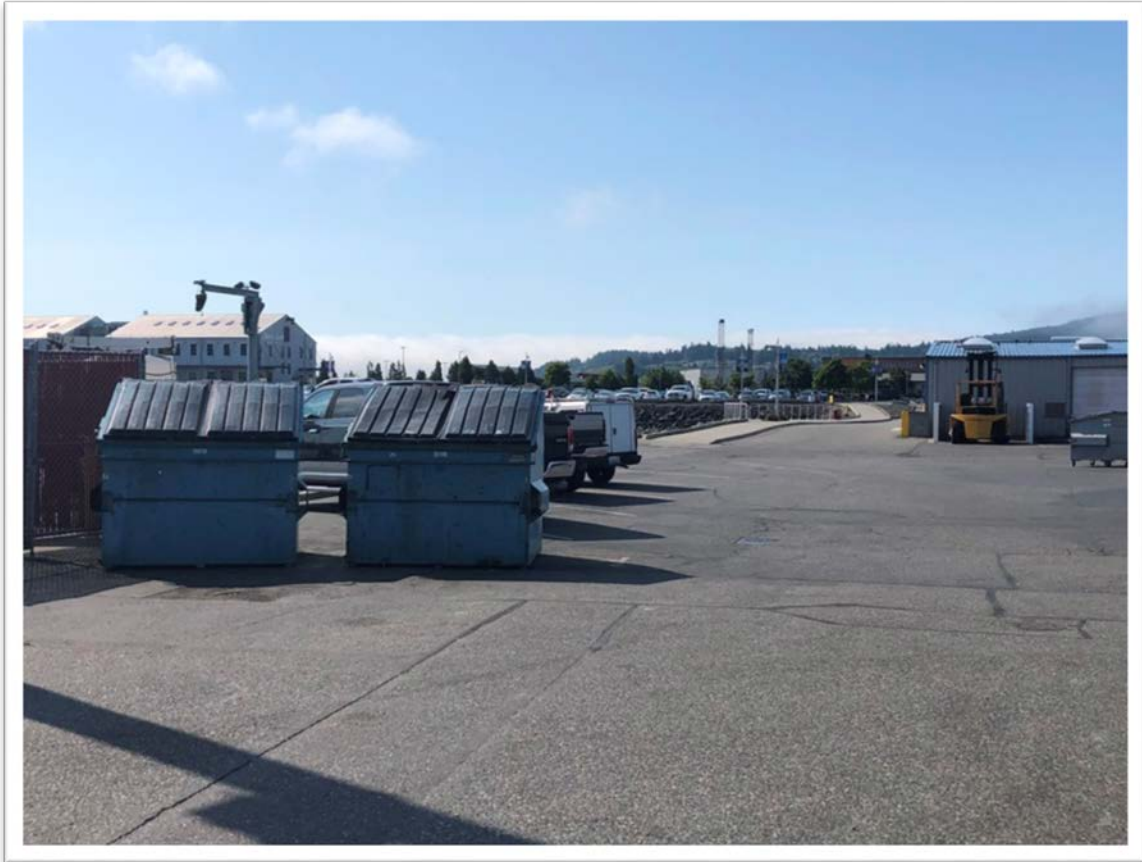
Photo A1: Protective asphalt barrier looking southeast from Control Point A1 (See Figure 1).

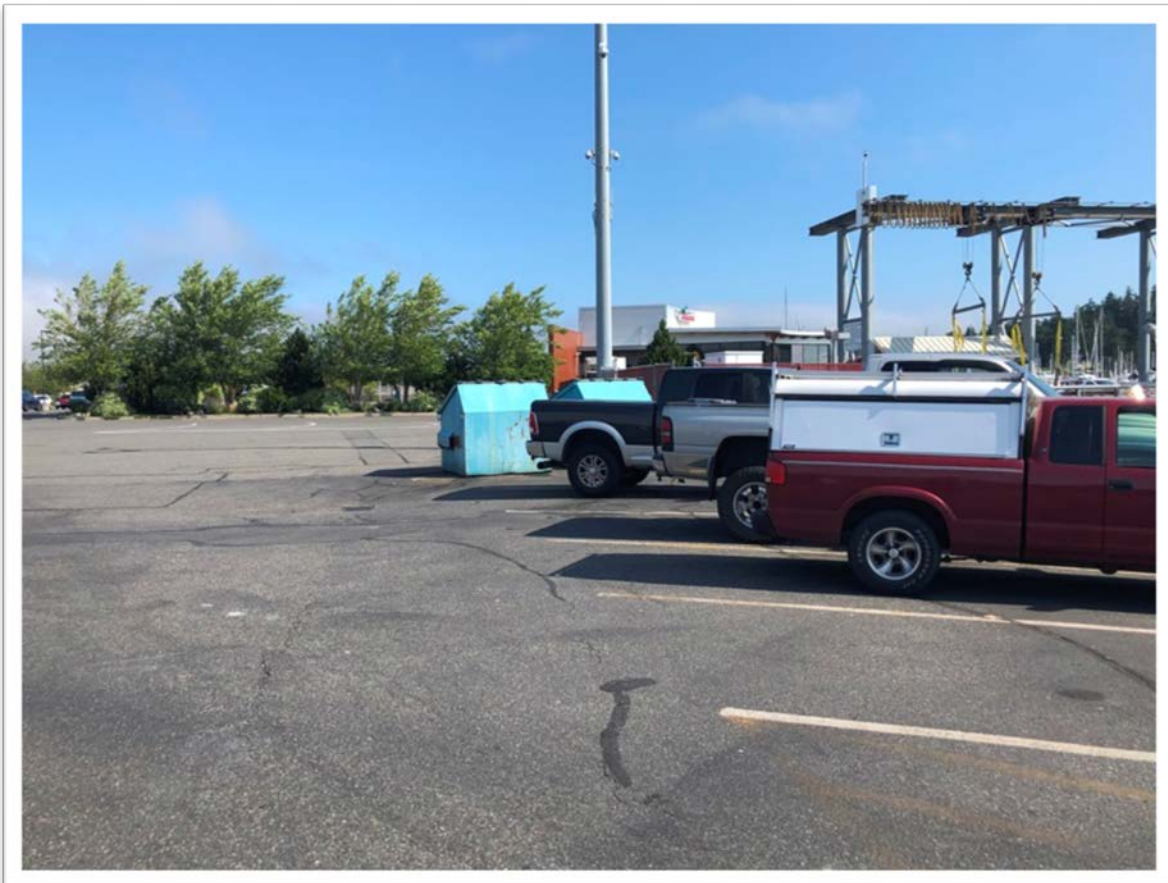
Photo A2: Protective asphalt barrier looking northeast from Control Point A2 (see Figure 1).

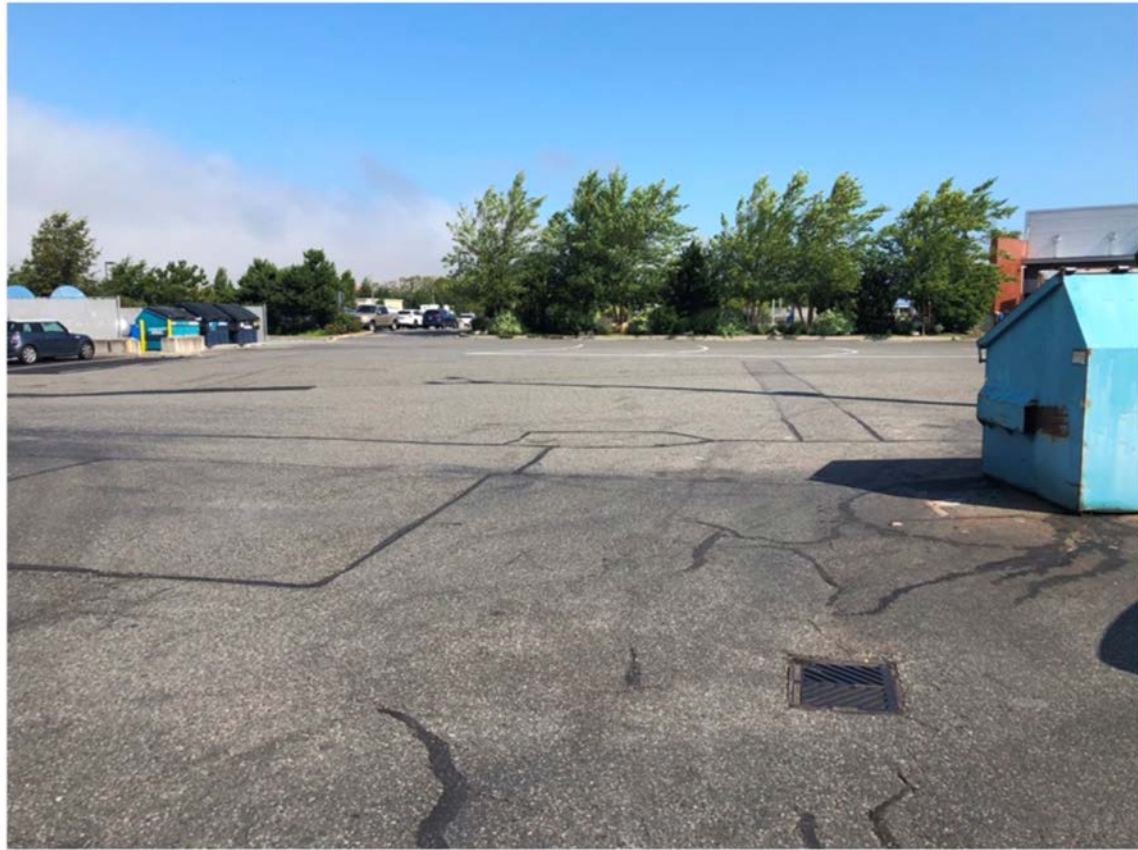
Photo A3: Protective asphalt barrier looking north (see Figure 1).

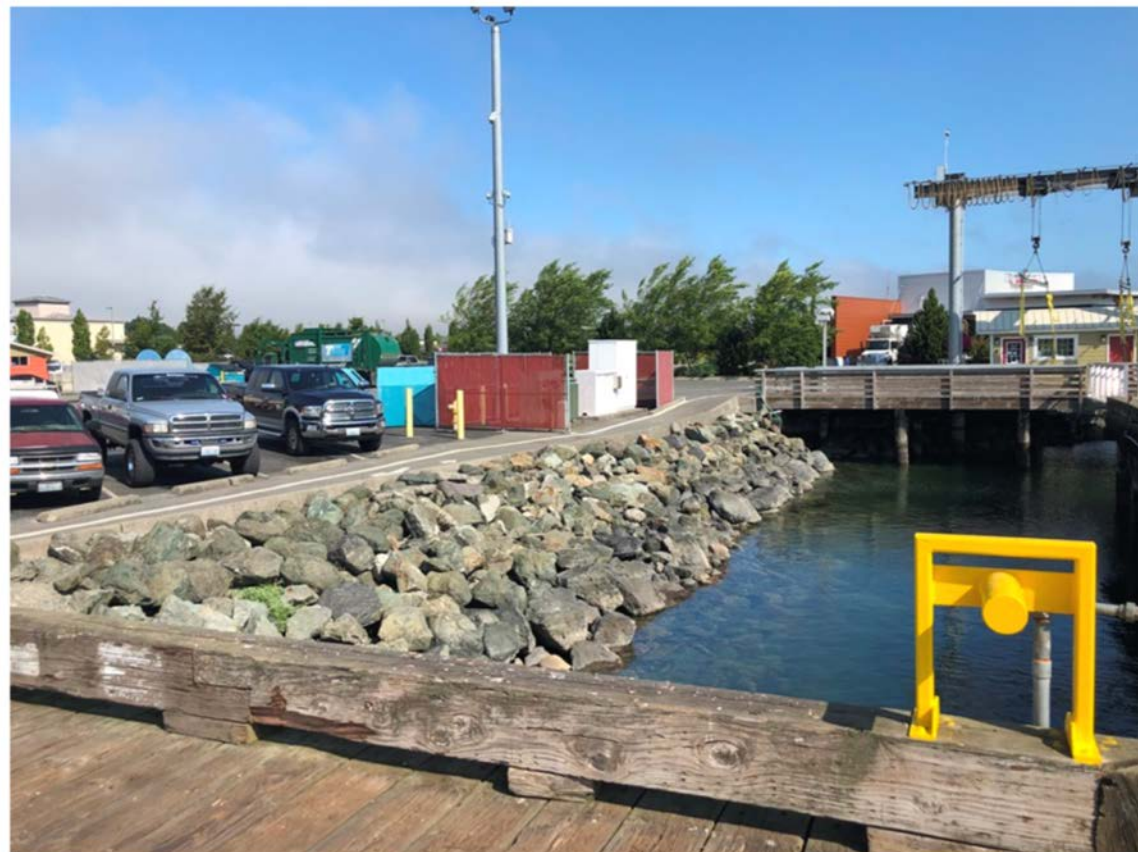
Photo A4: Protective stone revetment barrier looking northwest (see Figure 1).

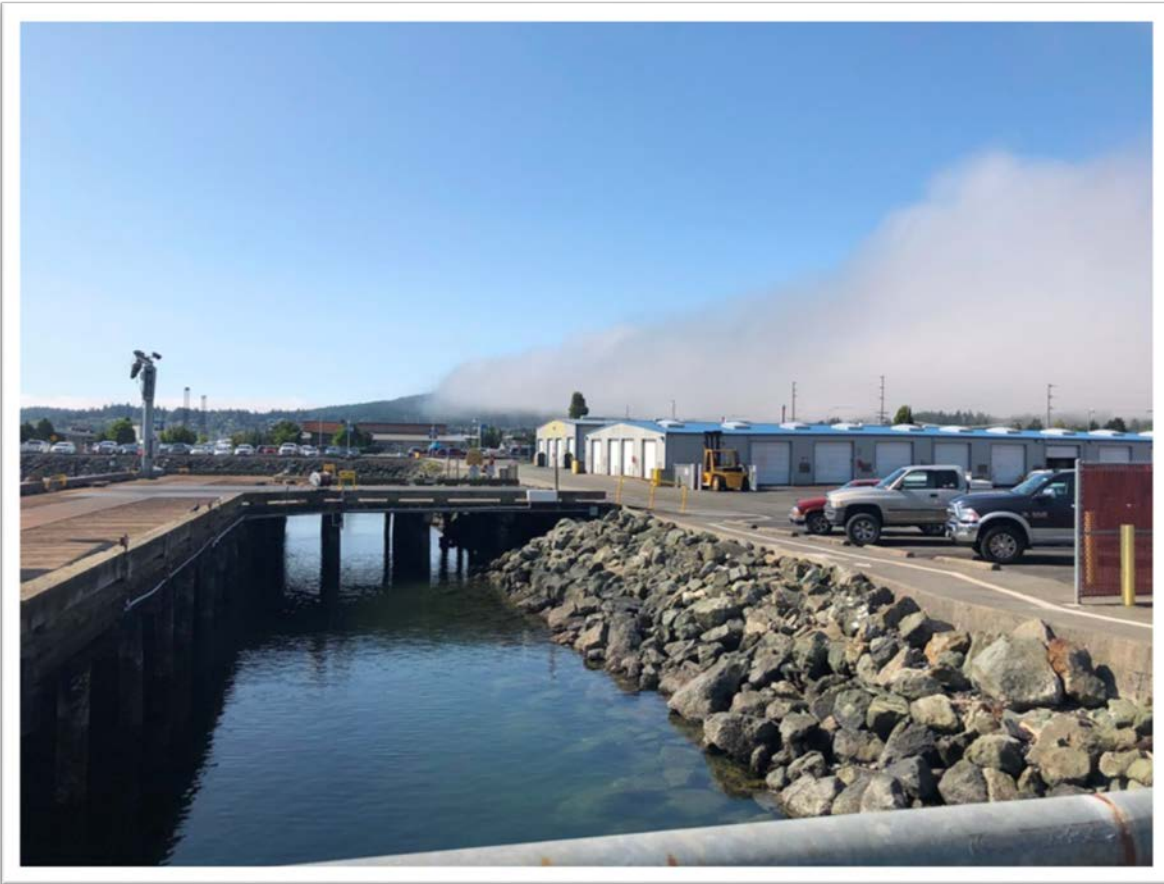
Photo A5: Protective stone revetment barrier looking southwest (see Figure 1).

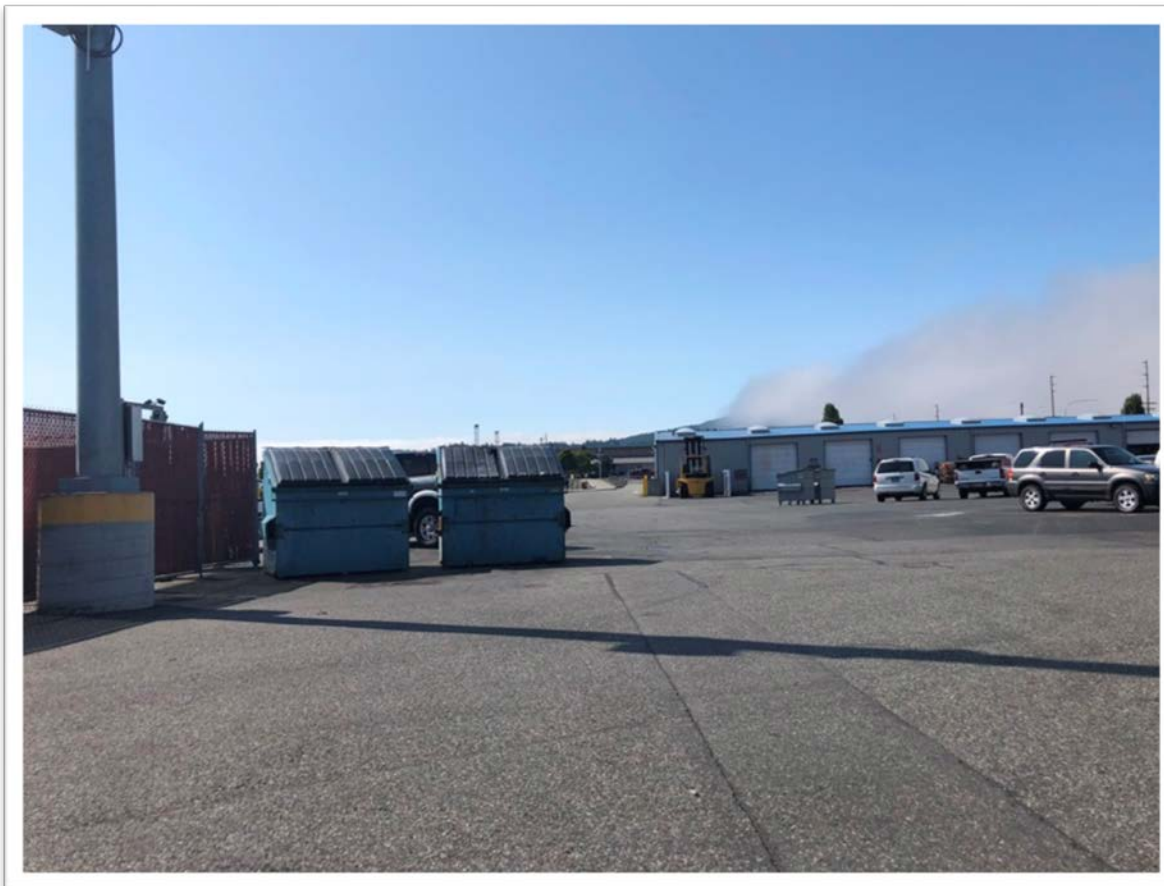
Photo A6: Protective asphalt barrier looking south (see Figure 1).

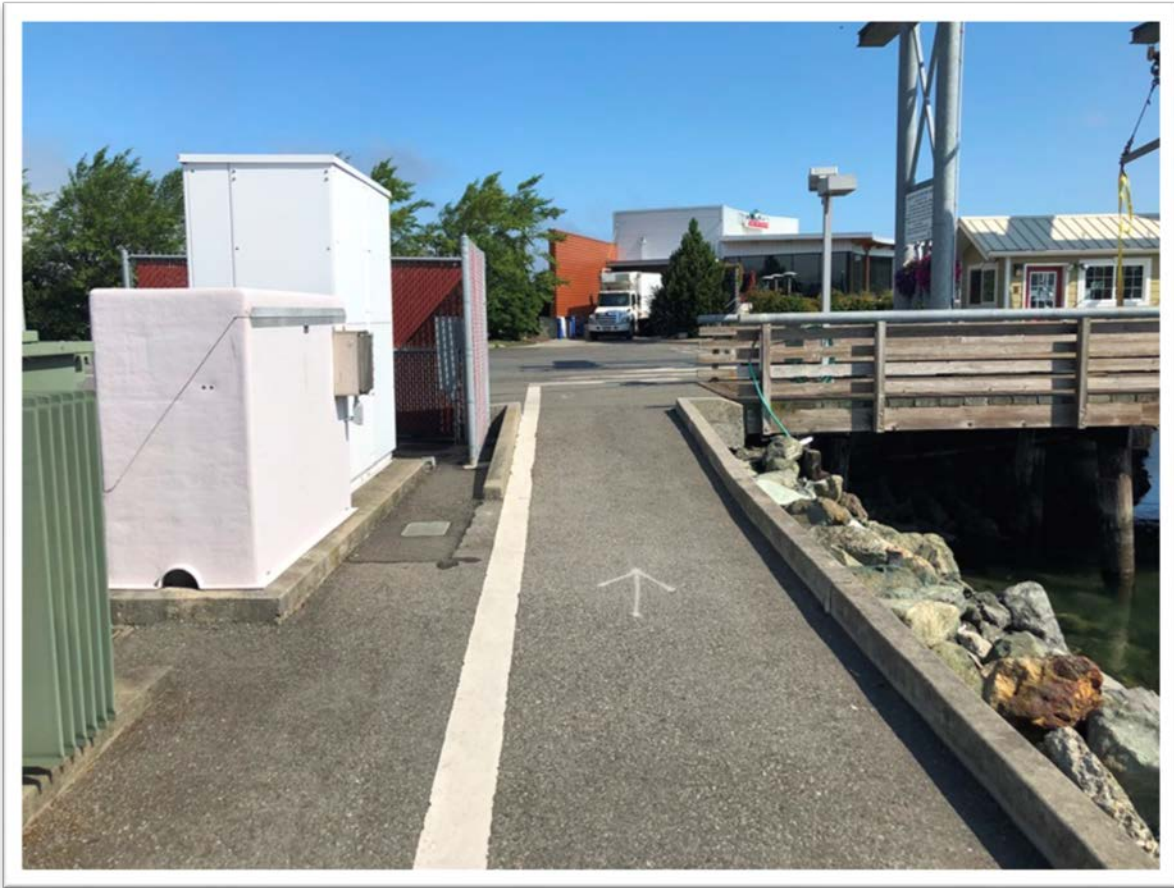
Photo A7: Protective asphalt barrier east of the utilities looking north (see Figure 1).

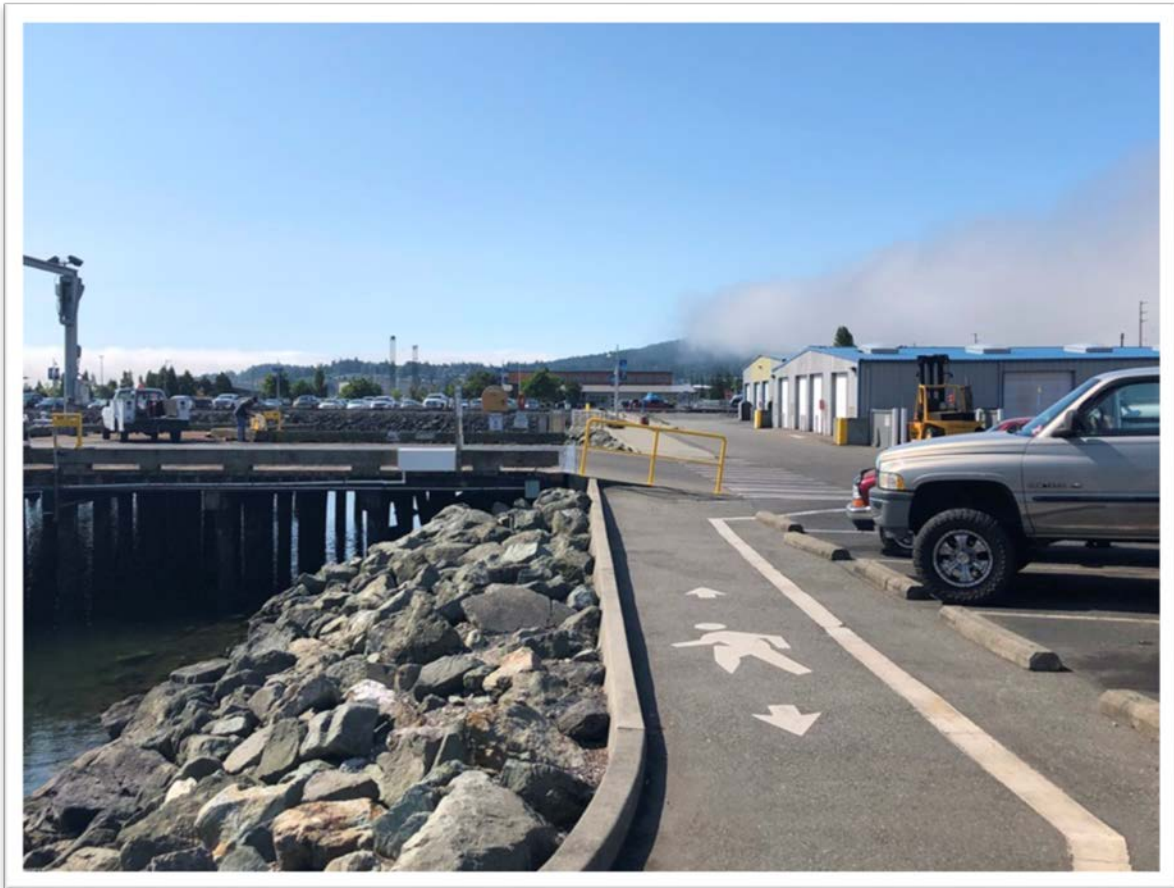
Photo A8: Protective asphalt barrier east of the utilities looking south (see Figure 1).

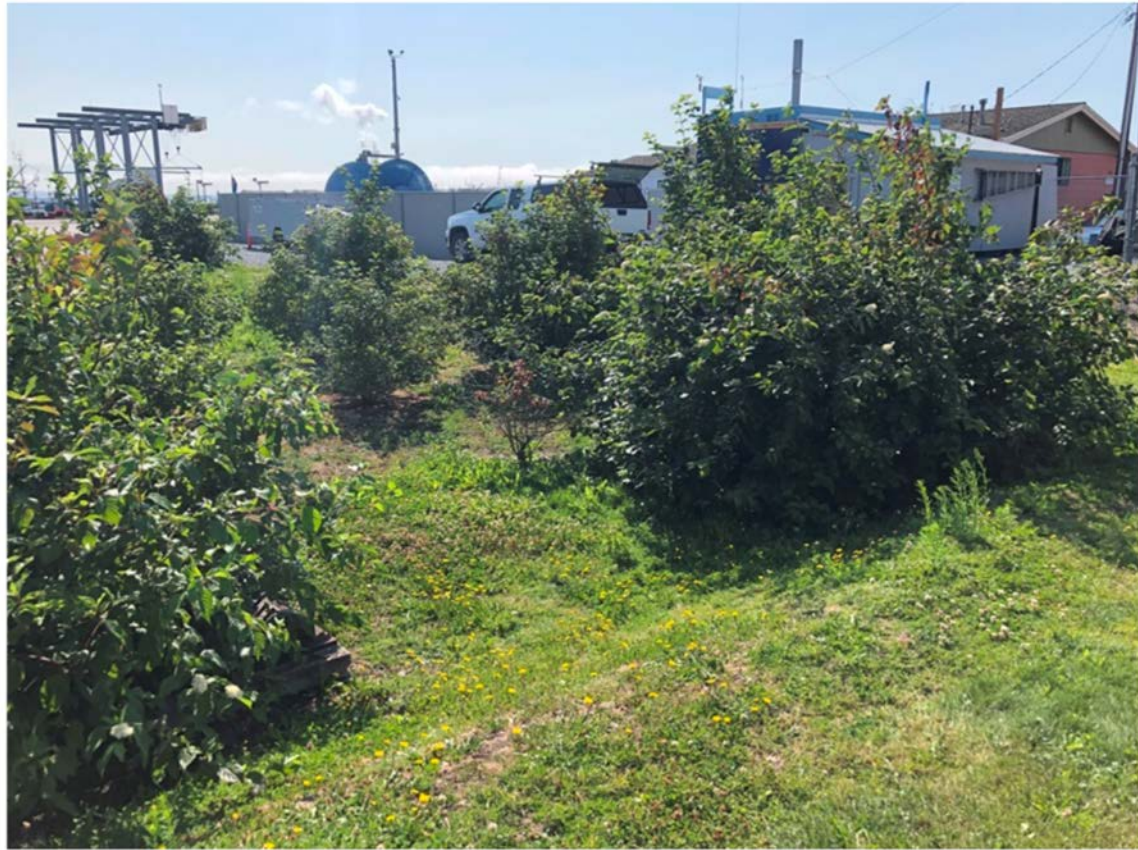
Photo B1: Protective vegetated topsoil barrier looking southeast (see Figure 2)

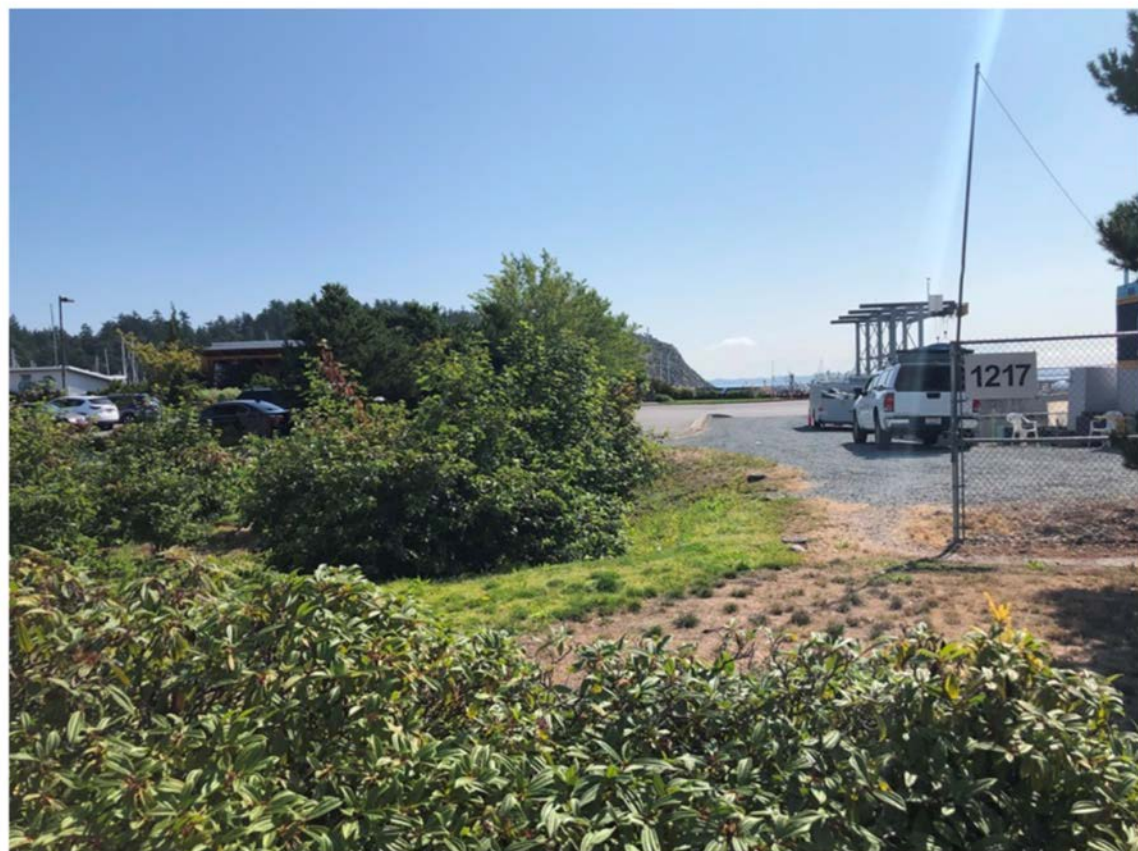
Photo B2: Protective vegetated topsoil and crushed gravel barriers looking north (see Figure 2)

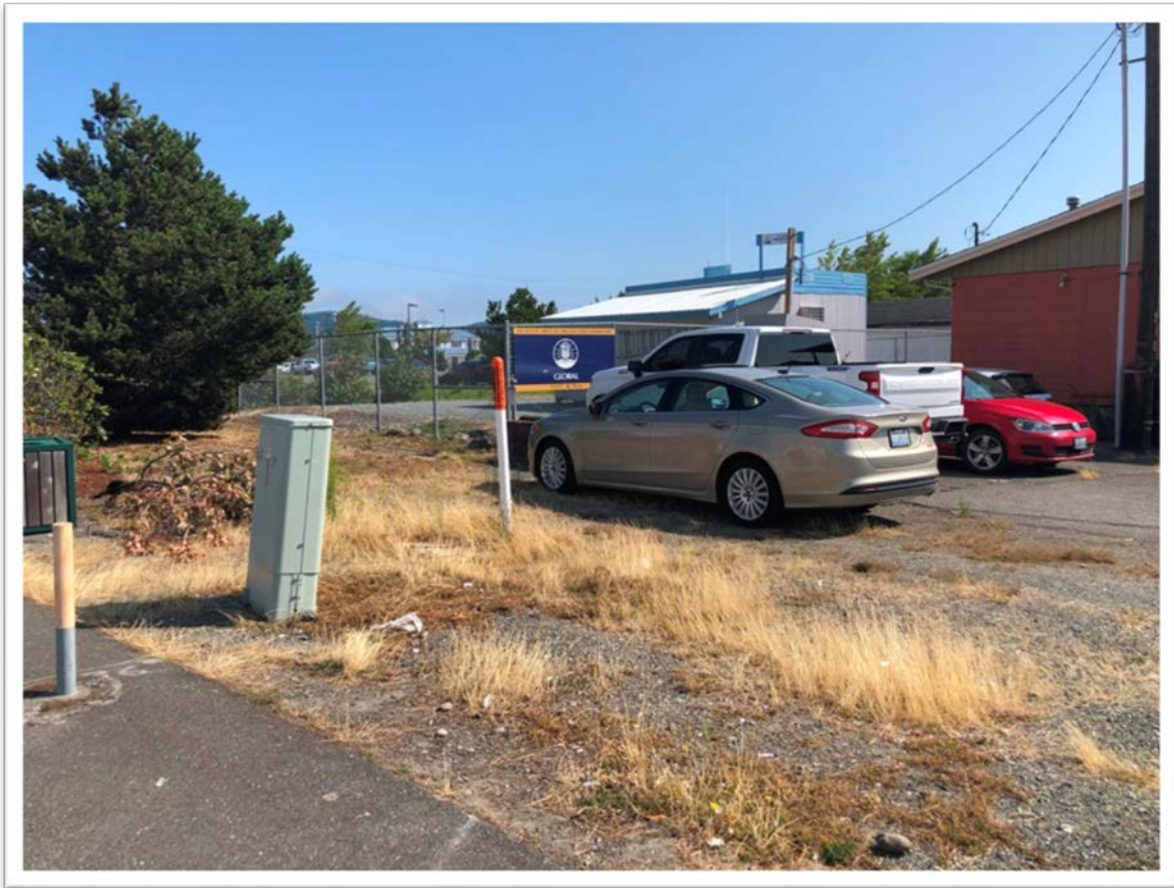
Photo B3: Protective asphalt and crushed gravel barriers looking northeast (see Figure 2)

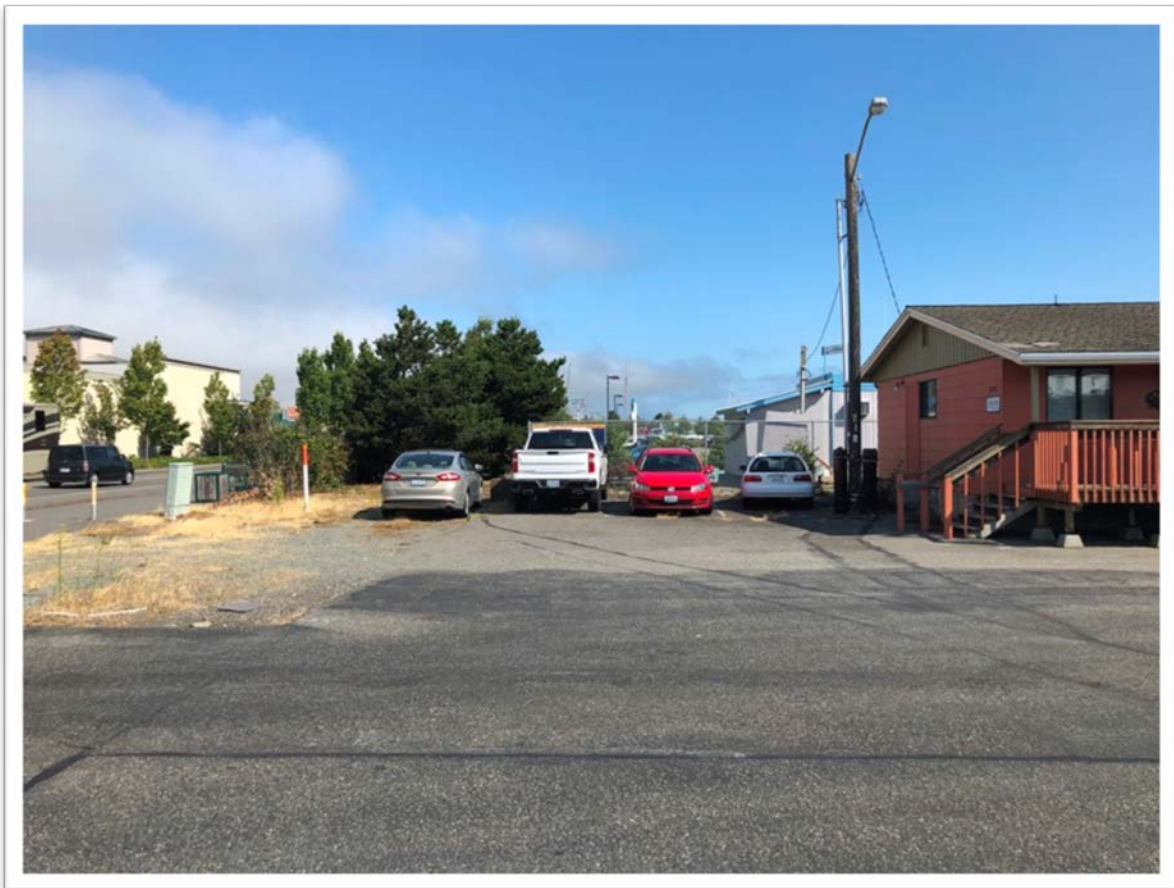
Photo B4: Protective asphalt barrier south of the office building (see Figure 2)

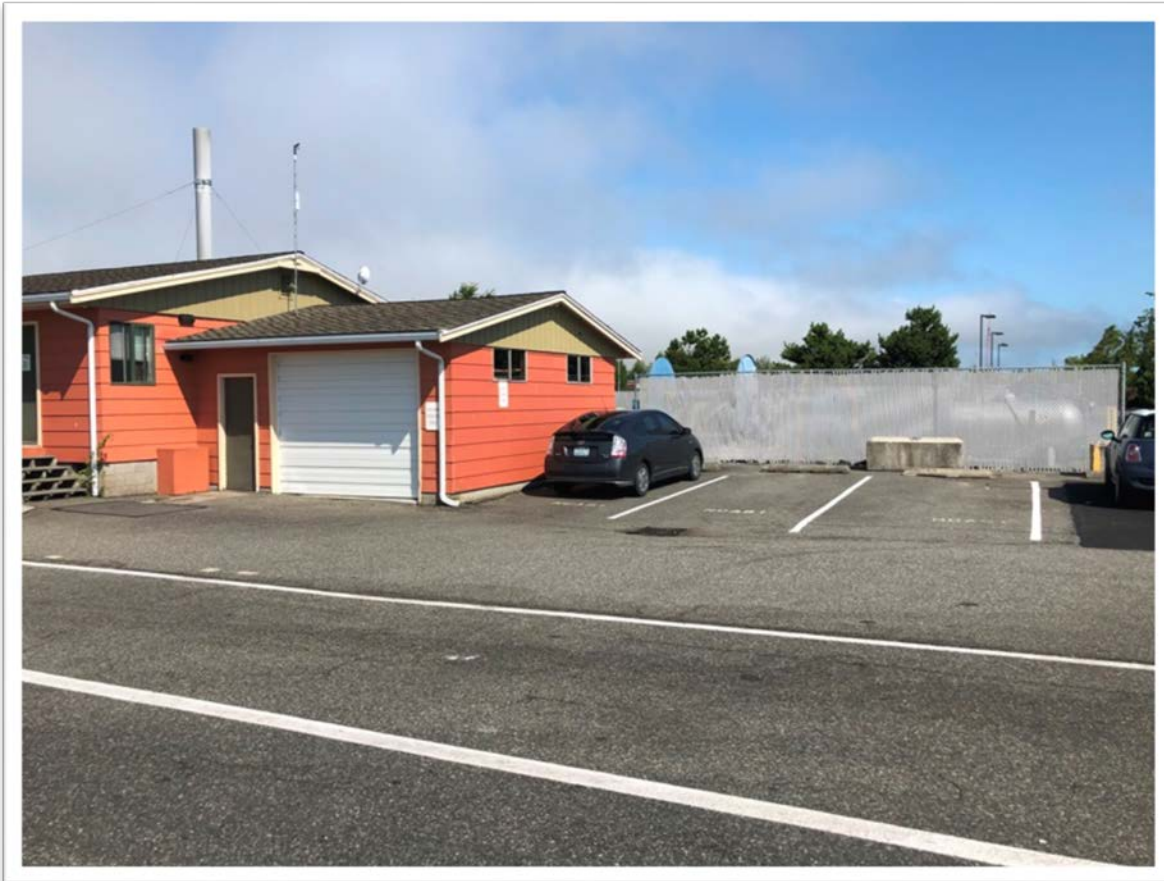
Photo B5: Protective asphalt barrier looking northwest from Control Point B1 (see Figure 2)

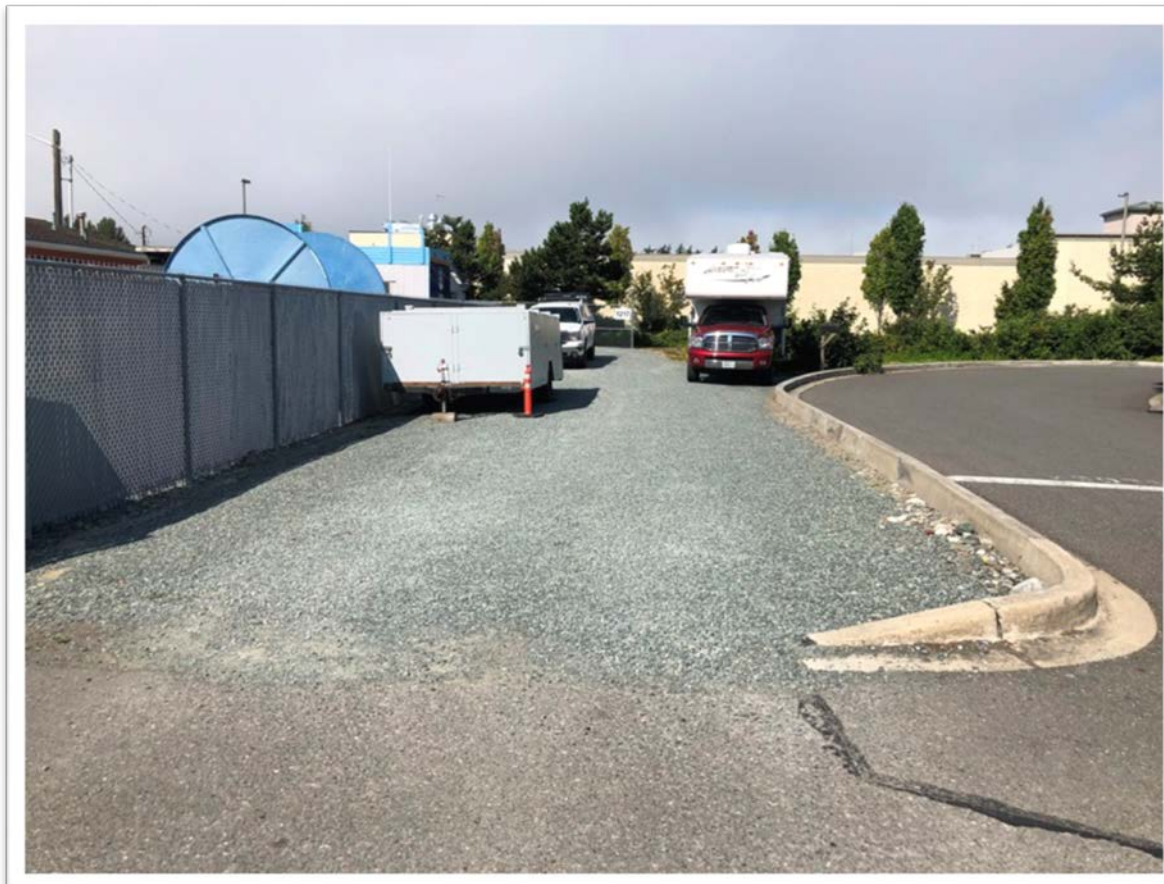
Photo B6: Protective crush gravel and topsoil barriers with fenced enclosure north of the office building (see Figure 2)

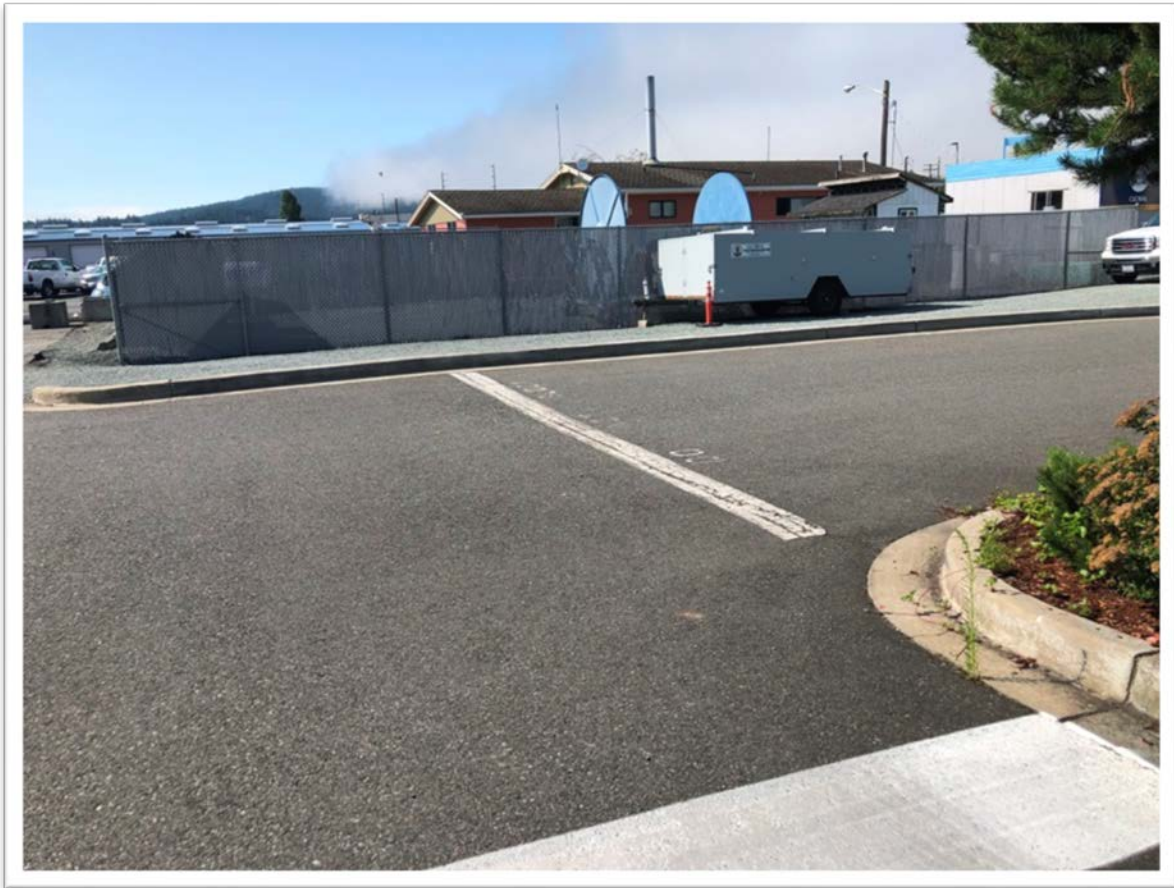
Photo B7: Protective crush gravel, topsoil and asphalt barriers north of the office building (see Figure 2)

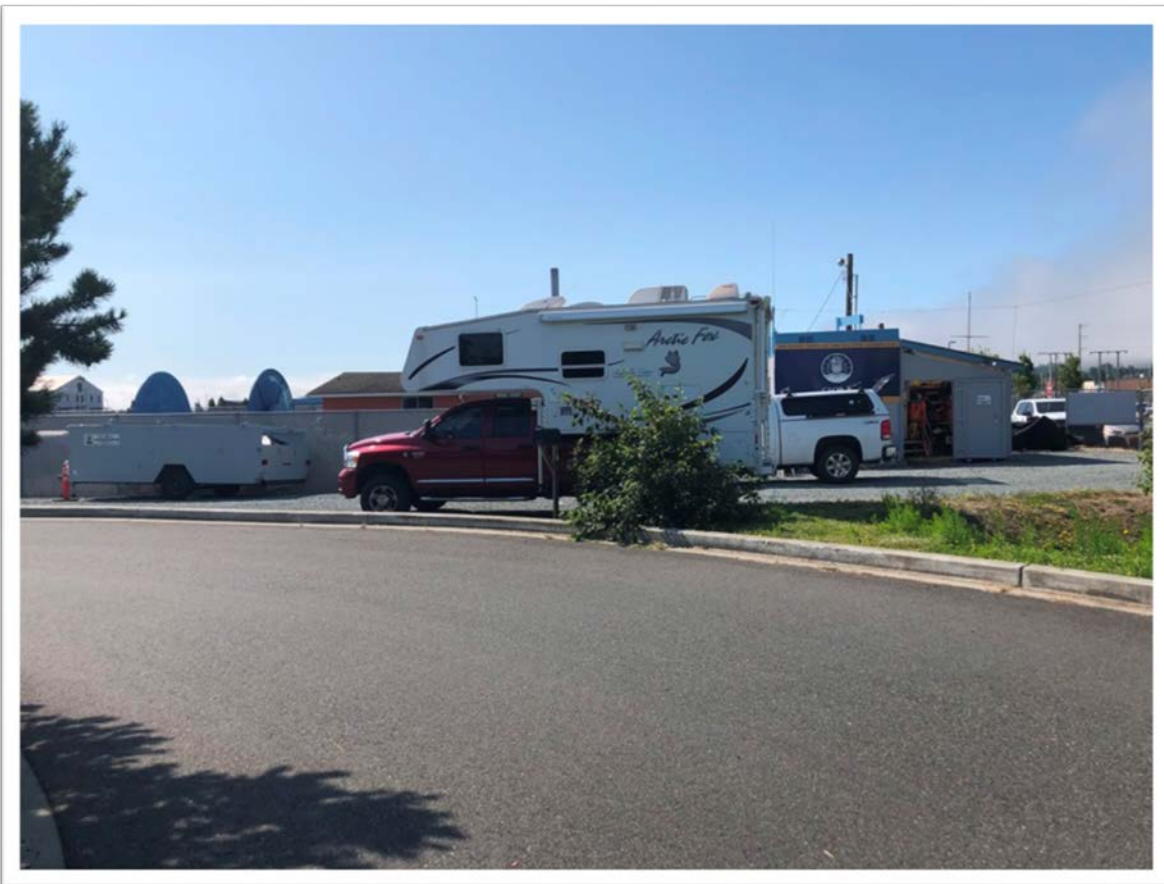
Photo B8: Protective crush gravel and topsoil barriers with fenced enclosure north of the office building (see Figure 2)
