March 4, 2005

Re: Focused Subsurface Investigation
770 Andover Park East
Tukwila, Washington

EPI Project No. 47202.0

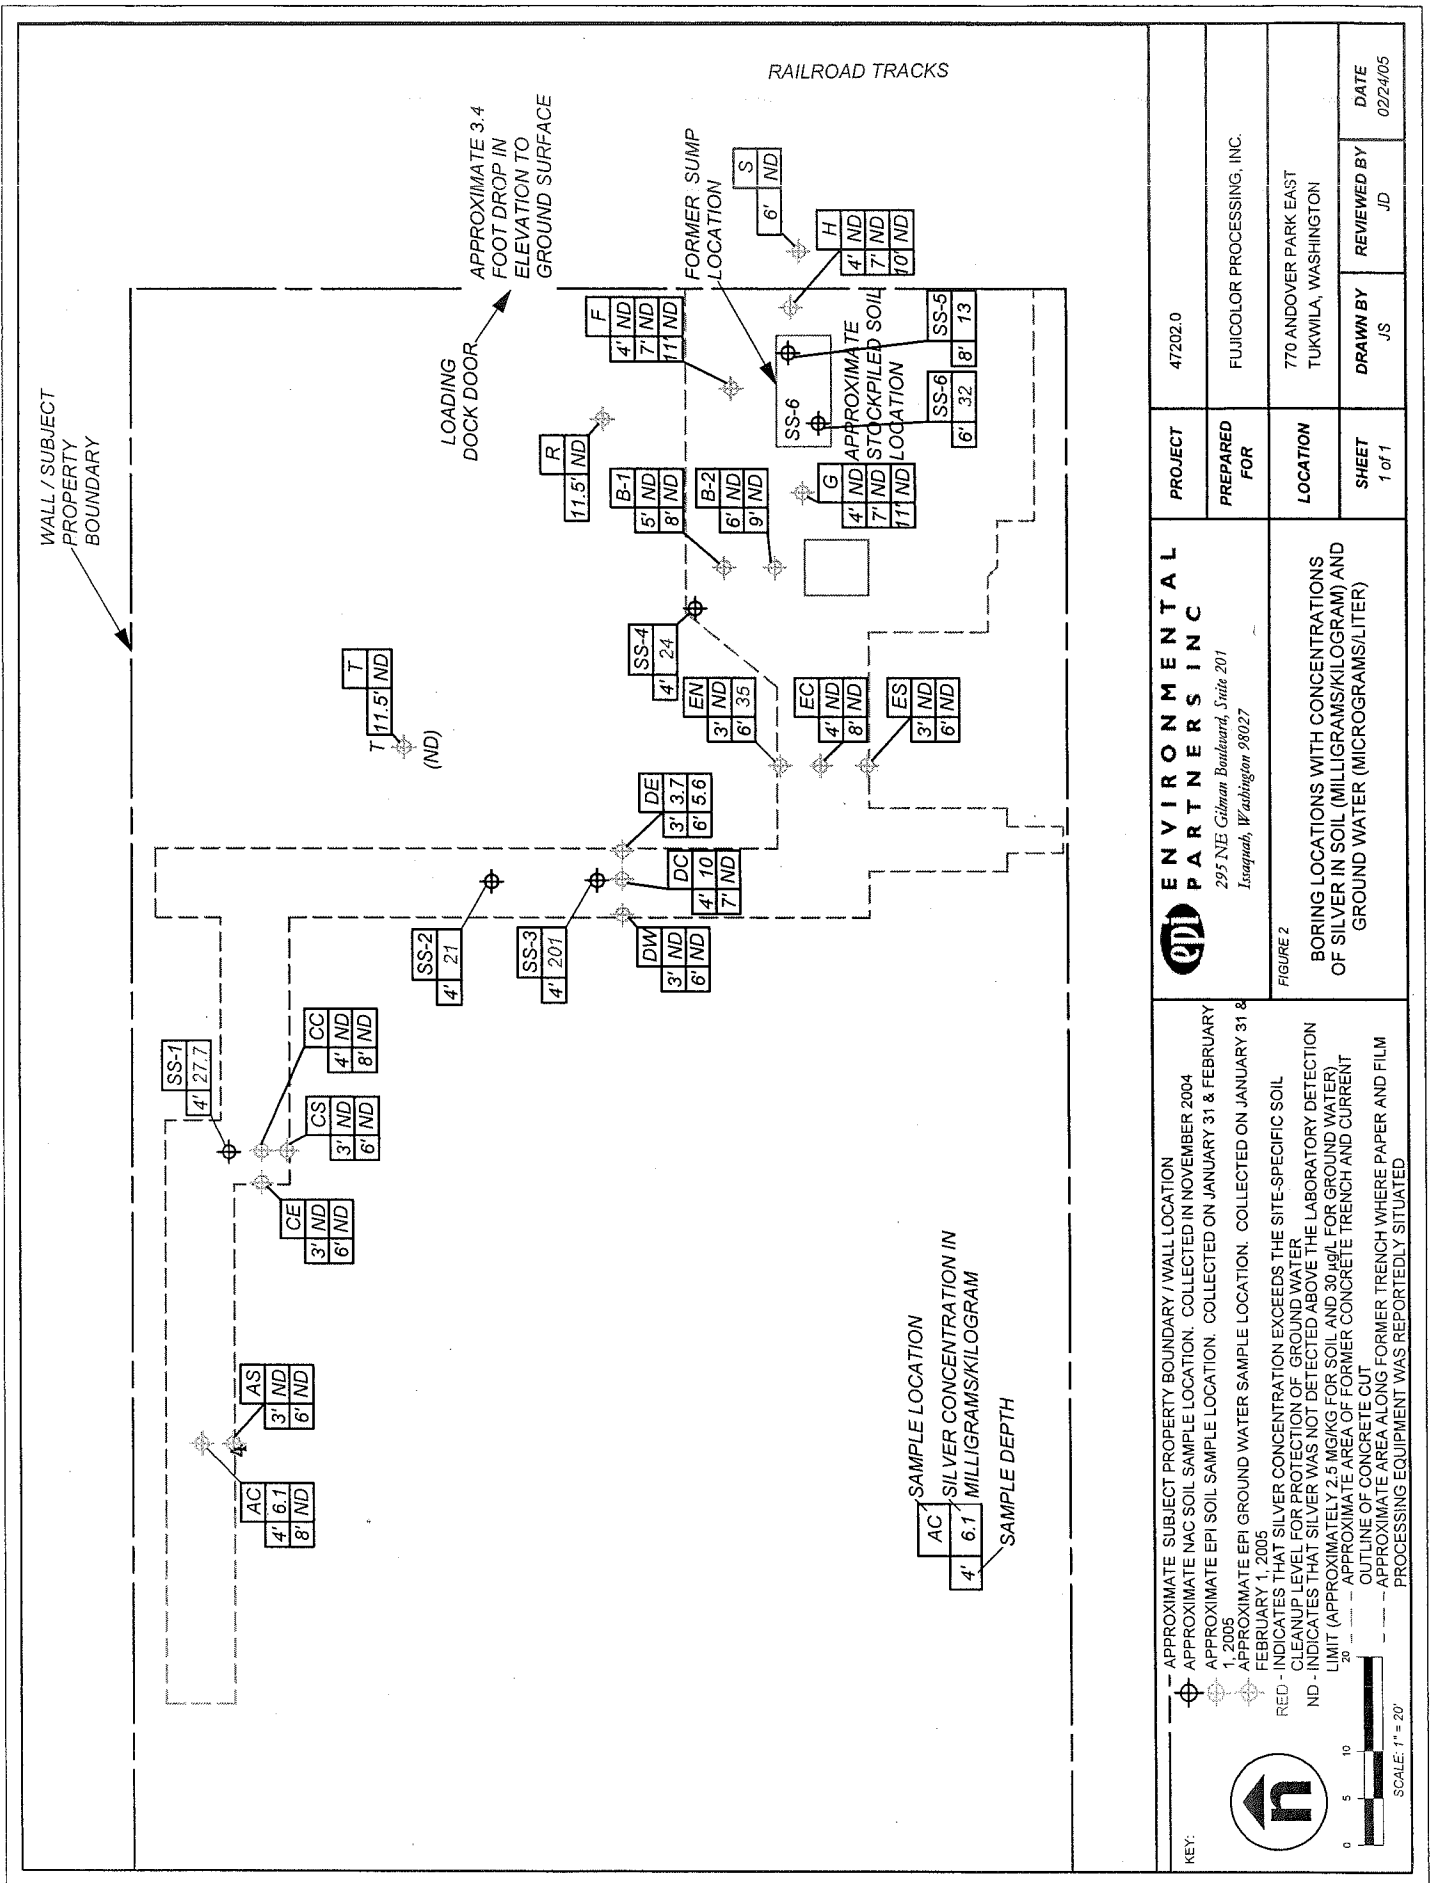
Figure 2 – Boring Locations With Concentrations of Silver in Soil and Ground Water

Silver was detected in one soil sample location (EN:6) at a concentration exceeding a site-specific soil cleanup level of 13.7 mg/kg. The detected silver concentration in sample EN:6 was 35 mg/kg at approximately 6 feet below bfs. This sample location is situated between the former location of the processing equipment and the former sump at a depth approximately two feet below the bottom of the former concrete trench. Silver was also detected in four additional sample locations, but at concentrations below the cleanup level. Silver was not detected in any of the remaining 34 soil samples above the laboratory detection limits of approximately 2.7 mg/kg.

None of the ground water samples submitted for analysis contained silver concentrations exceeding laboratory detection limits.

- A water table was encountered in three boring locations at relative depths between 6 and 8 feet bgs.
- Concentrations of silver in soil exceeded a site-specific soil cleanup level protective of ground water (i.e., 13.7 mg/kg) in one of the thirty-nine EPI soil sample locations and five of six NAC soil sample locations. This impacted soil was consistently located at depths between approximately four and six feet bfs in the locations of the former concrete trench, which had previously housed piping for feed and return solutions, and former sump. Given the fact that the trench bottom was previously situated at approximately 4 feet bfs, the observed soil impacts would be consistent with a release occurring along the bottom of the former concrete trench. Soil impacts appear limited to the immediate vicinity of the former trench and sump areas and do not appear to extend substantially, if at all, beyond these locations.

- Ground water does not appear to be impacted with silver on the subject property.
- It appears that a readily applicable remedial strategy for the subject property would be to excavate soil impacted by silver concentrations exceeding a site-specific soil cleanup level at the subject property. It is estimated that approximately 90 to 100 cubic yards of potentially impacted soil would need to be excavated. Approximately 35 cubic yards of soil would need to be excavated in a 3-foot wide by 2-foot deep cross-section along the center of northwest and central parts of the trench (from near sample AC to the corner south of sample DC). An estimated 20 cubic yards of soil would be excavated from the north edge of the concrete cut near the locations of samples EN and SS-4. The excavation in this area would be between 4 and 8 feet deep near sample location EN and 2 to 6 feet deep near sample location SS-4. An estimated 30 cubic yards of soil would be excavated from depths of between 6 and 10 feet at the location beneath the former sump. Finally, an estimated additional 10 cubic yards of stockpiled soil from the area immediately south of the former sump and from soil fill used in the trench just west of the former sump should also be excavated.
