**KEY BANK OF WASHINGTON**  
*KIRKLAND BRANCH*  
**AERIAL PHOTOGRAPHIC INVESTIGATION**

**KEY BANK OF WASHINGTON -- KIRKLAND BRANCH**  
**132 KIRKLAND AVENUE**  
**KIRKLAND WA**

*December 15, 1995*

Project No. 9523-012

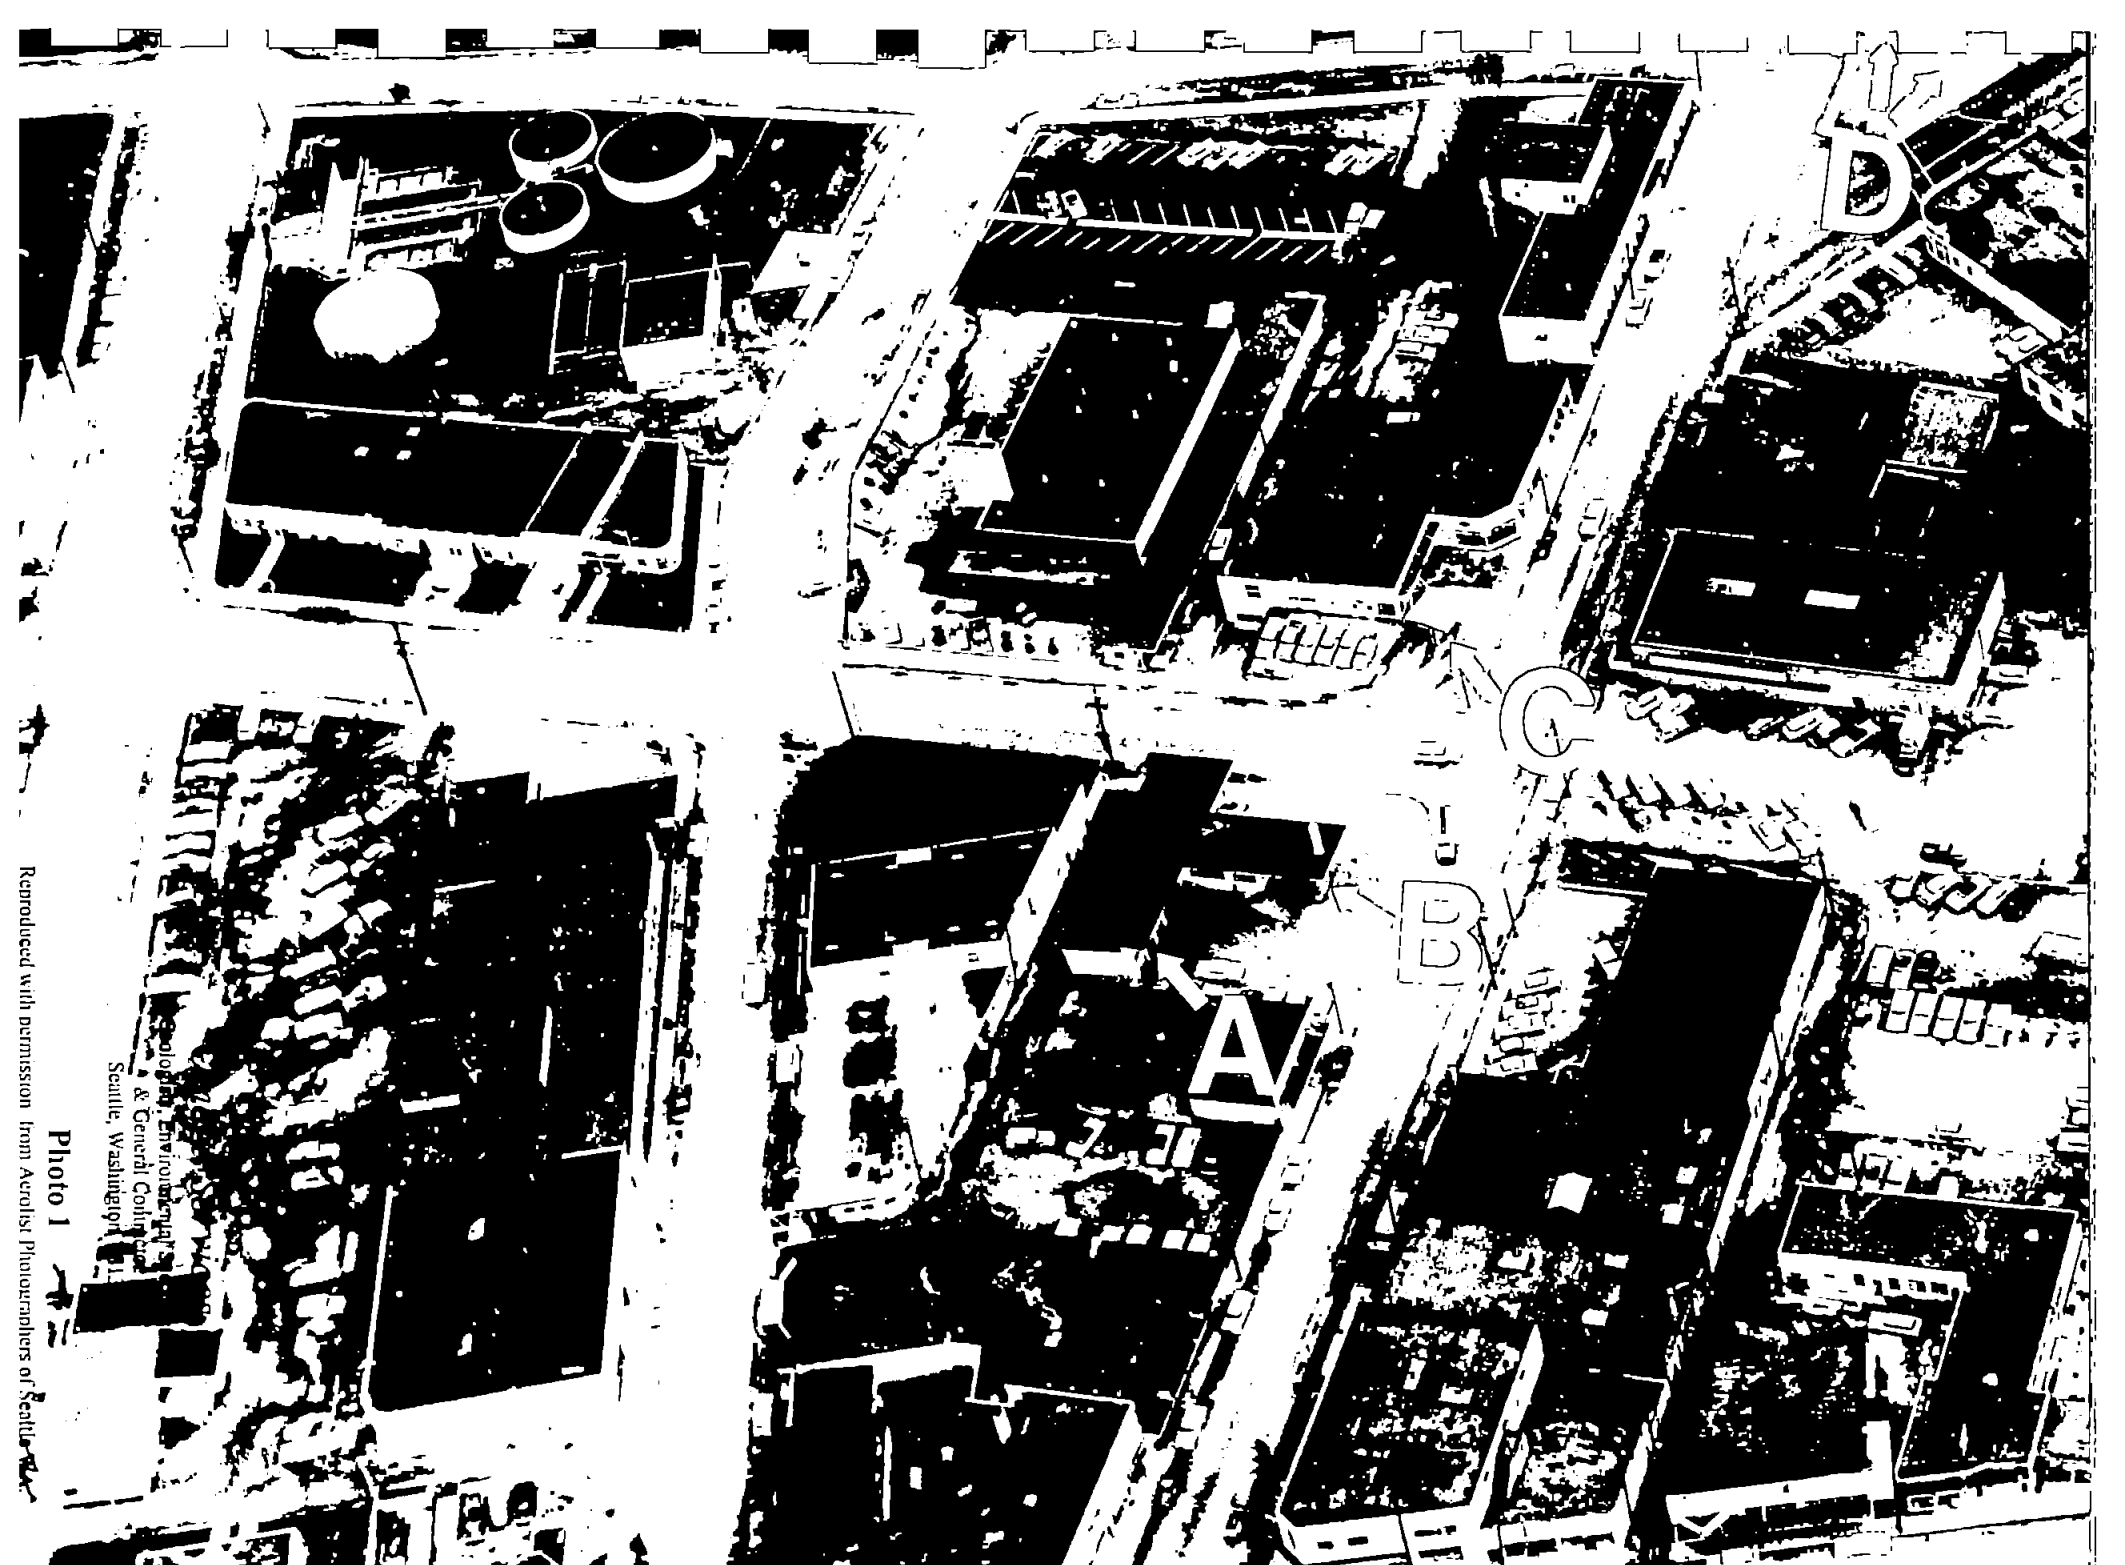
Photo 1

The 1957 aerial photograph (Photo 1) clearly shows that the subject property was occupied by what appears to be a Texaco service station. Service bays are visible in the northwest corner of the subject property (Photo 1; Reference A). One (1) pump island is visible beneath the canopy in the southeast quarter of the subject property (Photo 1; Reference B). Fill ports for USTs cannot be distinguished. However, the surface of the southeastern quarter of the subject property appears to be concrete. Based on the lack of obvious surface features present elsewhere on the subject property, Omega suspects that the former USTs were located beneath the canopy between the pump island and service station building. The former pump island identified in this photograph and the possible locations of the USTs is coincident with the existing Key Bank building.

The 1957 photograph also shows a pump island and canopy on the adjoining property to the east (across Main Street; Photo 1; Reference C). In addition, two pump islands can be seen one (1) block east of the subject property (Photo 1; Reference D).

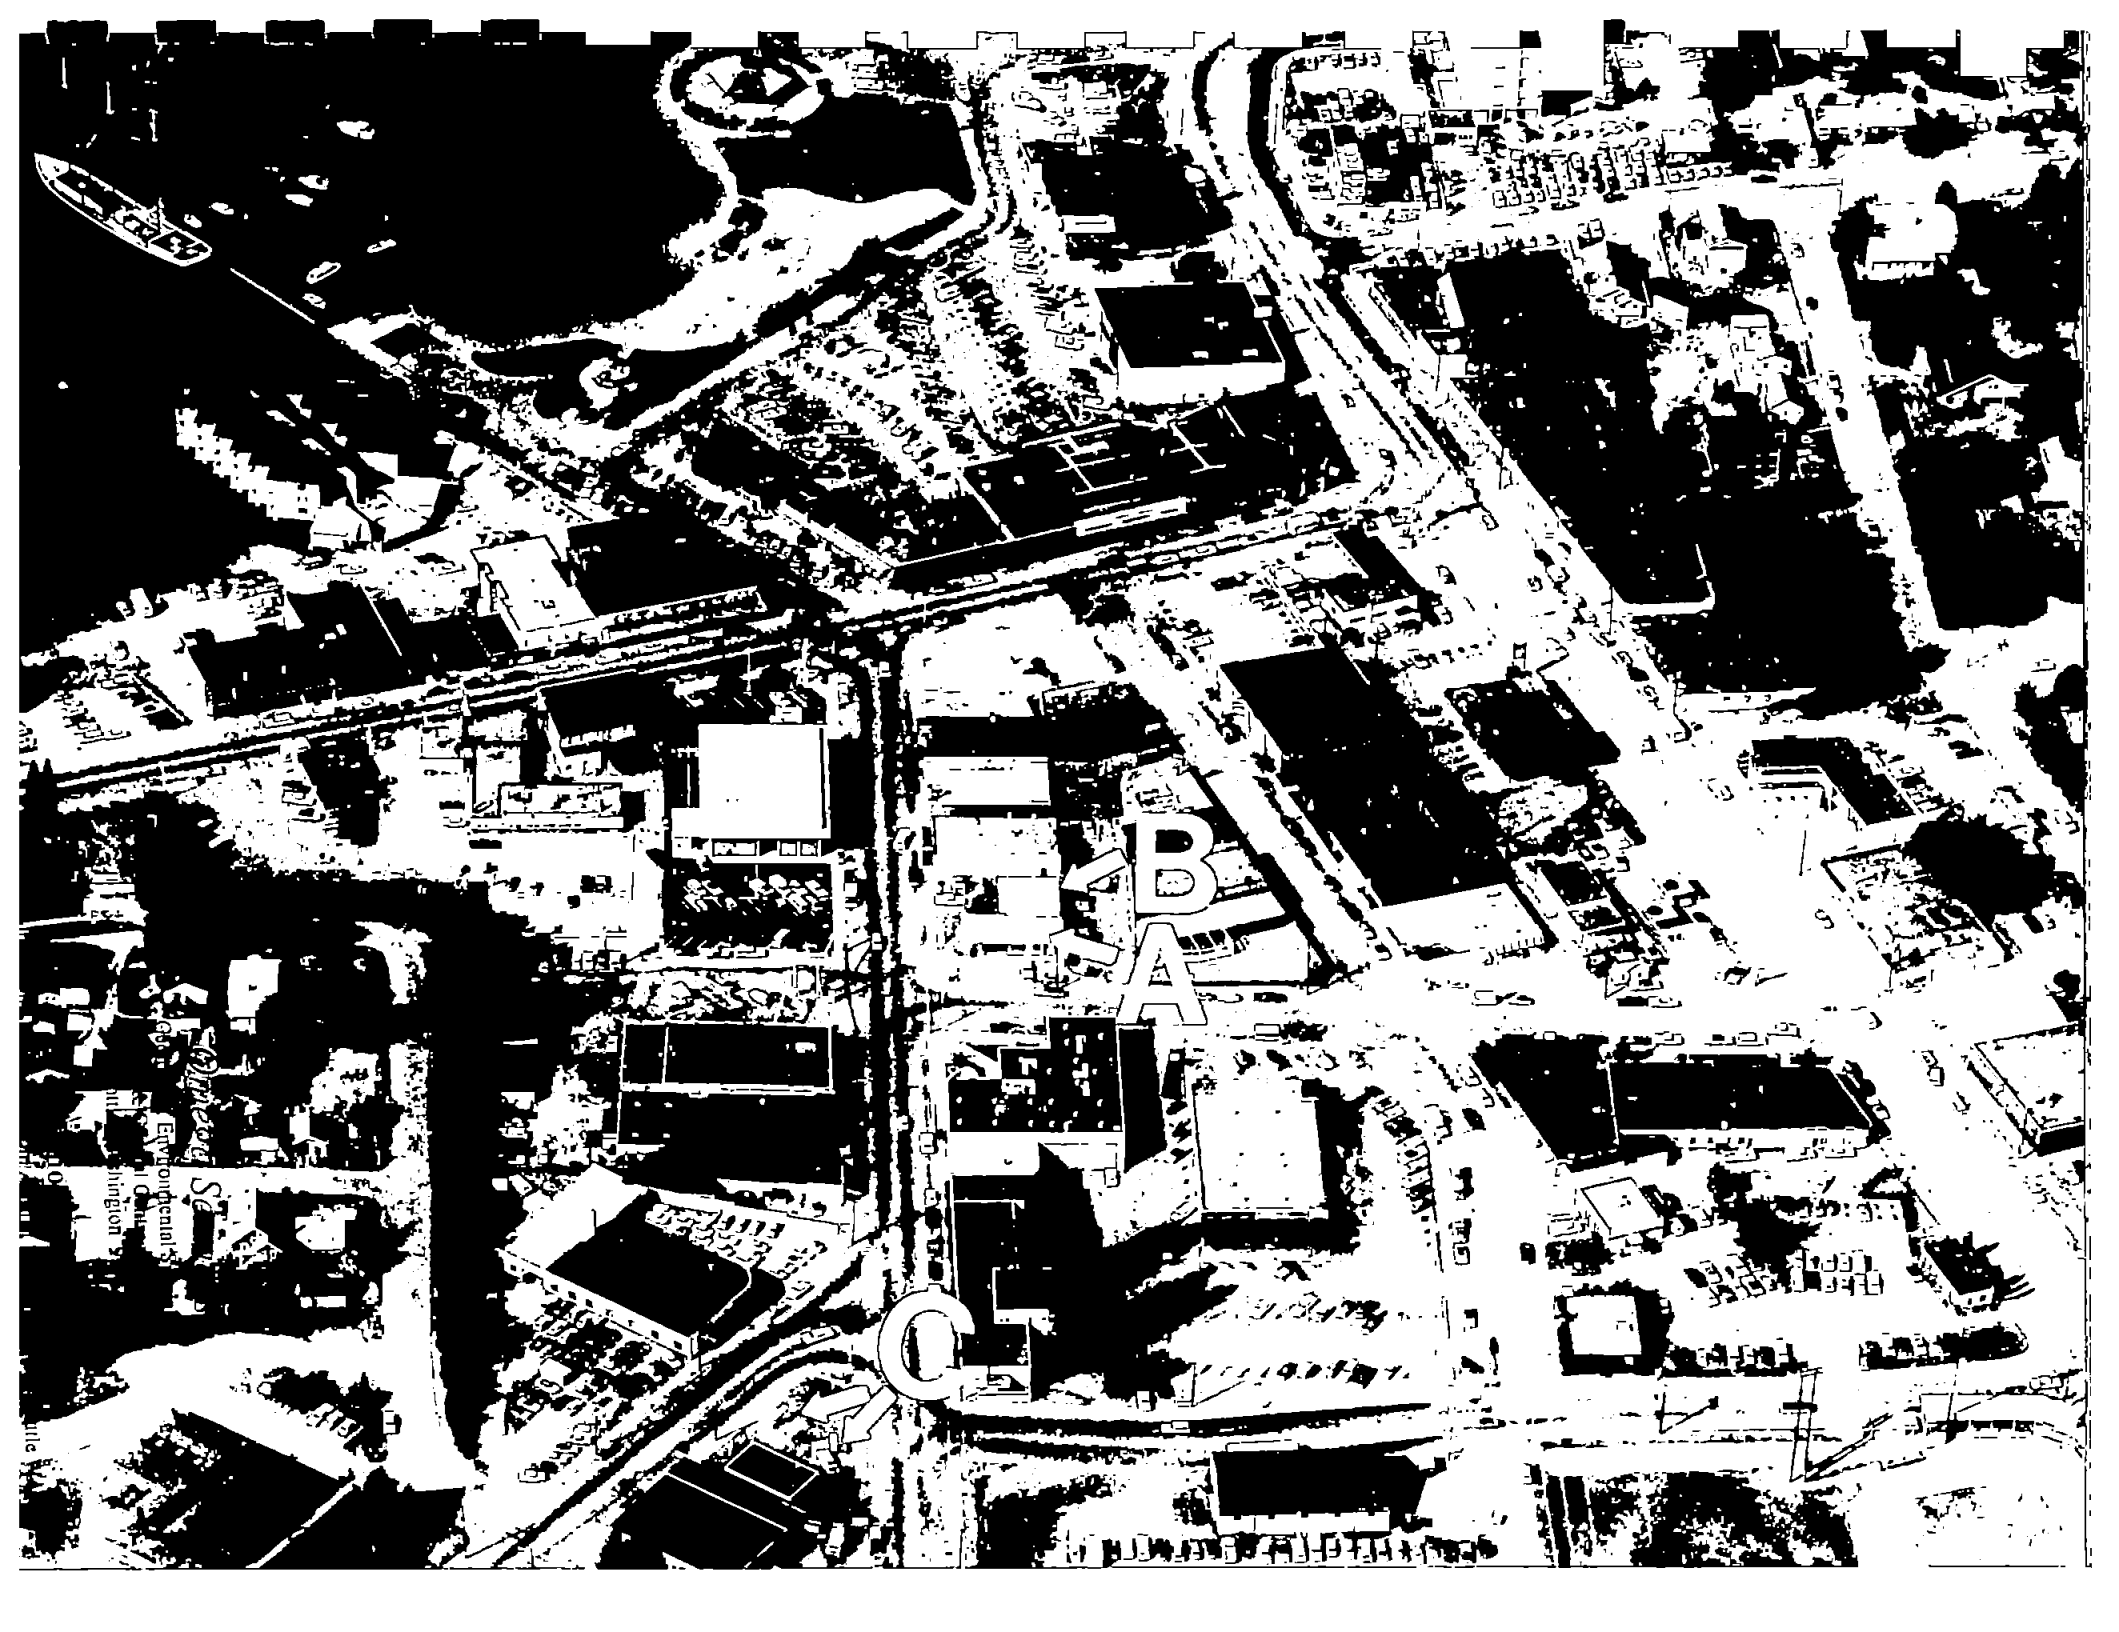
The 1964 aerial photograph (Photo 2) shows a different angle of the subject property than that of the 1957 photograph. In this photograph, a second pump island can be identified on the east side of the canopy (Photo 2; Reference A). In addition, the adjacent property to the east (across Main Street) no longer has a canopy and pump island. However, the presence of large bay doors suggests that the adjacent property was still conducting automotive repair activities at this time.
