May 5, 2022

**Re: Opinion pursuant to WAC 173-340-515(5) on Remedial Action for the following Hazardous Waste Site:**

- **Site Name:** Tye Aircraft McKechnie Group
- **Site Address:** 3008 100th Street SW, Everett, WA 98204
- **Facility/Site No.:** 91865744
- **Cleanup Site ID No.:** 1217
- **VCP Project No.:** NW2193

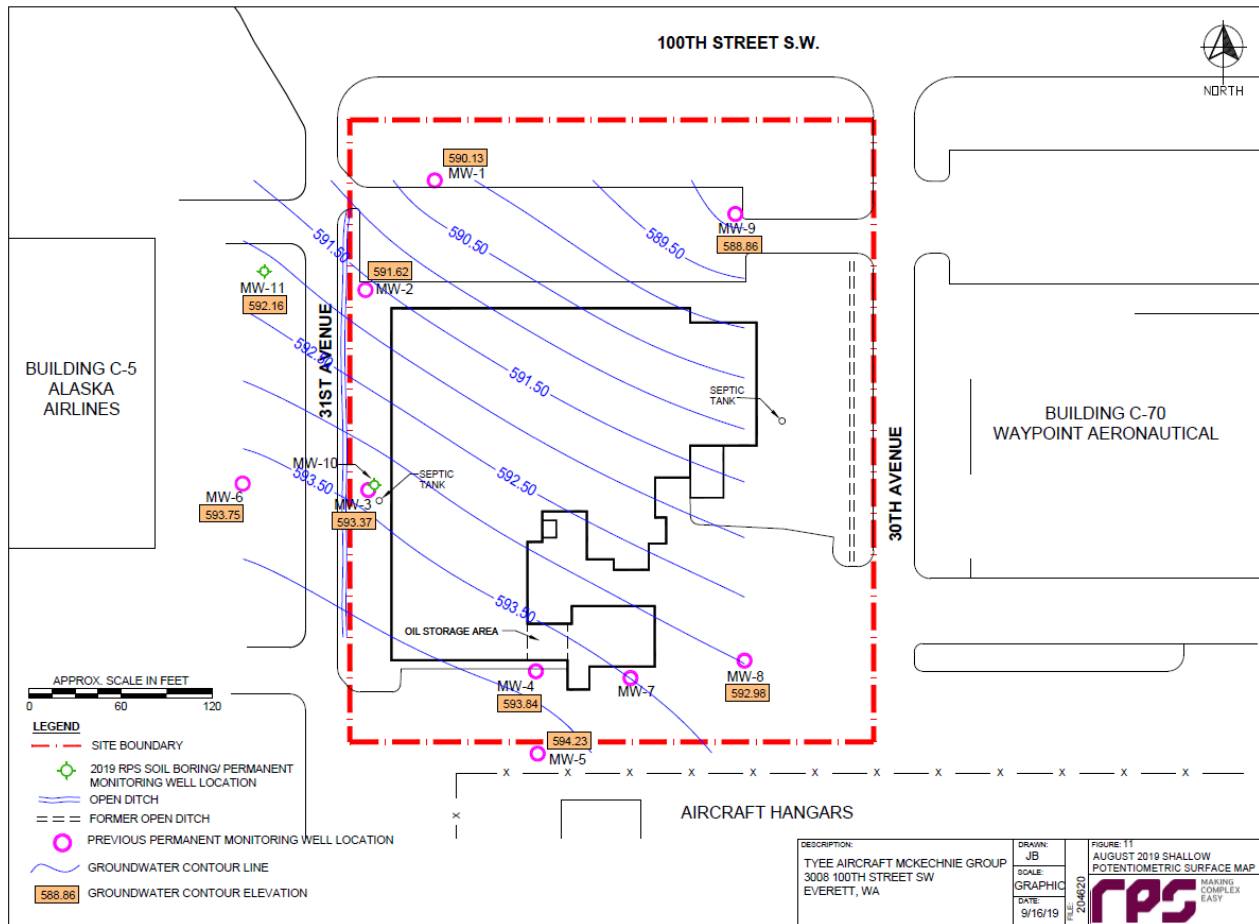
Enclosure A, Figure 2

The Property corresponds to Snohomish County tax parcel account 28042200100102, which is located within parcel 28042200100100. The Property has a one-story, 28,000-square foot building and a 1,078-square foot metal pole building (**Figure 2**), also known as Paine Field Building C-71. The Property is located between 30<sup>th</sup> Avenue W and 31<sup>st</sup> Avenue W on the south side of 100<sup>th</sup> Street SW.

An old, inactive, underground tank (referenced in many documents as the "western septic tank" and located on the west side of the building) appears to have been previously used to collect floor drain fluids and spills from the former metal finish room, and is also a potential contaminant source (see **Figure 2**). Elevated levels of vinyl chloride have been identified in water in the tank. A former oil storage area in the southern portion of the building and a nearby former oil sump pit (that may have contained oils impacted by chlorinated solvents) has been identified as another potential source area. This area is within the building, but is open to outdoor air on one side. The "western septic tank" and the oil sump pit were removed in 2021.

**Groundwater:** A perched zone of saturation underlying the Site occurs within the fill and permeable areas of the Vashon till between 3.1 and 8.5 feet below ground surface (bgs). The occurrence of perched groundwater fluctuates seasonally. The direction of perched groundwater flow is to the northeast, based on water levels measured in groundwater monitoring wells at the Property (see **Figure 2**).

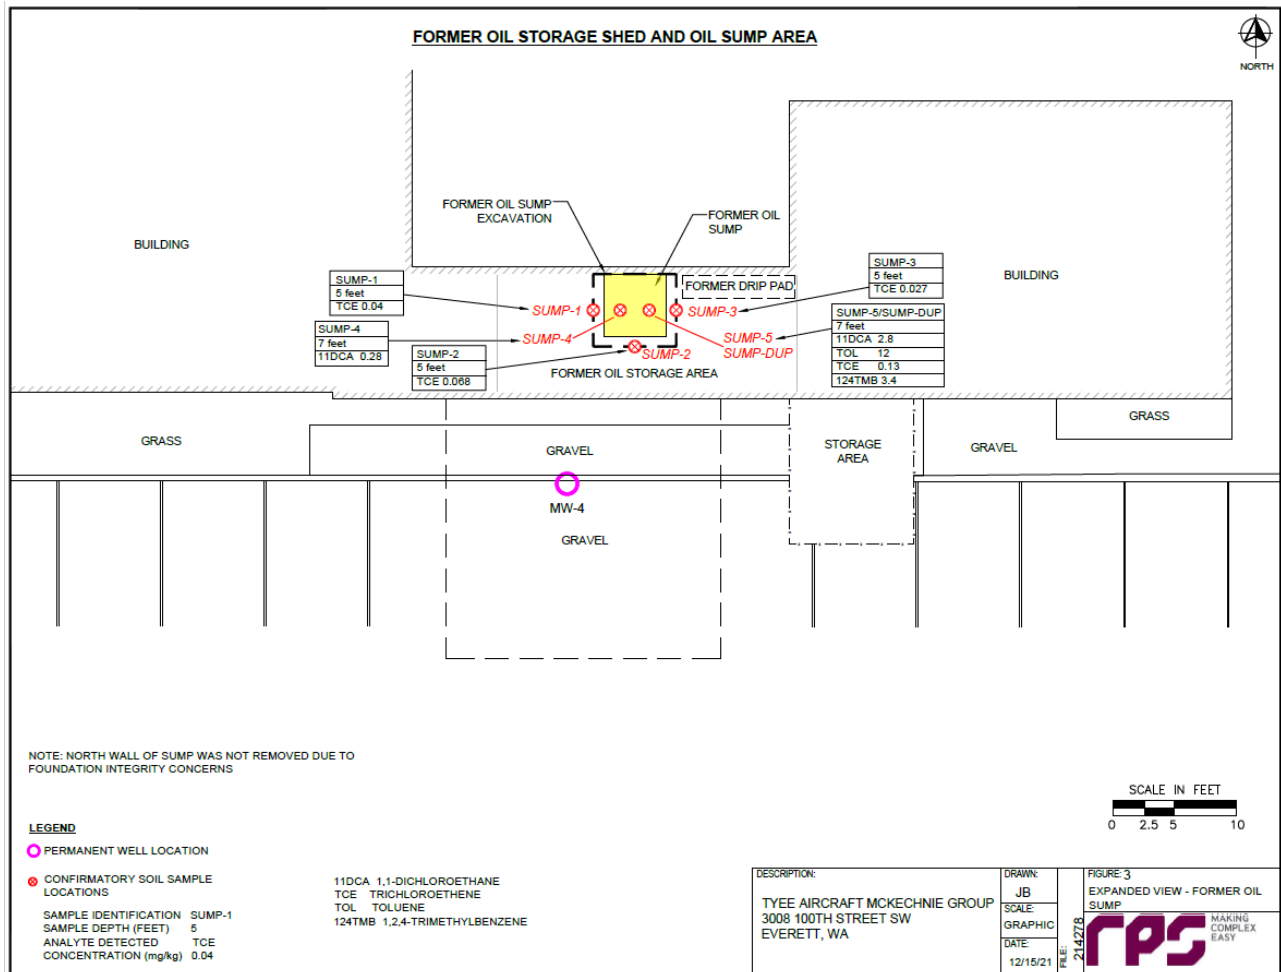
Enclosure A, Figure 3

Confirmation soil sampling indicates that the contaminants of concern were remediated by means of excavation and/or injections to below cleanup levels in the following areas: Injection Area #1, Injection Area #2, TPH Excavation Area, and the former septic tank area. Confirmation soil sampling in the former oil sump cleanup area (located in the former oil storage area of the building) indicates that contaminated soils remain that exceed the Method A cleanup level for TCE (in samples Sump-1, Sump-2, Sump-5, and SB-103B), with one of the samples also exceeding the Method A cleanup level for toluene (Sump-5) (see **Figure 3**). The extent of contaminated soil in the former oil storage area has not been characterized.

In this case, the contaminated soil is accessible and therefore should be remediated, which may require additional excavation. If soil amendments in the excavation is the proposed approach to remediating these contaminated soils, confirmation soil sampling would need to be completed that shows the remaining soils meet cleanup levels.

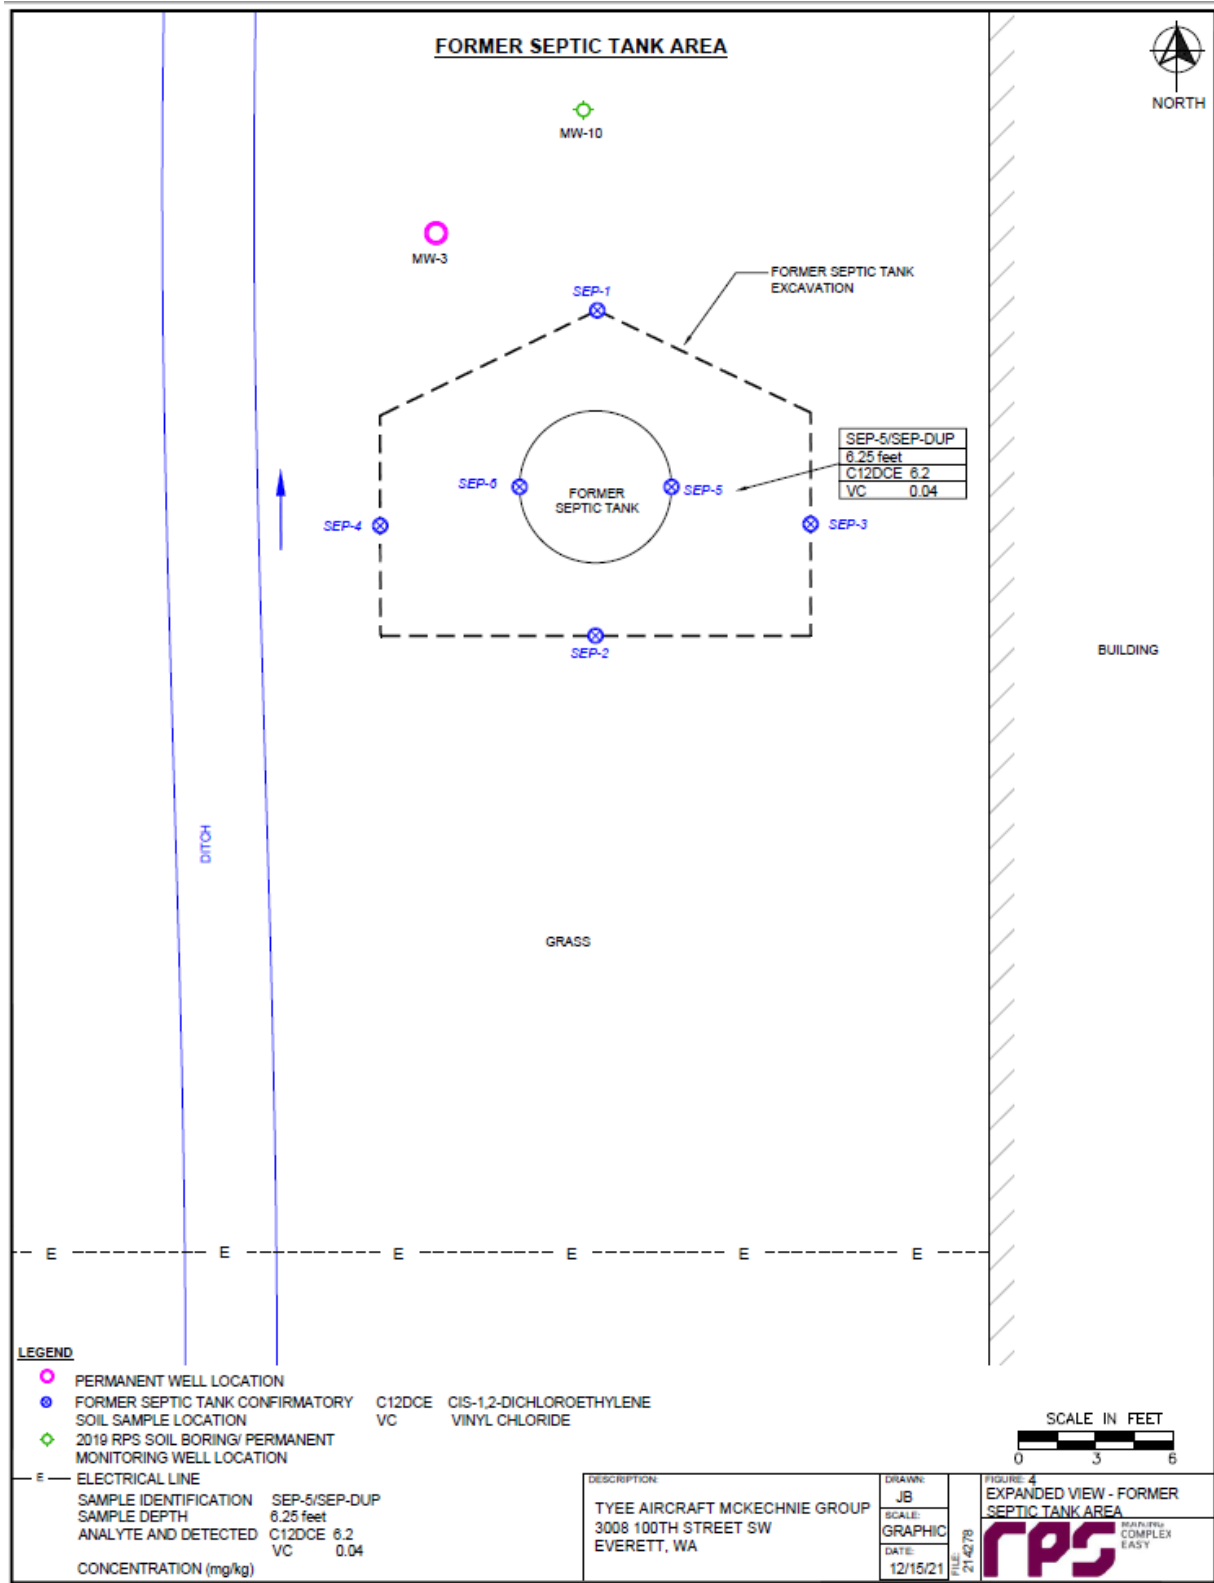
Enclosure A, Figure 4

Figures associated with interim remedial actions completed in 2021 are included as **Figures 3, 4, and 5** (from RPS's 2022 Interim Remedial Actions Report). Figures associated with interim remedial actions completed in prior years are included in RPS's 2017 Interim Corrective Action Completion Report and RPS's 2019 Supplemental Site Investigation Report.
