FOCUSED SITE ASSESSMENT REPORT

COLLEGE AVENUE STEAM PLANT
PULLMAN, WASHINGTON

Prepared for
PORT OF WHITMAN COUNTY
March 30, 2022
Project No. M0457.02.003

Prepared by
Maul Foster & Alongi, Inc.
601 East Front Ave., Suite 202, Coeur d'Alene, ID 83814

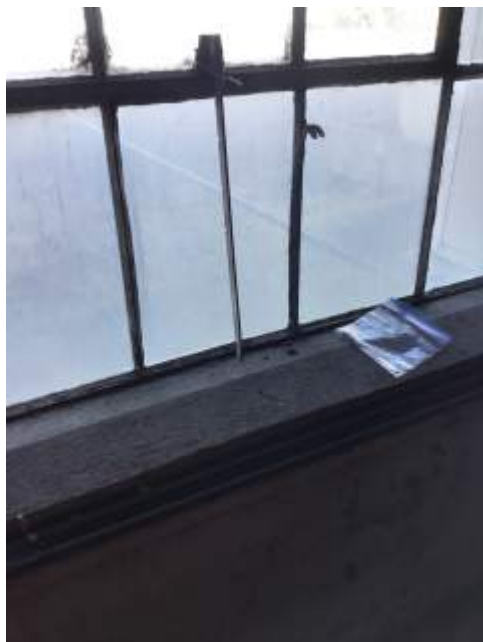
Additional Sample Notes:		White pipe covering with yellow insulation.
Sample ID:	Sample Type:	
1-3-MISC-4	MISC	
Sample Location:	Detailed Sample Location:	
Room 101	Window at northwest corner of room.	
Sample Quantity:	4,030 linear feet.	
Misc Sample Material:	Sample Condition:	Sample Friable?:
Window glazing.	Potential ACBM with potential for damage	Yes

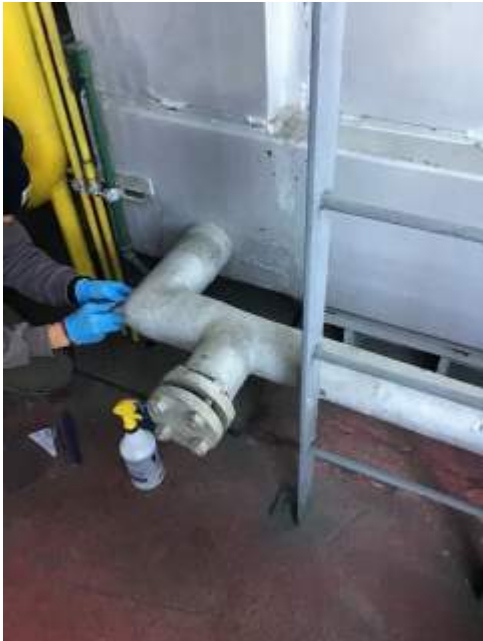
1-8-TSI-10

Misc Sample Material: Tan cementitious material **Sample Condition:** Damaged or significantly damaged **Sample Friable?:** Yes

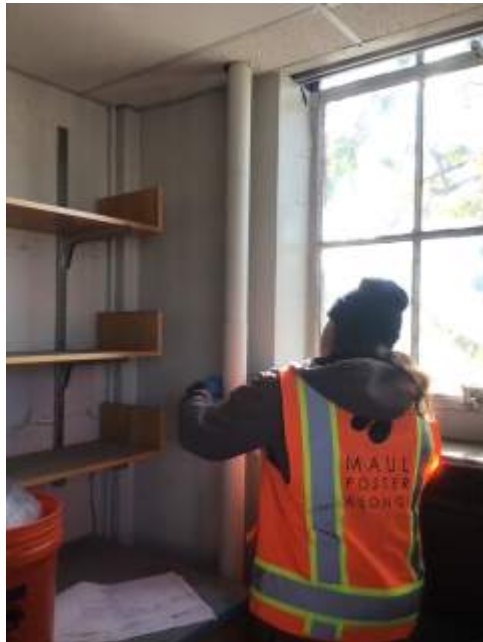
Sample ID:	Sample Type:	
1-8-TSI-32	TSI	
Sample Location:	Detailed Sample Location:	
Room 104	Southeast corner of room on white pipe.	
Sample Quantity:	3,000 linear feet.	
Sample Color:	XRF:	
Misc Sample Material:	Sample Condition:	Sample Friable?:
	Damaged or significantly damaged	Yes

Additional Sample Notes:	White pipe wrap with yellow insulation.
---------------------------------	---

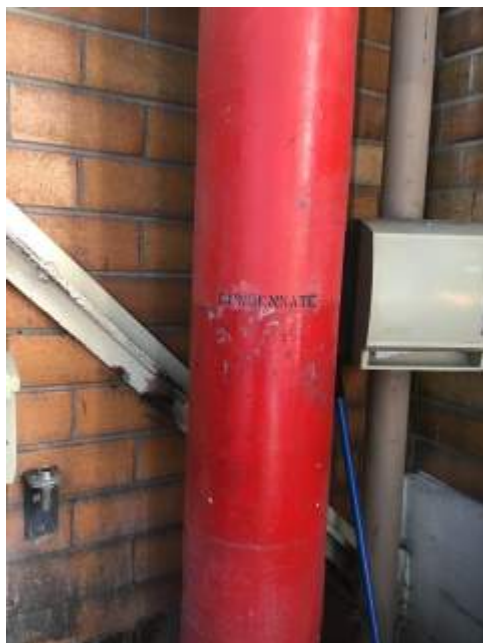
Additional Sample Notes:	Difficult to quantify.
Sample ID:	Sample Type:
1-10-PB-16	PB
Sample Location:	Detailed Sample Location:
Room 101	Steam pipe in southwest corner of room 101.
Sample Quantity:	N/A
Sample Color:	XRF:
Red	0.616

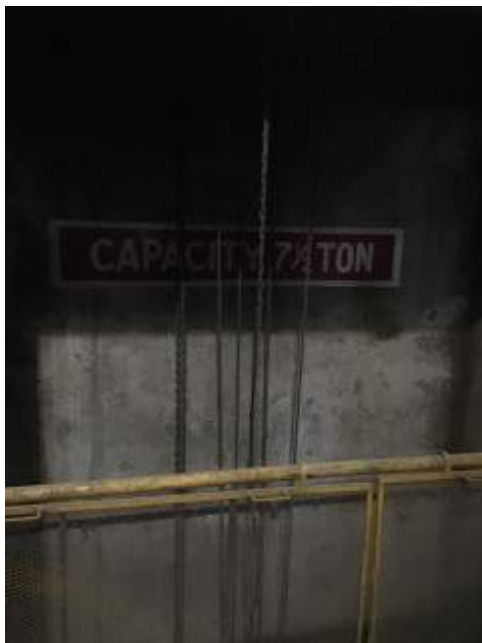
General Fixture Location:	Detailed Fixture Location:
Room 101	Northwest corner of room 101.
Type of Fixture:	Quantity:
Equipment lift system.	1
Condition:	Additional Fixture Notes:
Good	Mechanical hazard with motor.

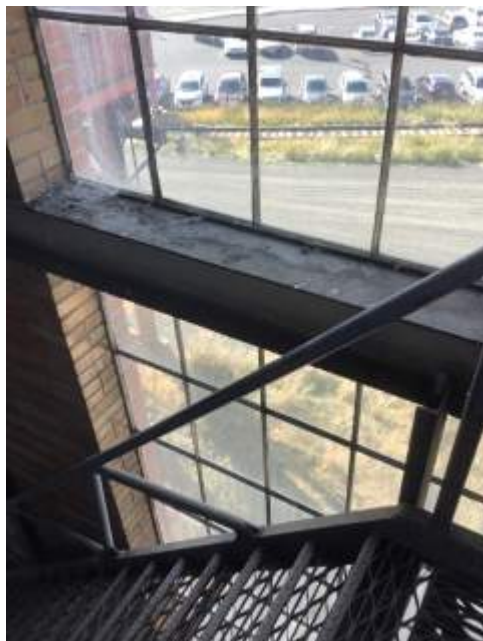
Sample ID:	Sample Type:	
2-7-MISC-33	MISC	
Sample Location:	Detailed Sample Location:	
Room 101	Northwest corner; highest catwalk.	
Sample Quantity:	4,030 linear feet.	
Misc Sample Material:	Sample Condition:	Sample Friable?:
Window glazing.	Damaged or significantly damaged friable miscellaneous ACM	Yes

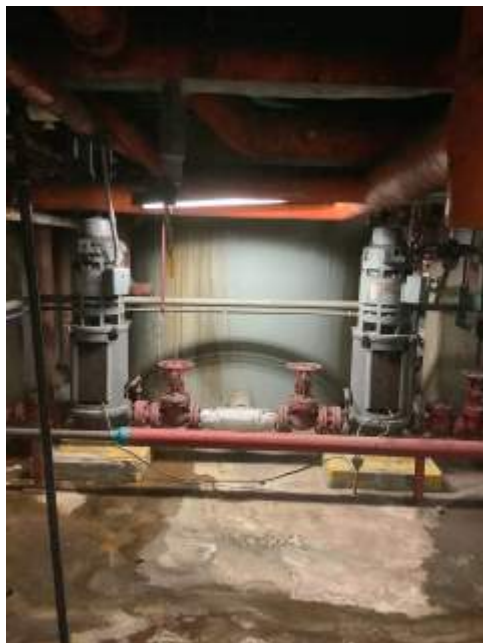
General Fixture Location:	Detailed Fixture Location:
Room 11	North side of room.
Type of Fixture:	Quantity:
Active steam equipment.	Several
Condition:	Additional Fixture Notes:
Good	Active tanks, pumps, and lines.
