**FINAL REPORT
INVESTIGATION AND SOIL REMEDIATION
DIAMOND TANK TRANSPORT PROPERTY
SEATTLE, WASHINGTON**

**DIAMOND TANK TRANSPORT, INC.
D&M JOB NO. 38229-001-005
May 13, 1998**

Final Report
Subsurface Investigation and Soil Remediation
Diamond Tank Transport Property
912 Dexter Avenue North
Seattle, Washington
D&M Job No. 38229-001-005

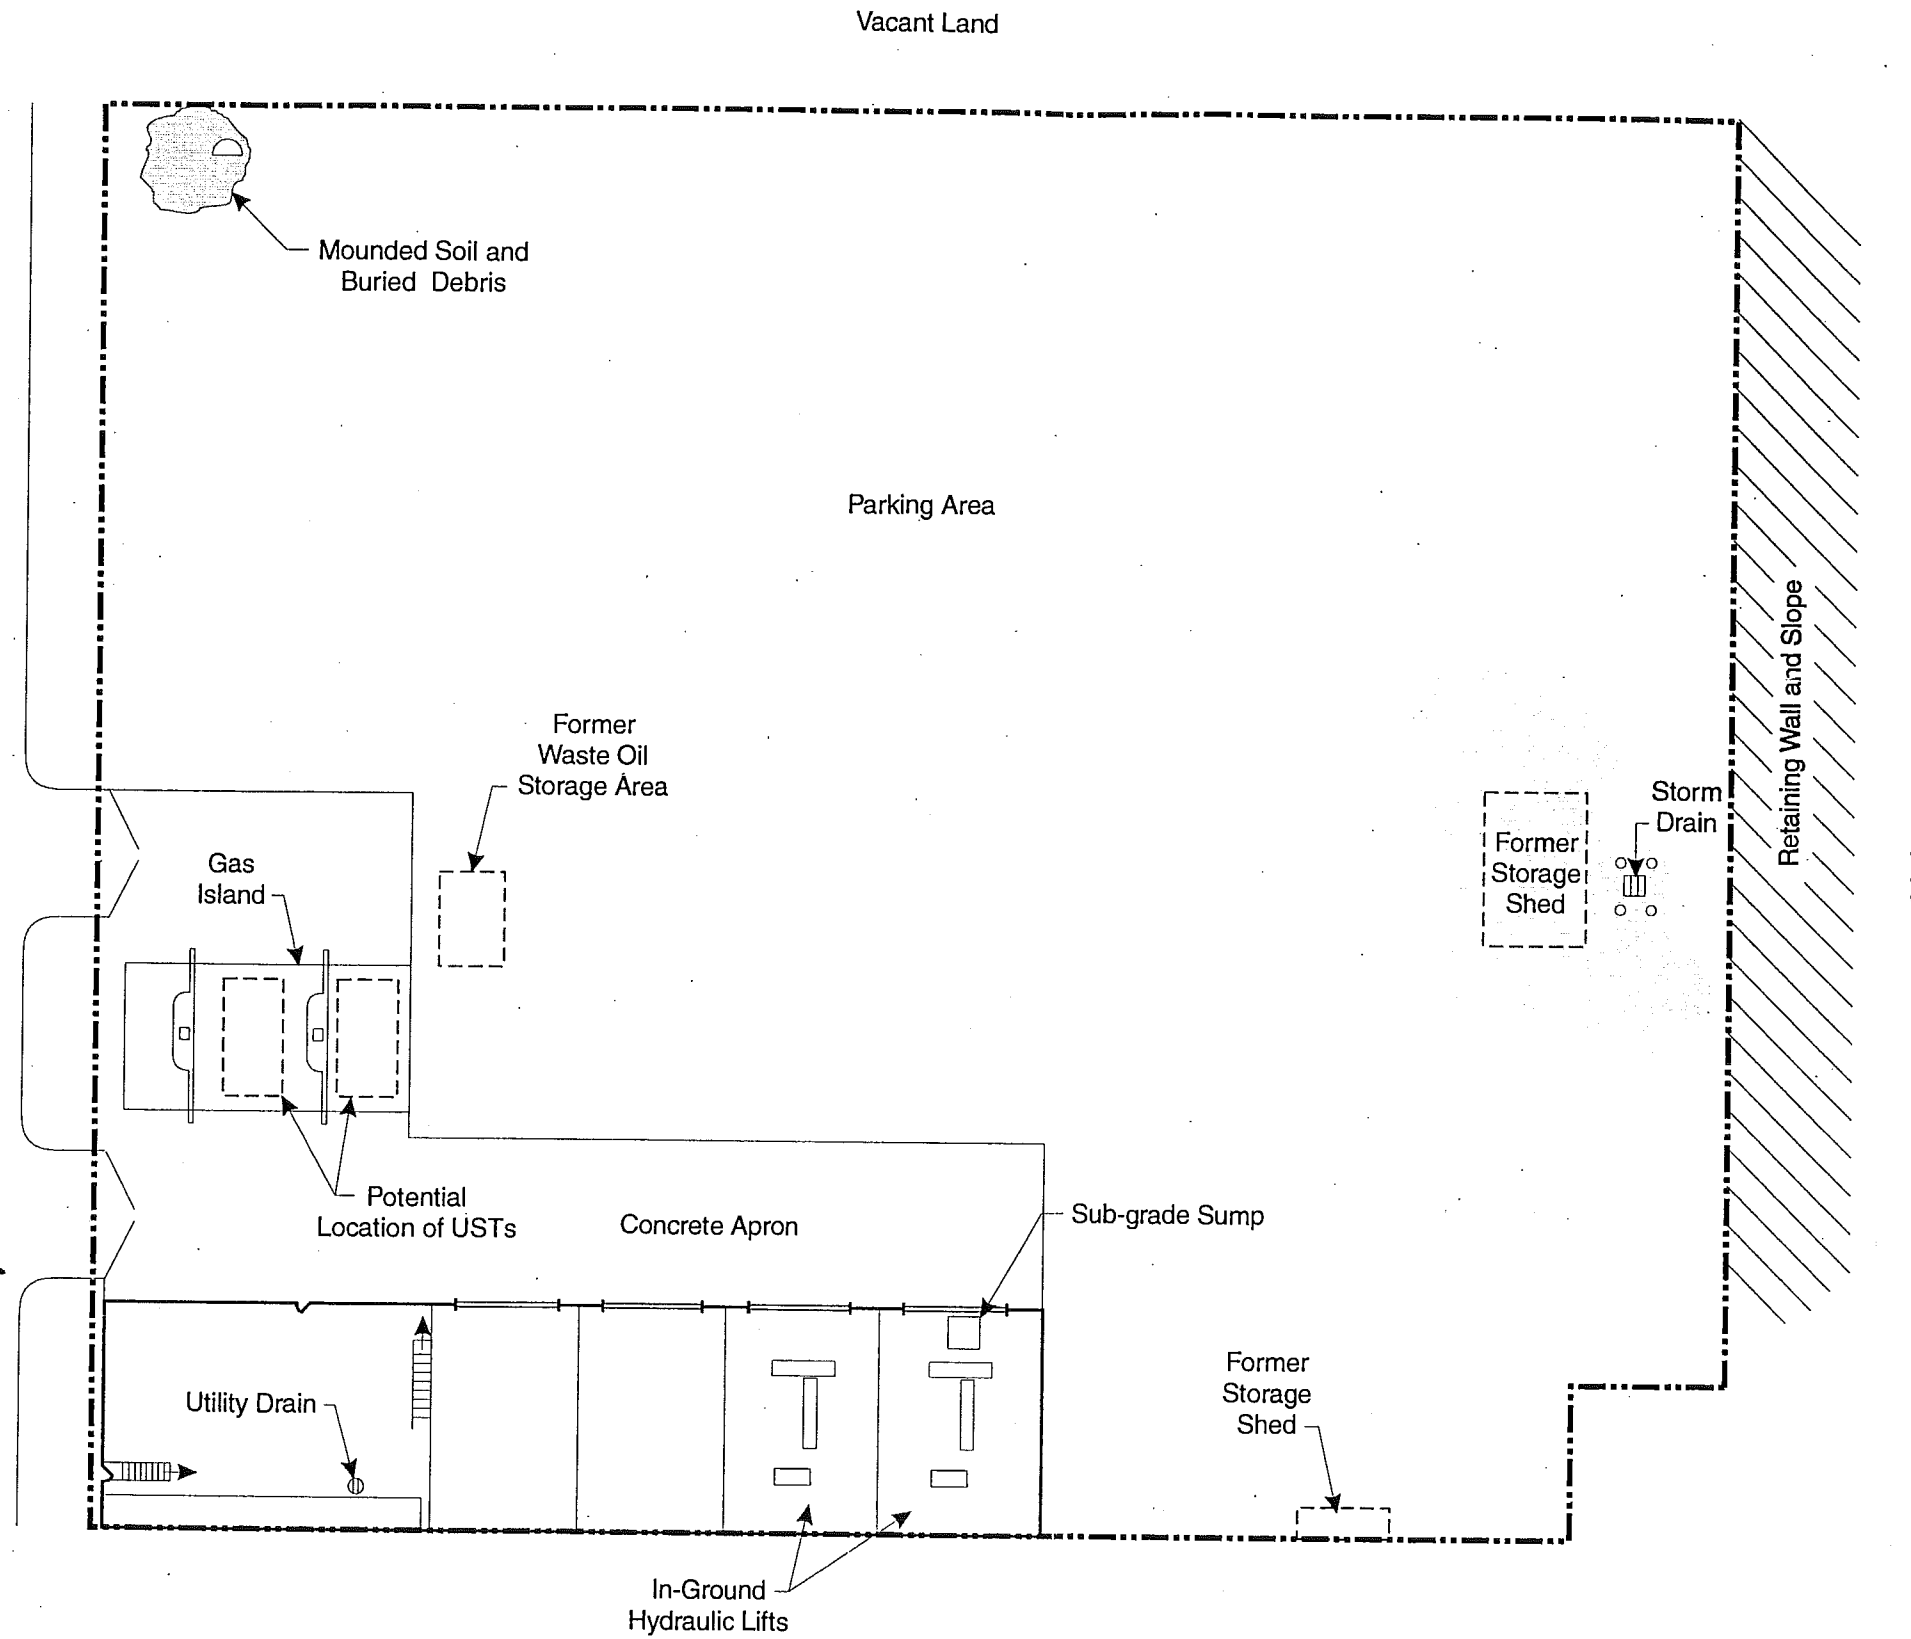
The subject property is approximately 48,400 square feet and is variously paved with gravel/cobble, asphalt, and concrete or unpaved ground (Figure 2). A fence surrounds the perimeter of the property at the property line on the north, east, and west sides and a portion of the south side. The southern portion of the property extending from the western property line east approximately 150 feet and approximately 36 feet northward from the southern property boundary is occupied by the largest building observed at the site. The building is approximately 5800 square feet and consists of a concrete poured foundation and floor, with concrete masonry unit (CMU) structural walls. The western third of the building has two floors which are finished as office spaces.

In the northern, central, eastern and southeastern portions of the site, areas of oil staining similar to the staining described during the ESA were exposed after cobble and gravel had been scraped away. Based on these observations, several of the planned areas of excavation were expanded laterally to remove the newly exposed oil stained areas and in some cases, the depth in excavations specifically near the former storage shed and storm water catch basin (Figure 2) and the southeastern area of the property required removal of soils at greater depths than initially planned by Dames & Moore.

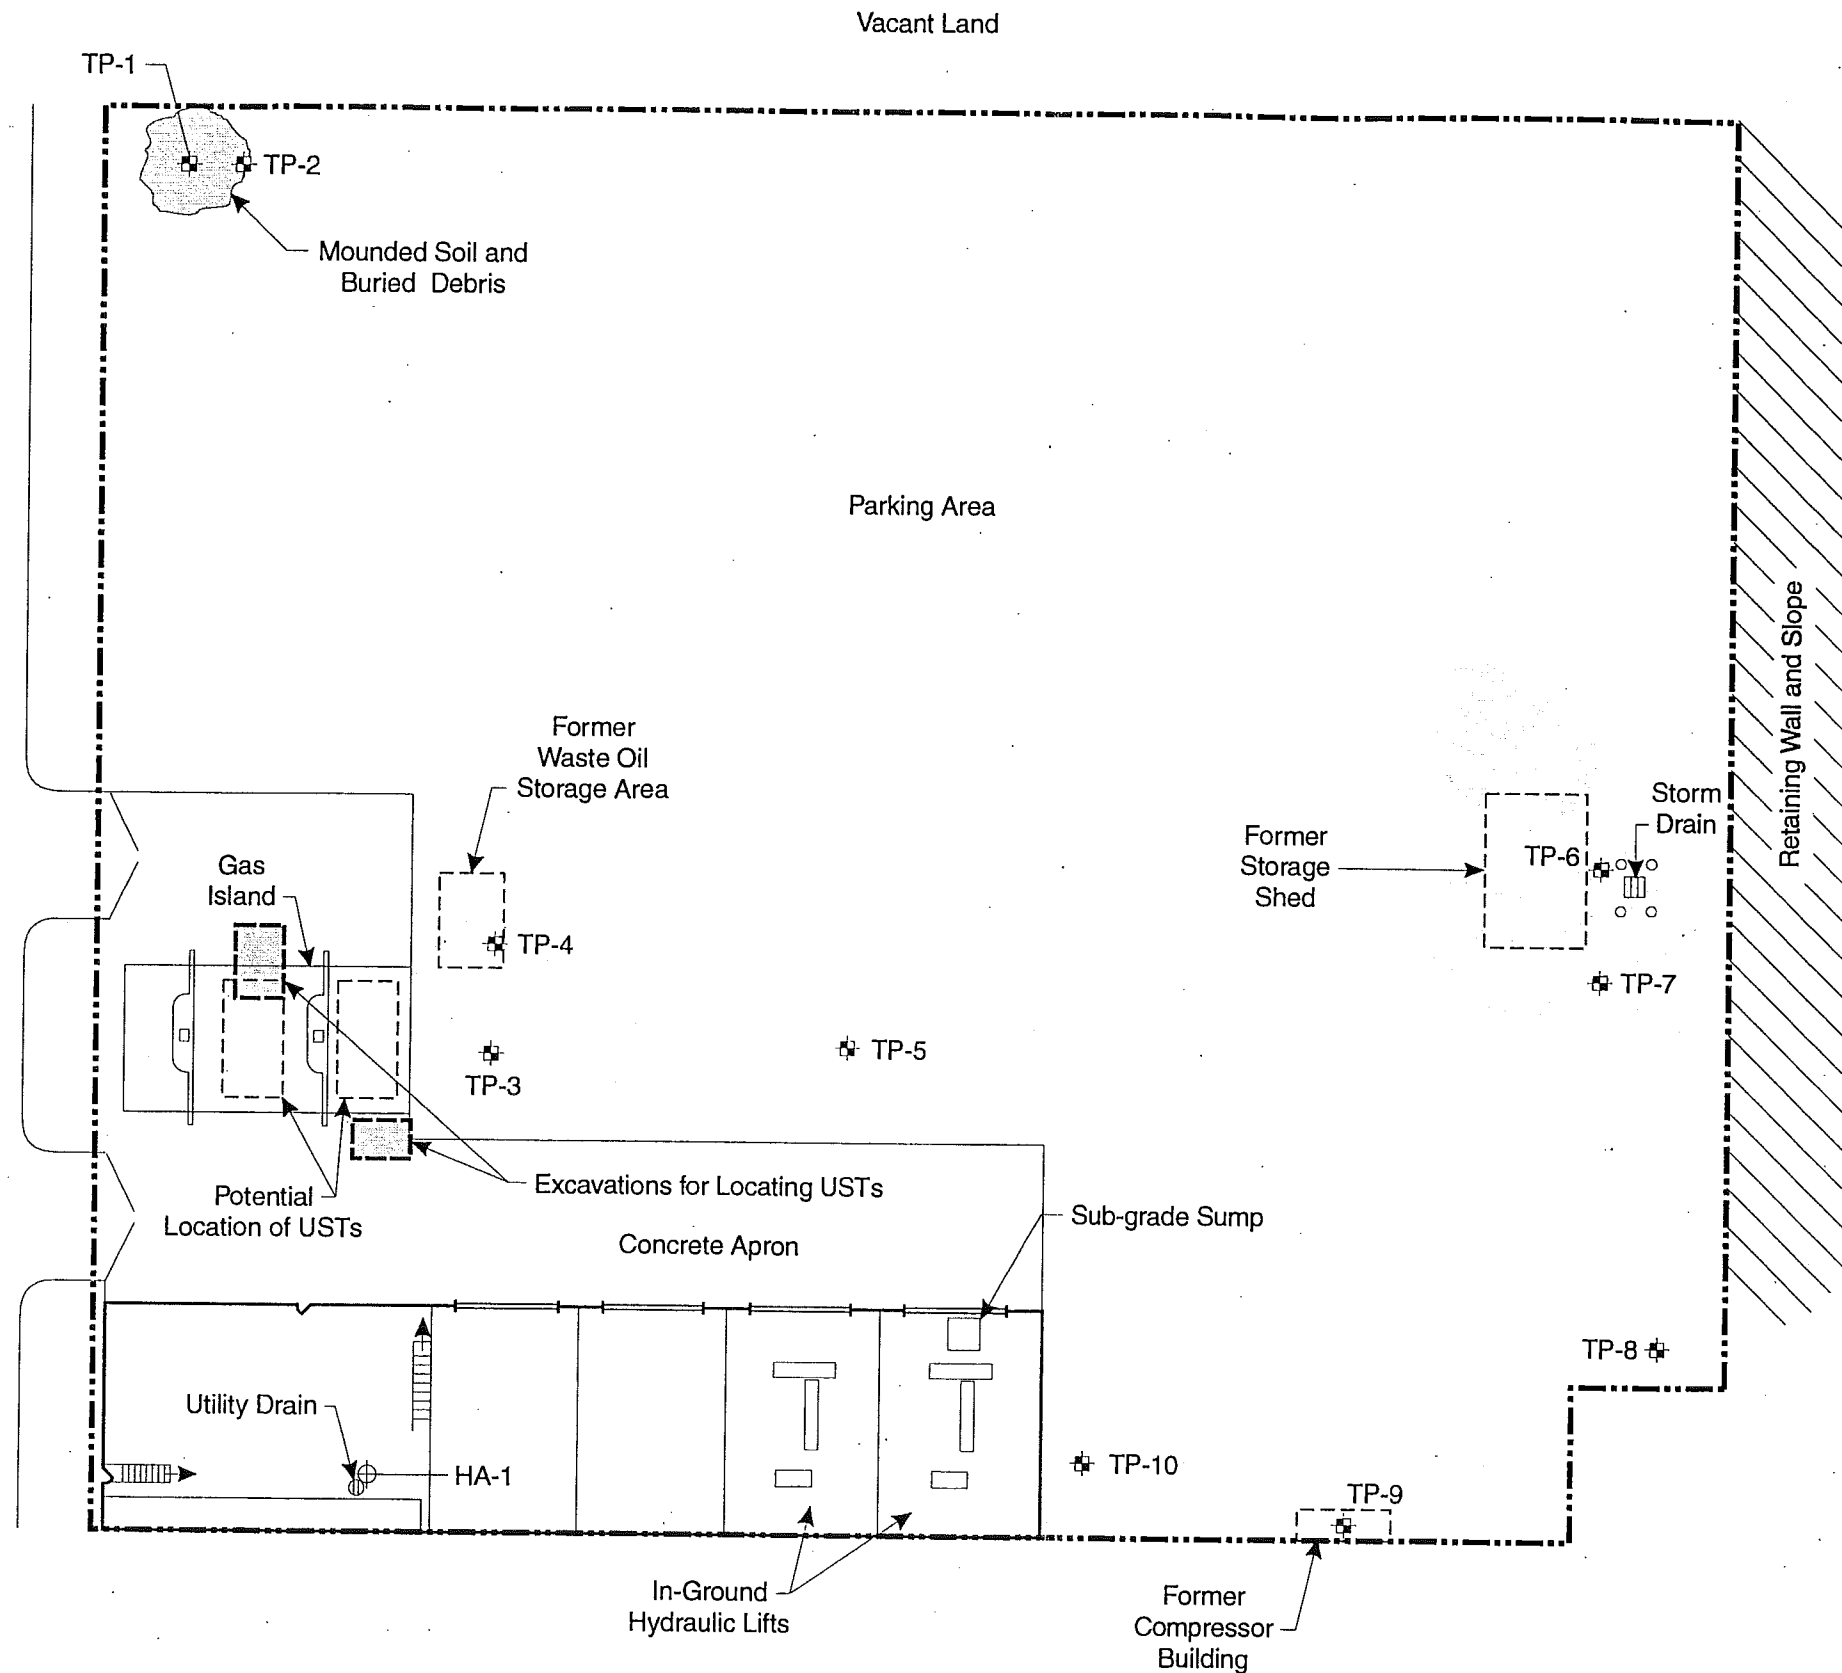
Soils in the test pits completed typically consisted of a thin layer of gravel or cobble at the surface followed by alternating layers of moist brown, reddish brown, and gray sand, silty sand, and sandy silt fill. This fill extended to depths ranging from approximately four feet in the western portion of the site to a depth greater than five feet in the eastern portion of the site (Figure 3). Groundwater was not encountered in any of the test pits excavated.

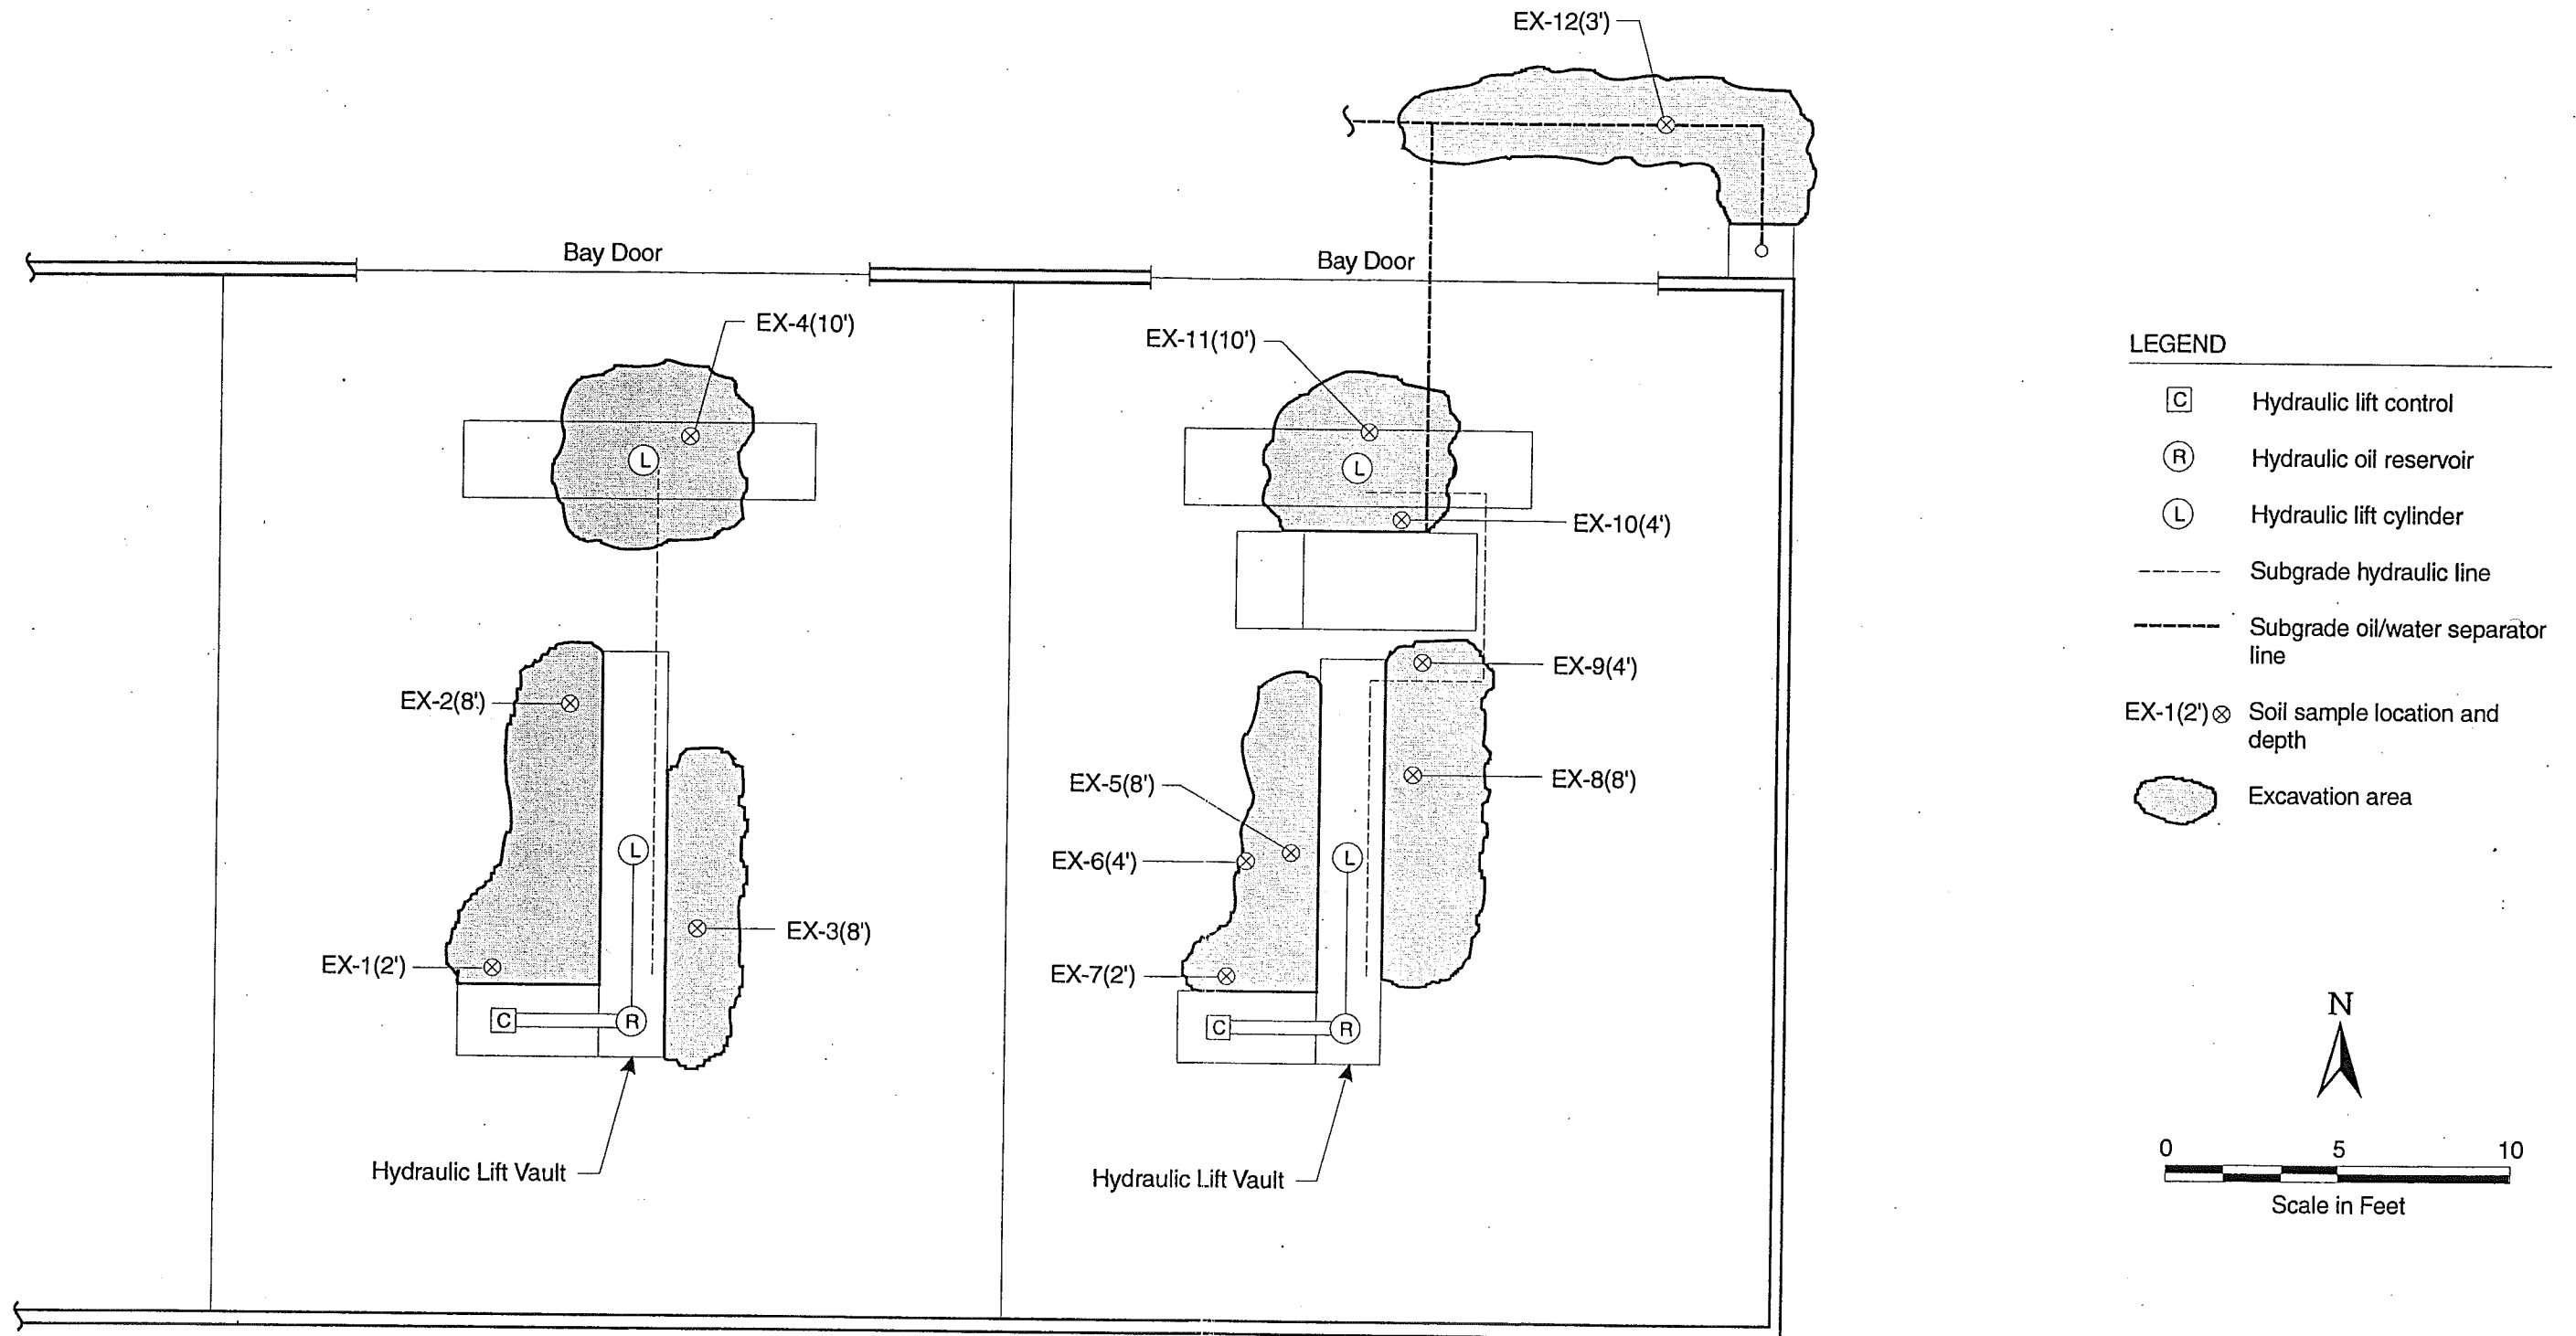
On January 22, 1998, Ace Contractors demolished concrete and excavated soil surrounding the two in-ground hydraulic lifts located in former service bays on the east end of the main building (Figure 3 and 4), and soil adjacent to and underlying the concrete sump and uncovered piping from the sump to a small sump outside the service bay entrance (Figure 4). Prior to excavation and removal, liquids observed in vaults associated with the lifts (Section 6.2.1) were removed and transported off site by Marvac, a industrial cleaning firm subcontracted by Ace Contractors. After the liquids were removed, the lifts and accessory components including piping, reservoir tanks and controls were removed and properly disposed of. Dames & Moore observed soil conditions and collected samples from the excavations with assistance from the contractor.
