**FINAL REPORT  
INVESTIGATION AND SOIL  
REMEDiation  
DIAMOND TANK TRANSPORT  
PROPERTY  
SEATTLE, WASHINGTON**

**DIAMOND TANK TRANSPORT, INC.  
D&M JOB NO. 38229-001-005  
December 10, 1998**

Final Report  
Subsurface Investigation and Soil Remediation  
Diamond Tank Transport Property  
912 Dexter Avenue North  
Seattle, Washington  
D&M Job No. 38229-001-005

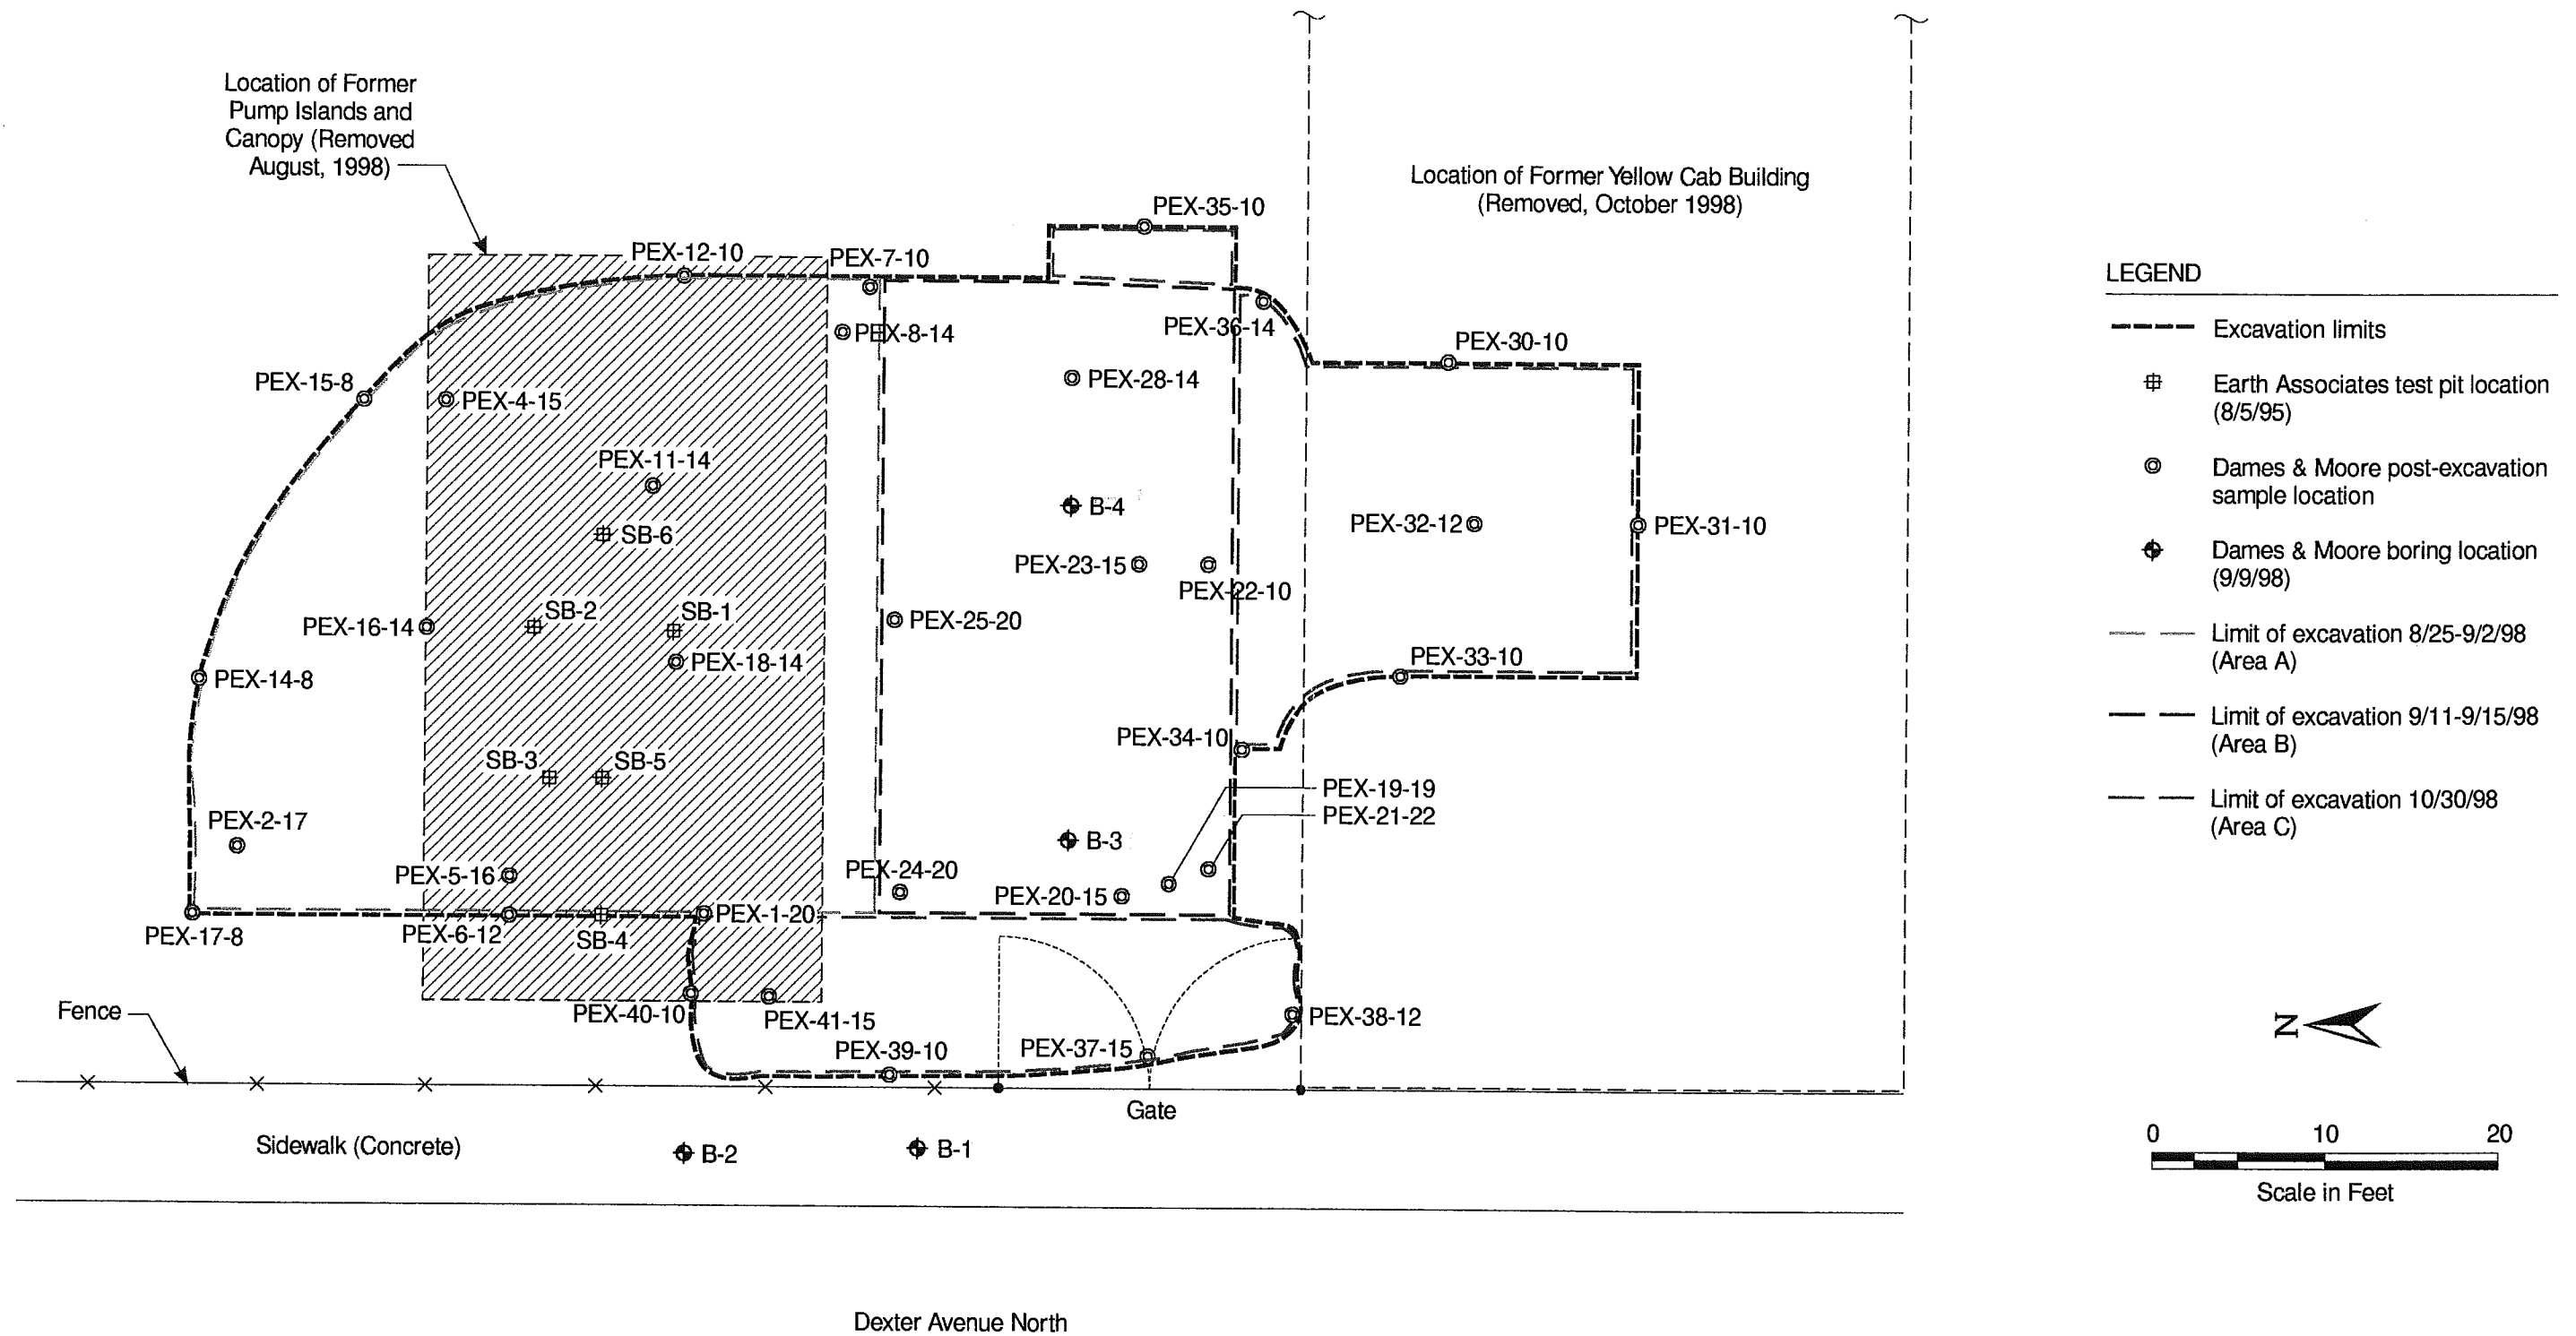
Figure 6  
**PUMP ISLAND CANOPY EXCAVATION  
AND SOIL SAMPLE LOCATIONS**

Based on the results of the subsurface investigation, the excavation was extended to the south to include Area B (Figure 6) on September 11, 14, and 15, 1998. Apparently clean surficial soils were segregated, and the excavation was extended to the south (Figure 6) to the edge of the building. Perched groundwater was encountered at approximately 18 feet bgs. Eleven soil confirmation samples were collected from the base and sidewalls of the excavation. At the time of sampling, a two- to three-foot thick layer of petroleum-affected soil was noted in the western sidewall of Area B. Results of the sample analysis

Because of the elevated hydrocarbon concentrations remaining in the south excavation sidewall, WestPac subcontracted the demolition and removal of the garage building. After the building was removed, excavation was continued to remove remnant volumes of petroleum-affected soil to the south (Area C). On October 28, the excavation was extended approximately 20 feet south to remove a layer of petroleum-affected soil observed at a depth of approximately 10 feet bgs. The excavation was extended to a depth of 12 feet, bgs, where decreased hydrocarbon impact was noted. Three sidewall samples and one base sample (PEX-30 to PEX-34) were collected to confirm that cleanup levels were achieved. Elevated hydrocarbon concentrations were not detected in any of these samples (Table 5). A limited excavation was also extended southeast (Figure 6) to remove a small volume of affected soil in the sidewall and base of the excavation in this area. Two confirmation samples (PEX-35-10 and PEX-36-14) were collected in the excavation. Neither sample indicated elevated hydrocarbon concentrations.
