TECHNICAL MEMORANDUM

SUBJECT: 2022 Landfill Cap Inspection

PROJECT NUMBER: 553-1550-067

PROJECT NAME: South Park Landfill Site Coordination

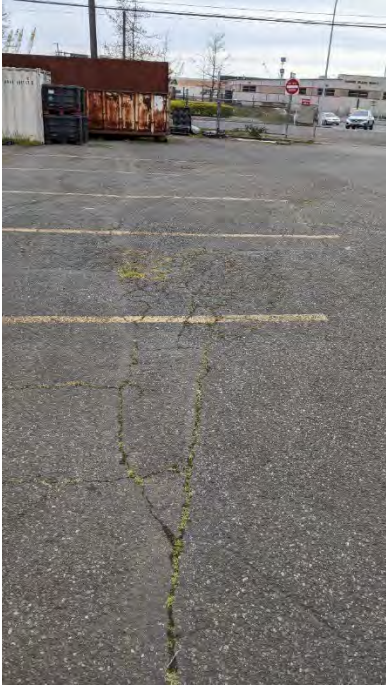
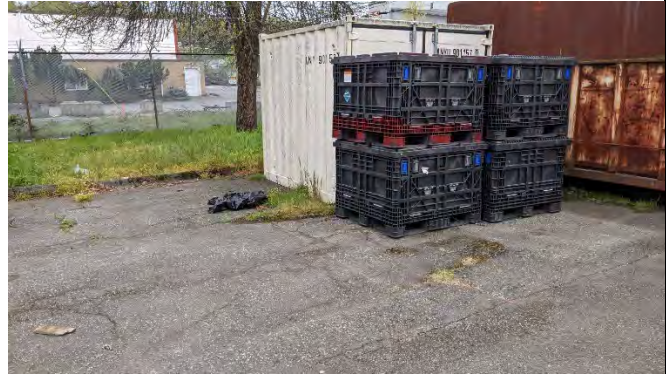
SRDS AC-1: Minor cracking

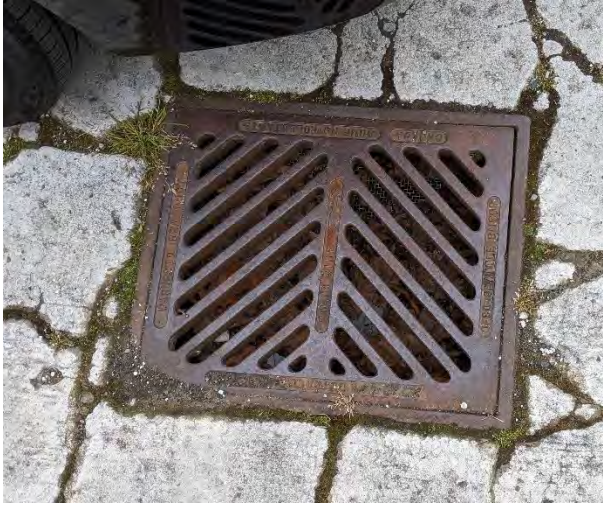
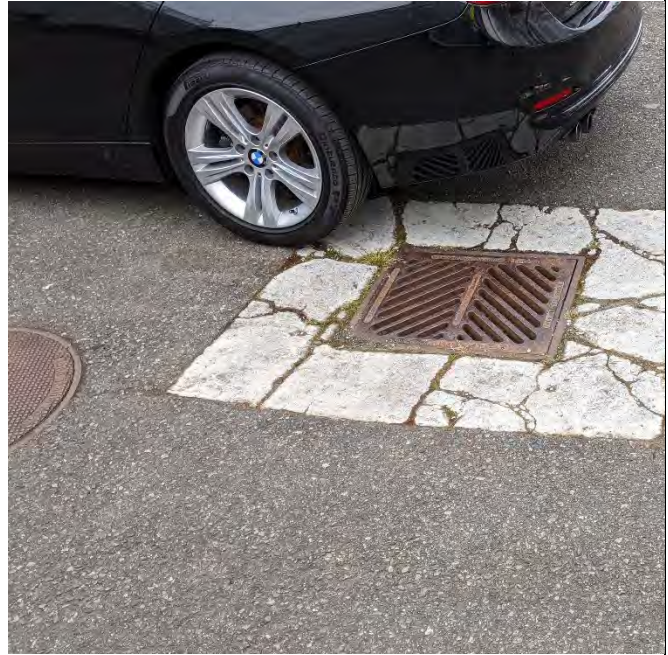
Separation of pavement from curbs, gutters, or catch basins	<input checked="" type="checkbox"/>	<input type="checkbox"/>	<input checked="" type="checkbox"/>	SRDS AC-2: Cracking in concrete slab around catch basin needs to be repaired.
Sloughing or crumbling of edge materials	<input type="checkbox"/>	<input checked="" type="checkbox"/>	<input type="checkbox"/>	
Erosion	<input checked="" type="checkbox"/>	<input type="checkbox"/>	<input type="checkbox"/>	SRDS AC-14: Minor pavement spalling with moss
Other signs of cap damage, failure, or disturbance	<input type="checkbox"/>	<input checked="" type="checkbox"/>	<input type="checkbox"/>

SRDS AC-2: there is cracking concrete at a catch basin that needs to be repaired.

SRDS AC-2: Minor cracking and debris in catch basin

- The concrete cracking around the catch basin at location **SRDS AC-2** should be repaired by the end of the calendar year and the debris cleared out.
- **SRDS AC-5** has worsened since the last inspection. The pavement cracking and small depression identified in 2021 has deepened to a pothole and should be repaired within the calendar year.
- The catch basins at **SRDS SW-1 and SW-2** should have the obstructions removed in the next 6 months.
- 6-month reinspection of locations of concern not recommended for repairs in 2022.

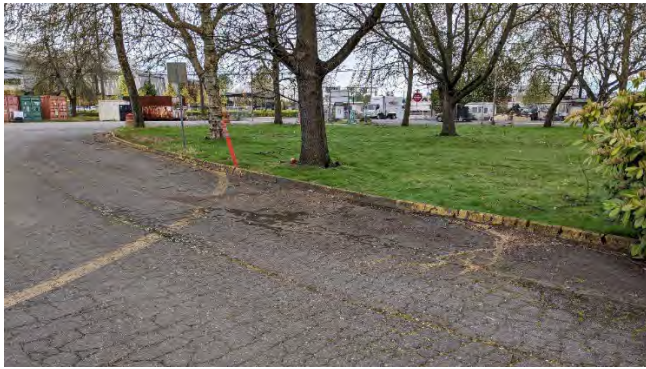
SRDS AC-3: Minor cracking and ponding

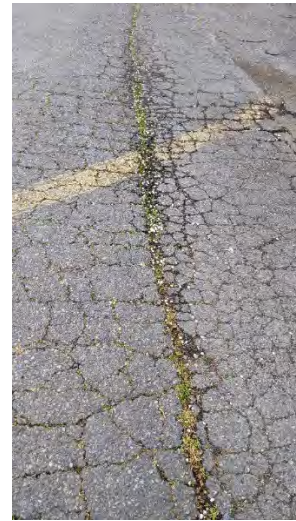
SRDS AC-3: Minor cracking

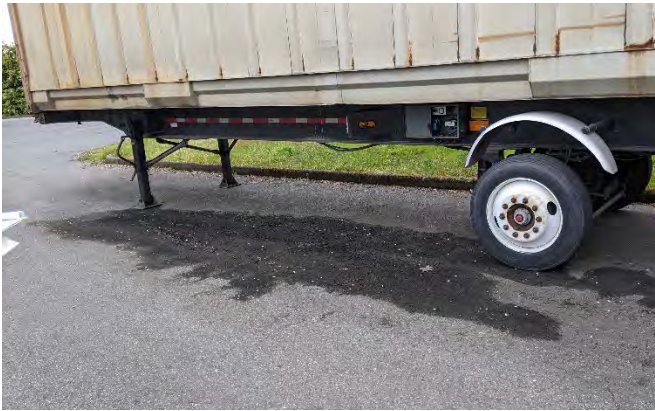
SRDS AC-4: Ponding

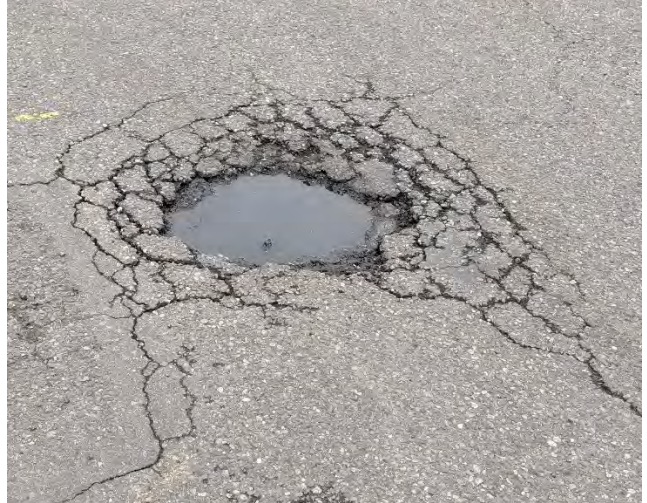
SRDS AC-5: a pothole that needs to be repaired/filled. This continued sinking of pavement is concerning. If left unmitigated, the sinkhole will continue to allow runoff to seep below the asphaltic cap which could lead to water ponding underneath the cap. Runoff in this area should be reaching the next downstream catch basin instead of entering the pothole.

SRDS AC-5: Pothole

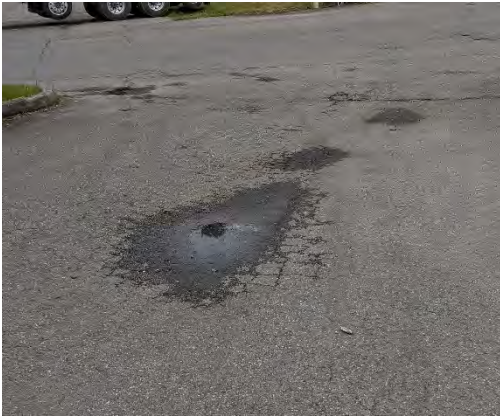
SRDS AC-6: Minor Cracking

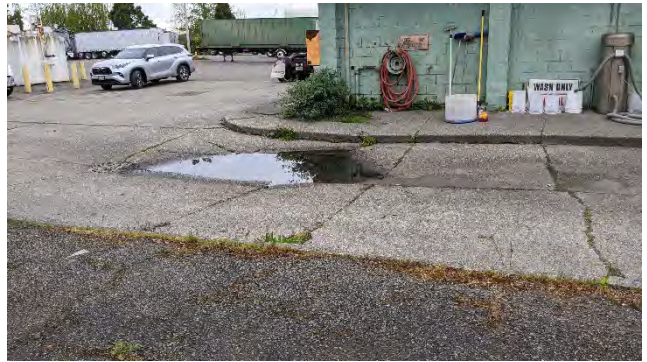
SRDS AC-7: Ponding

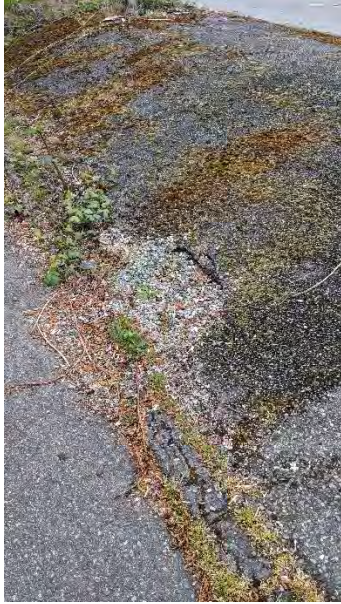
SRDS AC-8: Sinkhole filled with gravel

- **SRDS AC-8** was noted as a sinkhole in 2021 and has been filled with gravel as a repair on 3/18/2021 (Appendix B2-B of the 2021 Annual Report).

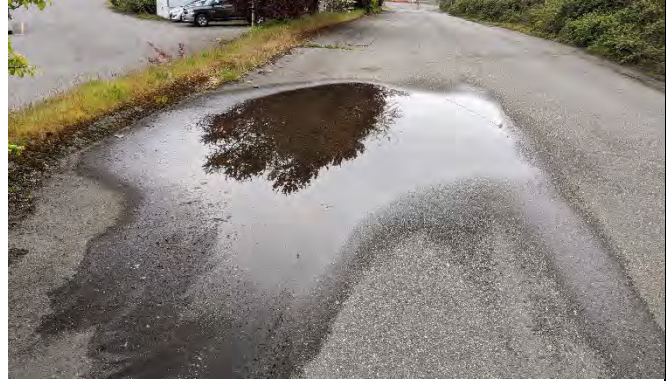
SRDS AC-9: Ponding

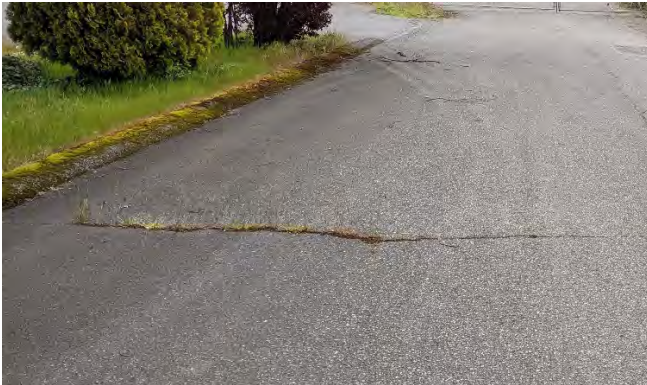
SRDS AC-10: Minor cracking

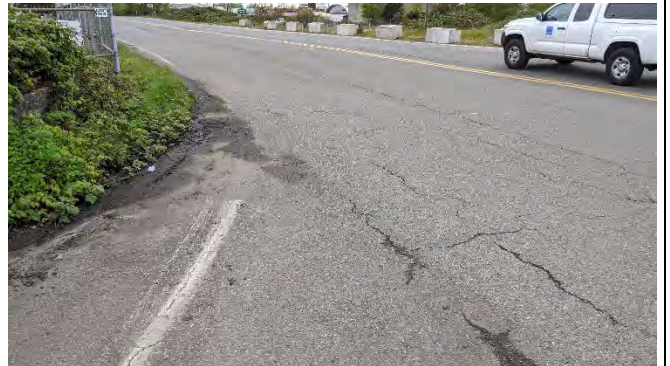
SRDS AC-11: Ponding

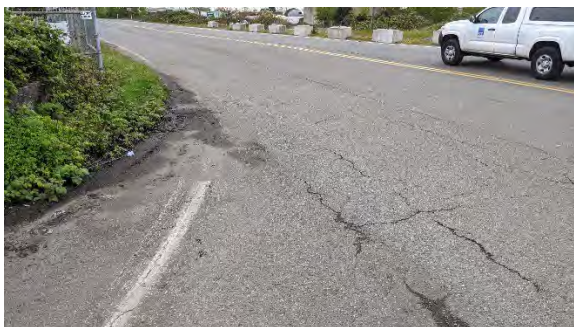
SRDS AC-12: Minor cracking

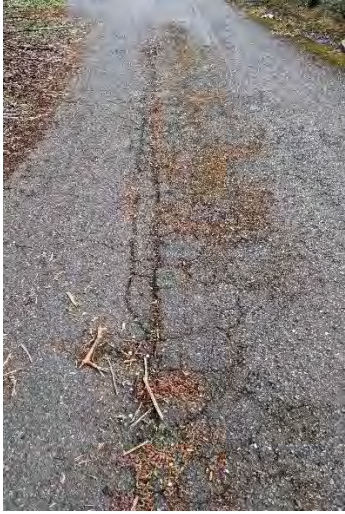
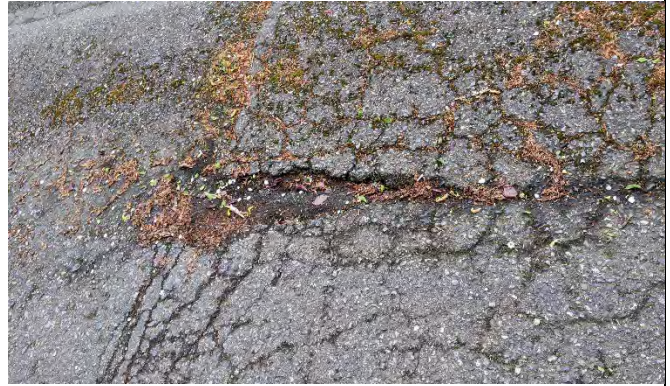
SRDS AC-13: Minor cracking and rutting

SRDS AC-13: Pavement cracking and rutting

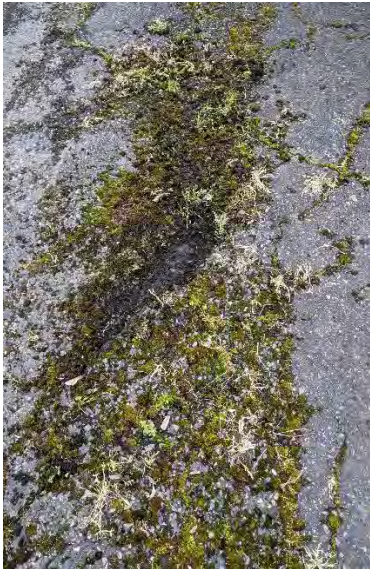
SRDS AC-14: Minor pavement spalling with moss

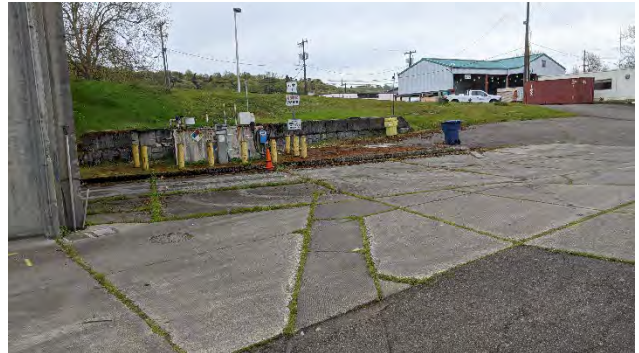
SRDS AC-15: Minor cracking

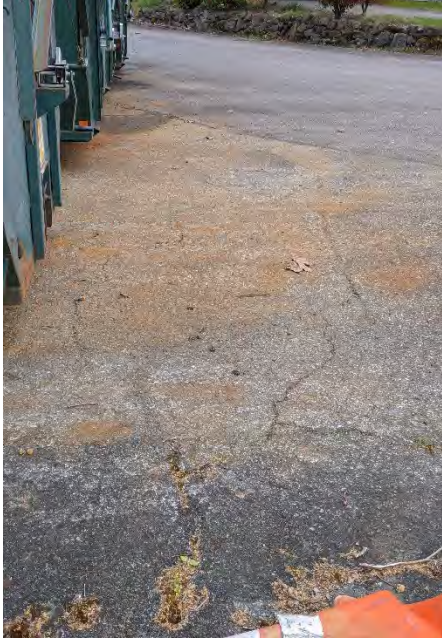
SRDS AC-16: Minor cracking

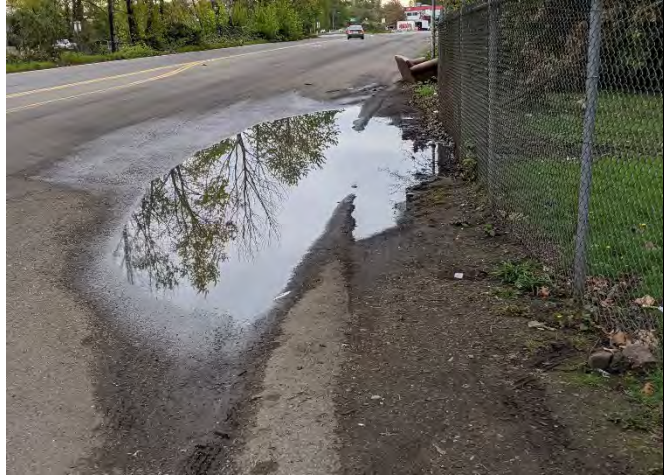
SRDS AC-17: Ponding

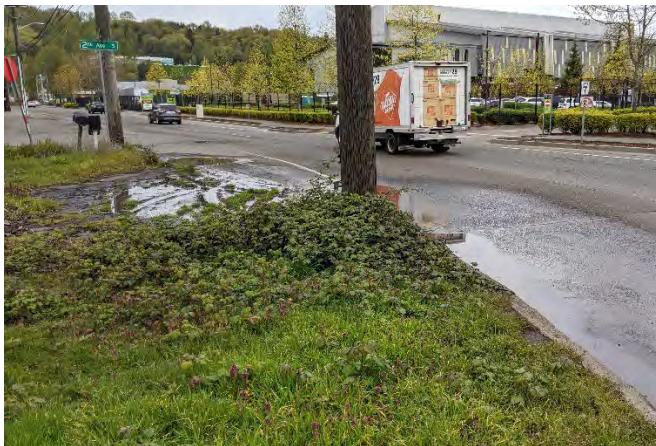
SRDS AC-18: Ponding

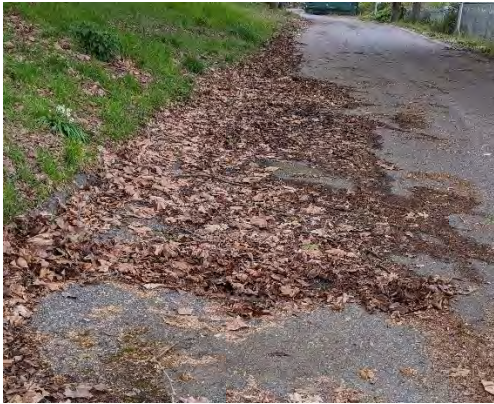
SRDS SW-1: Obstructed catch basin

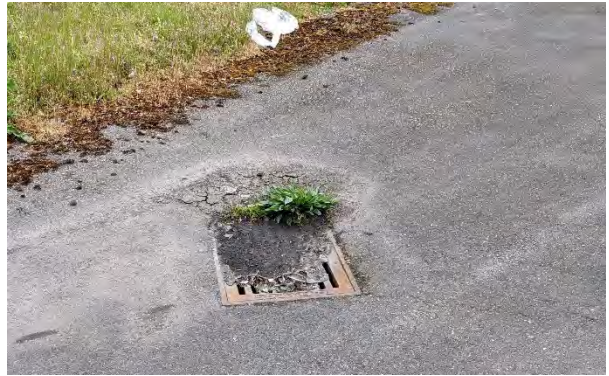
SRDS SW-2: Obstructed catch basin

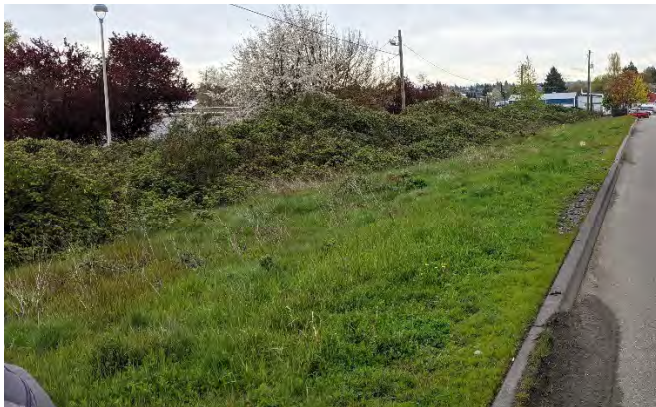
SRDS SW-3: Potential area of geomembrane

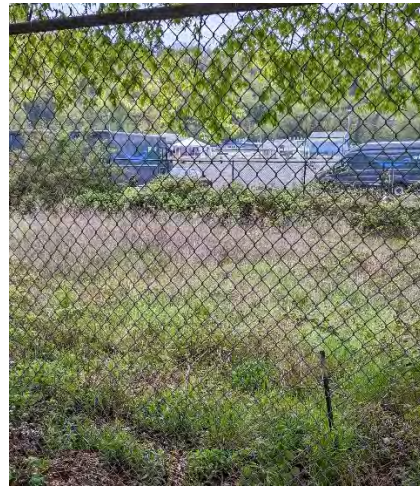
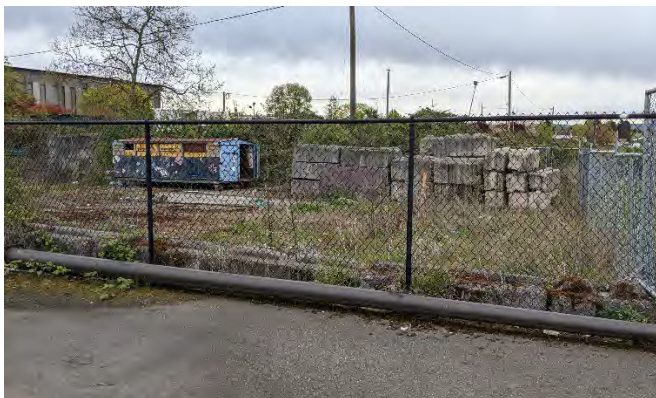
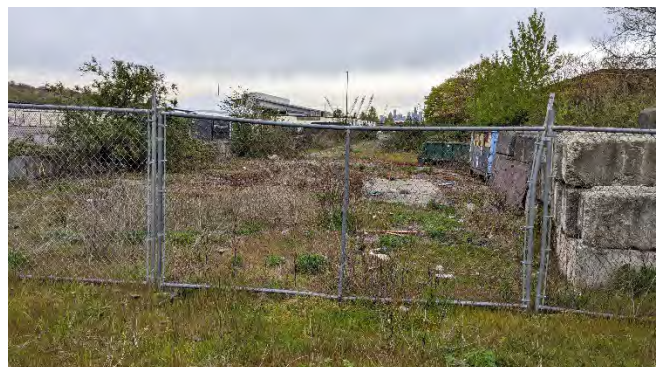
SRDS SW-4: Potential Run-on from SPPD

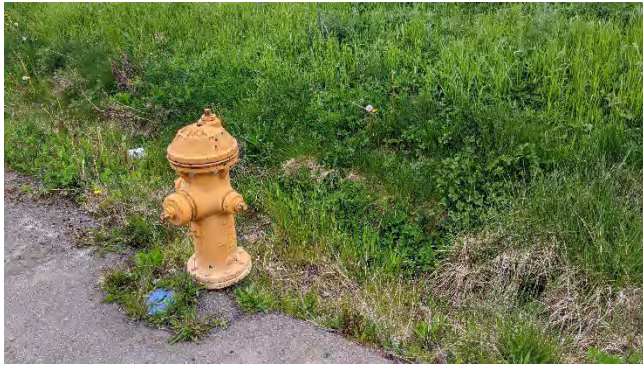
SPPD AC-2: Depression at fire hydrant

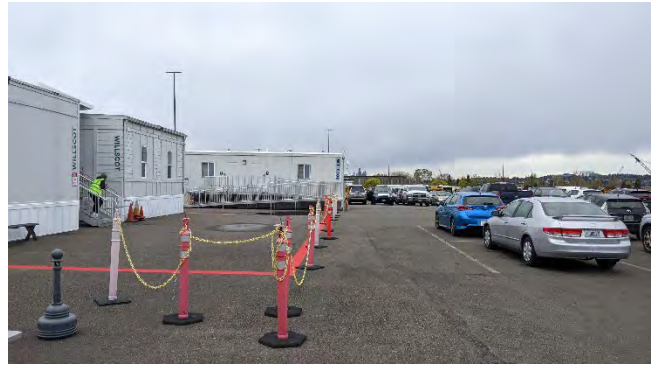
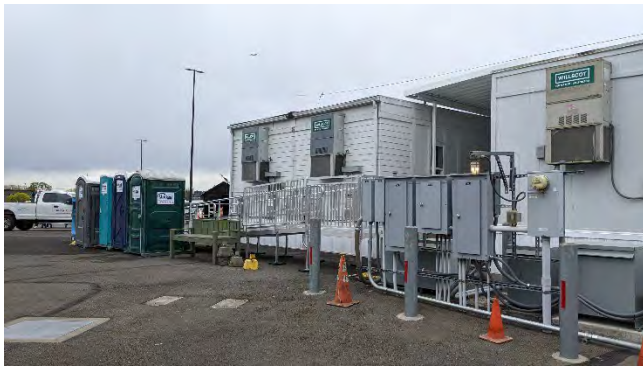
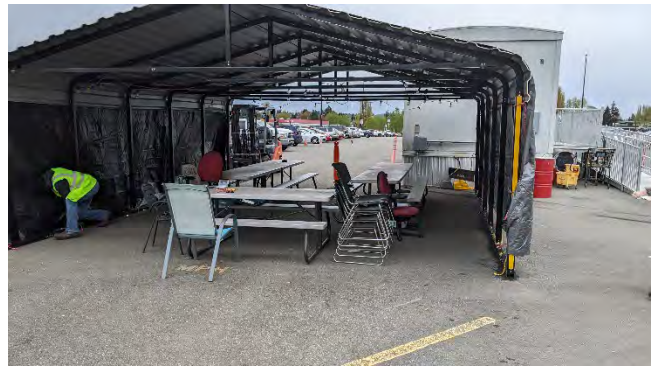
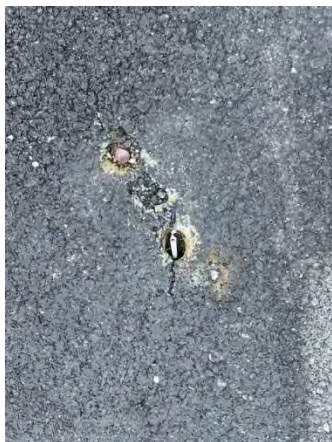
- There were significant changes at the location of the onsite buildings (**SPPD AC-3**). In 2021, some drill hole asphalt penetrations had been noted and since then new trailers have been added and the original trailer has been removed in the vicinity of location SPPD AC-3. There are small drill holes where the previous trailer had been and active drilling with a hand drill to anchor a tent was occurring during the site visit. No maintenance report had been submitted for these activities. The Site Coordinator was not informed of this construction by the property owner.
- An electric security fence was installed around the First Student tenant's portion of the property since the April 2021 inspection. The Site Coordinator was not informed of this construction until February 23, 2022, by Ecology (Maintenance Report 11/15/21 in Appendix B2-B of the 2021 Annual Report).

Erosion	<input type="checkbox"/>	<input checked="" type="checkbox"/>	<input type="checkbox"/>	
Other signs of cap damage, failure, or disturbance	<input checked="" type="checkbox"/>	<input type="checkbox"/>	<input type="checkbox"/>	SPPD AC-3: There are new buildings with aprons that kept us from visualizing any potential penetrations, active drilling into the asphalt to anchor tent (depth unknown), holes noted in the cap from where the previous building was. These need to be checked to determine if the cap was fully penetrated.

SPPD AC-3: New Buildings, potential cap penetration

SPPD AC-3: Old building location, potential cap penetration

- SPPD should provide the Site Coordinator with foundation details for the new trailers (**SPPD AC-3**) to demonstrate that the cap was not penetrated within the next 60 days. Permitting information and/or photographs of the foundations should also be provided to the Site Coordinator.

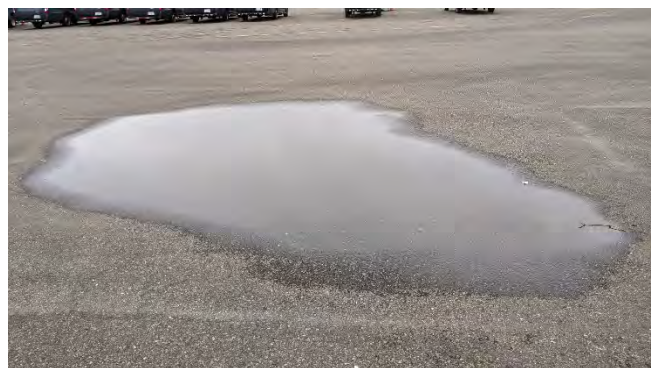
SPPD AC-4: Ponding

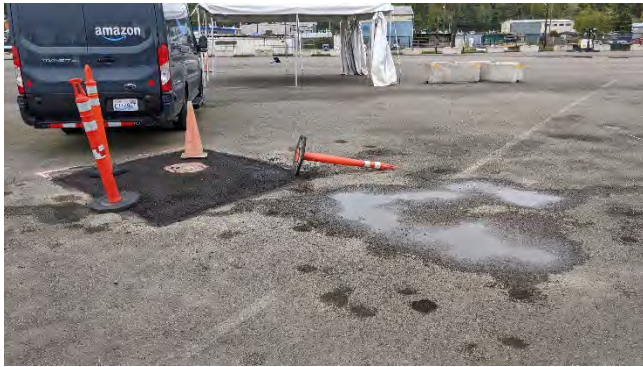
SPPD AC-5: Modification of asphalt

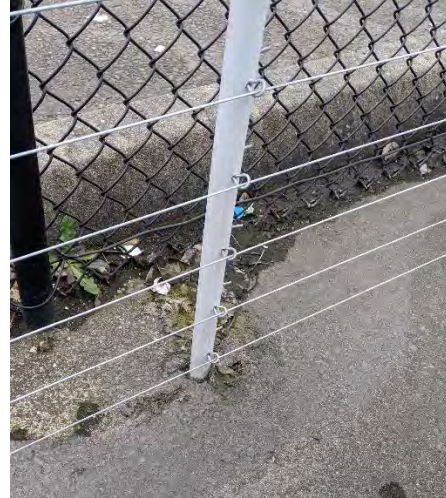
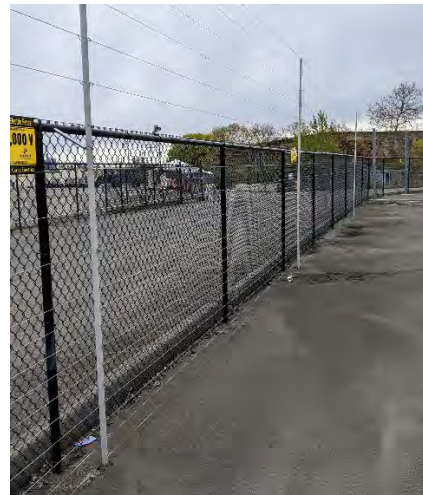
SPPD AC-6: New electric fence

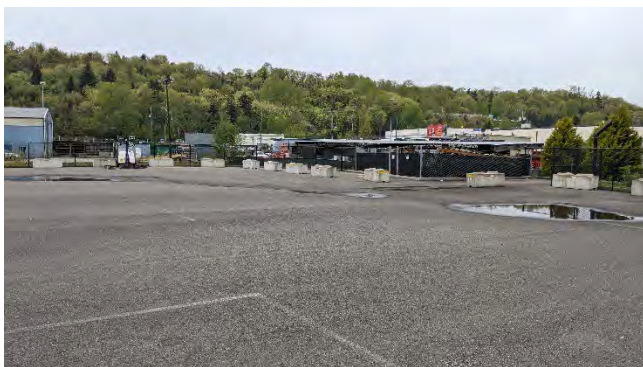
SPPD AC-7: Several areas of ponding

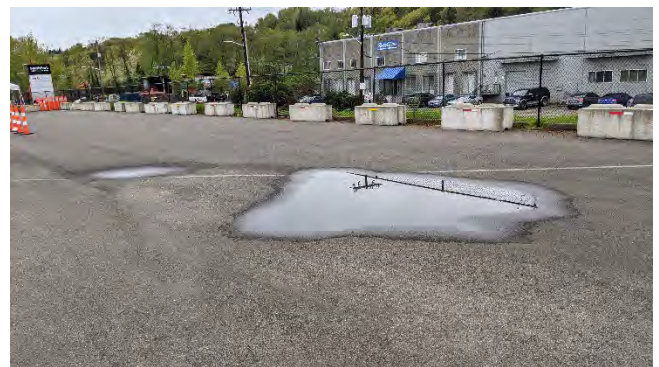
SPPD AC-8: Ponding

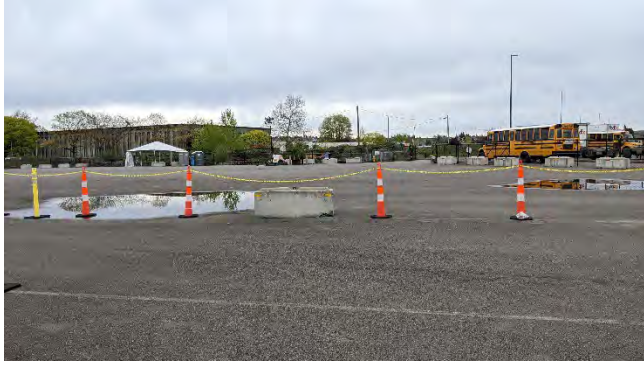
SPPD AC-9: Ponding

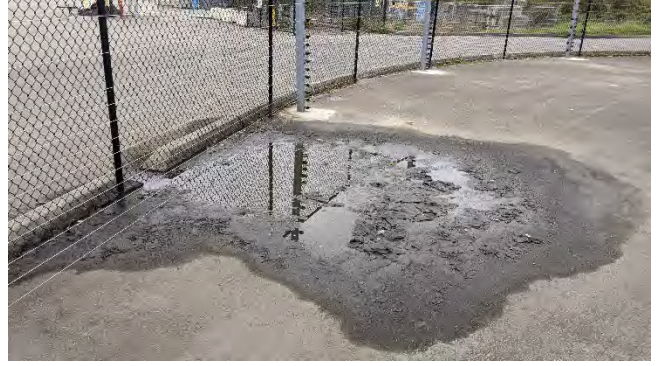
SPPD AC-10: Ponding

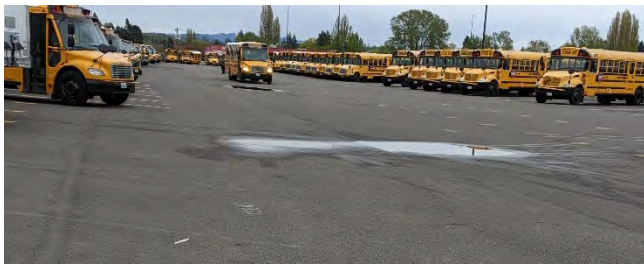
SPPD AC-11: Ponding

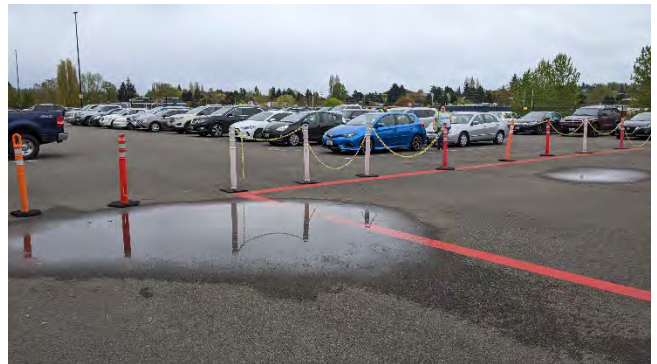
SPPD AC-12: Ponding

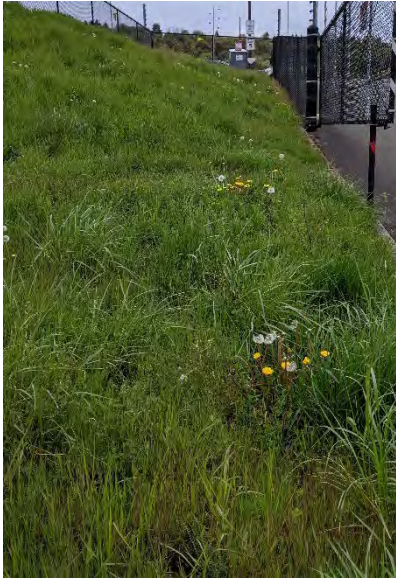
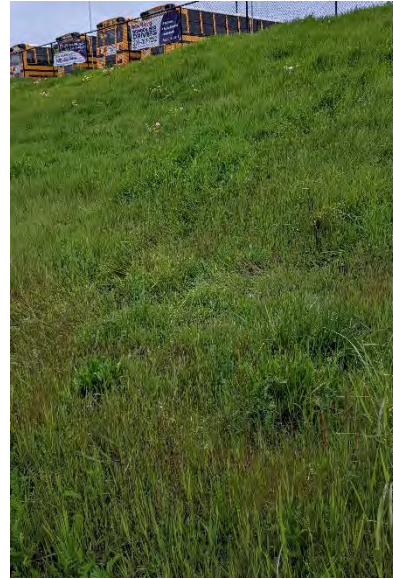
SPPD G-1: Unidentified pipes have been removed

- Removal of pipes at **SPPD G-1**
- 6-month reinspection of locations of concern not needing repairs in 2022.

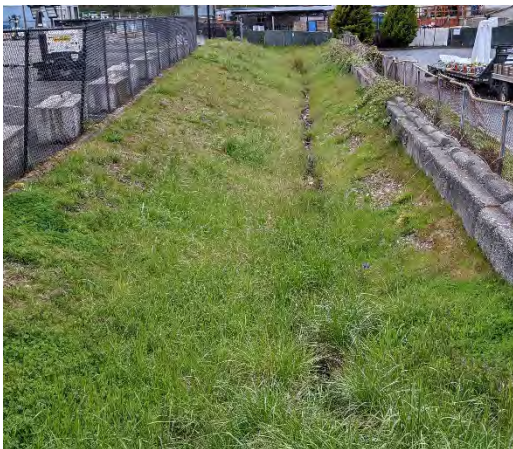
SPPD G-2: Erosion of soil cover

- Repair the soil and vegetation at **SPPD G-2**. SPPD should investigate source of erosion, identify possible solutions in coordination with Site Coordinator, and take corrective action. Area should be inspected by Site Coordinator after heavy persistent rain.

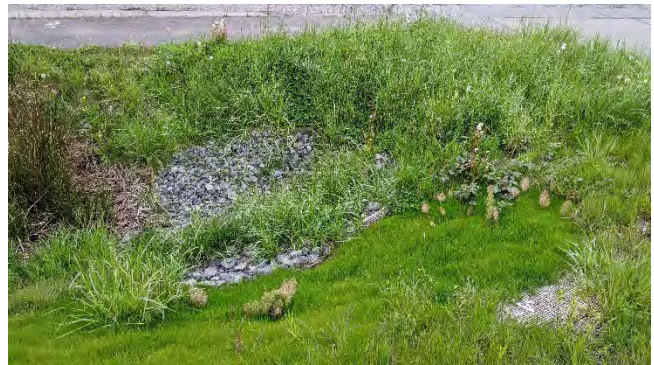
SPPD G-3: New vegetation and rock around culvert

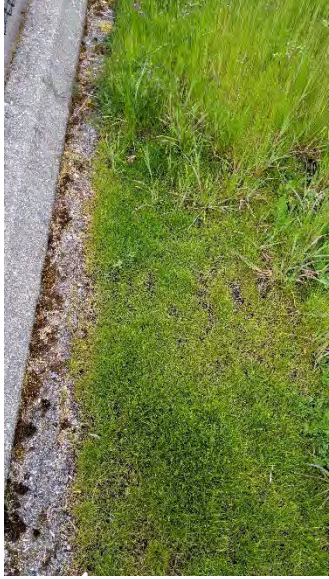
G-4	New grass cover over previously exposed geomembrane	The configuration of the geomembrane and cover at the interface of the parking area does not appear to be in accordance with Figure 5 of the Interim Action Work Plan (IAWP). The geomembrane appears to be directly below the asphalt with no drainage layer or surfacing layer in between. Some locations show evidence of geomembrane damage. Along with Site Coordinator, prepare a plan to reestablish cover over the geomembrane. Most likely, the area should be exposed, and the geomembrane tested for damage before repairs should be made. The crest of slope should then be provided cover to the maximum extent possible considering the existing asphalt and curb configuration.	Exposed geomembrane areas within the work area were covered with 2 to 3 inches of unconsolidated topsoil then heavily seeded. Erosion control measures, which included Jute netting and secured with 6-inch staples, were installed on the steep slopes but not at the top of the hill adjacent to the paved cap. (Maintenance Report 11/2/21)	Improved	Construction documentation should be used to determine how the installation was performed and how to bring the existing location back to design conditions. Currently exposed geomembrane should be cleaned and inspected for cracking or signs of failure. If geomembrane is in good condition, revegetated to the maximum extent practicable and monitored for erosion.	60 days	SPPD will work in coordination with Site Coordinator to establish a solution

SPPD G-4: New grass over membrane

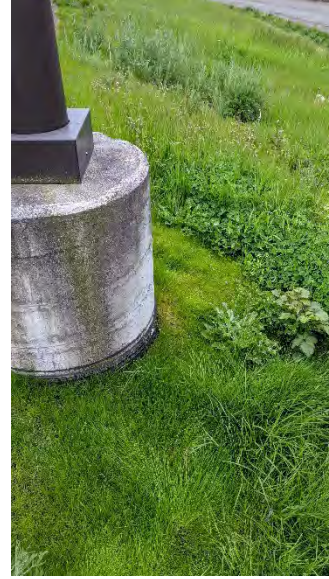
G-5	New grass cover over previously exposed geomembrane	See Location G-4 (#21-13) recommendations.	See Location G-4 activities.	Improved	See Location G-4 2022 recommendations.	60 days	SPPD will work in coordination with Site Coordinator to establish a solution
G-6	New grass cover over previously exposed geomembrane	See Location G-4 (#21-13) recommendations.	See Location G-4 activities.	Improved	See Location G-4 2022 recommendations.	60 days	SPPD will work in coordination with Site Coordinator to establish a solution
G-7	Exposed and damaged geomembrane at the parking area interface	See Location G-4 (#21-13) recommendations.	See Location G-4 activities.	No Change	See Location G-4 2022 recommendations.	60 days	SPPD will work in coordination with Site Coordinator to establish a solution

SPPD G-5: New grass over membrane

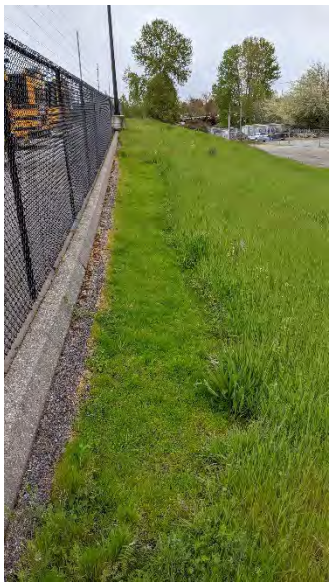
SPPD G-6: New grass over geomembrane

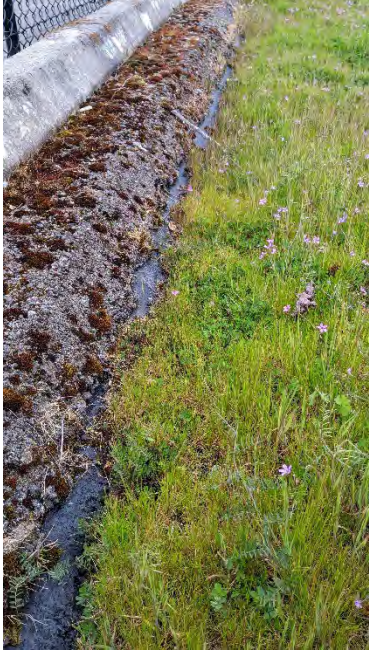
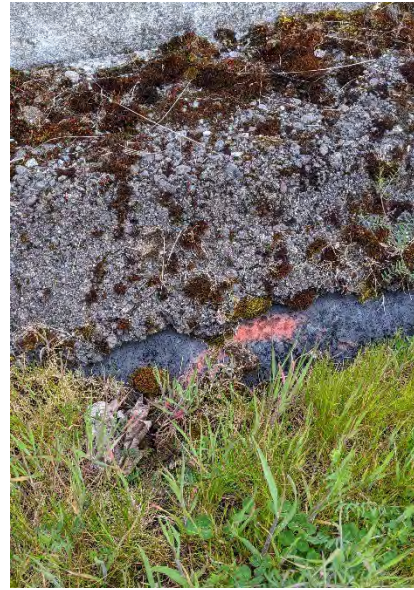
SPPD G-7 Exposed and damaged geomembrane

- The landfill cap geomembrane is exposed at **SPPD G-7** and **G-10** at the interface of the parking area. This area is of highest concern due to the potential compromise of the landfill cap. The improvements completed in 2021 at **SPPD G-4, G-5** and **G-6** did not appear to adequately restore the cover system in accordance with the IAWP. Construction documentation should be used to determine how the installation was performed and how to bring the existing location back to design conditions. Exposed geomembrane should be cleaned and inspected for cracking or signs of failure. If geomembrane is in good condition, revegetate to the maximum extent practicable and monitor for erosion. Site Coordinator should be present during the investigation and at any restoration activities. Action should be taken within the next 60 days.

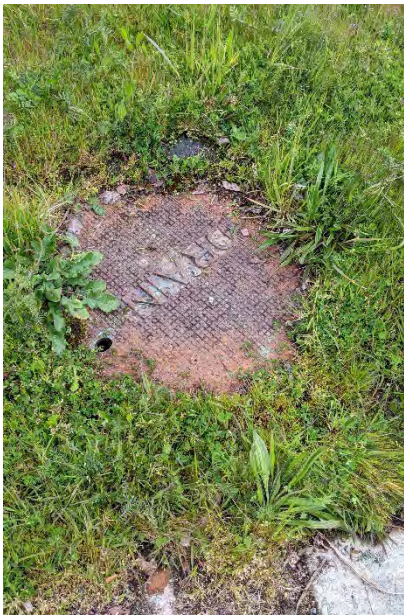
SPPD G-8 Exposed geomembrane around manhole

- Exposed and shallowly covered geomembrane at **SPPD G-8** should be carefully exposed so as to not damage the geomembrane and inspected to determine if it is excess material or part of the cover. Make repairs as necessary and install adequate cover soil in accordance with the IAWP within the next 60 days.

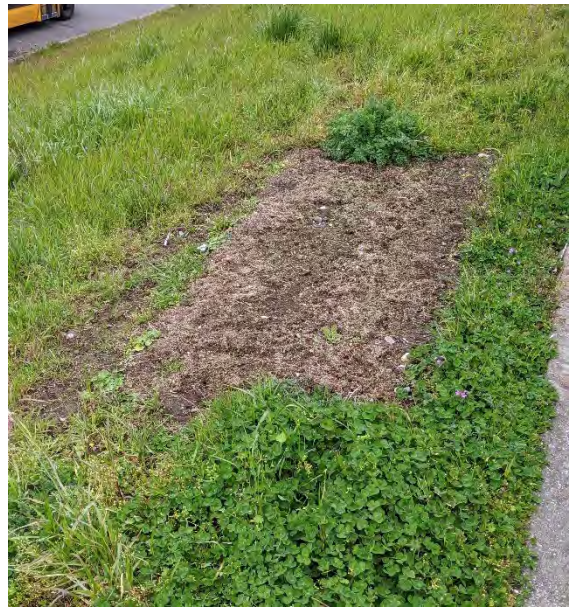
SPPD G-9: Bare patch of soil

- Re-establish vegetation in the next 60 days to prevent erosion at **SPPD G-9**.
- The bioswale at **SPPD SW-1** has standing water with a sheen on it. The water should be tested to determine if the sheen is organic or total petroleum hydrocarbons (TPH) and dealt with accordingly. The standing water potentially does not meet the Department of Ecology's Stormwater Management Manual of Western Washington's design requirements. The swale was originally intended to have a 1.5% drainage gradient. The standing water increases infiltration potential into the landfill refuse. Along with Site Coordinator, prepare a plan to address this situation.

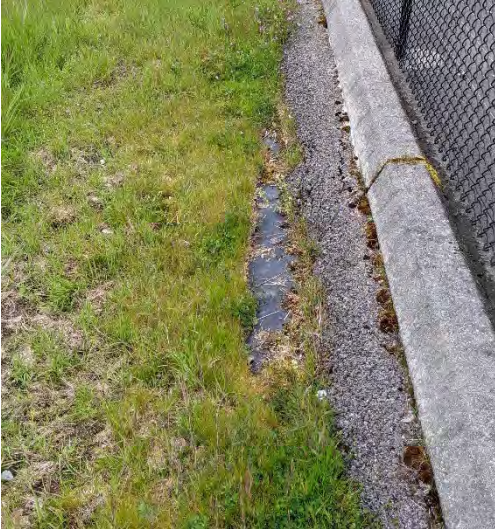
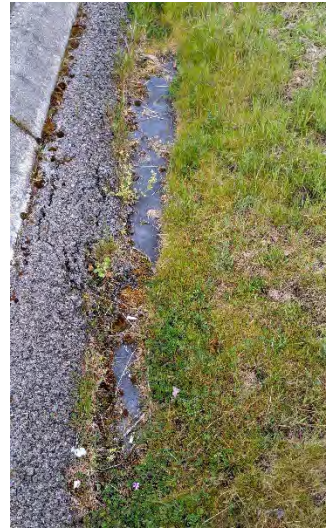
SPPD G-10: Exposed and damaged geomembrane

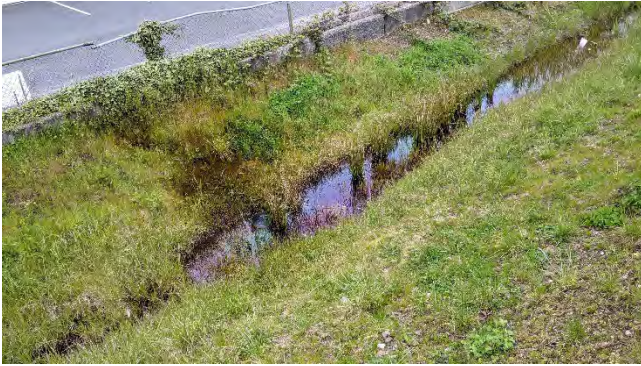
Proper flow direction as designed	<input type="checkbox"/>	<input checked="" type="checkbox"/>	<input checked="" type="checkbox"/>	SPPD SW-1: Standing water in north bioswale with a colorful sheen over the water
<p>Recommended Maintenance or Repair Type/Location:</p> <p>SPPD SW-1: The swale should be evaluated to determine if dredging and removal of herbaceous species would improve water conveyance and the water should be evaluated to see what is causing the sheen on the water.</p> <p>SPPD SW-2: The willow and black cottonwood shrubs located within the west swale are deep-rooted plants and should be cut down and maintained.</p> <p>Other Observations:</p> <p>There were some areas of erosion and poor vegetated cover that are covered under the Low-Permeability Geomembrane checklist.</p> <p>There was standing water in the west bioswale but that area has high groundwater and the standing water is likely groundwater since the swale is not lined</p>

SPPD SW-1: Standing water in north bioswale with sheen

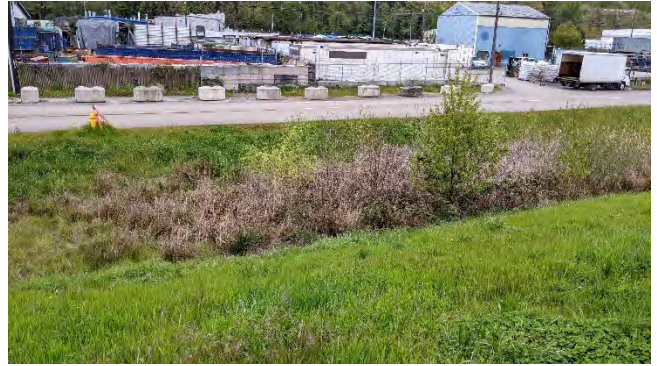
SPPD SW-2: Invasive/deep rooted plants

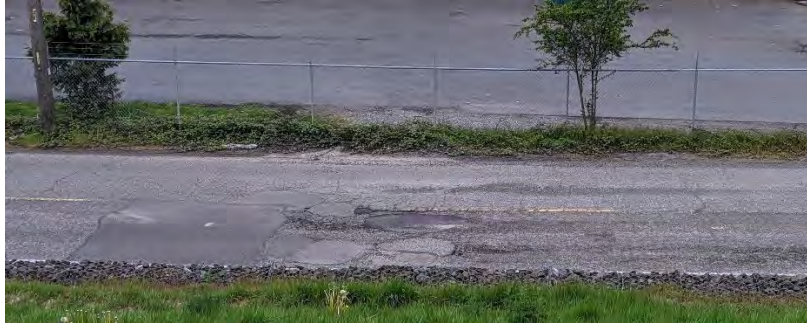
- The S Sullivan Street pavement has several potholes (ROW AC-1). Some portions of the asphalt was recently repaired but there is a section that was not re-paved. The repair was done by SDOT. Under the CAP, routine street maintenance does not require Ecology notification or maintenance reports.

ROW AC-1: Cracks and pavement repair

- The asphalt at **ROW AC-1** should be repaired no later than the end of 2022.
- 6-month reinspection of locations of concern not needing repairs in 2022.

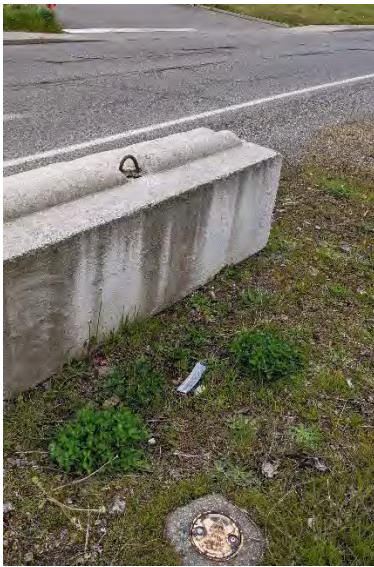
ROW AC-2: Cracking

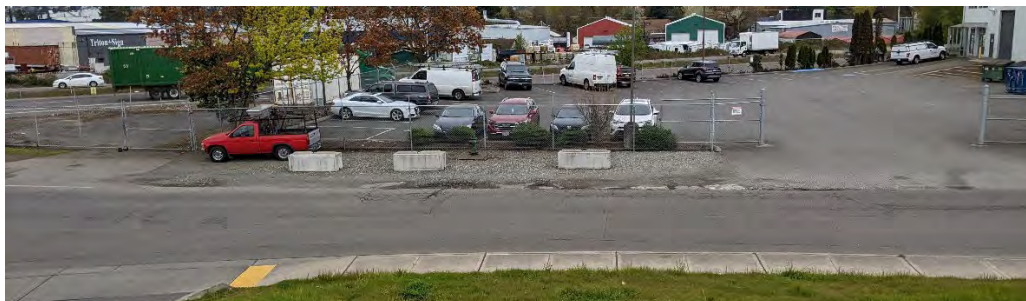
ROW AC-3: Cracking and pot holes
