# **LEVEL I ENVIRONMENTAL SITE ASSESSMENT**

**UNIVERSITY VOLKSWAGEN**

**Seattle, Washington**

Subject: Level I Environmental Site Assessment  
4705 11 Avenue N.E.  
Seattle, Washington

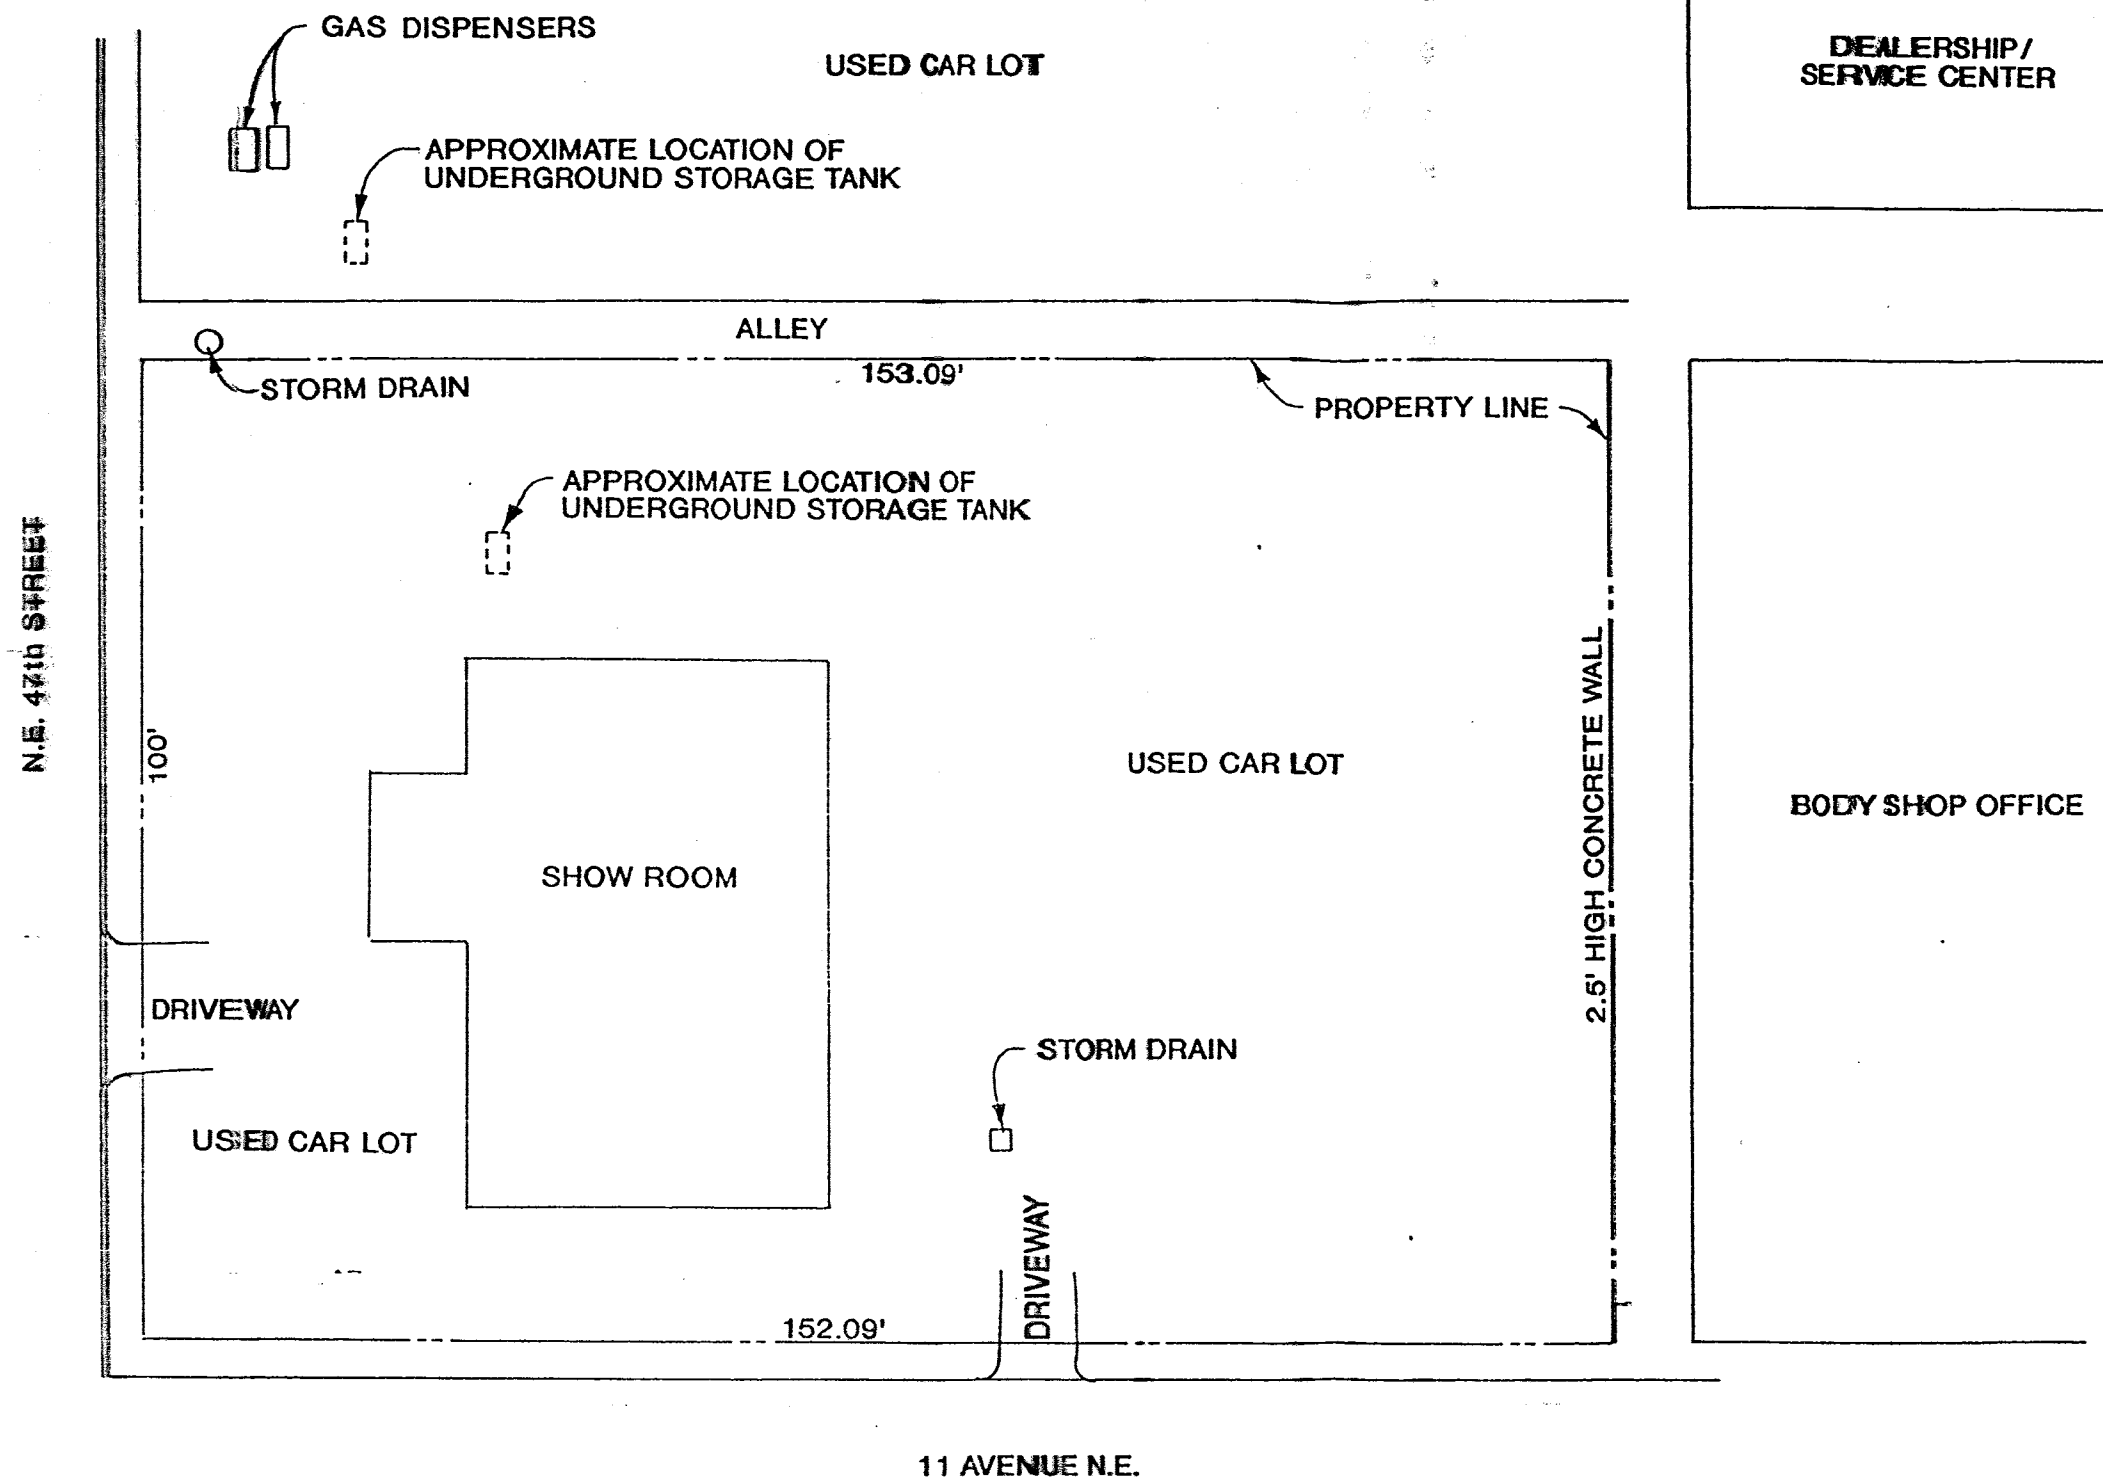
FIGURE 2

The majority of the parcel is covered with asphalt and currently functions as a used car lot. A one-story structure also occupies the subject parcel and serves as a car showroom. A UST is located in the southwestern portion of the lot. According to a representative from University Volkswagen, the tank contains approximately 4000 gallons of gasoline. No known problems are reported regarding this tank. Access to the site is via two driveways, one entering N.E. 47th Street and one entering 11th Avenue N.E. Two storm drains, located just west of the 11th Avenue N.E. driveway and at the southern portion of the alley, facilitate drainage of the parcel. At the time of our site visit conducted on 13 August 1990, we noted that the asphalt paving was stained with oil in several locations on the subject property, apparently the result of leakage from parked vehicles on the subject lot.

The UST on the property contains approximately 4000 gallons of unleaded gasoline and is reportedly 17 years old. Neither Ecology nor University Volkswagen representatives were aware of any leakage problems associated with this tank. If this tank were to leak, it could pose an environmental concern to the subject site and the sites located hydrologically downgradient (south) to the subject property.

The primary identified potential on-site contamination source is the existing 4,000 gallon gasoline UST located at the southwest corner of the site.

Our discussions with Mr. Rob Will of University Volkswagen indicate University Volkswagen intends to remove the on-site UST and associated piping, including documentation of site closure in accordance with recommended Ecology cleanup criteria. In addition, Mr. Will is in the process of tightness-testing the UST and piping associated with the pump island located adjacent to the subject site to the west. Once completed, these actions should address possible on-site contamination related to these potential sources.
