August 21, 2006

Adapt Engineering, Inc. Project No. WA06-14230-PHU

Subject: Phase I Environmental Site Assessment Update
Acrowood Corporation Facility
4425 South 3rd Avenue
Everett, Washington 98206

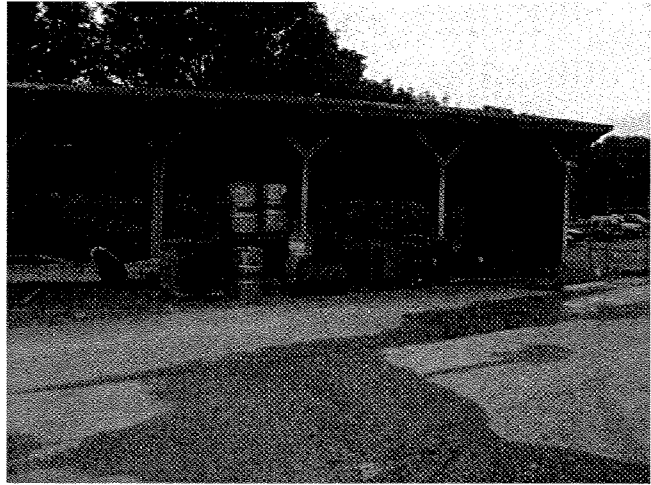
We observed several 55-gallon drums located adjacent to building #12 and to the south of building #4. According to the site operator, these drums were either empty or contained wood chips. We observed eight 55-gallon drums of fresh lube oil, hydraulic oil, coolant, and other heavy-end petroleum product stored within the southern portion of building #1. The drums were stored horizontally on saddles, with a secondary spill control basin located under the spigots (Photo 2). Some surficial spillage was observed, but it appeared limited in extent, and was being managed with dry sorbent compound.

1. View looking toward the east at empty 55-gallon drums staged in a shed located just south of building #4.

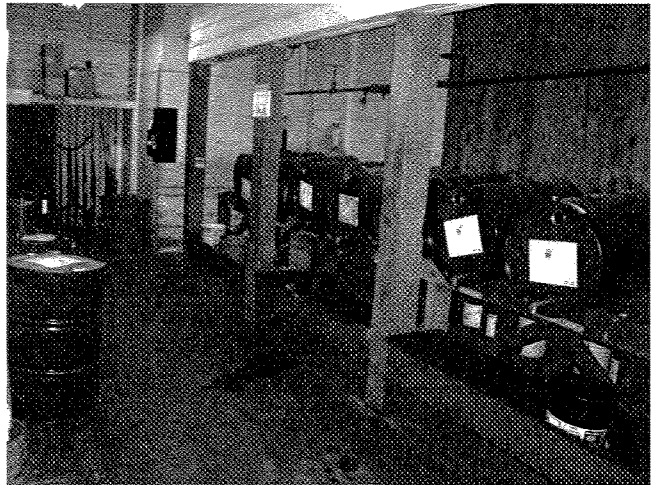
2. Fresh oil drum storage/distribution area within building #1. Note the secondary containment basin located under the fill spigots.

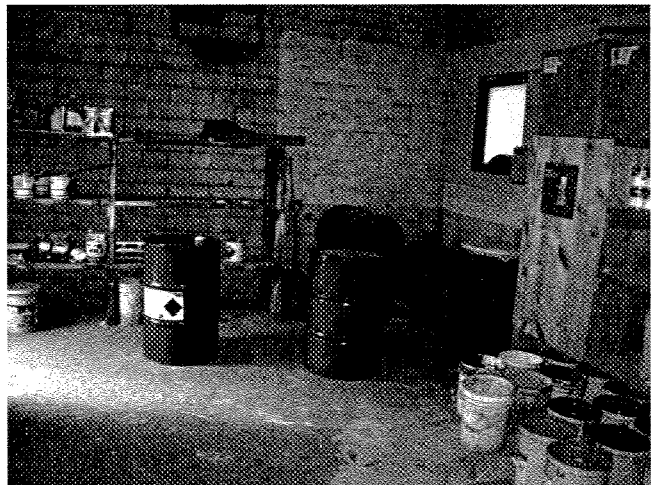
We observed three-55 gallon drums containing toluene, and one drum containing used paints within building #9, along with numerous smaller (one to 5-gallon) paint and lacquer containers (Photo 5). We did not observe signs of significant staining or spillage associated with the drums. However, the drums were not provided with secondary containment.

5. View looking at the interior of building #9, with blue 55-gallon drums of toluene in the background.

- Surficial staining associated with the catch basin located under the "pressure" tank – It would be prudent to control the source of surficial staining at this location, and possibly decommission this catch basin, if not in use.
- Some of the hazardous material drum storage areas did not include secondary spill prevention containment – It would be prudent to provide secondary containment of all hazardous materials drums and containers.

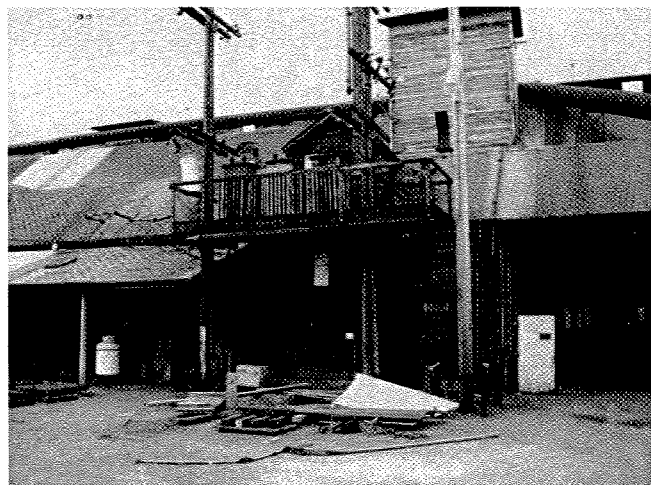
We observed several fluorescent light fixtures in the site office building and several above-ground electrical transformers associated with building #1 (Photos 6 and 8). Fluorescent light ballasts and electrical transformers manufactured prior to 1979 sometimes contained PCB oils. Ballast without "No PCBs" labels should be assumed to contain PCBs. Based on the reported age of the building, it is possible that the light ballasts contain PCBs. According to the operations manager, the fluid within the electrical transformers have been tested, and one bank of transformers has been shown to contain detectable concentrations of PCBs. These results were not available for Adapt's review at the time of this writing. The controller stated that these transformers are closely monitored, and have not exhibited leaks or structural compromise. We did not observe any obvious signs of leakage or surficial staining associated with the transformers at the time of our site visit.

6. View looking toward the west at building #1, with three electrical transformer located between the two power poles.

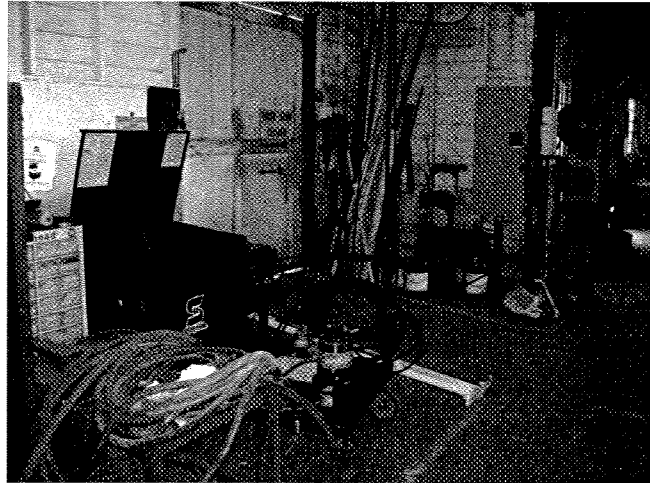
7. View looking at a shop area within building #1, with the red naphtha-based parts cleaning system on the left side of the photograph.

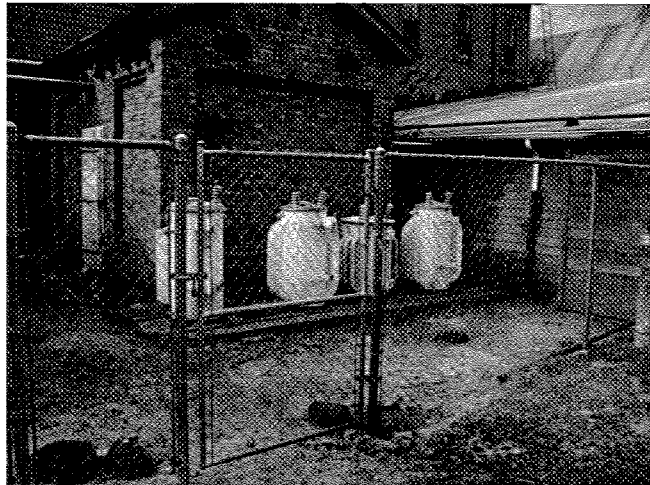
8. View looking toward the south, with three pad-mounted electrical transformers located in the background.

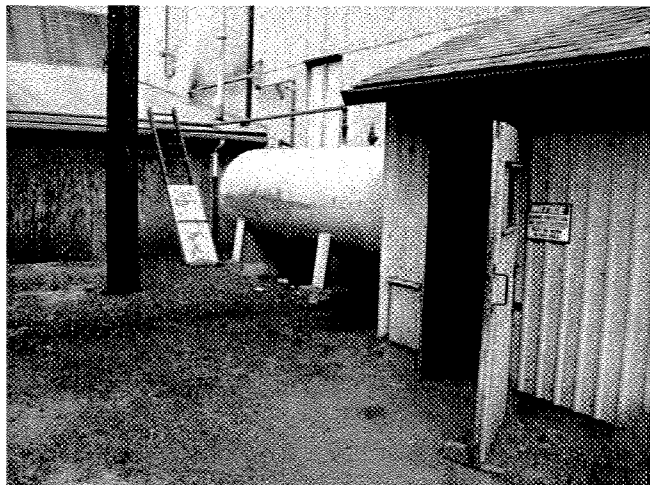
We observed stained surficially soils in the vicinity of the "pressure" tank adjacent to the north-central portion of building #1 (Photo 9). We also observed stained, paved surfaces within building #1 adjacent to fabrication machinery, within the compressor room, and in the fresh oil storage drum area.

We observed several catch basins within the gravel-surfaced yard on the northern portion of the property. We also observed surficially stained soils adjacent to the catch basin located under the "pressure" tank. According to Adapt's past reports and the operations manager, the drain outfall is located at the retaining wall on the eastern portion of the site (Photo 15). We did not observe any surficial staining at the pipe outfall location.

9. View looking toward the northwest, with the horizontal "pressure" tank in the background. Note the stained gravel surfaced area to the left of the tank.

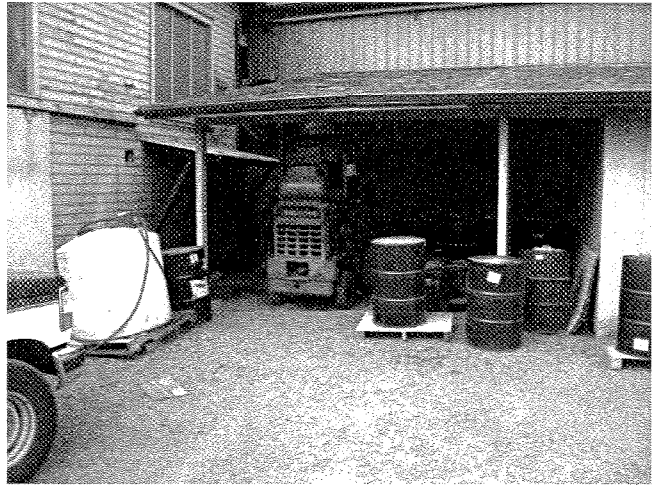
We observed approximately twenty (20) used oil and coolant drums stored in a covered area immediately to the south of the used oil AST in the southern portion of building #1 (Photo 10). No

obvious spillage was observed in this location. However, the drums were not provided with secondary spill prevention containment.

10. View looking toward the west at the covered used oil/coolant drum storage area in building #1. Note the lack of secondary containment.

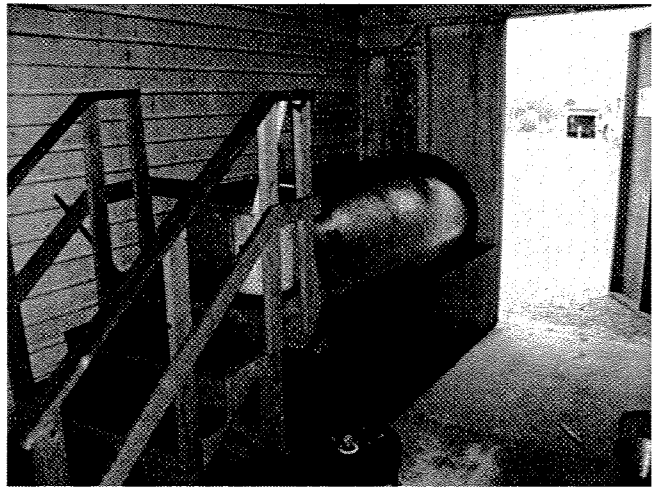
We observed one ~500-gallon capacity used oil above ground storage tank located in building #1 (Photo 11). The tank was located within a covered area with secondary containment. While minor surficial staining was apparent in the area of the tank, we did not observe obvious signs of significant surficial spillage.

11. View looking at the used oil AST and secondary containment basin located within building #1.

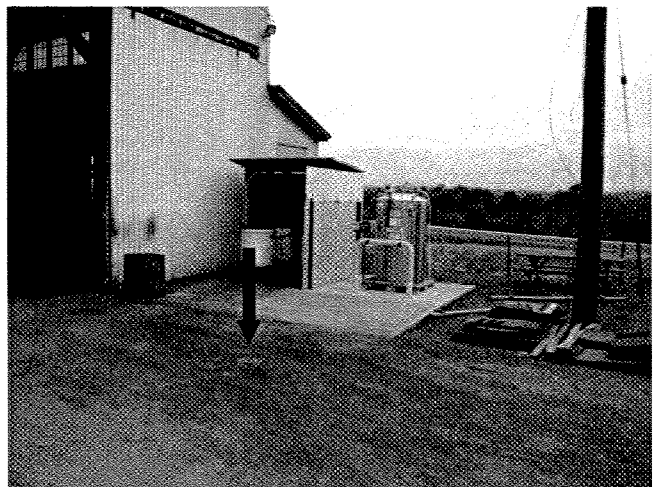
12. View looking toward the east at the former fuel storage tank area. The surface monument for monitoring well MW-1 is indicated by the red arrow.

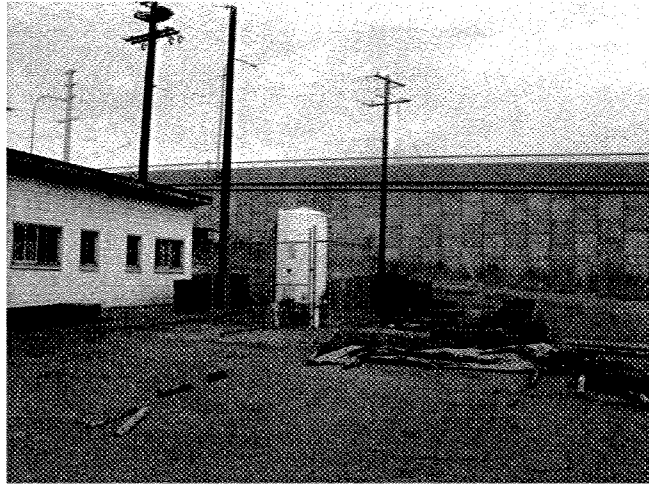
Monitoring wells MW-1, MW-2, and MW-3 associated with Adapt's past site work were observed on the eastern margin of the property (Photos 13 and 15). The well monuments remained locked and appeared surficially in good structural condition at the time of our site visit.

13. View looking toward the north, with the concrete retaining wall that marks the northern property boundary in the background.

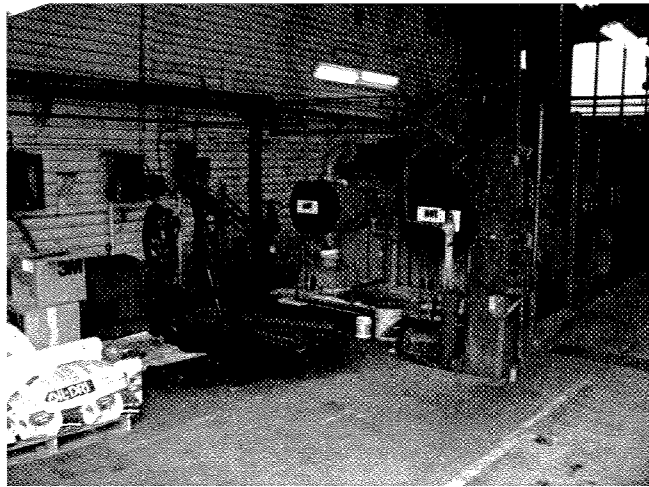
14. View looking within the production area of building #1. Note the stained concrete flooring in the foreground.

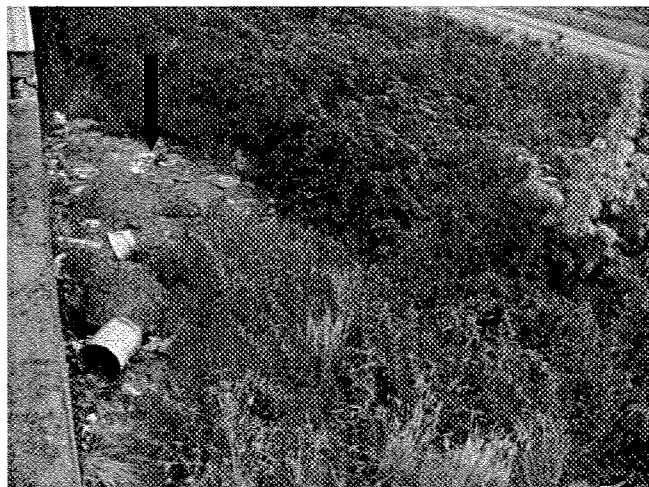
15. View looking toward the northeast at the drainage outfall area and the retaining wall located on the east side of the northern portion of the subject site. The red arrow marks the location of monitoring well MW-3.
