**SUBJECT:** Annual Inspection of Protective Cap at 255 South King Street

As required under the Consent Decree for the King Street property at 255 South King Street in Seattle, Washington (Consent Decree No. 11-2-27892-1; Facility ID No. 5378137), EHSI completed a yearly inspection of the protective cap at the King Street property.

King Street Property  
255 South King Street  
Seattle, Washington

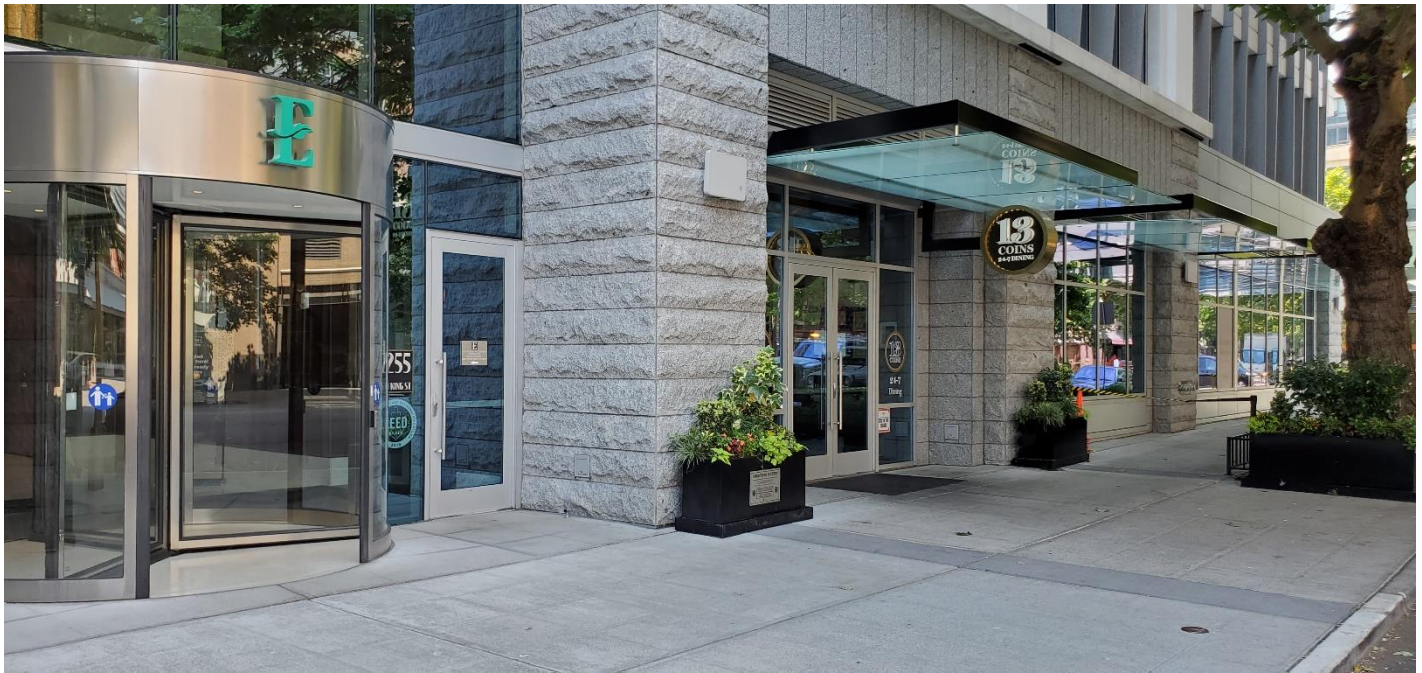
Photograph 1. Northern entrance surface conditions.

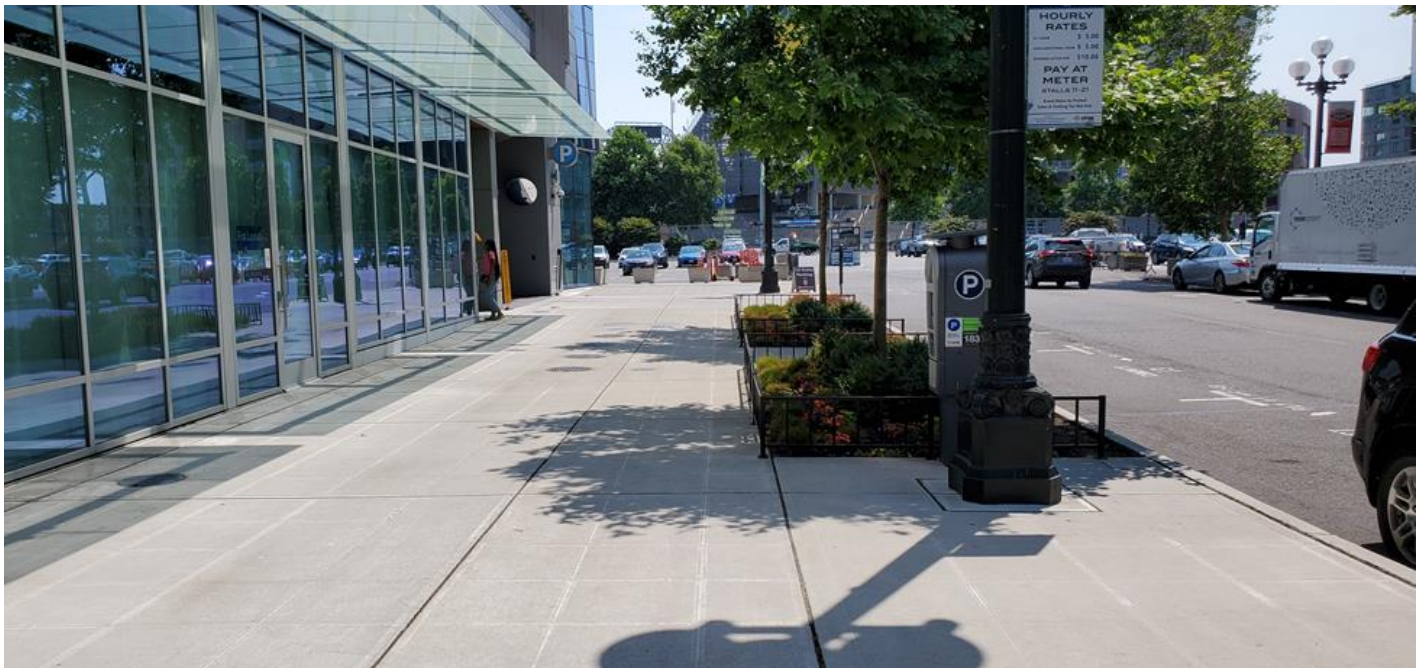
Photograph 2. Western concrete path surface conditions.

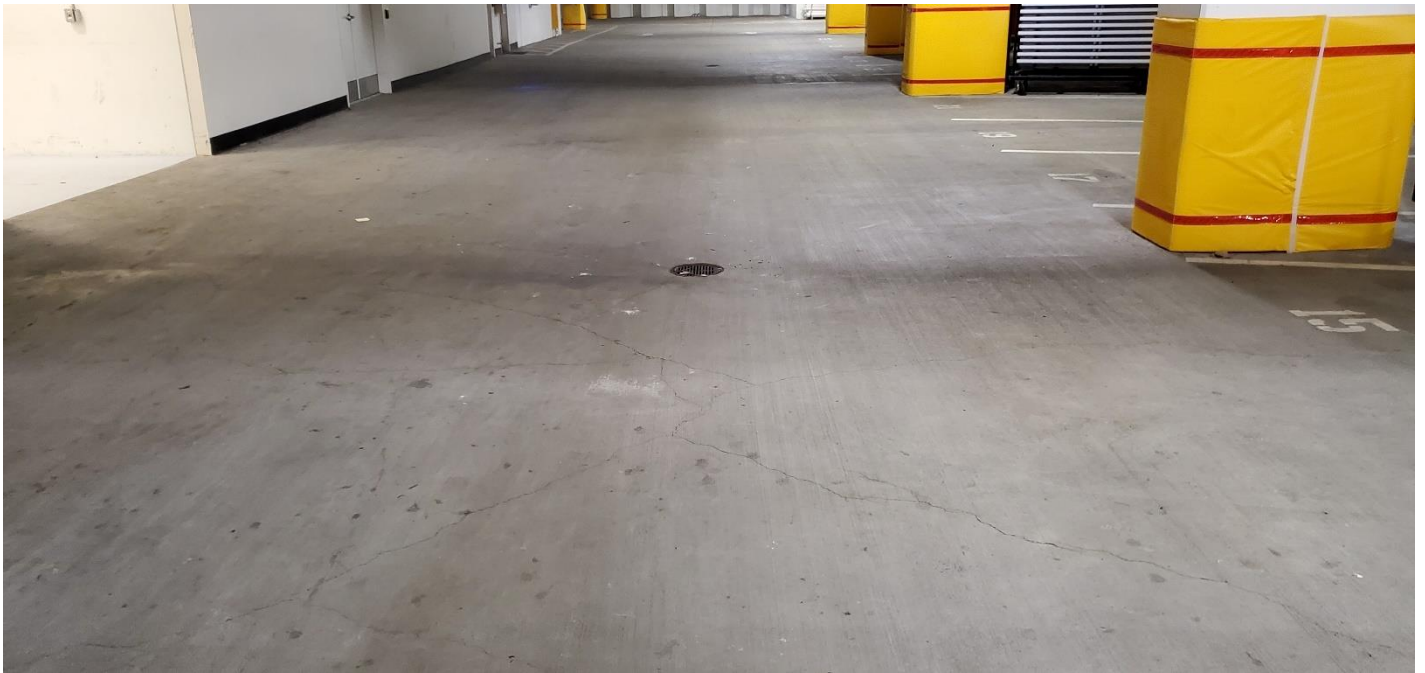
Photograph 3. Hairline cracking of nonstructural nature in the underground parking garage. This area is to be monitored in the next annual inspection; repairs are not needed at this time.

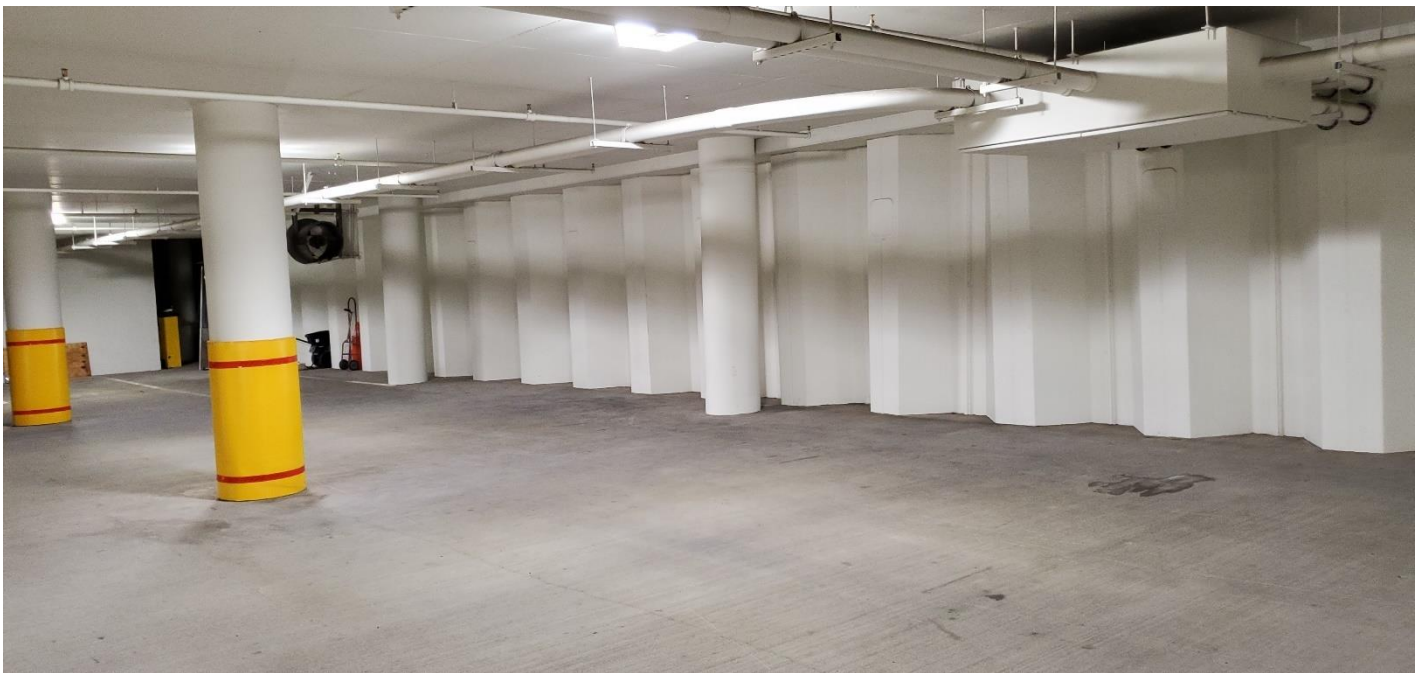
Photograph 4. Steel sheet pile walls in the parking garage. No damage or areas of concern were observed.

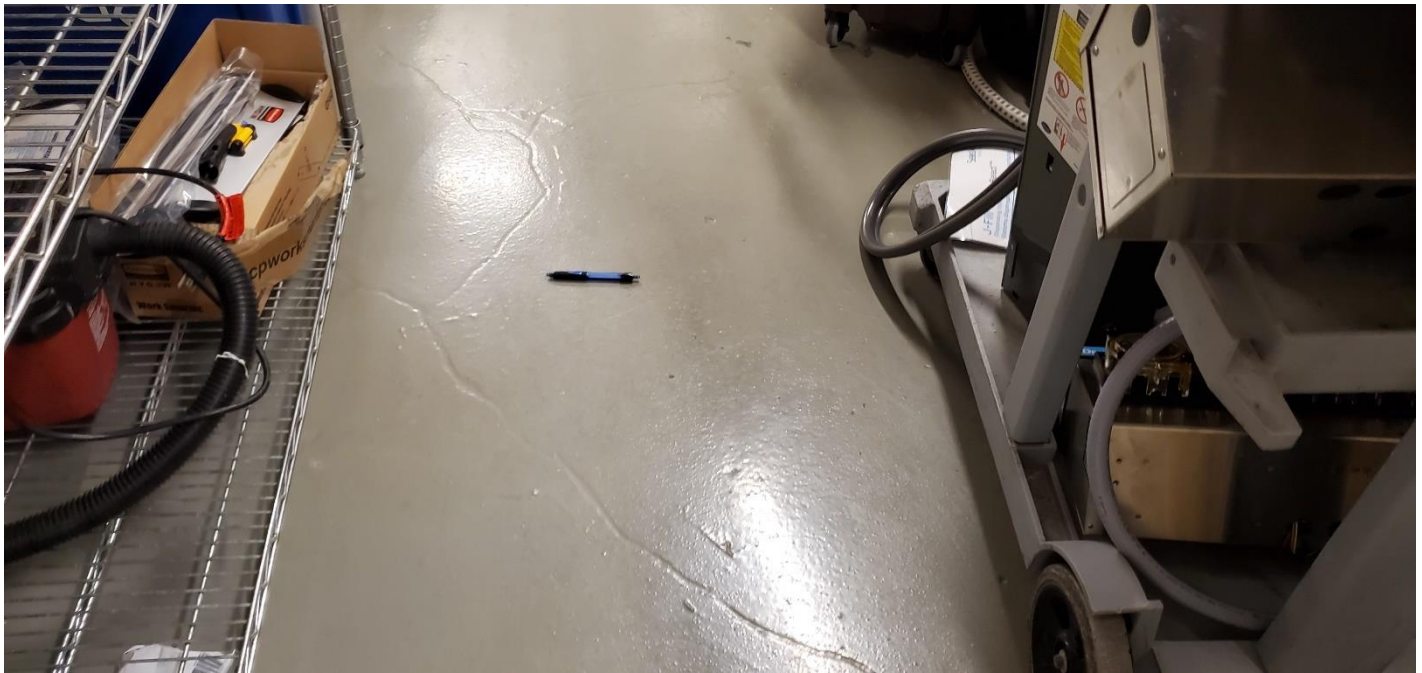
Photograph 5. Nonstructural cracking within the maintenance areas sealed by epoxy paint.

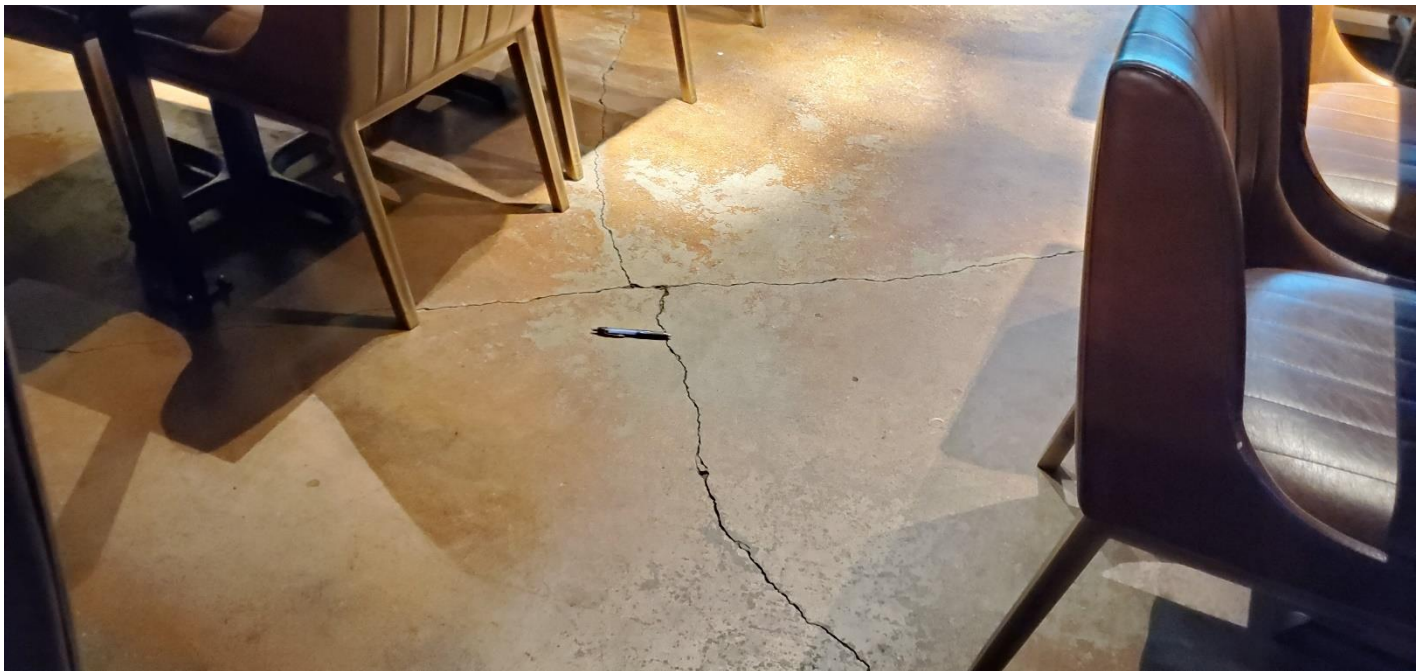
Photograph 6. Significant cracking in the northwestern portion of the 13 Coins Restaurant on the King Street property.
