**FINAL SOIL REMEDIATION REPORT  
LYNNWOOD DODGE  
20612 HIGHWAY 99  
LYNNWOOD, WASHINGTON**

**VOLUME I OF II**

**File #11-09664-01**

Subject: Final Soil Remediation Report  
Lynnwood Dodge  
20612 Highway 99  
Lynnwood, Washington

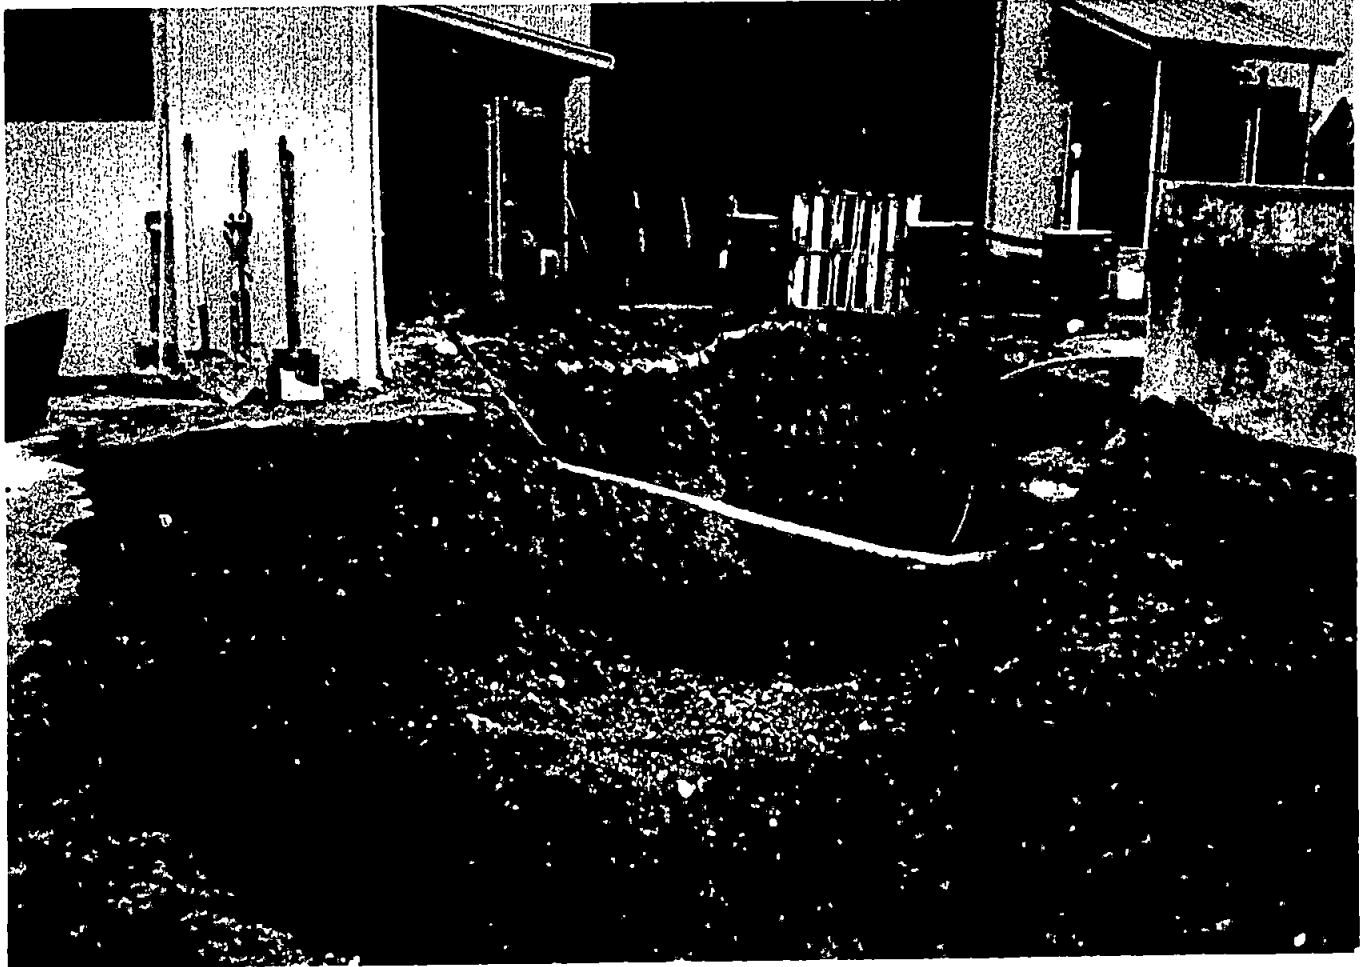
FIGURE 6

UPPER DRAINLINE OVEREXCAVATION, DECEMBER 1994  
VIEWING SOUTH AT NORTH BAY DOOR OF LOWER SERVICE GARAGE.

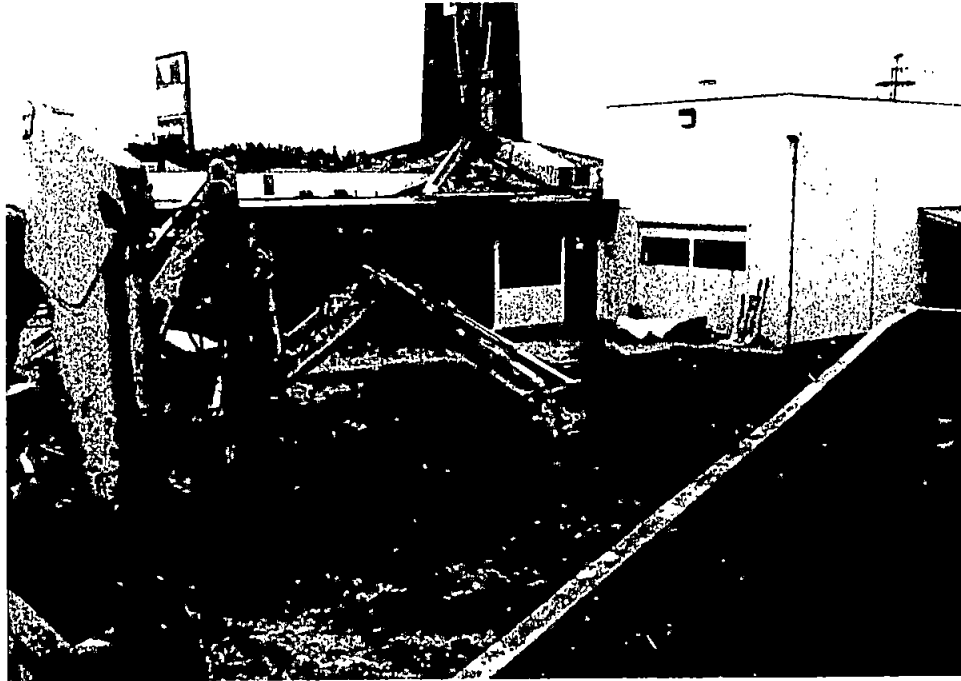
UPPER DRAINLINE OVEREXCAVATION, DECEMBER 1994  
VIEWING SOUTHEAST TOWARDS NORTH WING OF OLD FACILITY  
BUILDING

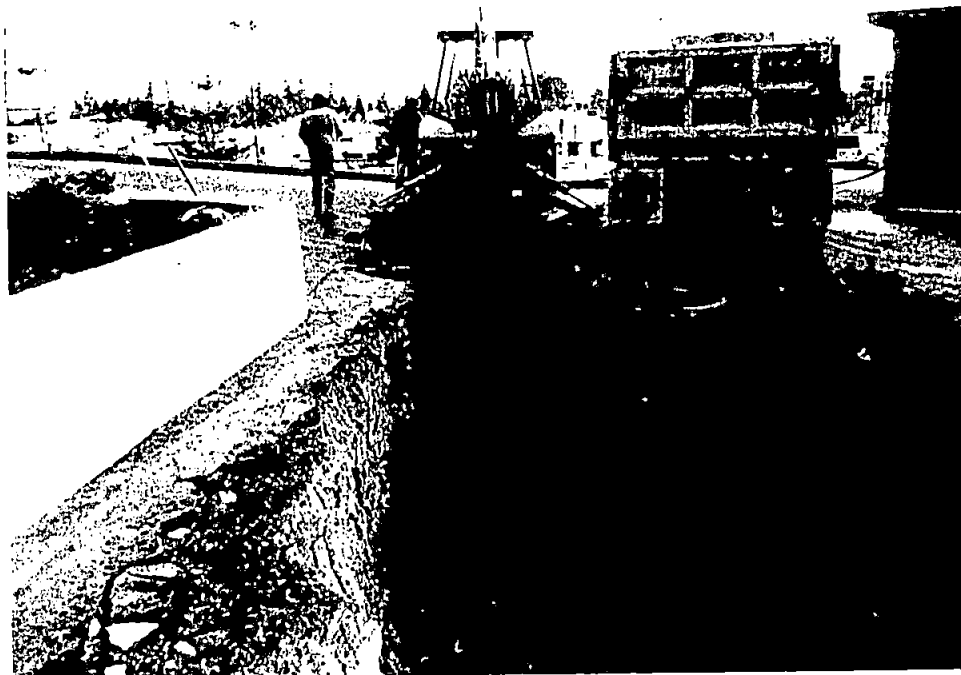
FIGURE 7

UPPER DRAINLINE OVEREXCAVATION, DECEMBER 1994  
VIEWING NORTHEAST PAST NORTH WING OF OLD FACILITY  
BUILDING

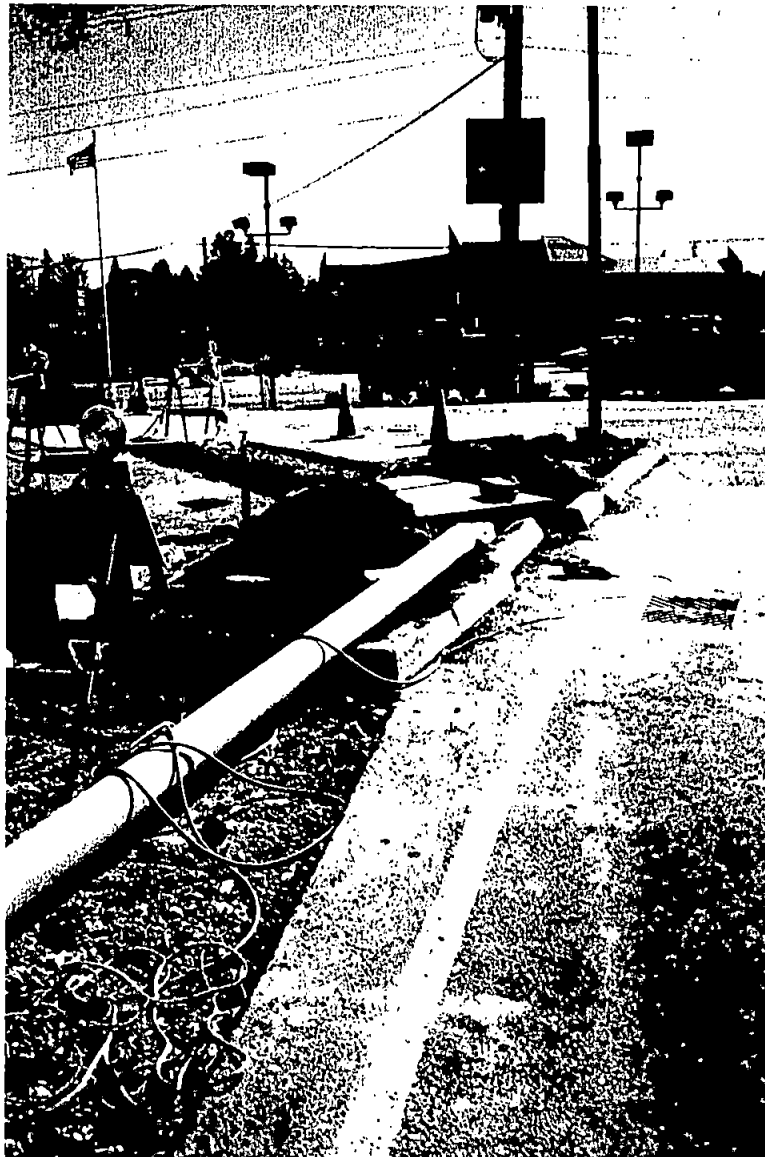
FIGURE 10

OIL/WATER SEPARATOR INSTALLATION, MARCH 1995  
EASTWARD VIEW OF OIL/WATER SEPARATOR LOCATED OFF  
SOUTHEAST CORNER OF OLD FACILITY BUILDING (NOT VISIBLE).

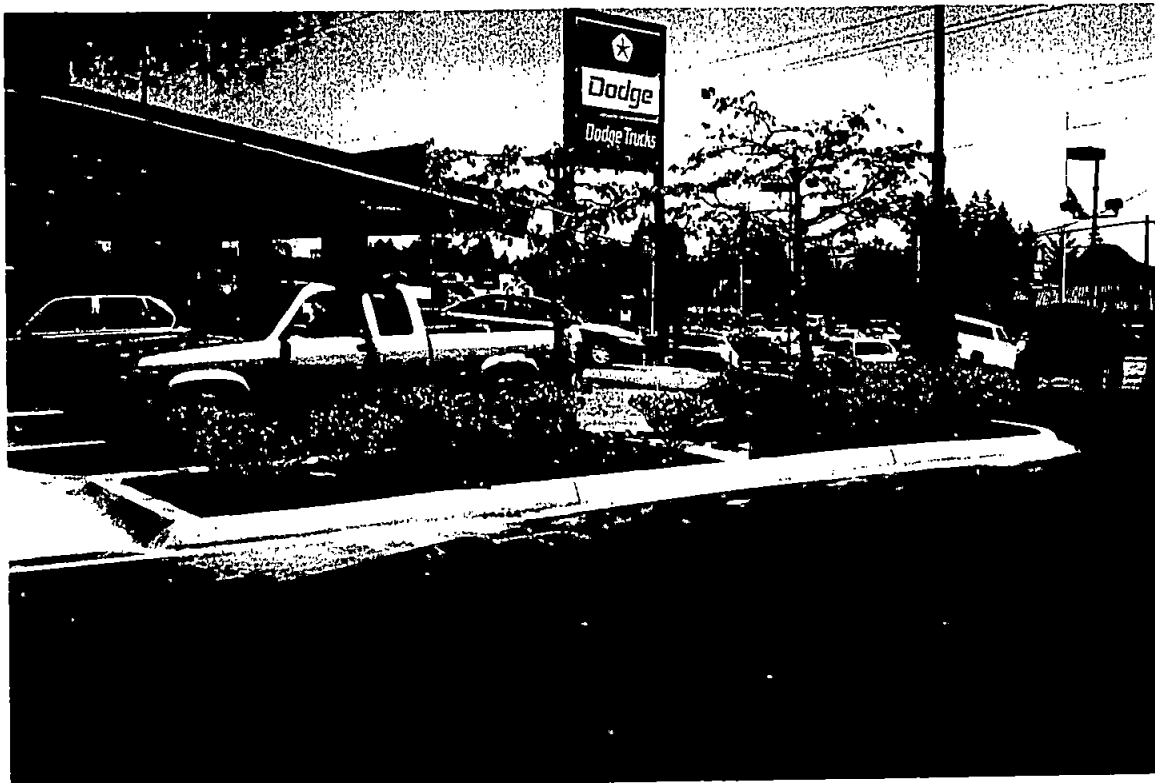
FIGURE 11

OIL/WATER SEPARATOR INSTALLATION, APRIL 1995  
 LANDSCAPING AND PAVING RESTORED AROUND NEW STRUCTURE.

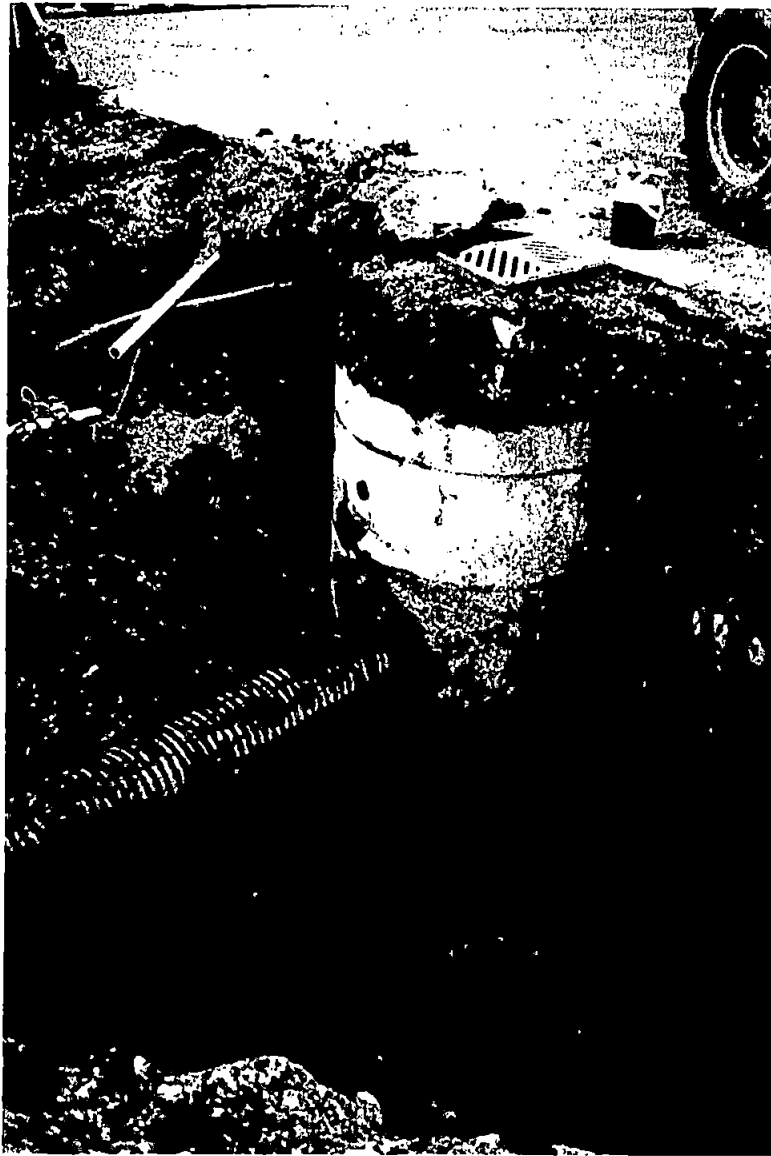
FIGURE 12  
LYNNWOOD DODGE  
LYNNWOOD, WASHINGTON  
SITE PHOTOGRAPHS

LOWER DRAINLINE OVEREXCAVATION, MAY 1995  
VIEWING EAST TOWARDS BIOSWALE DISCHARGE PIPE  
AND STORM RETENTION VAULT LOCATED AT  
INSIDE-NORTHEAST PROPERTY CORNER.

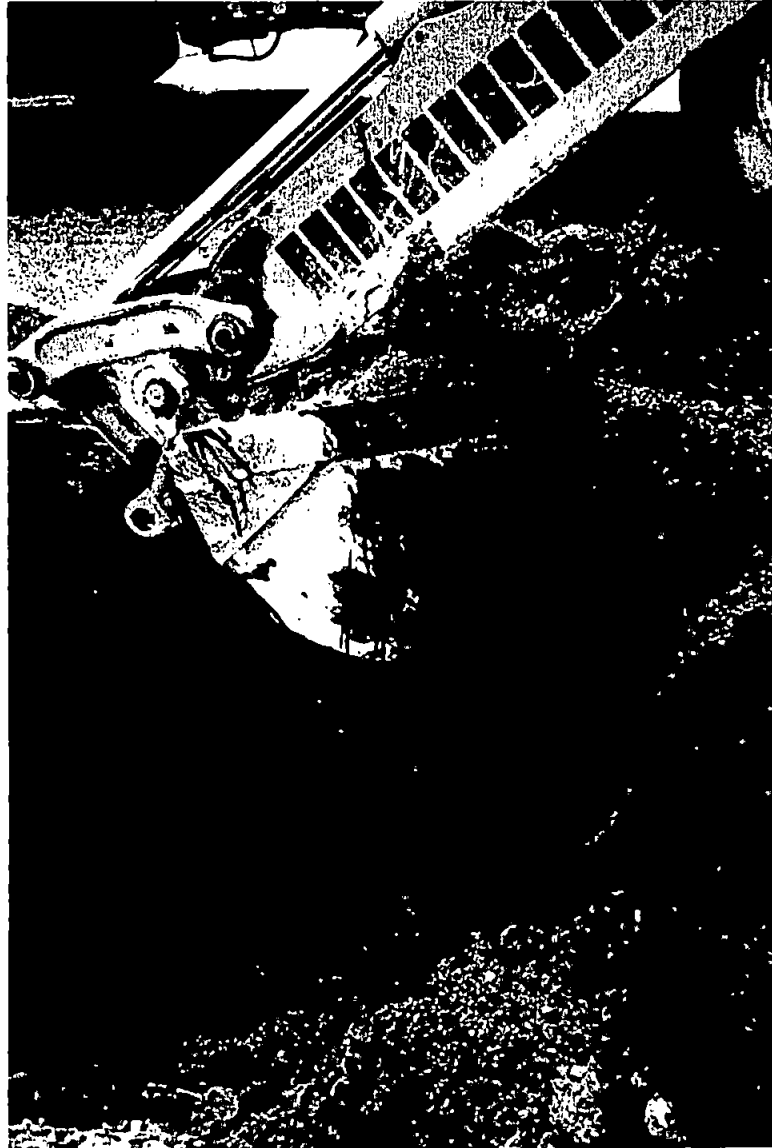
FIGURE 13

LOWER DRAINLINE OVEREXCAVATION, MAY 1995  
DRAINPIPE AND PEA GRAVEL BEDDING APPEAR IMPACTED  
WEST AND UPGRADIENT FROM 1992 STORM RETENTION  
VAULT.

Based on the analytical results and on our observations of subsurface conditions, we recommended that approximately 100 feet of the Lower Drainline between the newer storm retention vault and the old oil/water separator remain in place. Our observations of the Lower Drainline encountered no evidence that the alignment acted as a pathway for contaminant migration or perched groundwater interception, and the contents were jetted out, removing a potential source of contaminants.

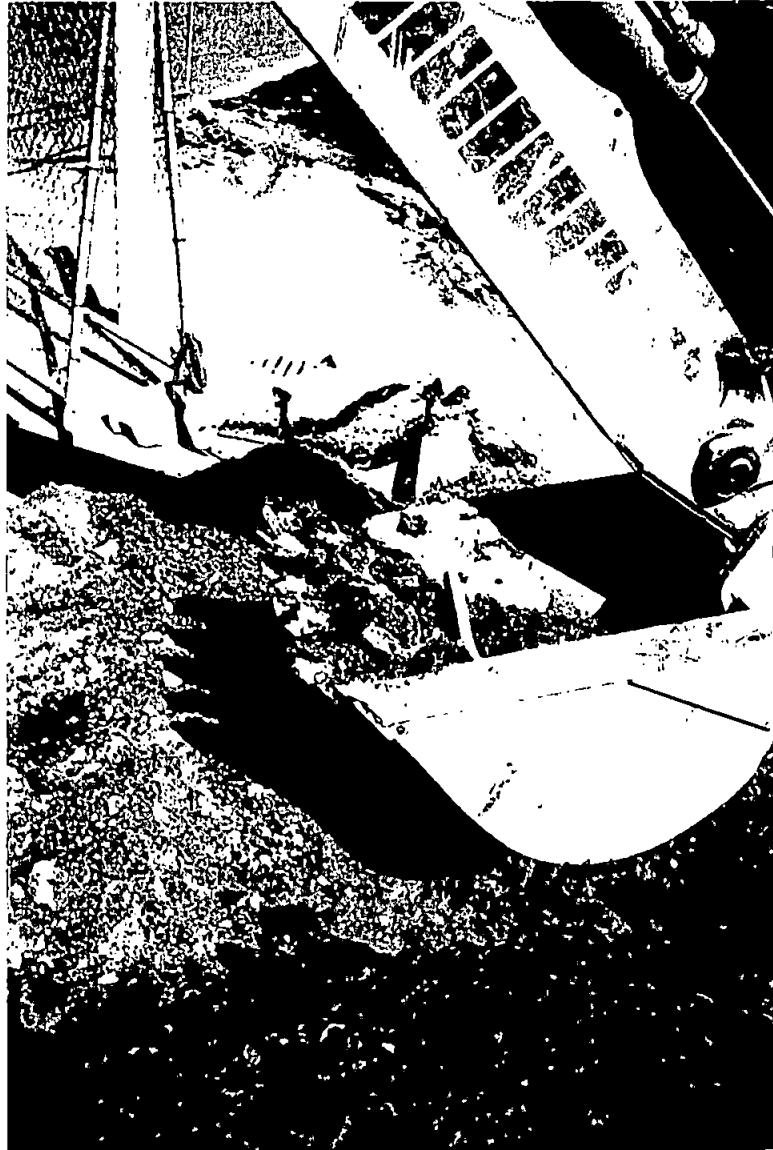
**FIGURE 14**

We proceeded to excavate a trench approximately 10 feet southeast of the storm vault and encountered the drainline at a depth of approximately 5.5 feet below surrounding grades. At this location, soils appeared unimpacted and the pea gravel bedding appeared dry and unaffected. A photograph showing the condition of the pipe and bedding east of the storm retention vault is included as Figure 14. We collected two soil samples from this test pit:

LOWER DRAINLINE EXPLORATION, MAY 1995  
DRAINPIPE AND PEA GRAVEL BEDDING APPEAR DRY AND  
UNAFFECTED EAST AND DOWNGRADIENT OF STORM  
RETENTION VAULT.

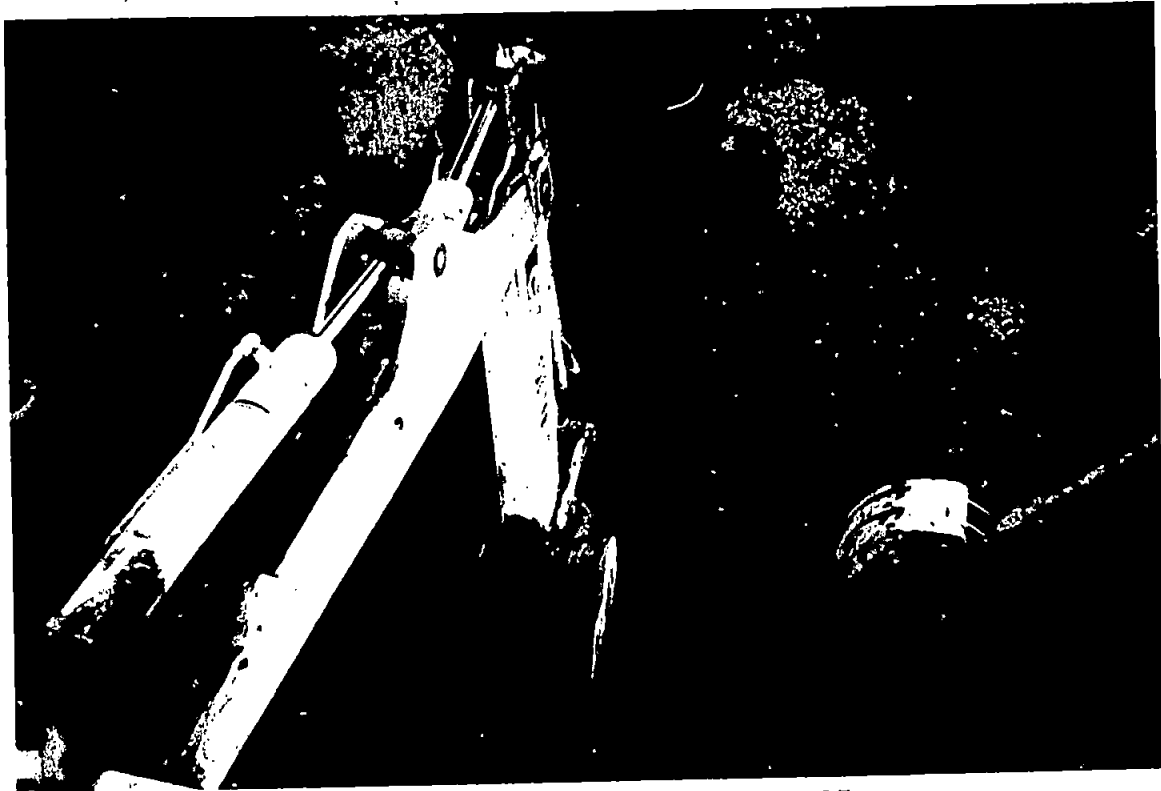
FIGURE 15

LOWER SERVICE GARAGE OVEREXCAVATION, MAY 1995  
UNDERPINNING COLUMNS SHOWN BENEATH WEST AND NORTH SIDEWALLS.

In order to facilitate characterization of the soil conditions directly beneath the foundation, the underpinnings were designed as three-foot-wide concrete columns, trenched at eight foot maximum intervals beneath the foundation. This method allowed direct observation of soil conditions and soil sampling for immediate planning purposes. Soils excavated during underpinning installation were treated by thermal desorption at the TPS Technologies, Inc. facility in Tacoma, Washington.

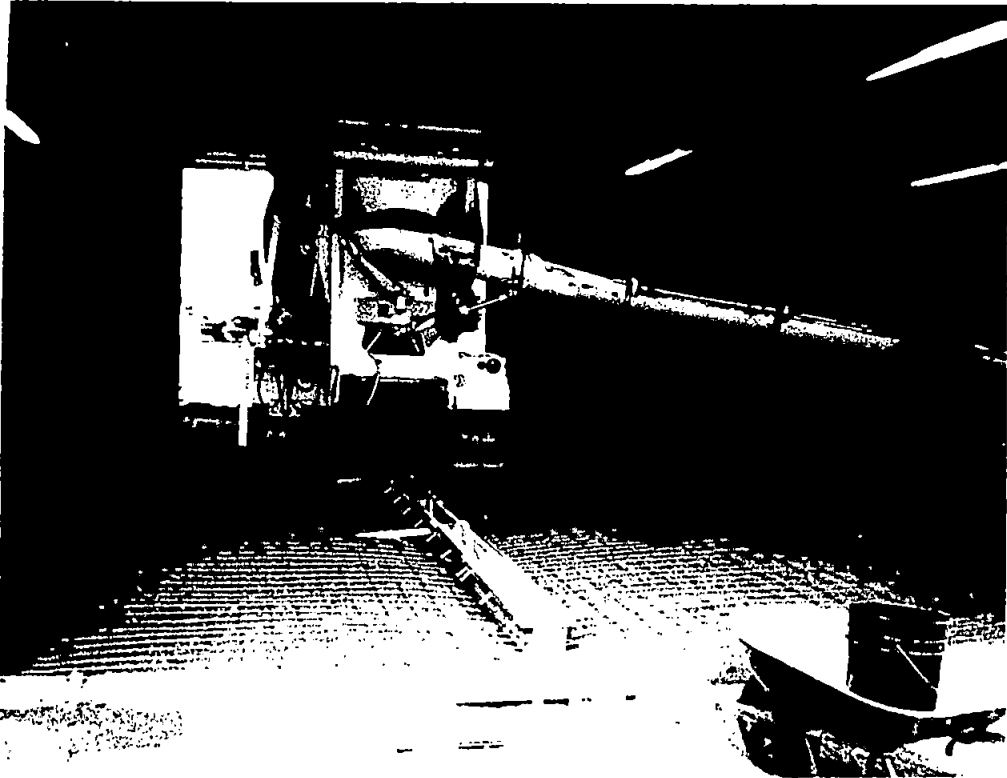
FIGURE 18

LOWER SERVICE GARAGE RESTORATION, JUNE 1995  
REPLACEMENT OF FLOOR SLAB-ON-GRADE AND TRENCH DRAIN.

Inside the garage, a new trench drain was installed with slab-on-grade replacement. A 6-inch thick slab-on-grade was placed on 14 June 1995, and the concrete reached its designed strength of 4,000 pounds per square inch (psi) within seven days of placement. Reinforcing steel was placed on 2-foot centers where the new slab abutted the foundation, and on 4-foot centers where the slab connected to the 3.5- to 4-inch slab-on-grade. The remainder of the original garage floor was blast-tracked to remove the paint coating, and the entire garage floor was coated with a sealant.

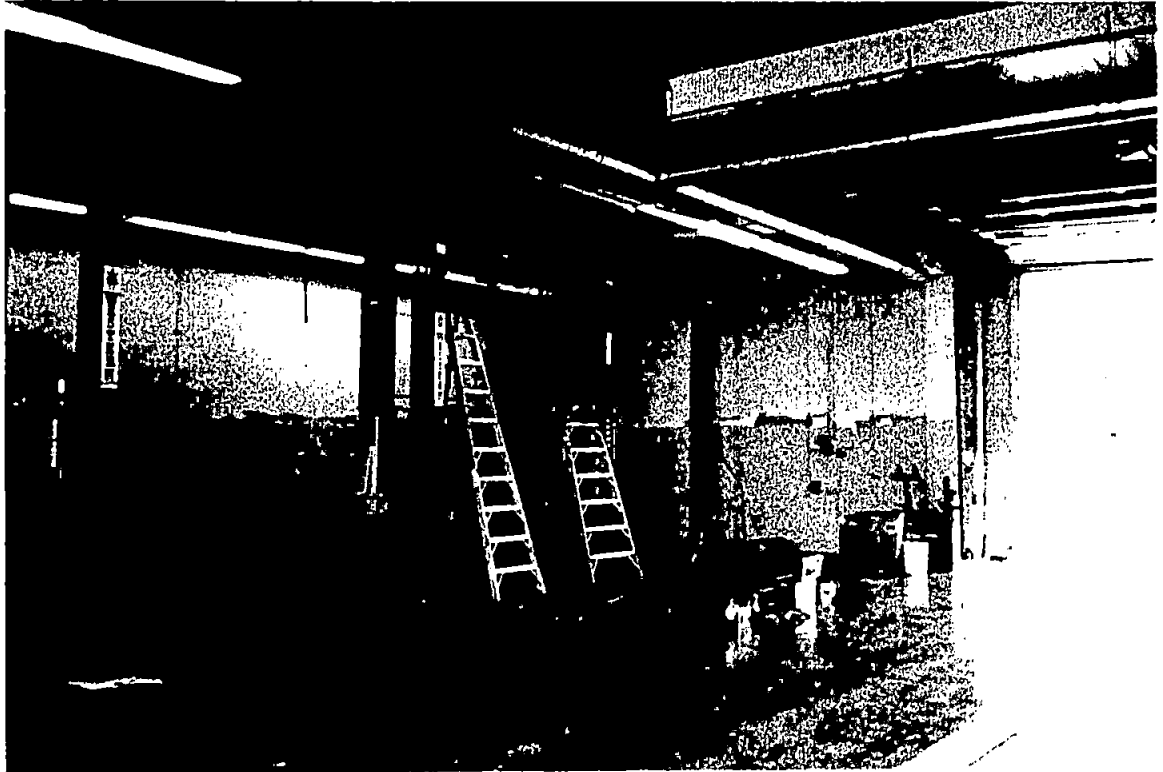
FIGURE 19

LOWER SERVICE GARAGE RESTORATION, JULY 1995  
VIEWING NORTHWEST: INSTALLATION OF ABOVE-GROUND CARBON SYSTEM  
IN PROGRESS. NEW TRENCH DRAIN AT LOWER RIGHT.

The original, underground CarMon system was removed during remediation. This system was replaced by Shop Equipment Inc. with an overhead system suspended from the ceiling. The primary purpose was to eliminate underground utilities where possible and minimize opportunities for surface contaminants to access the subsurface environment. Photographs showing floor slab placement and shop restoration are included as Figures 17, 18, and 19 of this report.

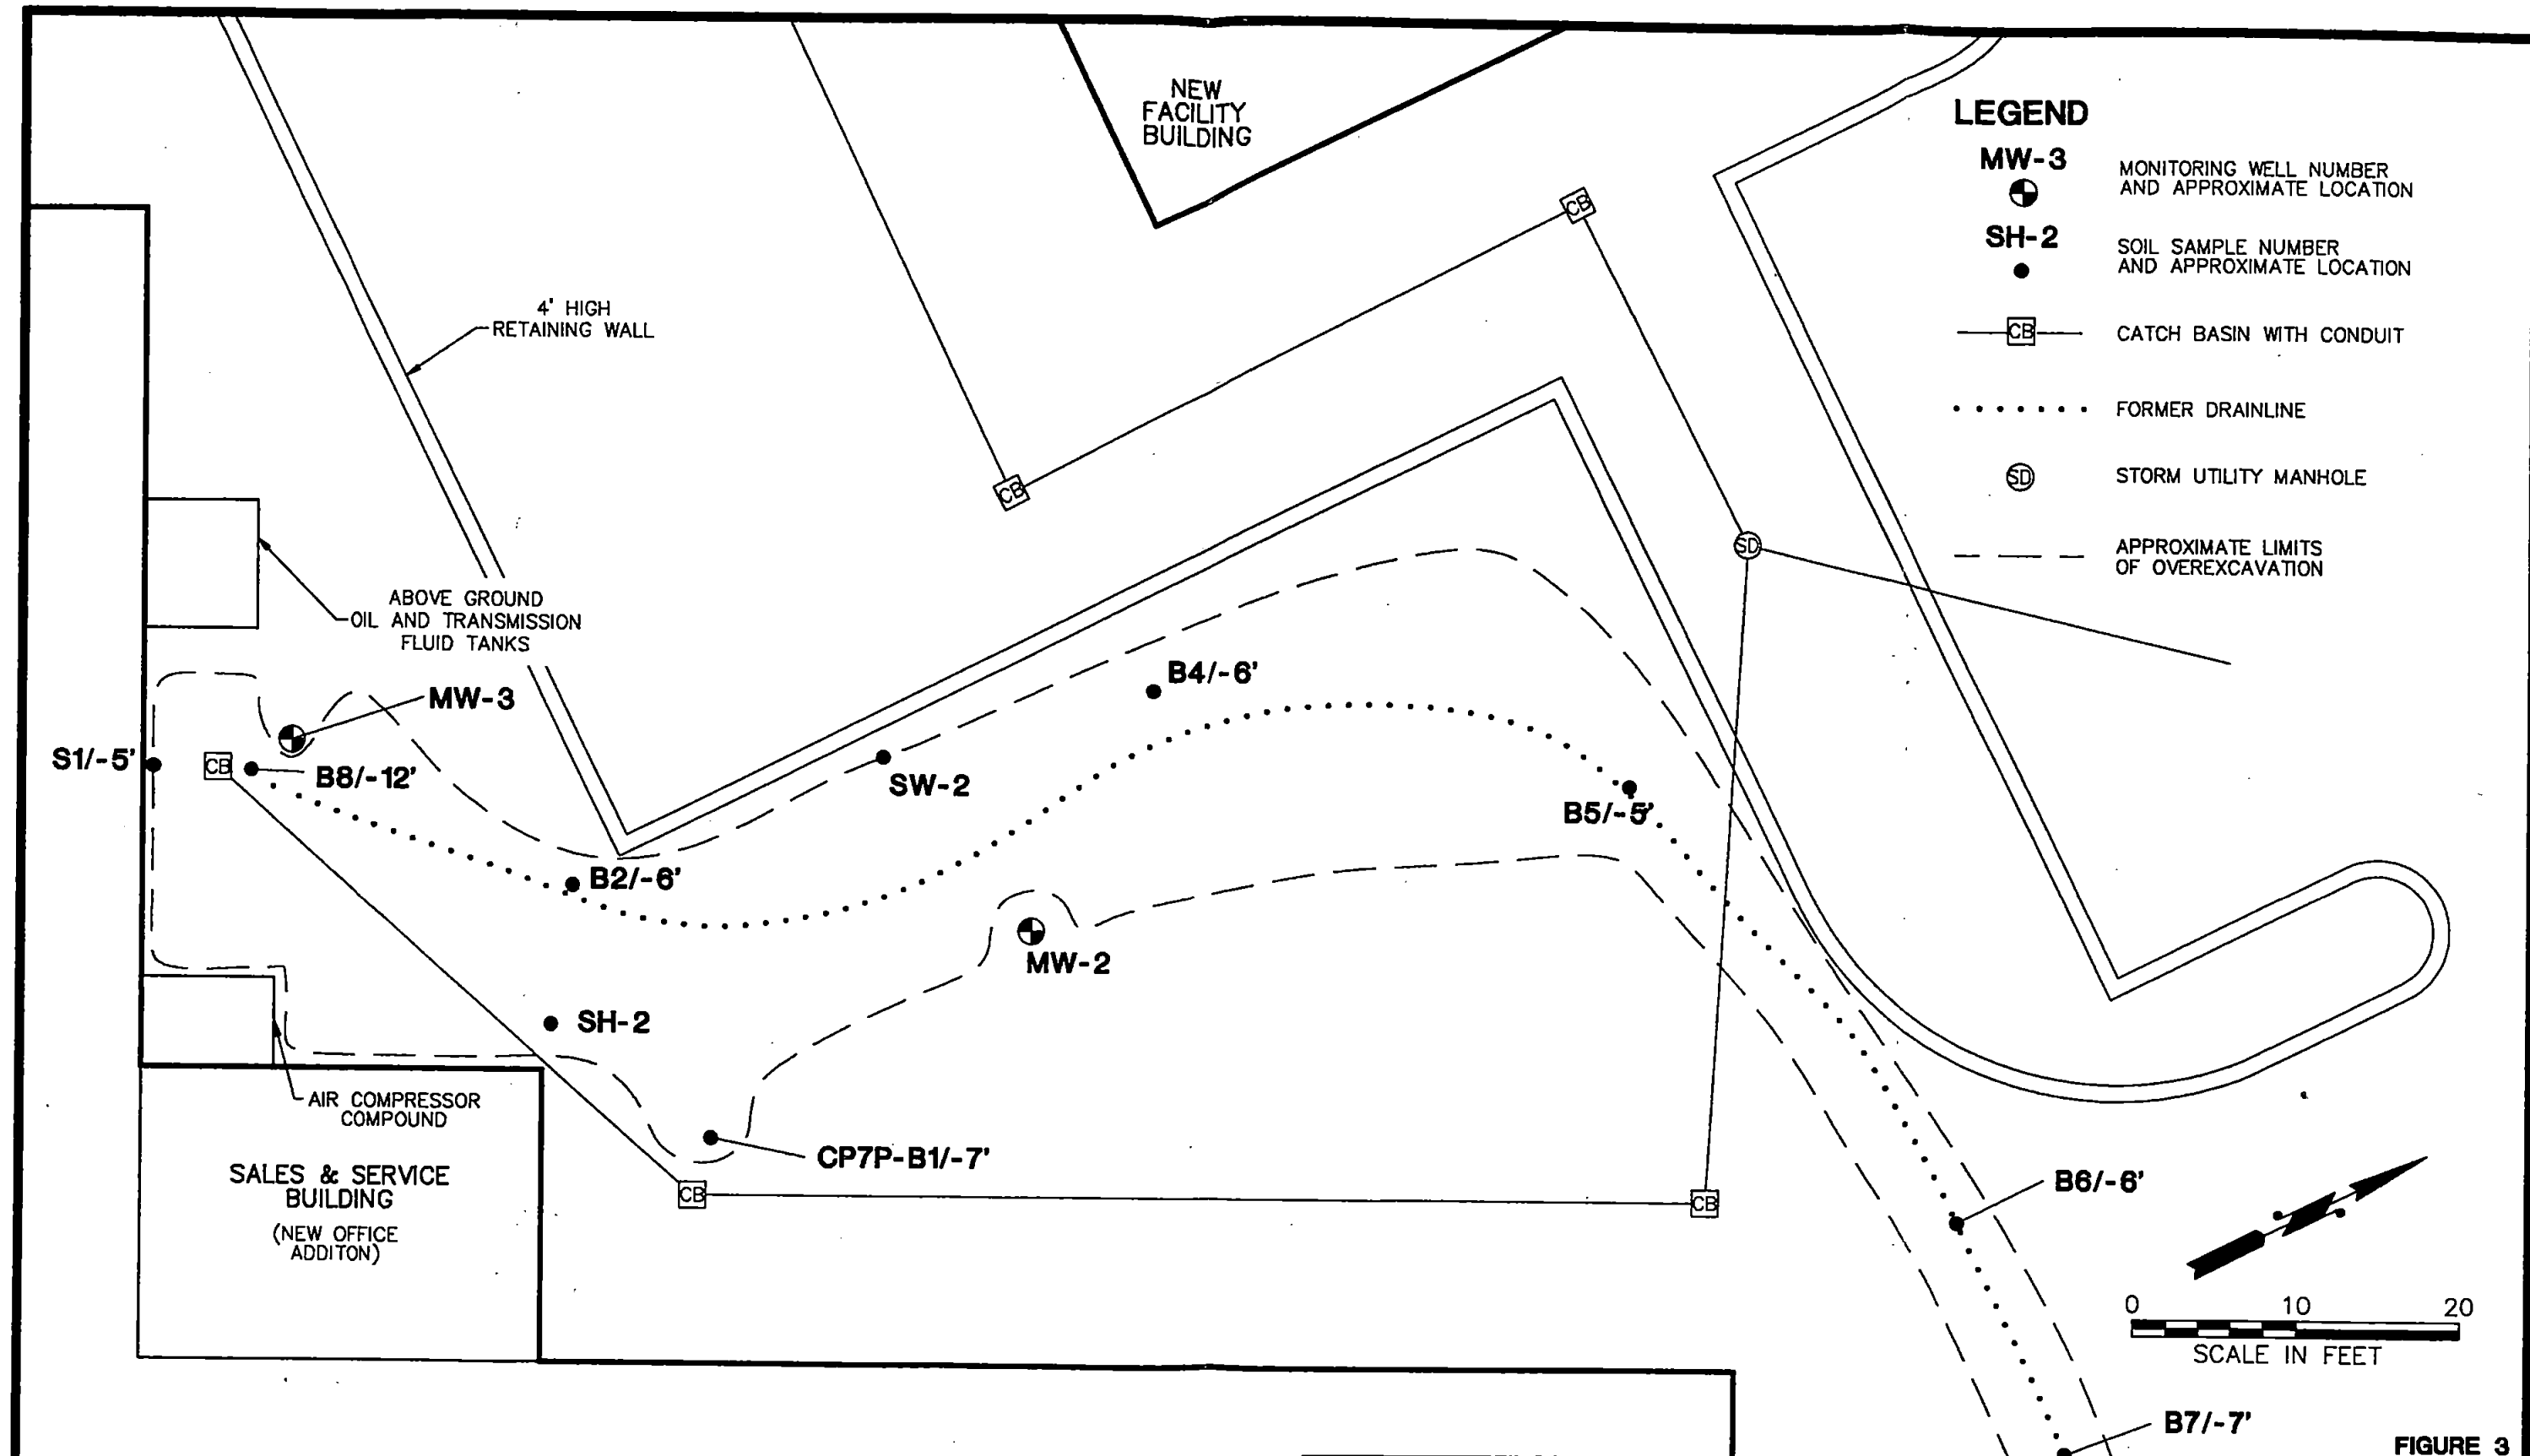
FIGURE 3

Ten representative soil samples collected from the base and sidewalls of the Upper Drainline Overexcavation were submitted for analysis. The locations of these soil samples are shown on the Upper Drainline Overexcavation Detail, Figure 3. The analytical results from these soil samples are summarized on Table 101. It should be noted that the results of soil sampling from our Additional Site Characterization also define the limits of TPH-impacted soils prior to the overexcavation activities. Refer to the previous report, dated October 1994, for those soil locations, analytical results, and supporting laboratory reports.
