STATE OF WASHINGTON
DEPARTMENT OF ECOLOGY

October 3, 2022

Re: Opinion and technical assistance for the following Site:

Site Name: Pend Oreille Mine Historic Debris Field
Site Address: 1382 Pend Oreille Mine Road
Facility/Site No.: 15428546
Cleanup Site No.: 16669
VCP Project No.: EA0369

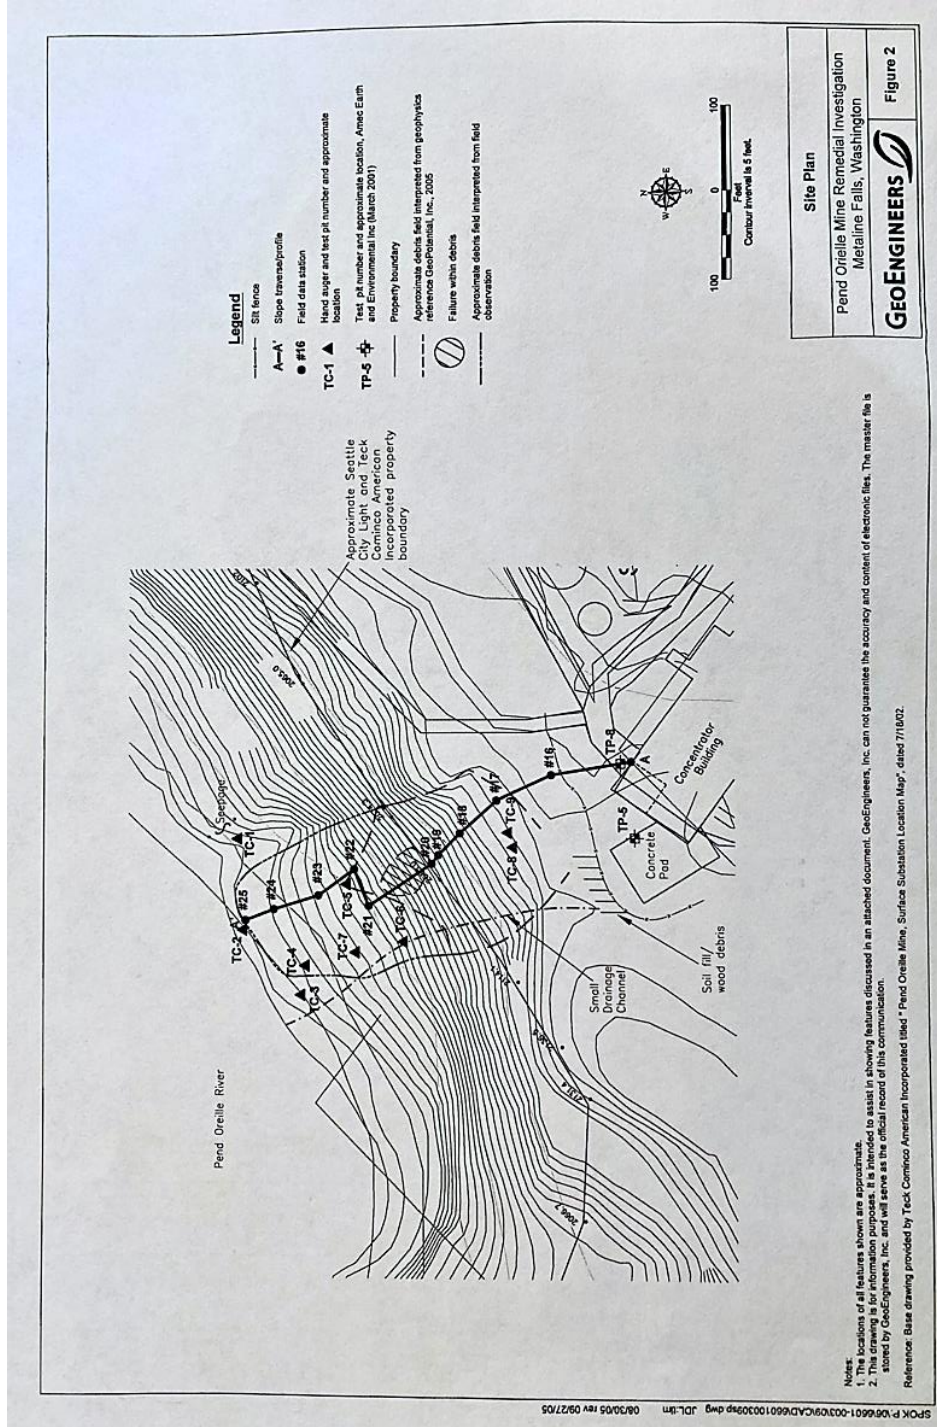
Site Diagram

A geophysical survey noted evidence of a past slope failure within the middle slope of the debris layer between field stations 20 and 21 (please see Enclosure A for a diagram with field station locations). There is no evidence of failure within the underlying native soil.

The HDF is separated into three areas based on topography; the upper slope ranges from 30-35 percent grade, the middle slope ranges from 70-90 percent grade, and the lower slope ranges from 18-20 percent grade. The native slope is inclined between 45-80 percent. There is evidence of a prior slope failure within the middle slope of the debris layer approximately 45-60 feet long perpendicular to elevation contour. This failure is not observed in the underlying native material. The Site is underlain by glaciolacustrine laminated clay, silt, and sands, while locally there are also thin deposits of gravel and sand present. Regional bedrock consists of the Ledbetter Slate and the Metaline Limestone formations.

3. An updated slope survey should be conducted to determine if additional slope failure has occurred since the 2006 assessment and evaluate the risks posed to workers during any planned remedial actions.

1. Not rely primarily on institutional controls and monitoring where it is technically possible to implement a more permanent cleanup action for all or a portion of the Site, and
2. Include measures to reduce stormwater infiltration through the debris field, and stabilize the slope to reduce the likelihood of continued slope failure and limit the potential migration of waste materials.
