2021 Land Use Control Inspections Technical Memorandum

**Sites 302, 303, and 304, and Tank 50
Manchester Fuel Depot, Port Orchard,
Washington**

**United States Department of the Navy
Naval Facilities Engineering Systems Command
Engineering Field Activity, Northwest**

DCN: LBJV-5006-4089-0003

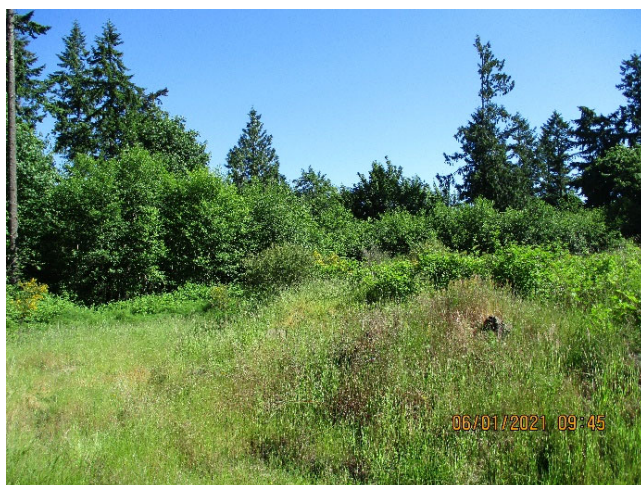
1. Site 302: The central portion of site is covered with large, older (covered with vegetation) stockpiles of soil and armor rock. The excess soil placed in the central portion of the site originated from a culvert replacement project that was located upgradient and outside the four sites with established LUCs, in an area that had not historically been used for industrial activity. The excess soils were sampled and characterized in January 2020 for site contaminants of concern (COCs; PCBs and total petroleum hydrocarbon [TPH]) as a precaution because the MFD operates as a fuel facility. Because there is no knowledge of additional COCs in the area from which the excess soils originated, the samples were not analyzed for other constituents. Analytical results indicated that neither PCBs nor TPH were detected in excess of Washington Model Toxics Control Act (MTCA) Method A Cleanup levels (Kane Environmental, Inc., 2020). The armor rock originated from a shoreline project. A decision on how to handle the stockpiles is being made in consultation with stakeholders and is pending; the Navy anticipates having a plan by summer 2022.

**Photograph 6****File Name:** IMG_0009.JPG**Description:** Stockpiles covered with vegetation, central area of site, facing northeast.

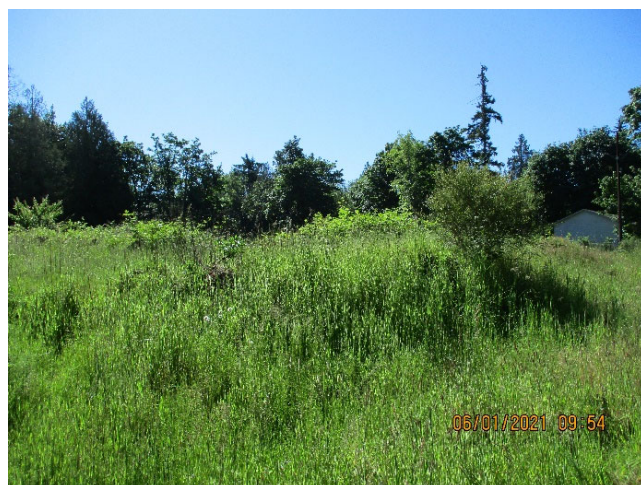
**Photograph 9****File Name:** IMG_0012.JPG**Description:** Stockpiles covered with vegetation, central area of site, facing southeast. Structure in the background is a residential building located off of the installation.

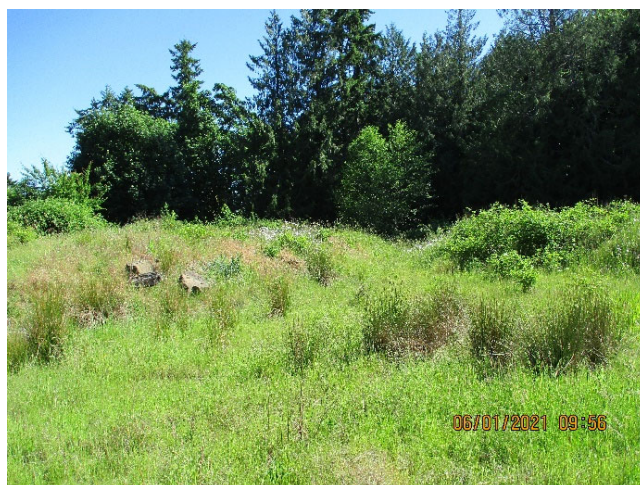
**Photograph 10****File Name:** IMG_0013.JPG**Description:** Stockpiles covered with vegetation, central area of site, facing northeast.

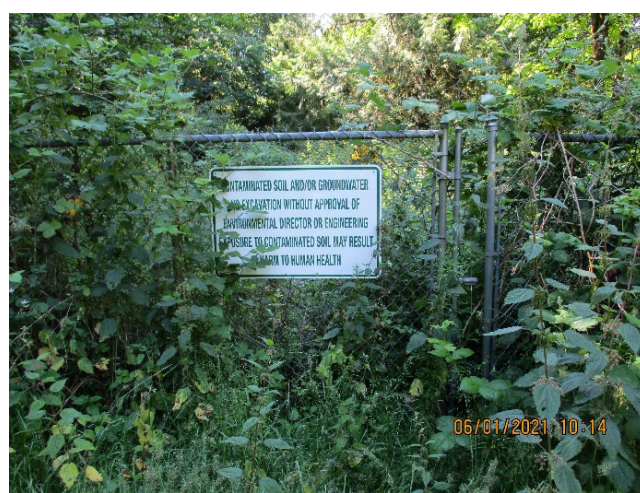
**Photograph 13****File Name:** IMG_0016.JPG**Description:** Locked access gate and LUC signage located on north side of site, facing south. Gate locked but not secure.

- Site 302: The gated entrance on the north side of the site is closed and locked, though not adequately secured, as the gate can be pushed open. It is recommended that the gate be properly secured to prevent it from being pushed open.

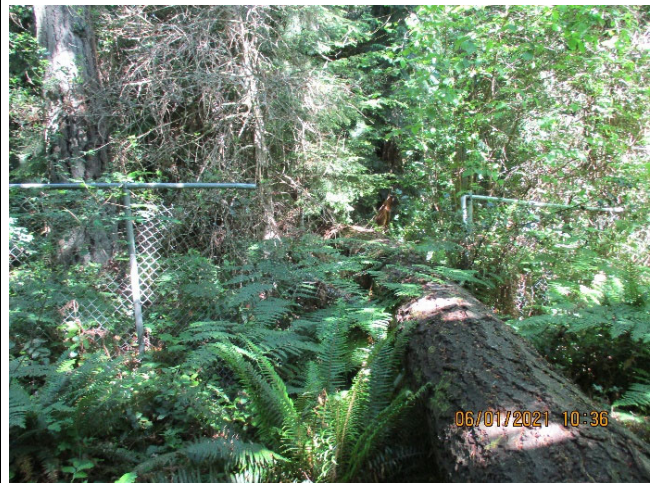
Approximately 60 linear feet of fencing were noted during the 2021 LUC inspection to have collapsed on the northwestern boundary of the site due to fallen trees.	Reconstruct fence.	Per the 2020 conclusion that the collapsed fence at Site 302 does not affect the LUC remedy (U.S. Navy, 2020), neither does this additional collapsed fence affect the LUC as designed. The Navy will coordinate with the installation on a plan and schedule to fix the damaged fence.
Site 303 – D-Tunnel Tanks		
Old stockpile of soil on a tarp surrounded by disintegrating absorbent boom in the laydown area north of Tank 29.	Properly characterize, transport, and appropriately dispose off site.	Same finding from 2017, 2018, 2019, and 2020 LUC inspections. U.S. Navy personnel are aware that soil stockpiles continue to be an issue and in coordination with the installation will take actions to address the stockpile. As indicated in the Fourth FYR (U.S. Navy, 2020), this finding does not affect the LUC as written.

**Photograph 16****File Name:** IMG_0019.JPG**Description:** Section of fence down (approximately 10 feet) due to treefall along west perimeter, facing northwest.

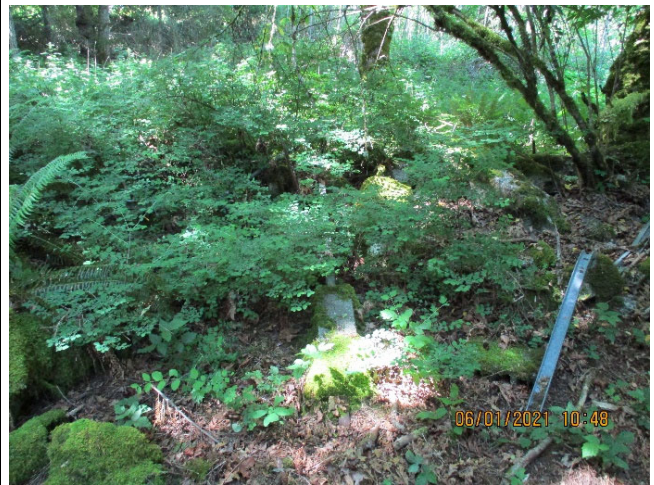
**Photograph 18****File Name:** IMG_0020.JPG**Description:** Concrete and metal debris (fence posts) located within the northeast area of site, facing southwest.

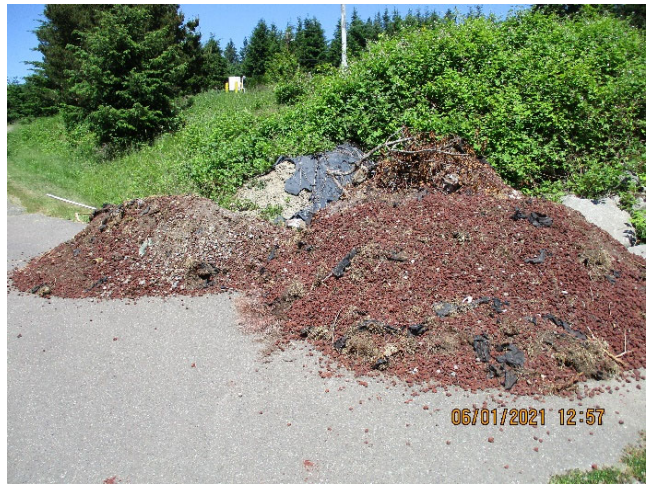
Two new stockpiles of landscape rock (red lava rock) and pieces of landscape fabric) were observed in the northwest corner of the construction laydown area south of Tank 25. The material in these stockpiles originated from the landscaped areas at the main gate (outside of a LUC site) and is authorized reusable material in an approved staging area.	Keep piles covered and maintained until an on-site use can be found.	U.S. Navy personnel are aware of the stockpiles and plan to reuse the material on-site. This finding does not affect the LUC as written.

**Photograph 16****File Name:** IMG_0049.JPG**Description:** Landscape material stockpile in construction laydown area south of Tank 25, facing northwest.

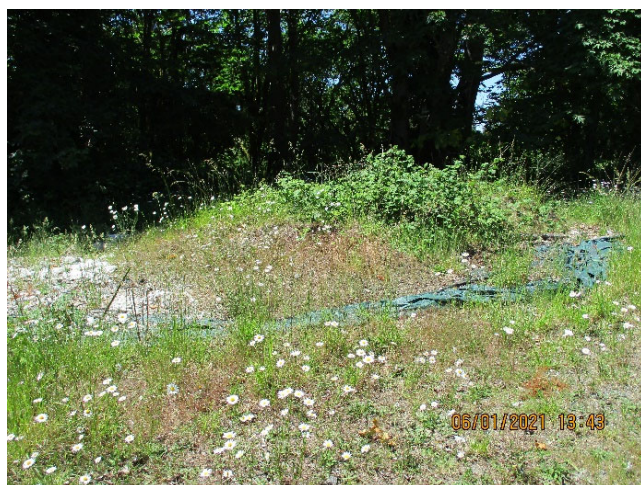
**Photograph 31****File Name:** IMG_0065.JPG**Description:** soil stockpile on tarp surrounded by degraded sorbent booms north of Tank 29, facing west.

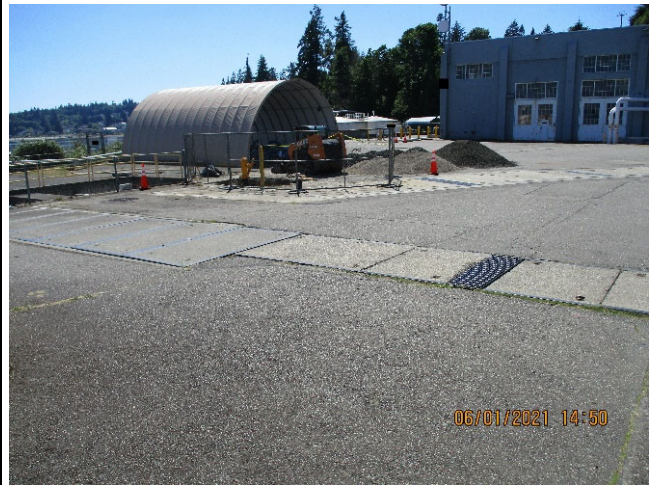
**Photograph 2****File Name:** IMG_0076.JPG**Description:** Parking lot along south-central area of site, small excavation in progress, facing southwest.

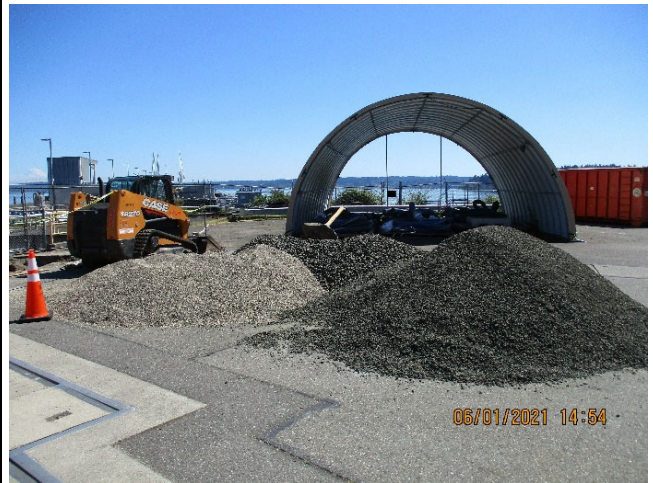
**Photograph 4****File Name:** IMG_0078.JPG**Description:** Parking lot along south-central area of site, small excavation in progress, facing south.

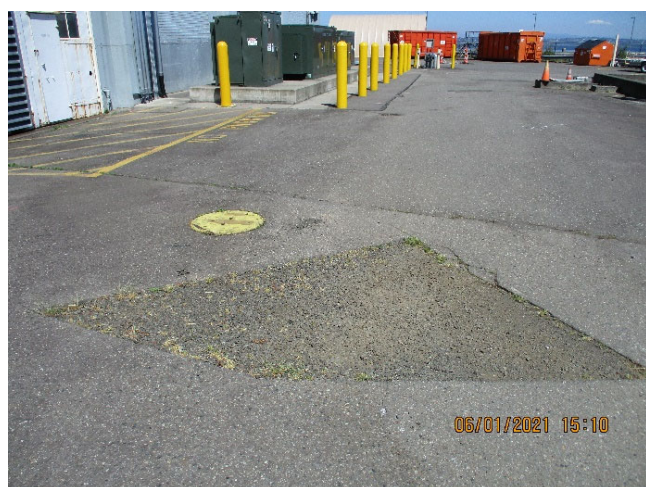
- Site 304: A cut in asphalt was observed off the southwest corner of Building 12, which was due to an excavation to repair a small area of subsidence near the building. The asphalt cut was triangular with surface dimensions of approximately 10 feet by 9 feet by 7 feet. It is recommended that the cut in the asphalt be repaired.

**Photograph 9****File Name:** IMG_0083.JPG**Description:** Former excavation through asphalt near the southwestern site boundary, facing east.
