2019 Land Use Control Inspection Technical Memorandum

Fleet Logistics Center Puget Sound Manchester Fuel Depot

Manchester, Washington

Department of the Navy

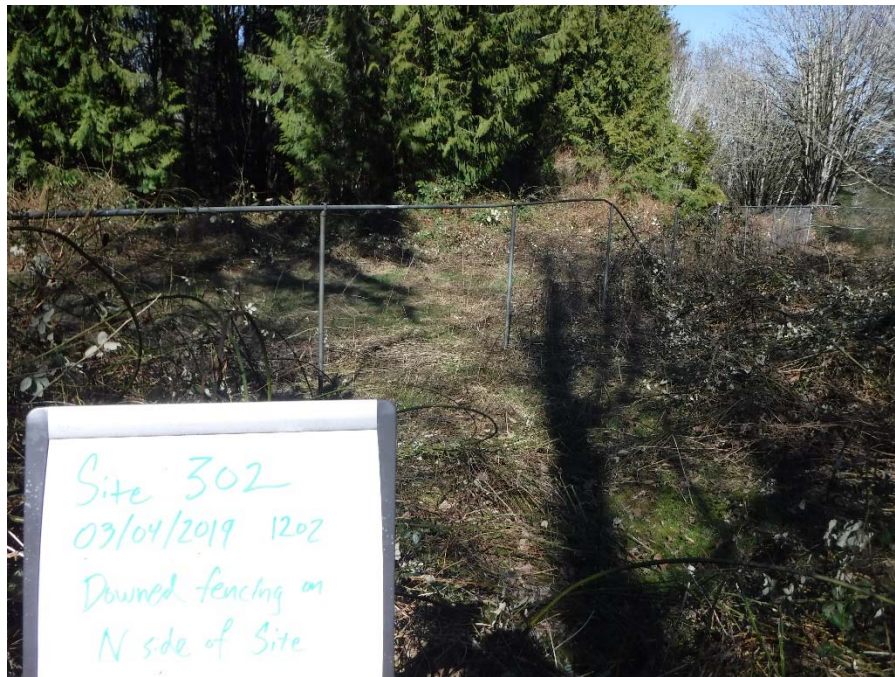
The gated entrance on the north side of the site has no lock or LUC signage.	Secure gate with lock and place LUC signage.	The entrance is in a relatively remote location of MFD, where personnel would not typically access the site from this location. Same finding from 2017 and 2018 LUC inspections.
Approximately 60 linear feet of chain-link fencing has collapsed on the northwest side of the site, likely due to incursion of vegetation.	Repair chain-link fencing.	The vertical posts remain in good condition, but the chain-linked fencing requires replacement. The northwest side is in a relatively remote location of MFD, and vegetative overgrowth serve as natural barricades for any persons accessing the site from this location. Same finding from 2016 Baseline Condition Assessment (Battelle, 2016c).
Site 303 - D-Tunnel Tanks		
An unmarked stockpile of soil covered by black poly sheeting in the northwest corner of the construction laydown area southwest of Tank 24.	Confirm soil stockpile is authorized reusable material and is located in an approved staging area.	Same finding from 2017 and 2018 LUC inspections.

Photo 10 - Description: Site 302, PCB Site, Gated entrance on north side of site. No lock or LUC signage.

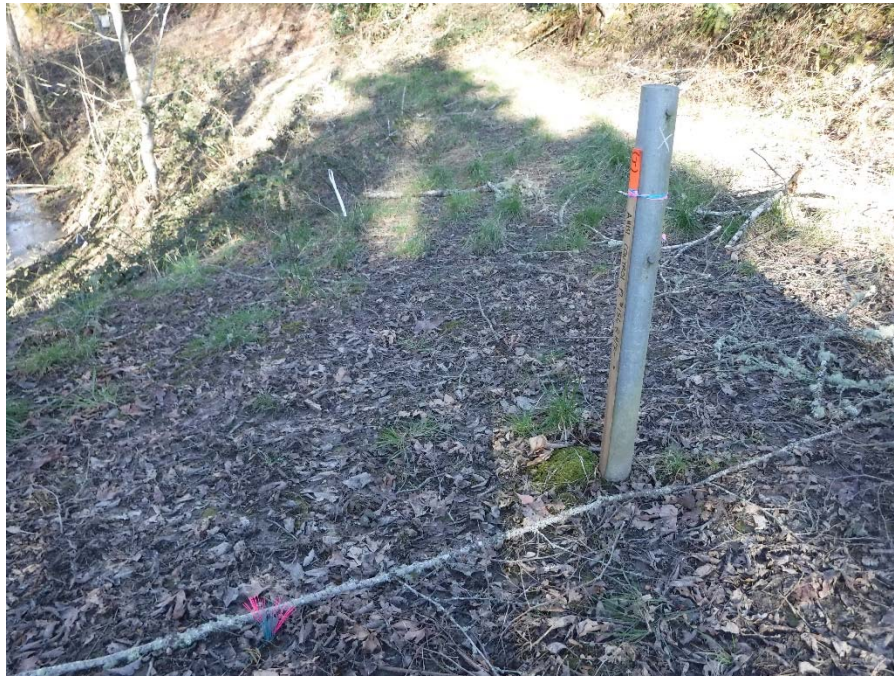
Photo 4 - Description: Site 303, D-Tunnel Tanks, Monument of abandoned monitoring well MW-3, South of Tank 24

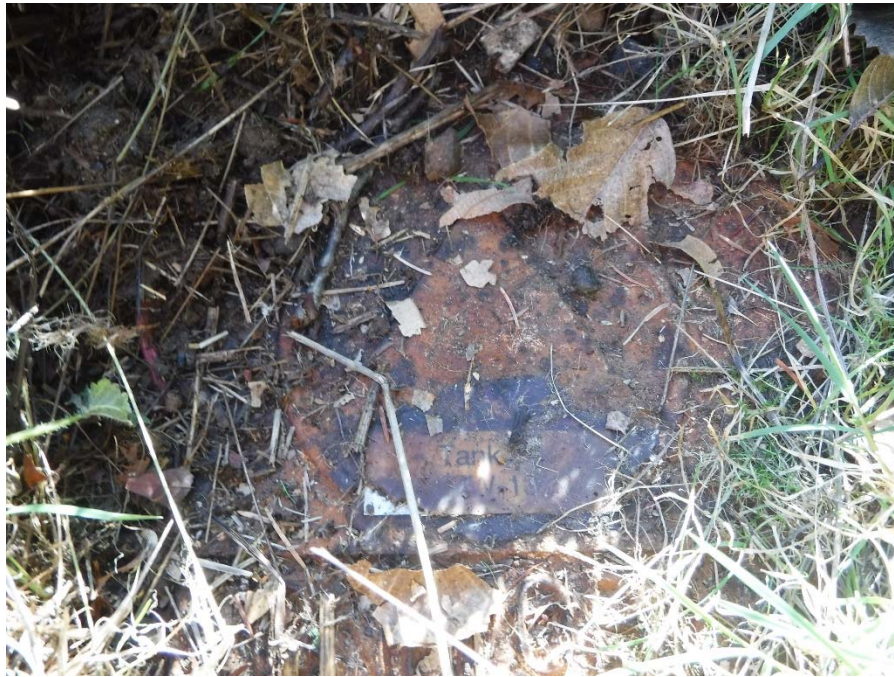
Found all 13 MWs; however MW-13 was found under trees + branches debris.

Photo 22 - Description: Site 303, D-Tunnel Tanks, Tank 26 MW-13 identified in thick overgrowth

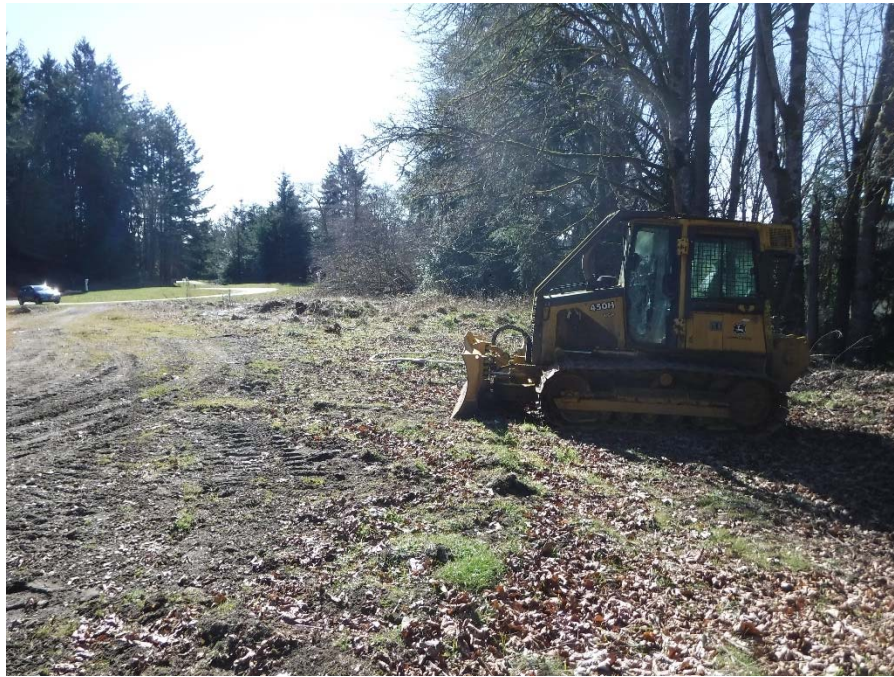
Findings	Recommendations	Comment
Old stockpile of soil on a tarp and surrounded by absorbent wattles in the laydown area north of Tank 29.	Properly characterize, transport, and dispose of (off site) the soil.	Same finding from 2017 and 2018 LUC inspections.
Monitoring wells MW-1 south of Tank 24 and MW-3 north of Tank 30 need casing to be lowered to fit cap under lid and minor maintenance/repairs.	Lower casing and perform needed minor maintenance/repairs on monitoring wells MW-1 and MW-3.	Monitoring well MW-1 south of Tank 24 is located along the southern boundary of the facility adjacent to a residential area. Therefore, the location of this well may provide useful information during future monitoring/investigations. Monitoring well MW-3 north of Tank 30 is already part of the monitoring network (Battelle, 2017a).
Site 304 - Industrial Area		
The LUC signage for Site 304 is located at the northern corner of Building 178, outside and north of the Site 304 LUC boundary.	Move the LUC signage to the corner of Cedar Avenue and Olympic Drive E to be consistent with the actual site boundary.	This is the primary entry/access point to the site; therefore, moving the LUC signage to this location would accurately inform staff, contractors, and visitors of the area with LUC restrictions. Same finding from 2018 LUC inspections.

Photo 32 - Description: Site 303, D-Tunnel Tanks, Old soil stockpile with tarp and absorbent booms in laydown area north of Tank 29 (2 of 2)

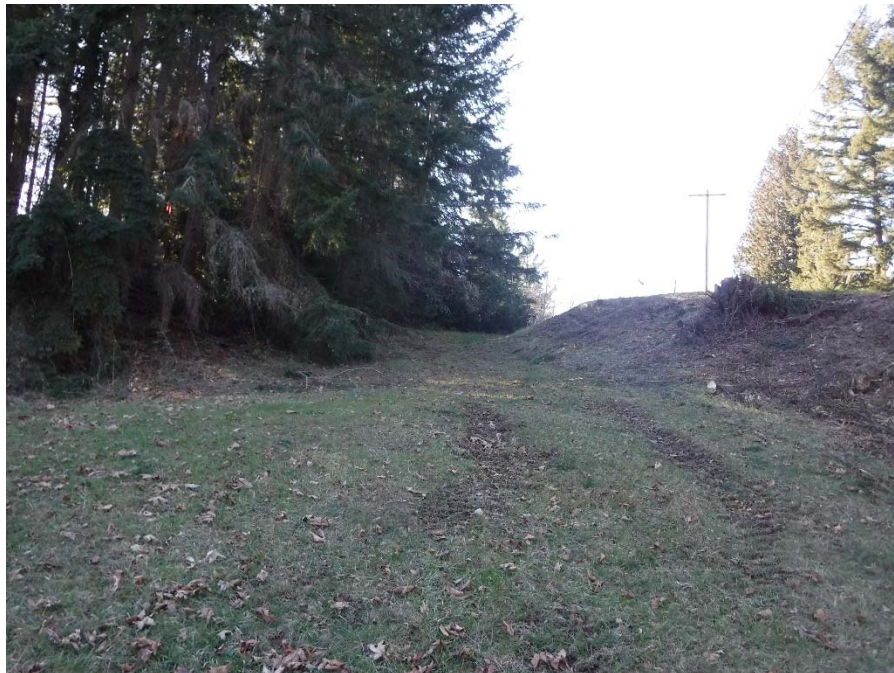
Photo 13 - Description: Tank 50, Tank 50 Release Site, Monitoring well MW-1 (in overall good condition)
