**FINAL**  
**2017 LAND USE CONTROL INSPECTION TECHNICAL MEMORANDUM**  
**FLEET LOGISTICS CENTER PUGET SOUND**  
**MANCHESTER FUEL DEPOT**  
**MANCHESTER, WASHINGTON**

**Prepared by**  
**Battelle**  
**Columbus, Ohio**

**Prepared for**  
**Naval Facilities Engineering Command Northwest**  
**Silverdale, Washington**

**October 9, 2017**

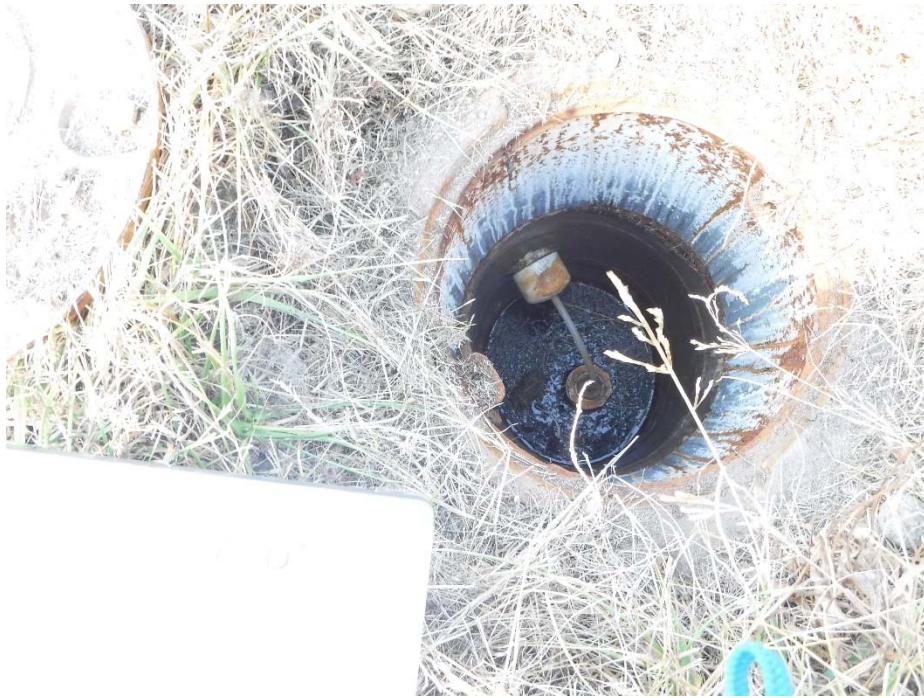
**File Name:** 303-Tank22-MW2-DSCF1633  
**Date Taken:** 08/29/17

**Photo #5 - Description:** Site 303, Tank 22, MW-2, well buried under grass

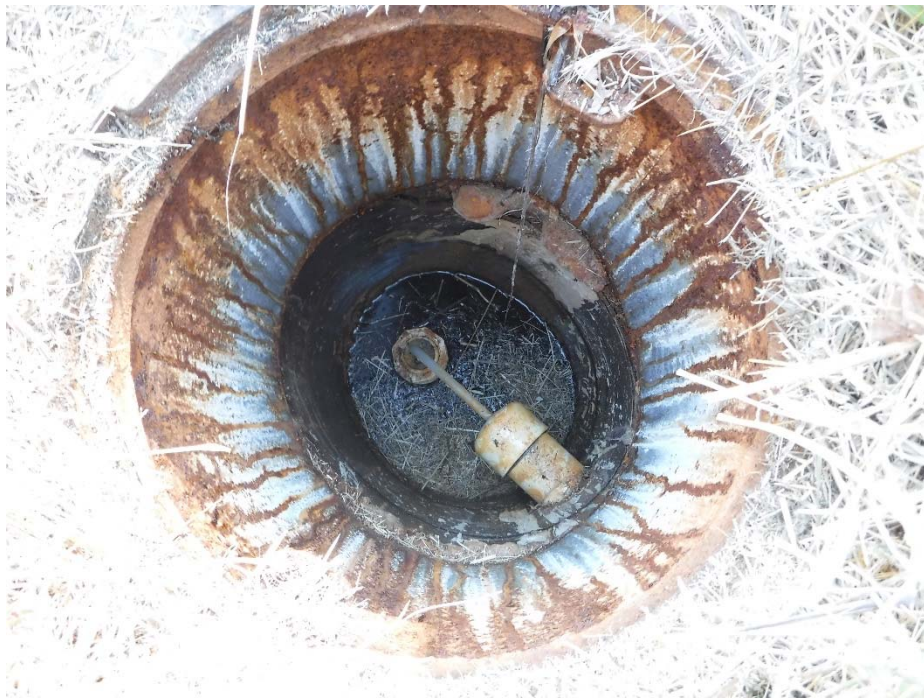
**File Name:** 303-Tank22-MW3-DSCF1636  
**Date Taken:** 08/29/17

**Photo #6 - Description:** Site 303, Tank 22, MW-3, water in monument

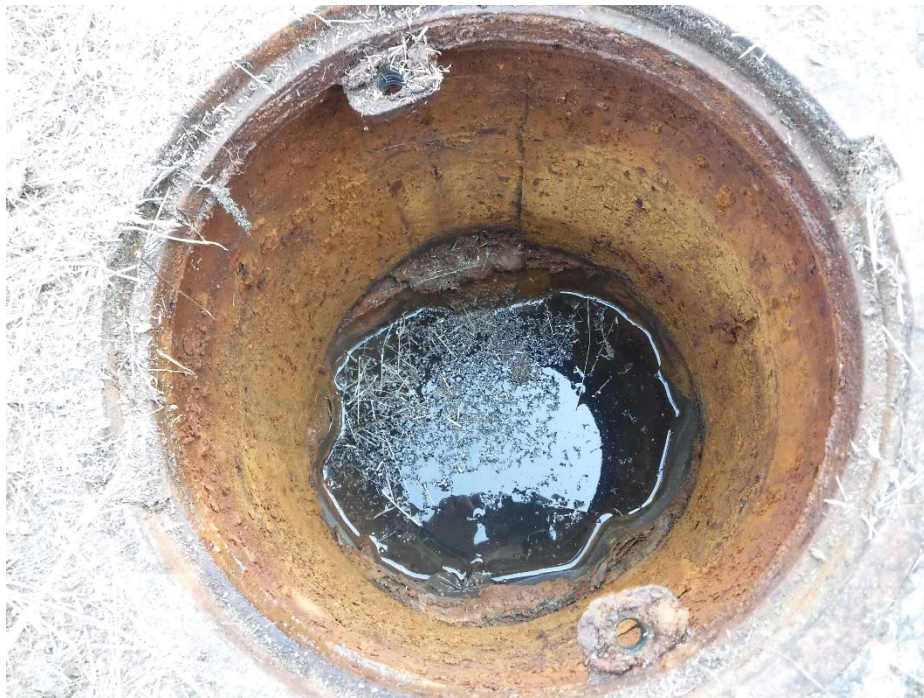
**File Name:** 303-Tank22-MW5-DSCF1640  
**Date Taken:** 08/29/17

7	–
MW-5	64046.46	371656.10	NA	8	Monument filled with water, preventing well condition determination.
MW-6	64040.00	371648.50	NA	9	Monument filled with water, preventing well condition determination.
MW-7	64037.05	371638.40

**Photo #8 - Description:** Site 303, Tank 22, MW-5, monument filled with water

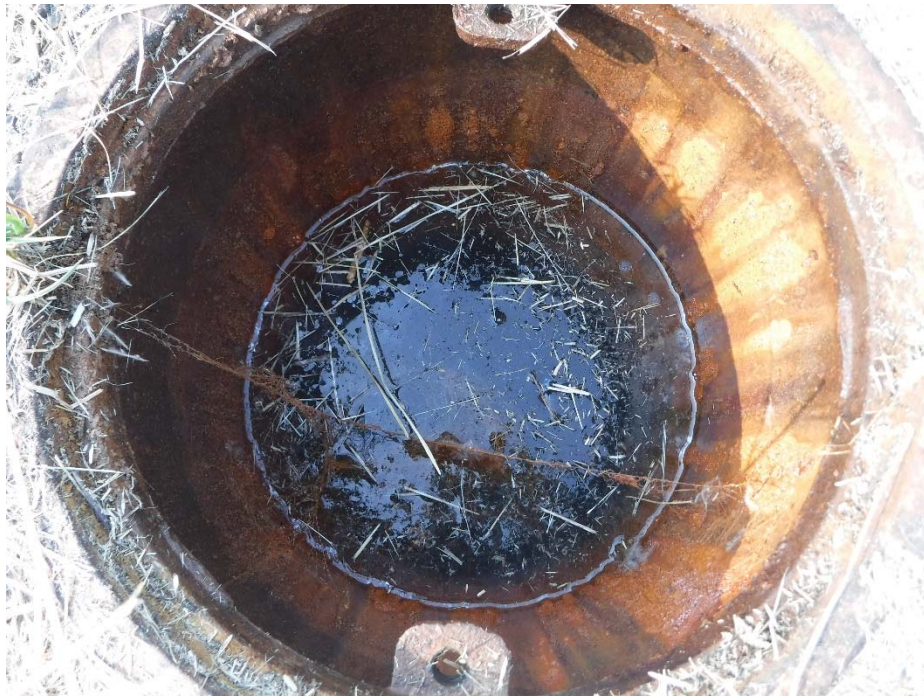
**File Name:** 303-Tank22-MW6-DSCF1642  
**Date Taken:** 08/29/17

**Photo #9 - Description:** Site 303, Tank 22, MW-6, monument filled with water

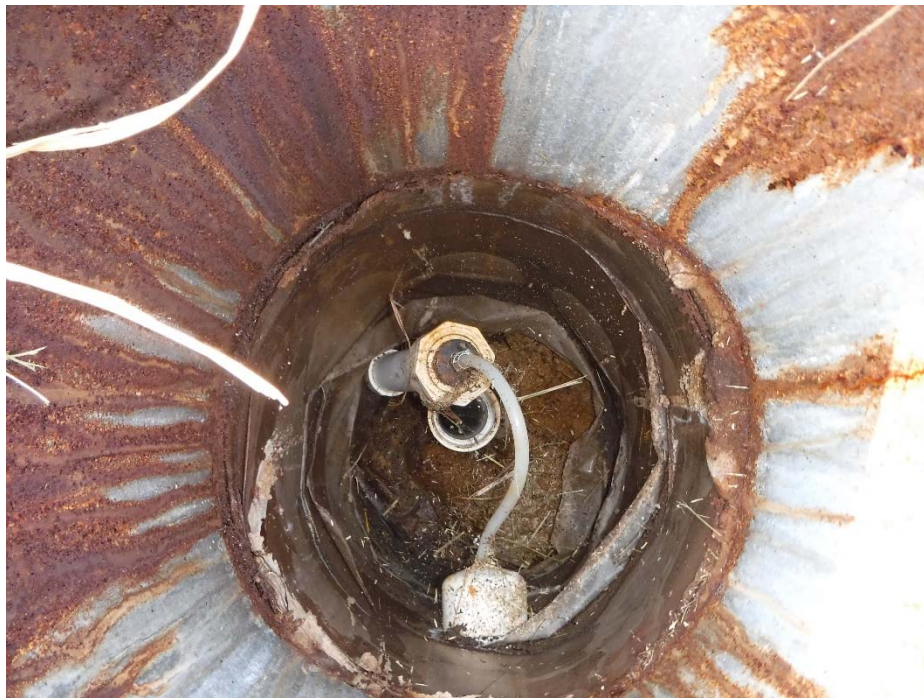
**File Name:** 303-Tank22-MW7-DSCF1644  
**Date Taken:** 08/29/17

**Photo #10 - Description:** Site 303, Tank 22, MW-7, cap removed from well casing

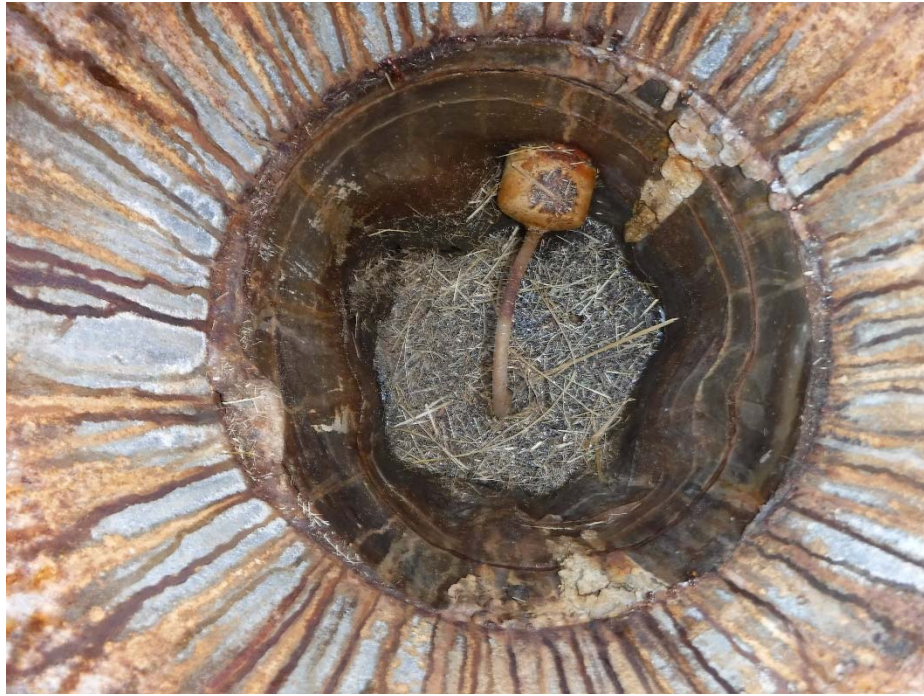
**File Name:** 303-Tank22-MW8-DSCF1646  
**Date Taken:** 08/29/17

**Photo #11 - Description:** Site 303, Tank 22, MW-8, debris inside monument

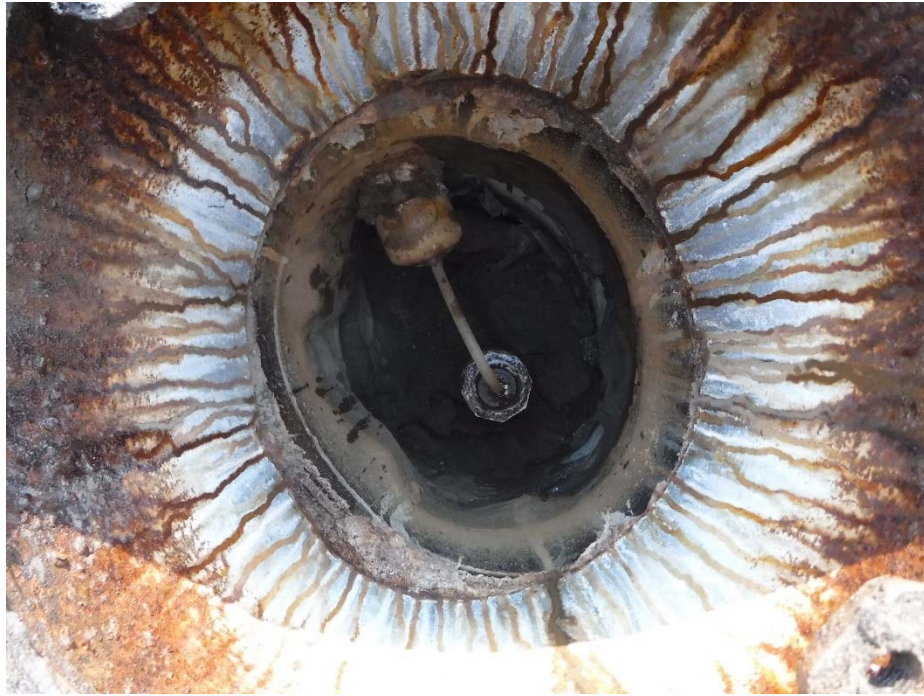
**File Name:** 303-Tank22-MW10-DSCF1650  
**Date Taken:** 08/29/17

**Photo #13 - Description:** Site 303, Tank 22, MW-10, located along access road

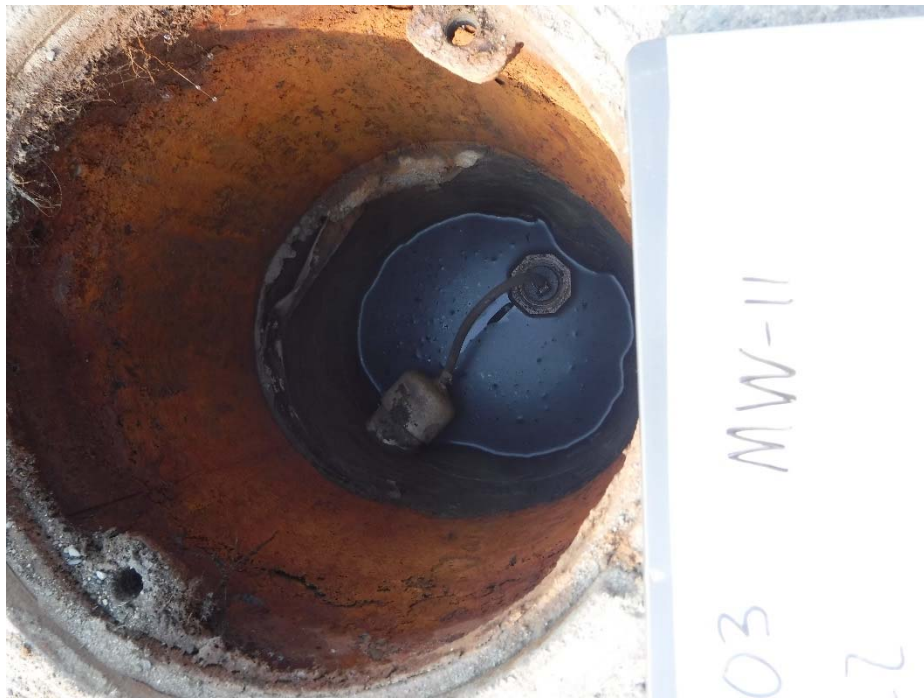
**File Name:** 303-Tank22-MW11-DSCF1627  
**Date Taken:** 08/29/17

**Photo #14 - Description:** Site 303, Tank 22, MW-11, located along roadside, water in annular spacing

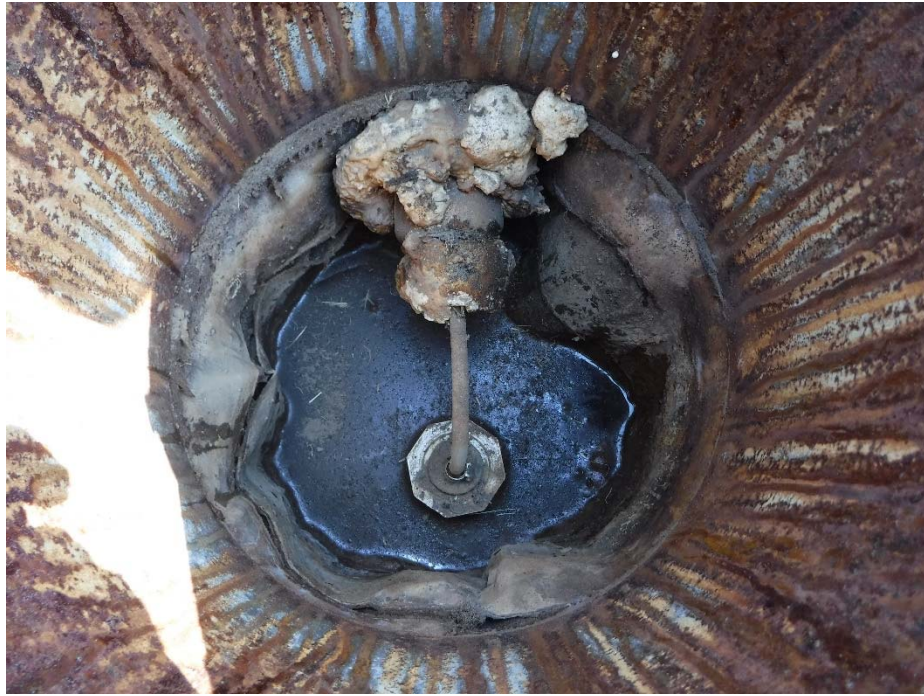
**File Name:** 303-Tank24-MW3-DSCF1685  
**Date Taken:** 08/29/17

**Photo #25 - Description:** Site 303, Tank 24, MW-3, ID plate not affixed to well lid, buried under ~1 inch of dirt/soil

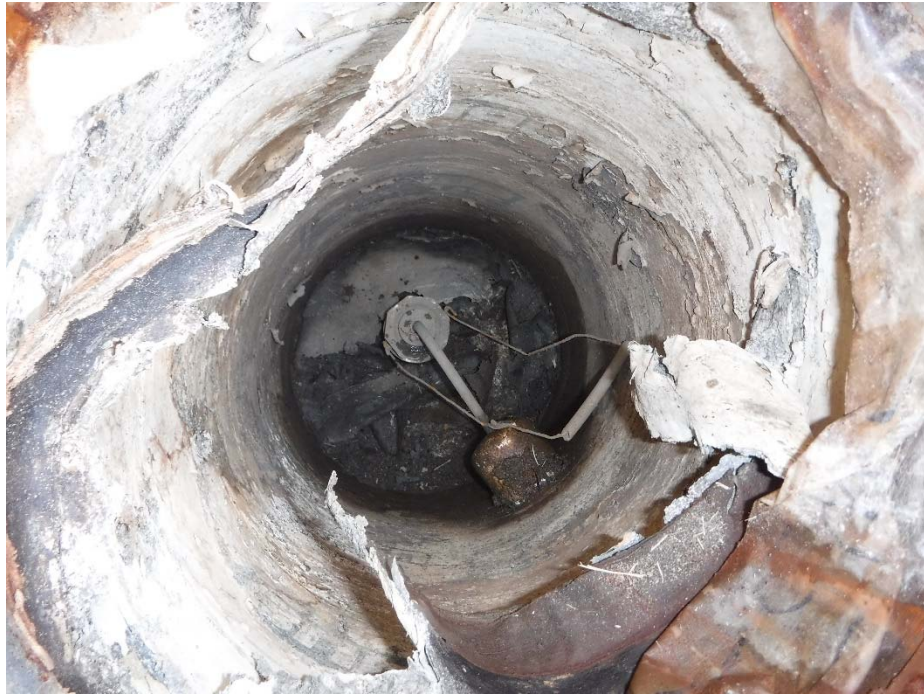
**File Name:** 303-Tank24-MW5-DSCF1691  
**Date Taken:** 08/29/17

27	Interior lining of monument deteriorating.
MW-6	64095.43	371467.60

**Photo #27 - Description:** Site 303, Tank 24, MW-5, interior lining of monument deteriorating

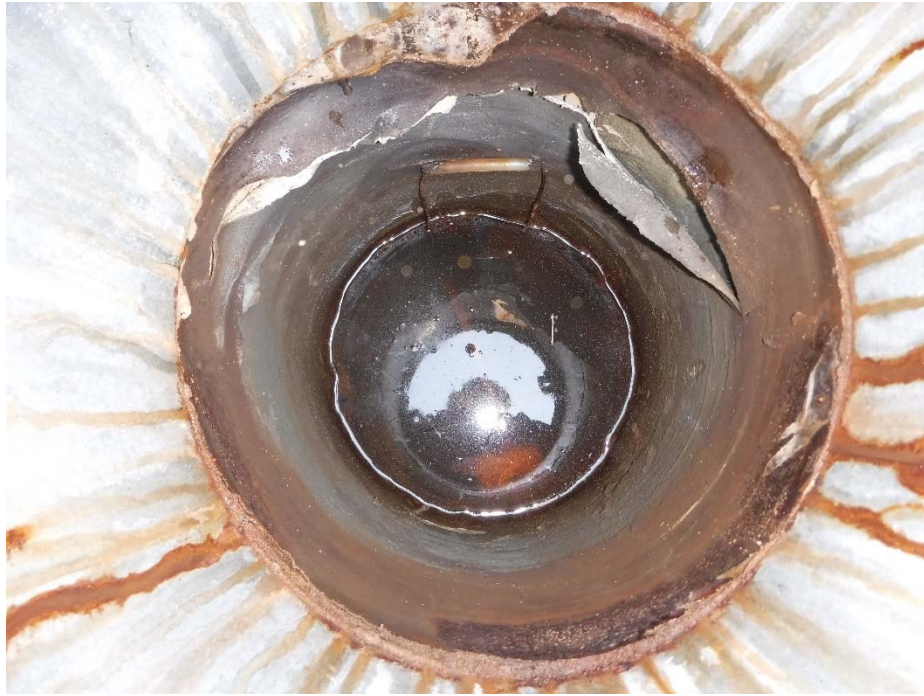
**File Name:** 303-Tank24-MW7-DSCF1695  
**Date Taken:** 08/29/17

28	Located in middle of road. Well ~3 feet deep in monument.
MW-7	64096.43	371477.90	NA	29	Well fully submerged under water, preventing well condition determination. Some sheen in water.
MW-8	64093.93	371487.30

**Photo #29 - Description:** Site 303, Tank 24, MW-7, well fully submerged under water, some sheen in water

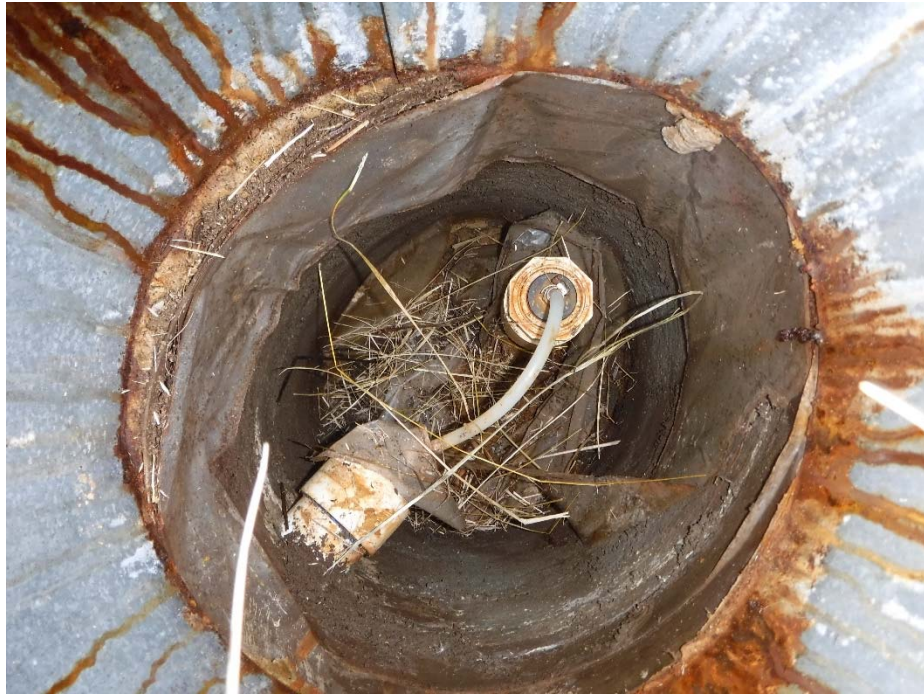
**File Name:** 303-Tank26-MW7-DSCF1709  
**Date Taken:** 08/29/17

**Photo #49 - Description:** Site 303, Tank 26, MW-7, well located in tall grass surrounding tank

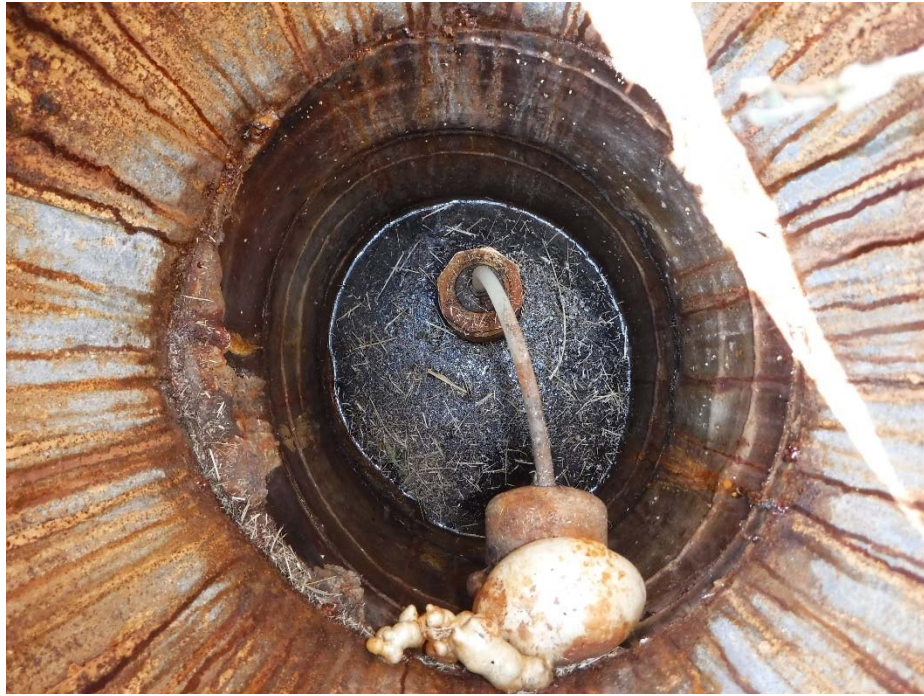
**File Name:** 303-Tank26-MW9-DSCF1705  
**Date Taken:** 08/29/17

**Photo #51 - Description:** Site 303, Tank 26, MW-9, water in monument

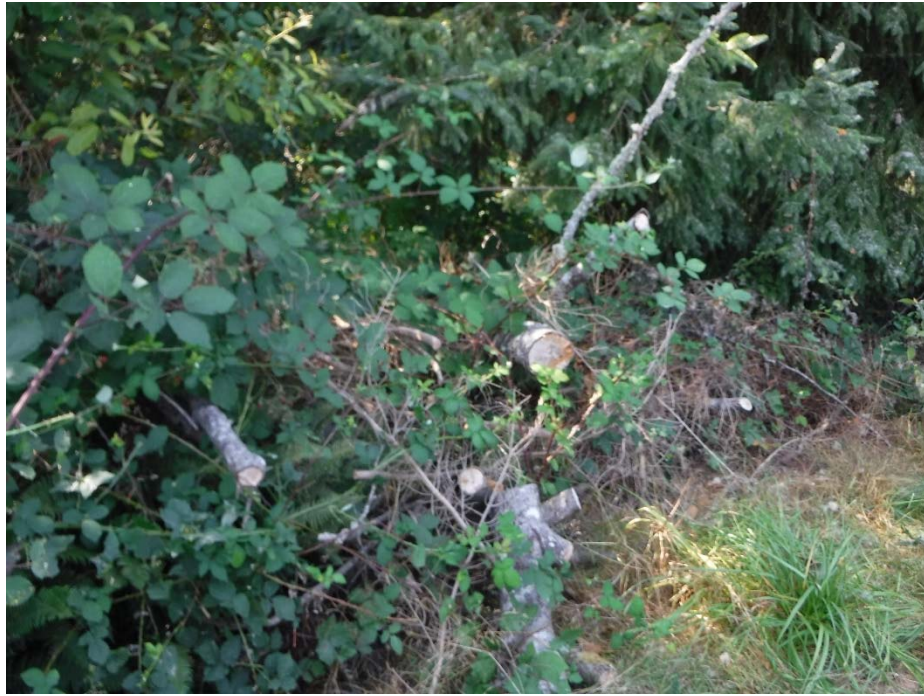
**File Name:** 303-Tank26-MW13-DSCF1730  
**Date Taken:** 08/29/17

**Photo #55 - Description:** Site 303, Tank 26, MW-13, covered by recently cut trees and overgrowth

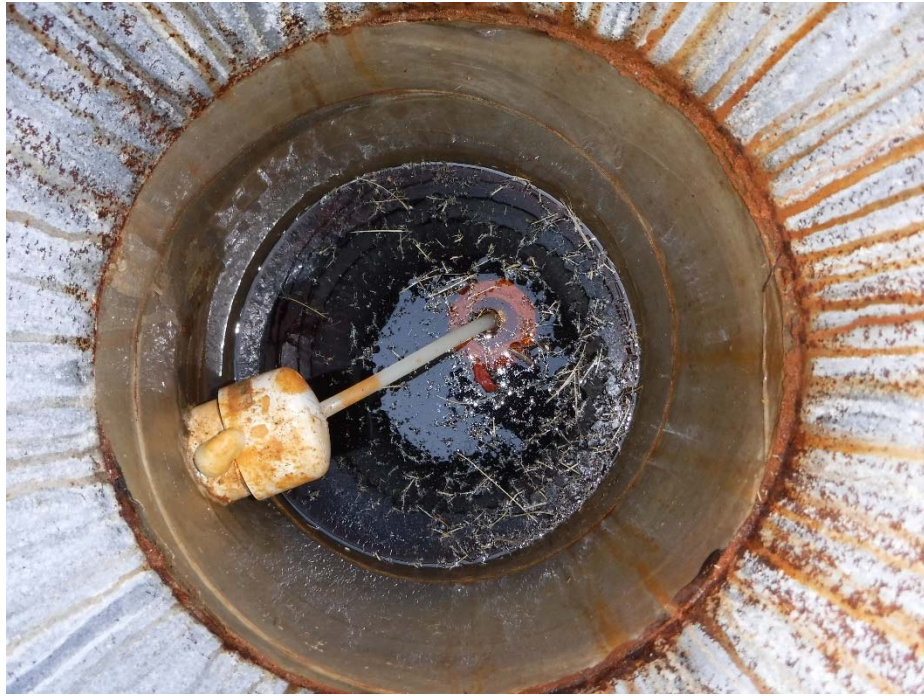
**File Name:** 303-Tank29-MW2-DSCF1784  
**Date Taken:** 08/29/17

58	Flex tube missing, well not connected to Soil Sentry System.
<b>Tank 29 – Vapor Monitoring Wells</b>					
MW-1	64409.96	371208.60	NA	68	Well fully submerged under water, preventing well condition determination.
MW-2	64420.01	371207.90	NA	69	Well fully submerged under water, preventing well condition determination.
MW-3	64428.66	371212.00	NA	70	Well fully submerged under water, preventing well condition determination.
MW-4	64049.98	371595.29

**Photo #69 - Description:** Site 303, Tank 29, MW-2, well fully submerged under water

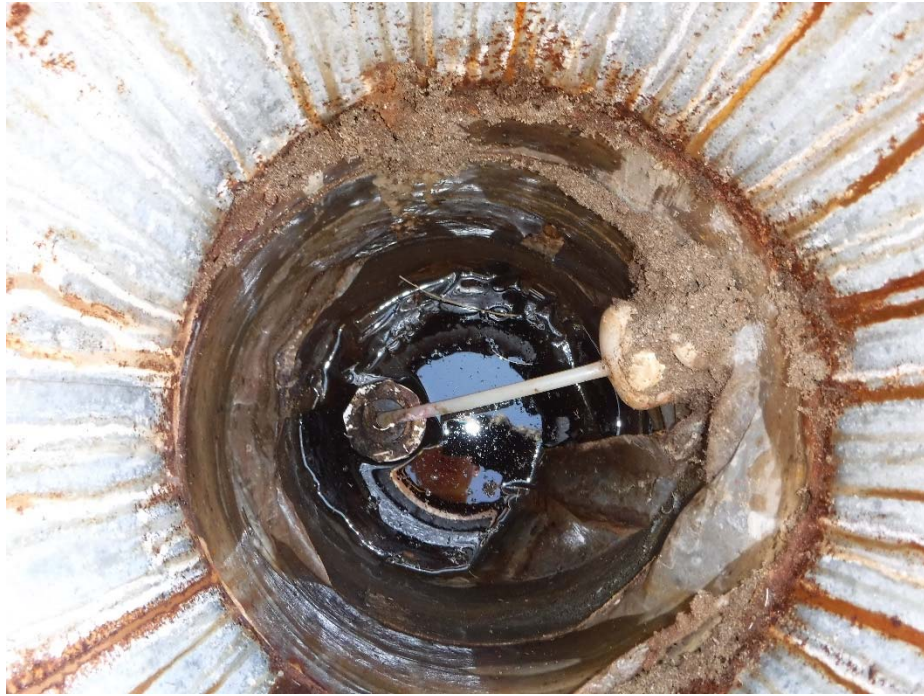
**File Name:** 303-Tank29-MW5-DSCF1778  
**Date Taken:** 08/29/17

73	Water in monument.
MW-6	64433.18	371240.40	NA	74	Well fully submerged under water, preventing well condition determination.
MW-7	64424.52	371246.70

**Photo #73 - Description:** Site 303, Tank 29, MW-5, water in monument

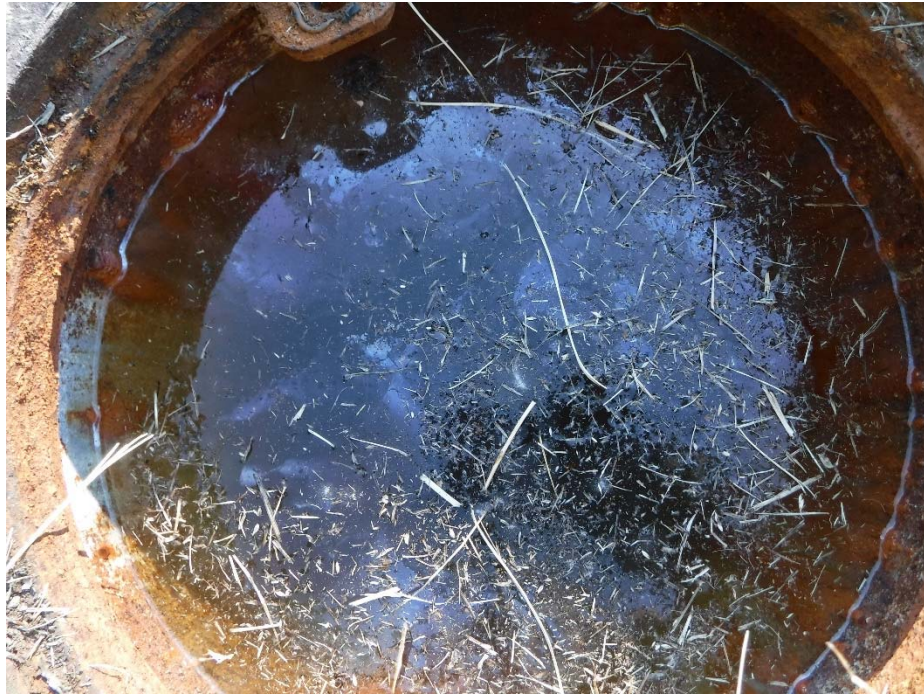
**File Name:** 303-Tank29-MW9-DSCF1796  
**Date Taken:** 08/29/17

76	Water in monument to top of casing.
MW-9	64405.98	371245.10	NA	77	Well fully submerged under water, preventing well condition determination. Sheen on water.
MW-10	64400.01	371235.80	NA	78	Well fully submerged under water, preventing well condition determination.
MW-11	64403.29	371217.30

**Photo #77 - Description:** Site 303, Tank 29, MW-9, water in monument with sheen

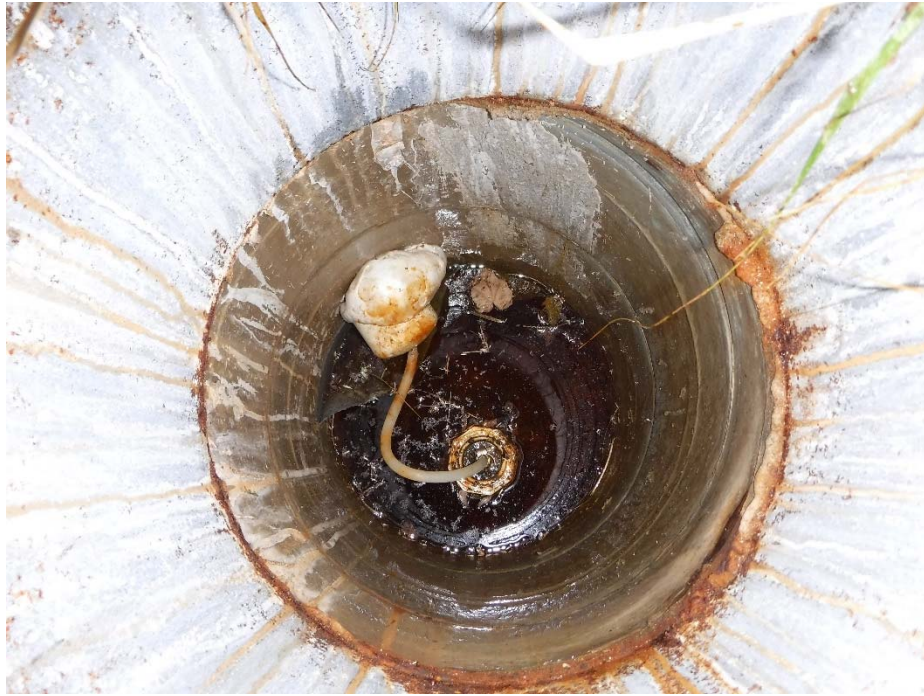
**File Name:** 303-Tank30-MW4-DSCF1802  
**Date Taken:** 08/30/17

**Photo #87 - Description:** Site 303, Tank 30, MW-4, water in monument to top of casing, located in tall grass surrounding tank, ID plate not affixed to well lid

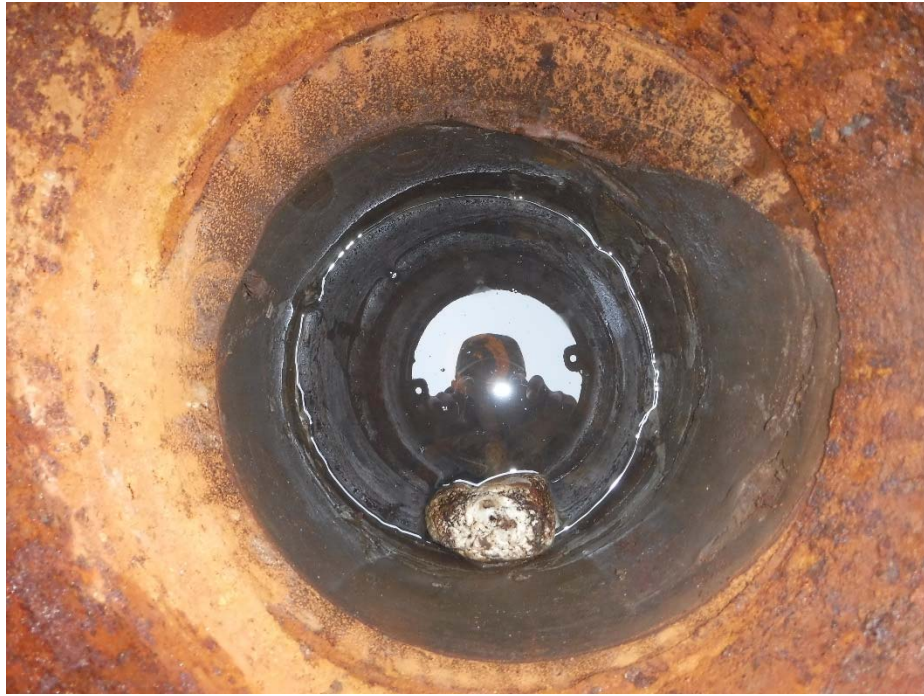
**File Name:** 303-Tank30-MW6-DSCF1824  
**Date Taken:** 08/30/17

88	Well fully submerged under water, but well cap and casing are visible. Sheen on water.
MW-6	64520.81	371288.40	NA	89	Well fully submerged under water, preventing well condition determination.
MW-7	64512.29	371296.70	NA	90	Well fully submerged under water, preventing well condition determination.

**Photo #89 - Description:** Site 303, Tank 30, MW-6, well fully submerged under water

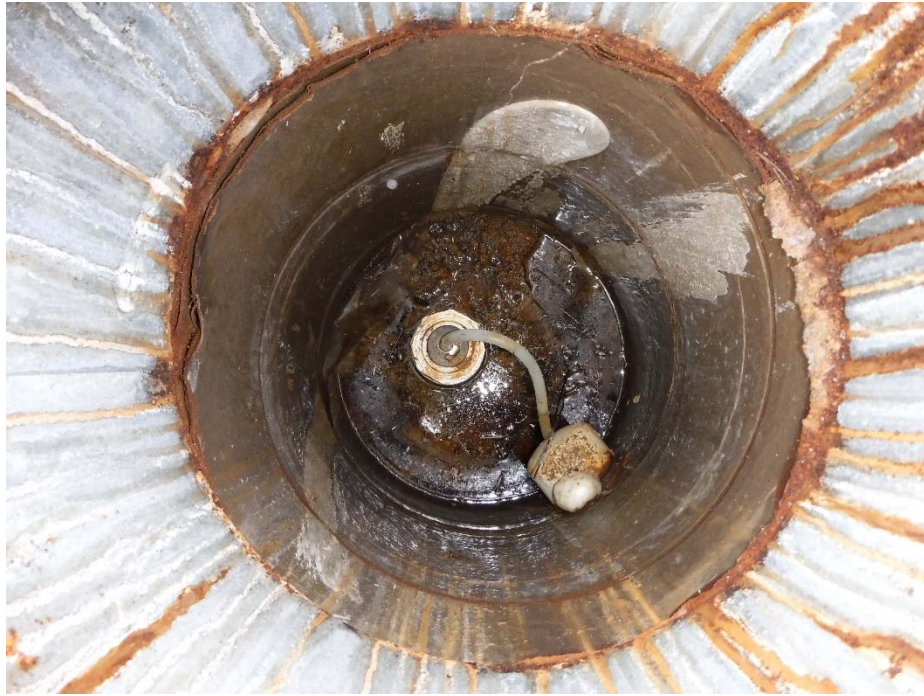
**File Name:** 303-Tank30-MW10-DSCF1816  
**Date Taken:** 08/30/17

**Photo #93 - Description:** Site 303, Tank 30, MW-10, water in monument

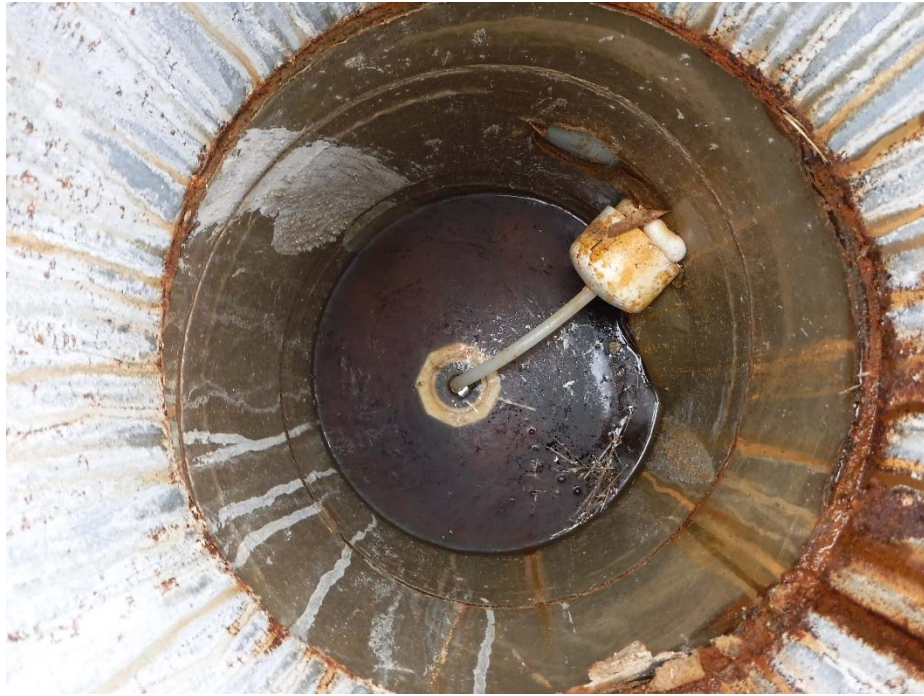
**File Name:** 303-Tank30-MW12-DSCF1810  
**Date Taken:** 08/30/17

**Photo #95 - Description:** Site 303, Tank 30, MW-12, water in monument

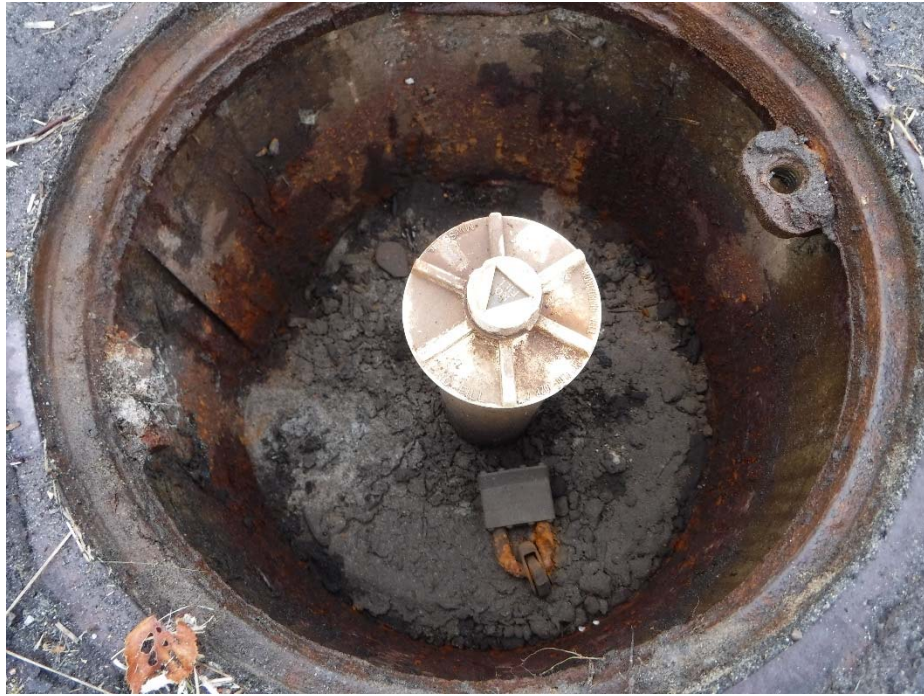
**File Name:** 304-IndustrialArea-MW1-  
DSCF1840  
**Date Taken:** 08/30/17

**Photo #109 - Description:** Site 304, Industrial Area, MW-1, lock not  
on well cap

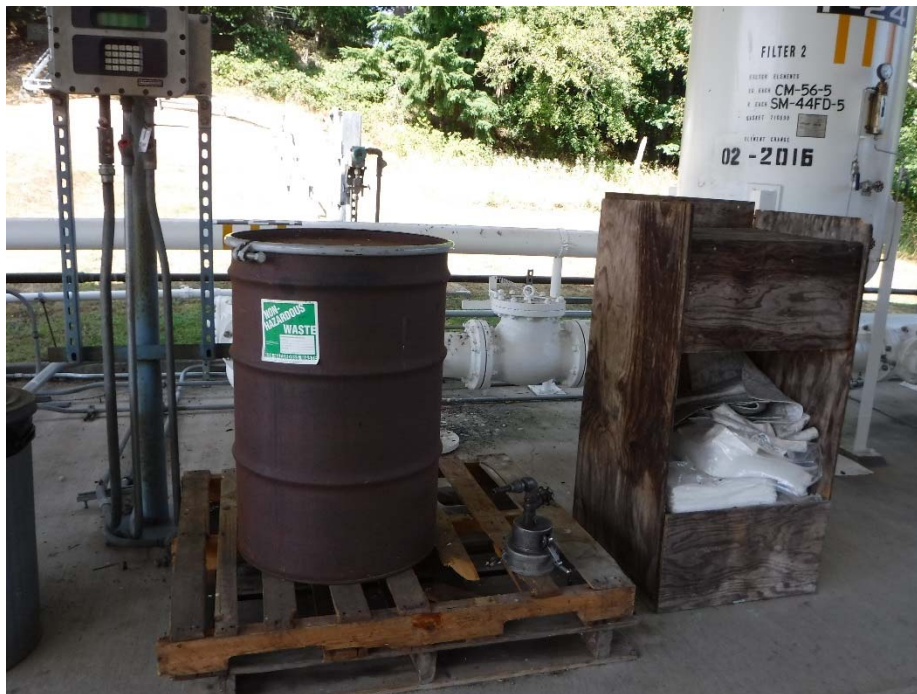
**File Name:** Tank50-DSCF1915  
**Date Taken:** 08/30/17

**Photo #119 - Description:** Tank 50 Release Site, 55-gallon non-hazardous waste drum for spills at Building 185 fueling station
