KJ project: 1996002.02
Texaco Strickland Remedial Investigation Field Support

Site visit date: 10/11/2022

KJ Staff: Jenny Mital

Attachment: Site visit photos

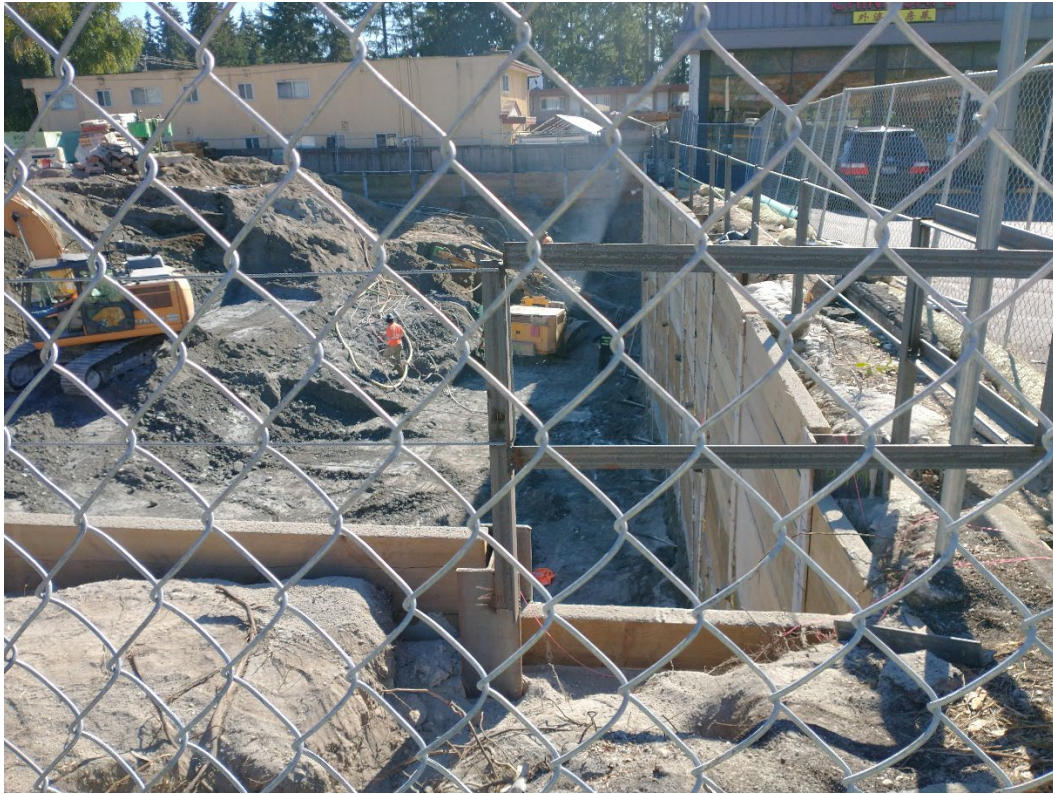
View of excavation and shoring wall from 196th St, facing south.

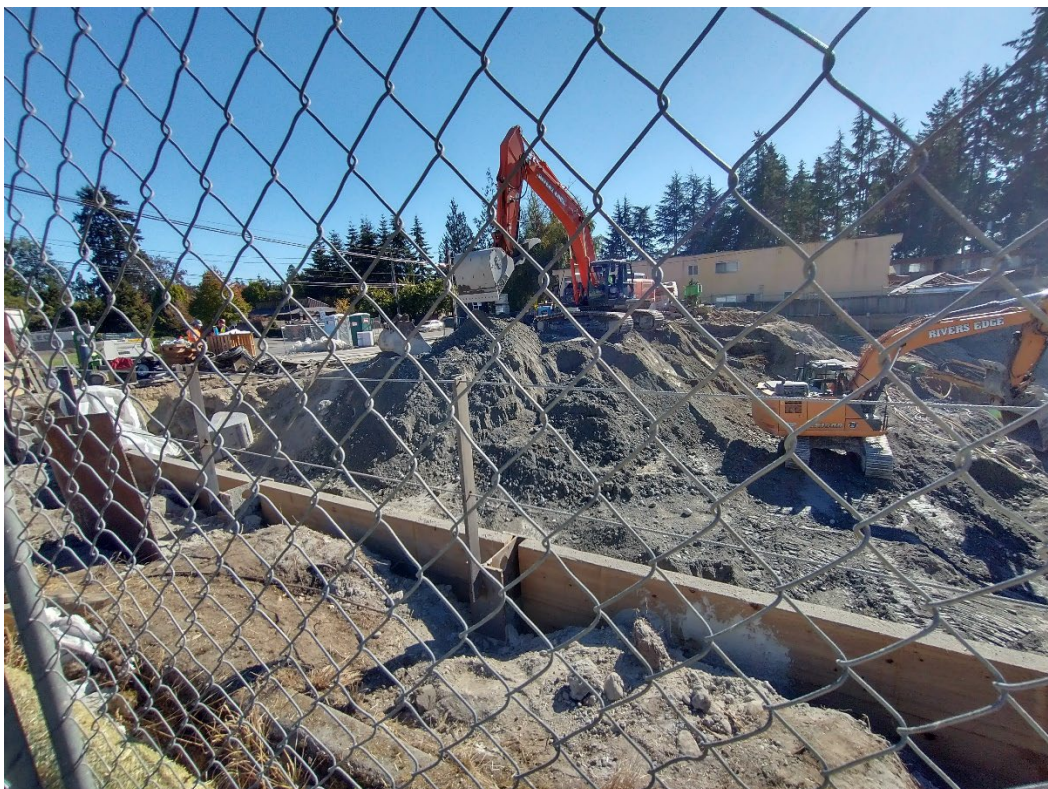
View of excavator for truck loading operations from 196th St, facing southwest.

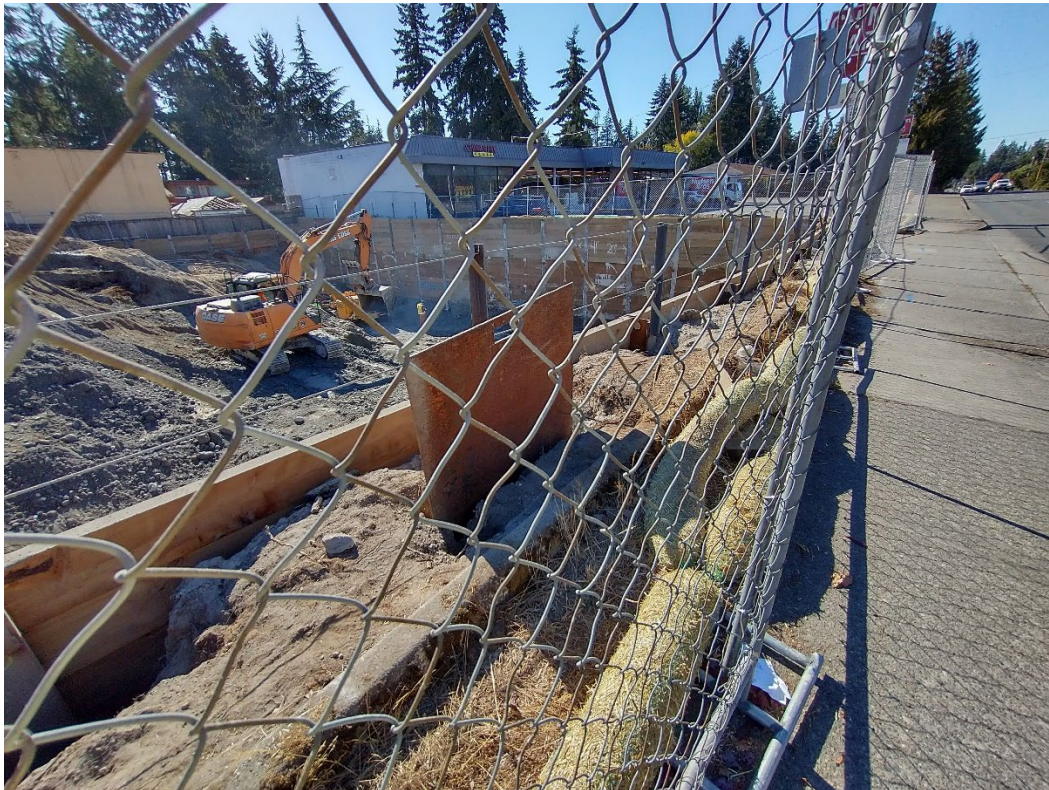
View of north perimeter fence and shoring wall from 196th St, facing southeast. Shoring wall location set by existing Telecom line behind metal plate.

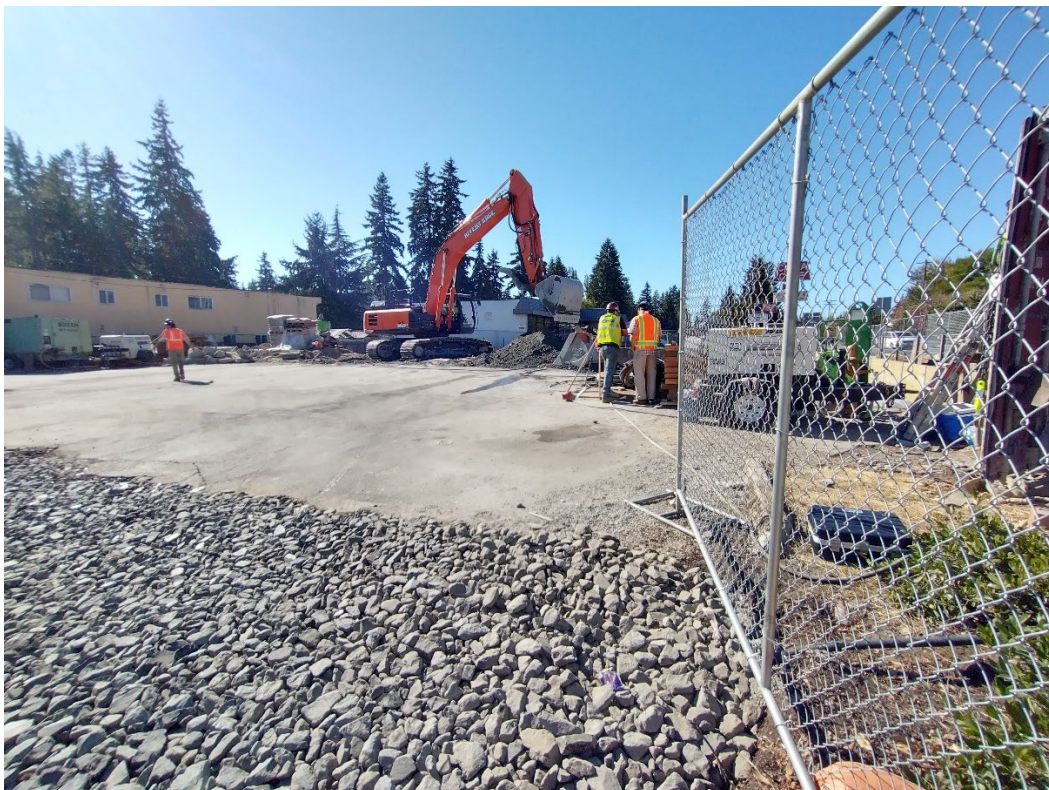
View from north site gate on 68th Ave., facing southwest.

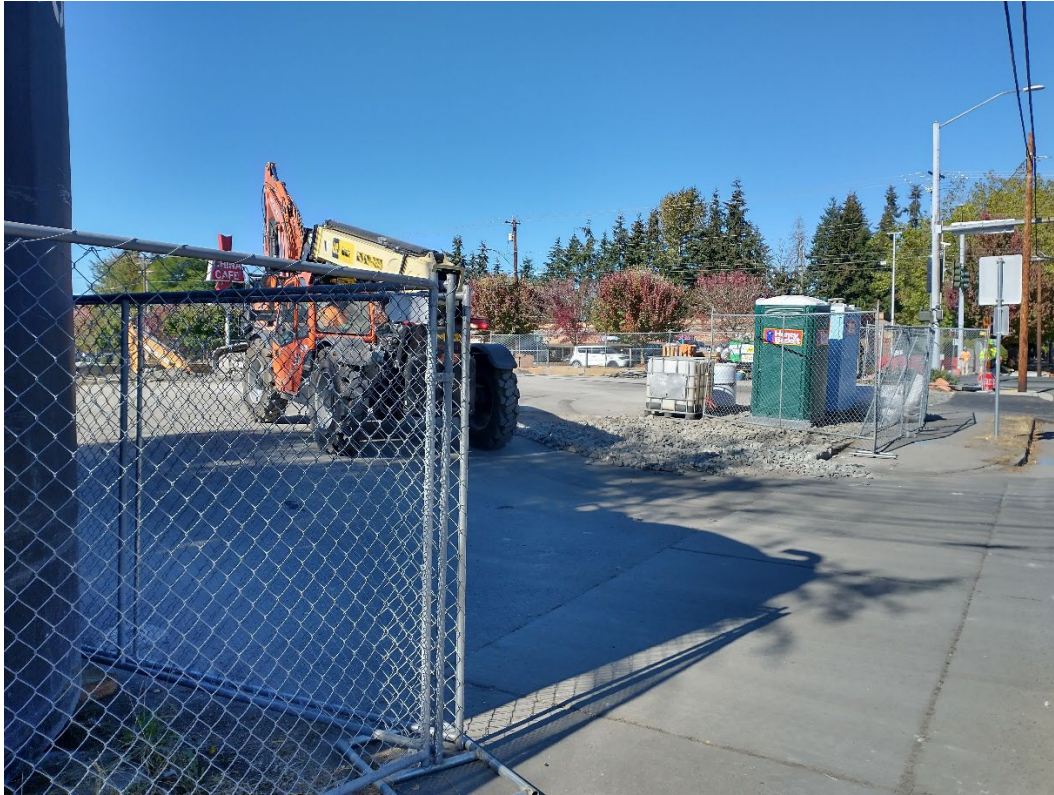
View from south site gate on 68th Ave., facing northwest.
