SITE HAZARD ASSESSMENT

Worksheet 1: Summary Score Sheet

SITE NAME: Duwamish Waterway Park

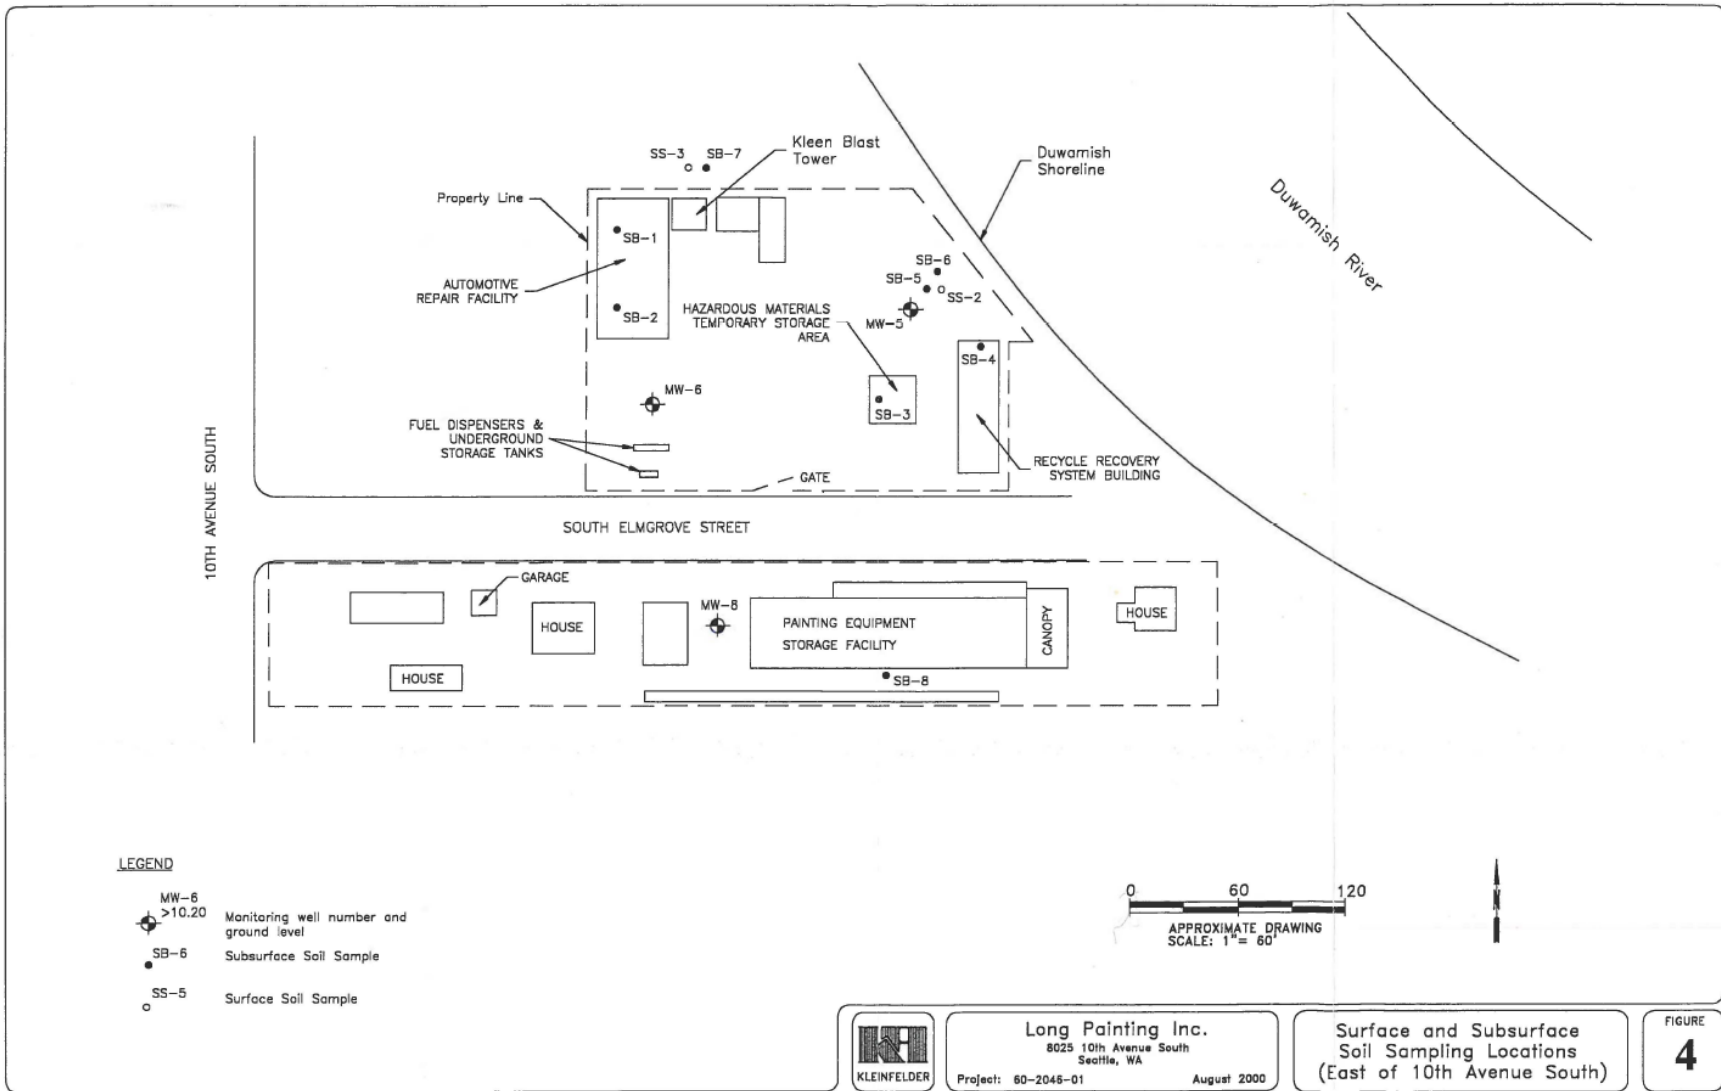
The Long Painting facility, during operations, included the Park Addition property and additional property south and west of the Site (Figure 4). The Long Painting Co 10th Ave cleanup site received a No Further Action letter from Ecology's Voluntary Cleanup Program in February 2003. The cleanup addressed by the letter included two areas of contamination located on the main Long Painting property located west of 10th Ave S and one area within the current Park Addition property. Cleanup on the Park Addition included the excavation of soil contaminated with tetrachloroethene above the applicable Method A cleanup level, located in an area where a solvent still had operated (Figure 5).

Figure 5. Areas of interest on the Park Addition Property when it was part of Long Painting operations. The PCE-contaminated soil removal was located around SB-4. The 1996 diesel spill was located generally northeast of location SB-6. From Kleinfelder (2000) Site Investigation Report.

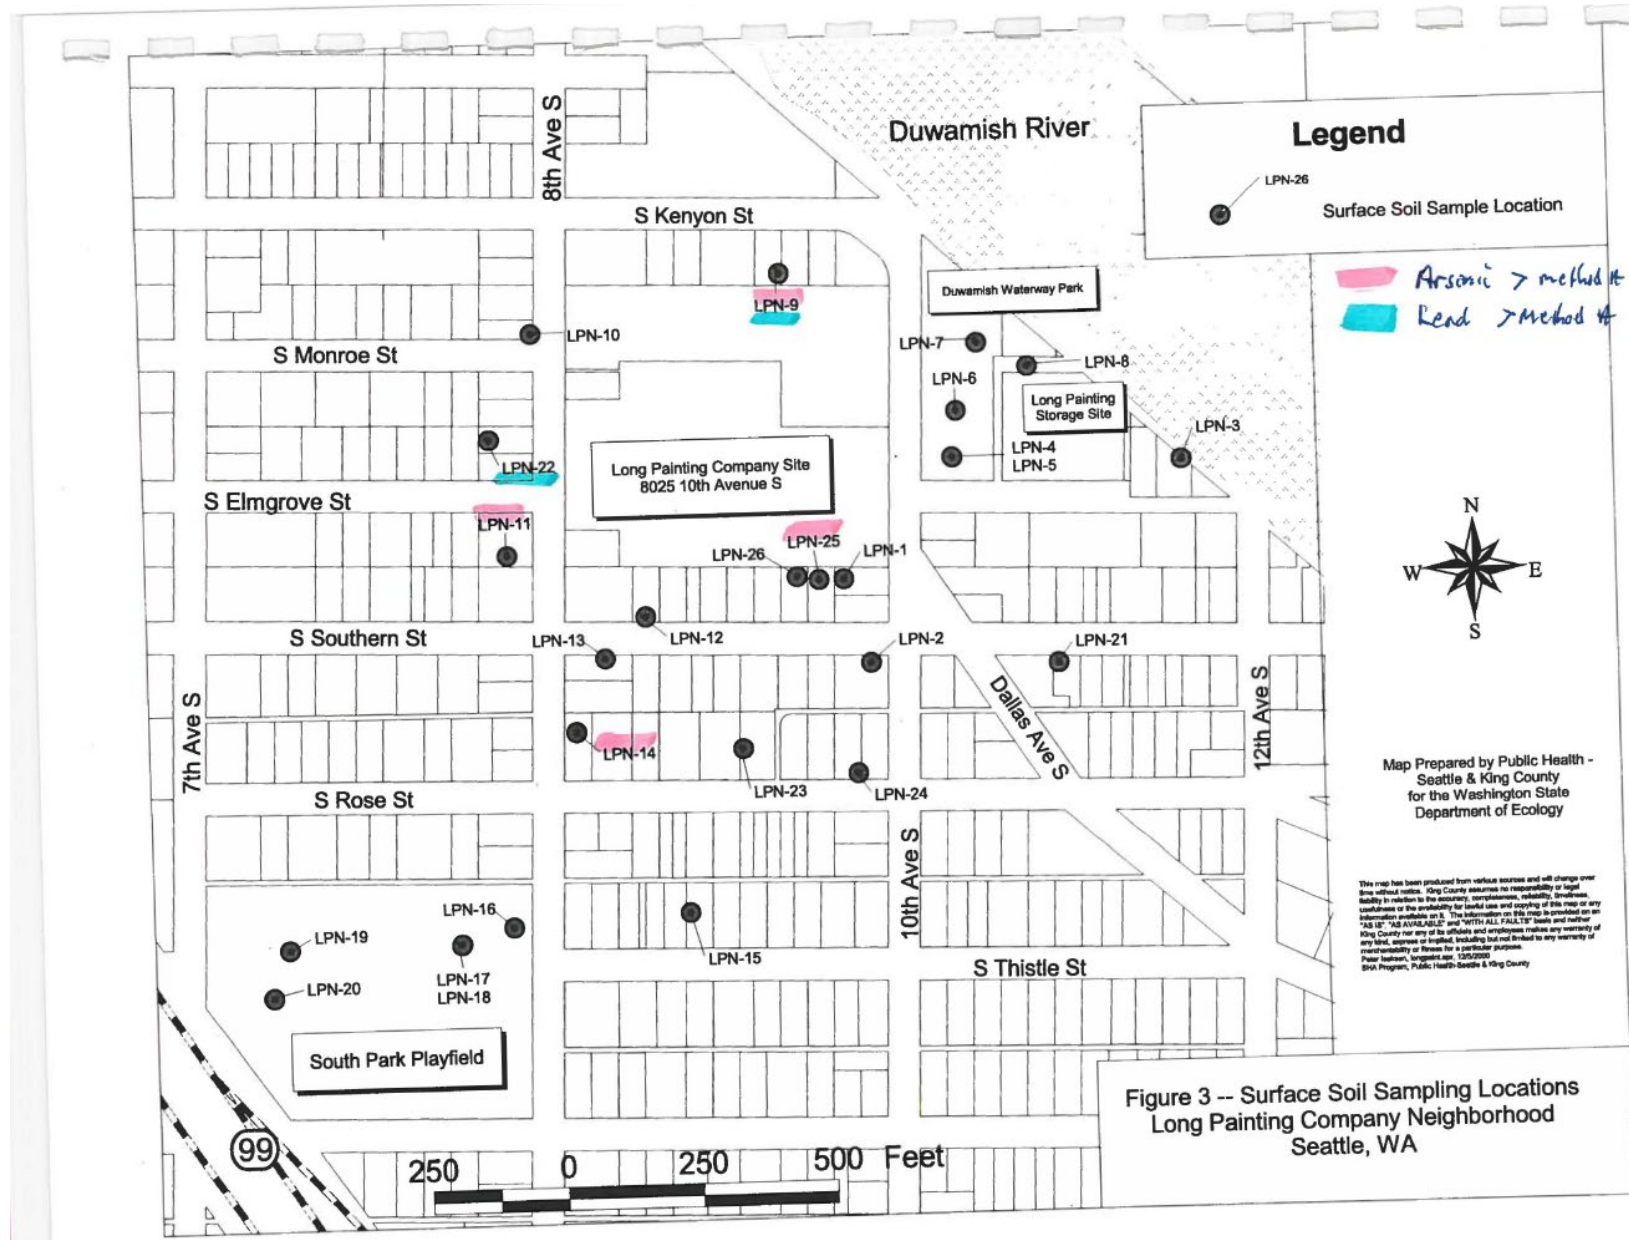
As part of an Initial Investigation for Long Painting, Seattle King County Public Health sampled surface soils (0-2 inches below ground surface (bgs)) from yards and parks in the neighborhood (Figure 6). Duwamish Waterway Park was included in the sampling. No samples were collected on the Park Addition property. Based on reports from community members about particulate matter deposited from the facility and what operations were performed at the Long Painting property, soil samples were analyzed for metals including antimony, arsenic, beryllium, cadmium, chromium (both trivalent and hexavalent), copper, lead, mercury, nickel, selenium, thallium, and zinc. Ecology presented the results of sampling in the 2000 Initial Investigation report. Lead and arsenic were present above the Method A cleanup level in some of the samples collected as part of the investigation, but not in any of the samples collected in the Park. (Method A cleanup levels have changed for some chemicals since 2000; the values for lead and arsenic were the same at the time of the Initial investigation as they are at the time of the Site Hazard Assessment.) Washington Department of Health further evaluated the results and the potential health risk for neighborhood residents in a 2001 Health Consultation report. Their conclusion was that there was no apparent public health hazard from the observed concentrations of arsenic and lead in soil.

Figure 6. Locations sampled for metals in soil as part of the Seattle-King County Public Health and Ecology investigation. Samples with arsenic or lead above the Method A cleanup level are highlighted. From Ecology (2000) Initial Investigation Report.

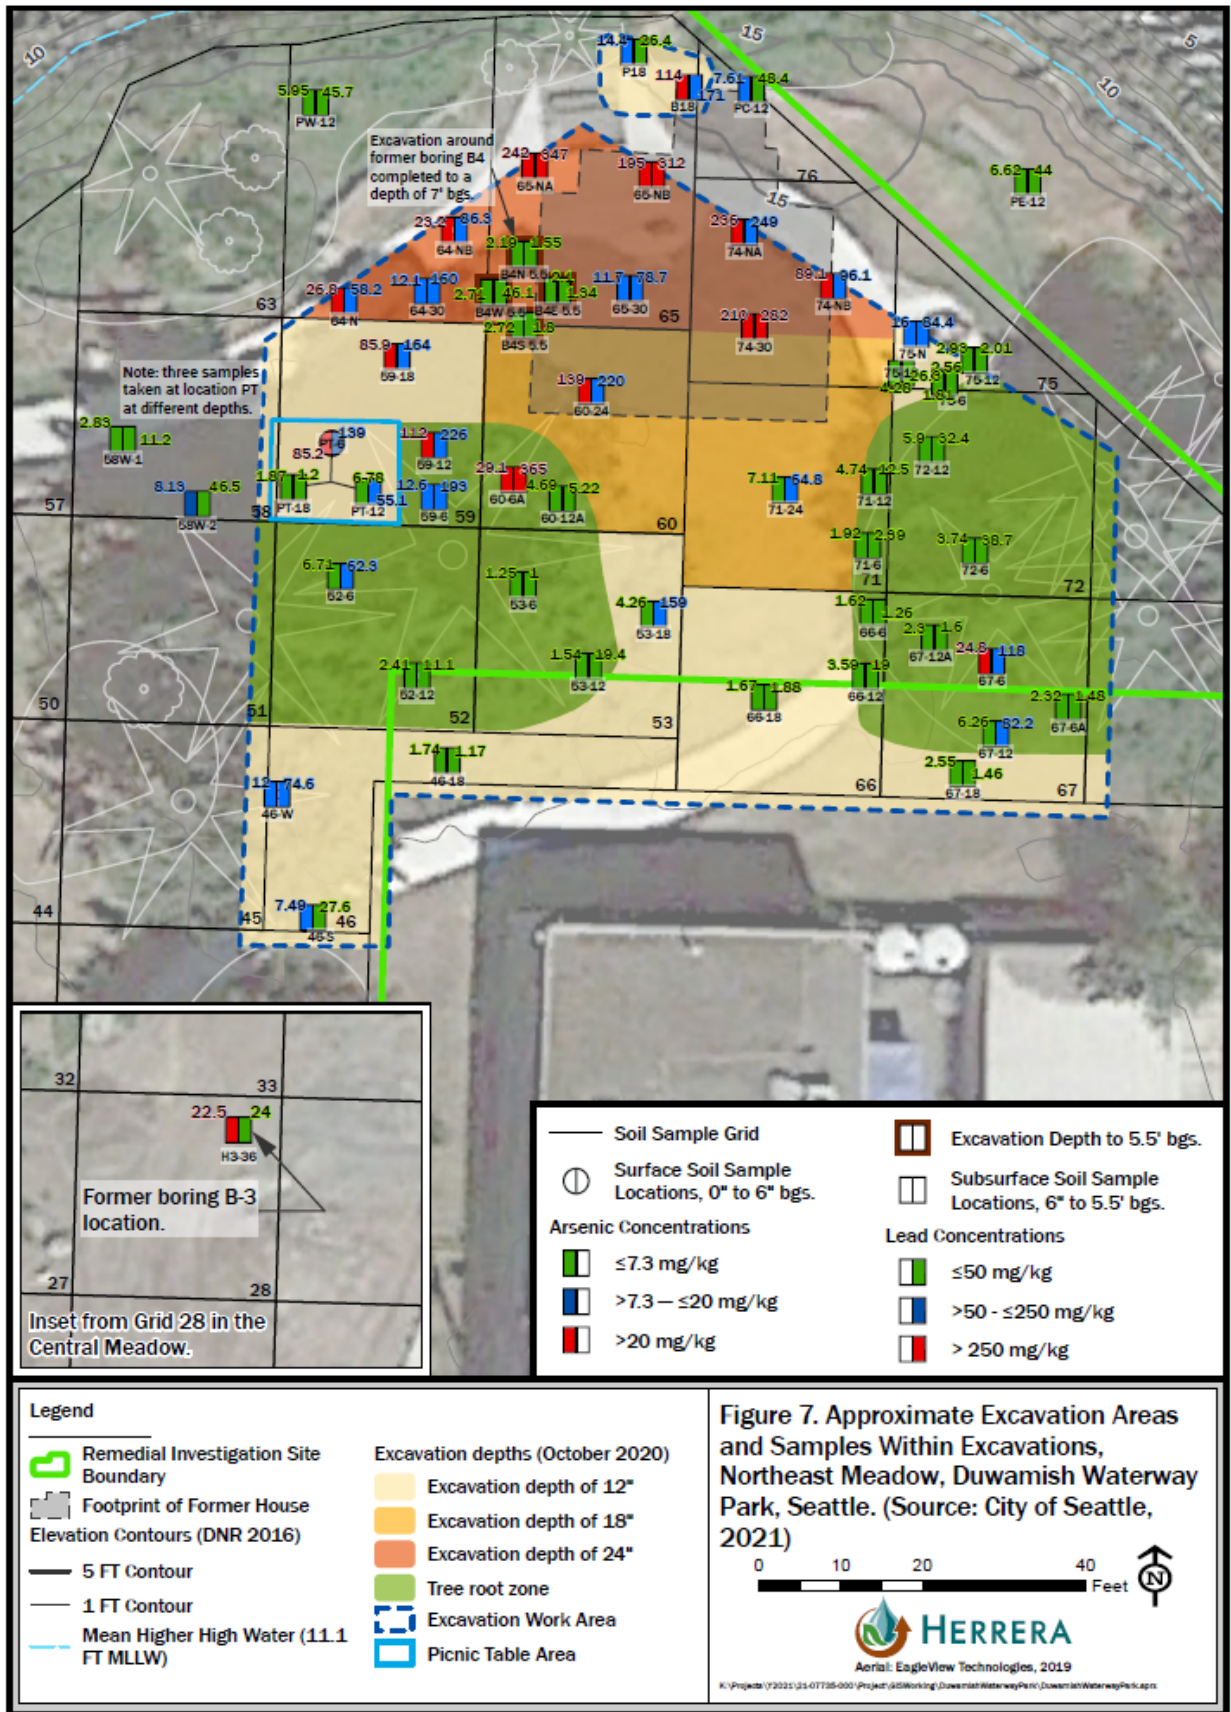
Contaminated soil was excavated and removed from the Site beginning in October 2020. Soil removal extended from between 1 and 7 feet below ground surface. The excavation area was mostly in the Northwest Meadow area of the Park (Figure 11). Excavation in areas with tree root zones was done using an air knife to help loosen and remove contaminated soil from around existing roots. Confirmation samples were collected from all areas of the grid where excavation had occurred prior to filling the excavation areas with clean imported fill soil. Soil conditions in subsurface soils in the Northwest Meadow following soil excavations are shown on Figure 12.

Figure 11. Locations of soil removal in 2020-2021. The area shown on the figure is located in the Northwest Meadow area of the Park. Areas of different colors indicate different excavation depths. Figure from Herrera (2022) RI/FS Work Plan.

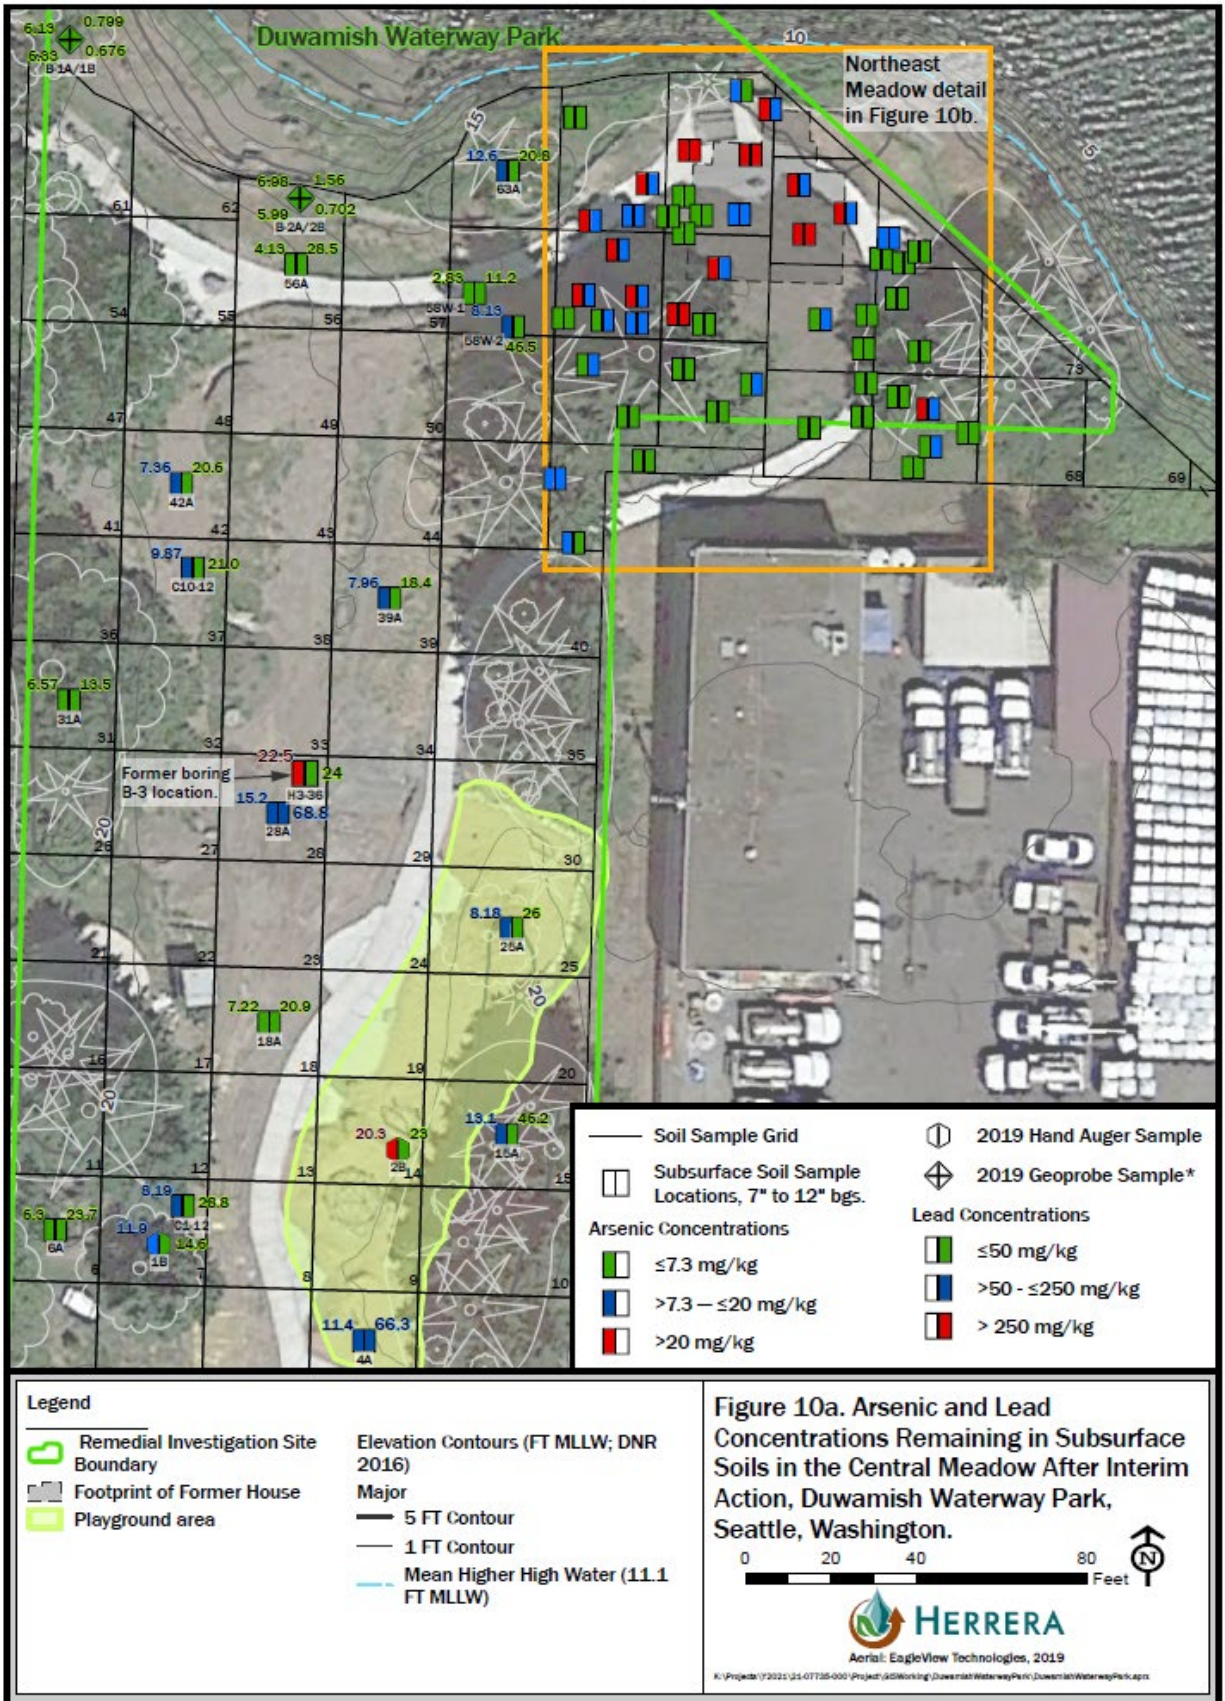
Figure 12. Post-soil removal sampling locations. Soil samples were collected from depths greater than 6 inches bgs. Arsenic and lead concentrations are indicated by the color of the rectangles on the sample locations. Red coloring indicates concentrations above the Method A cleanup level. Figure from Herrera (2022) RI/FS Work Plan.

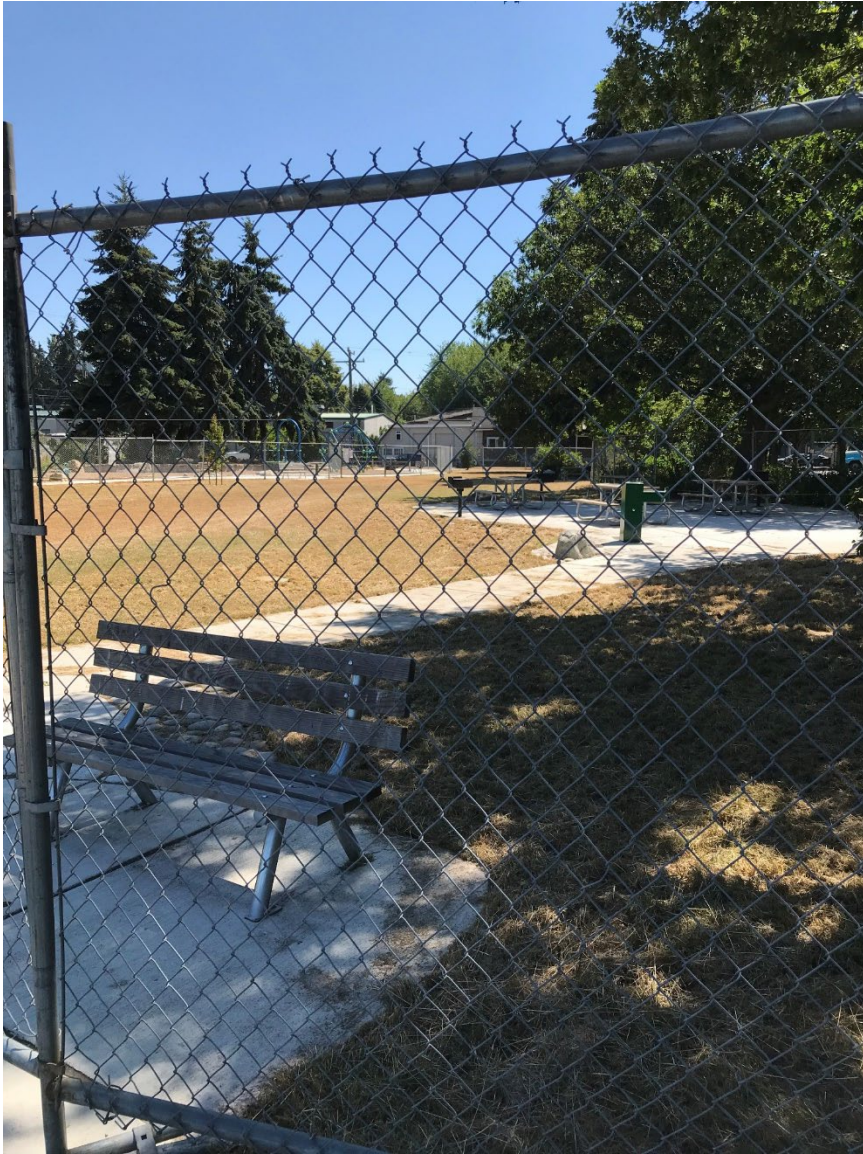
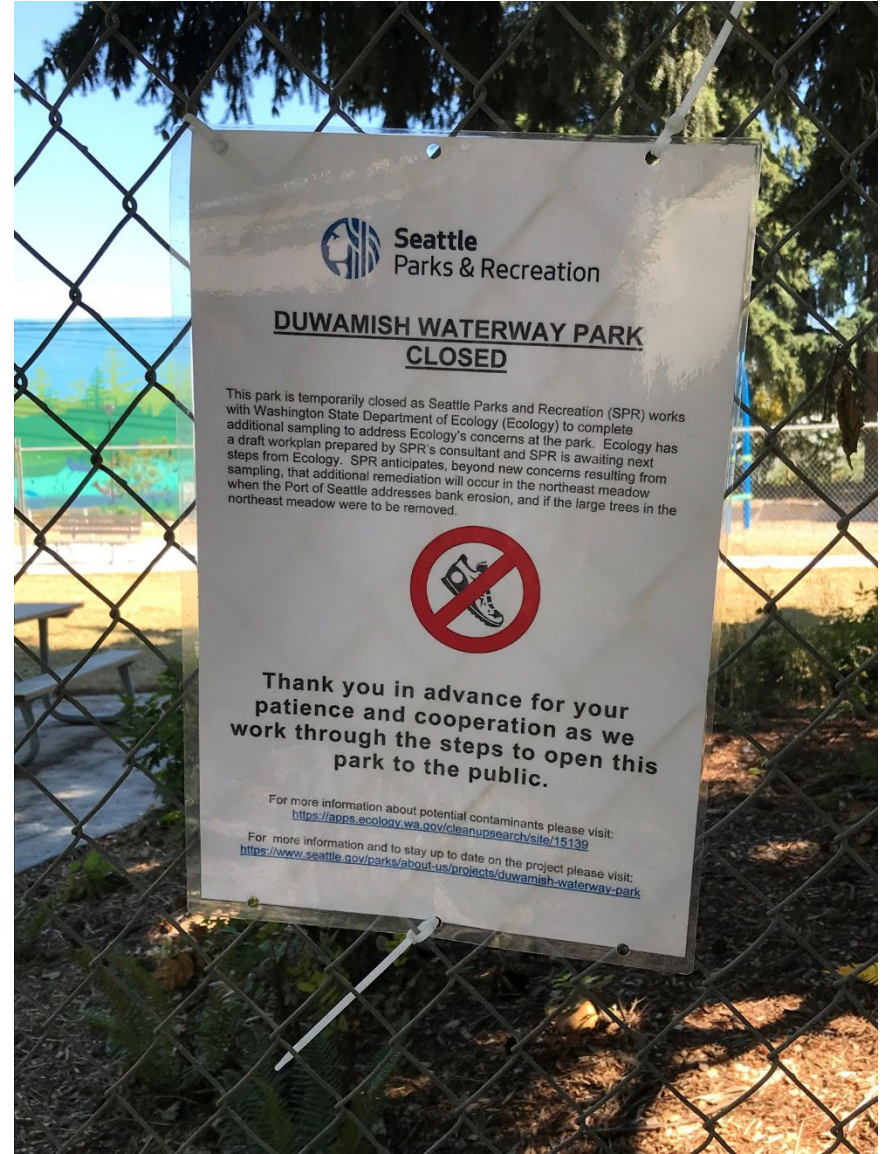
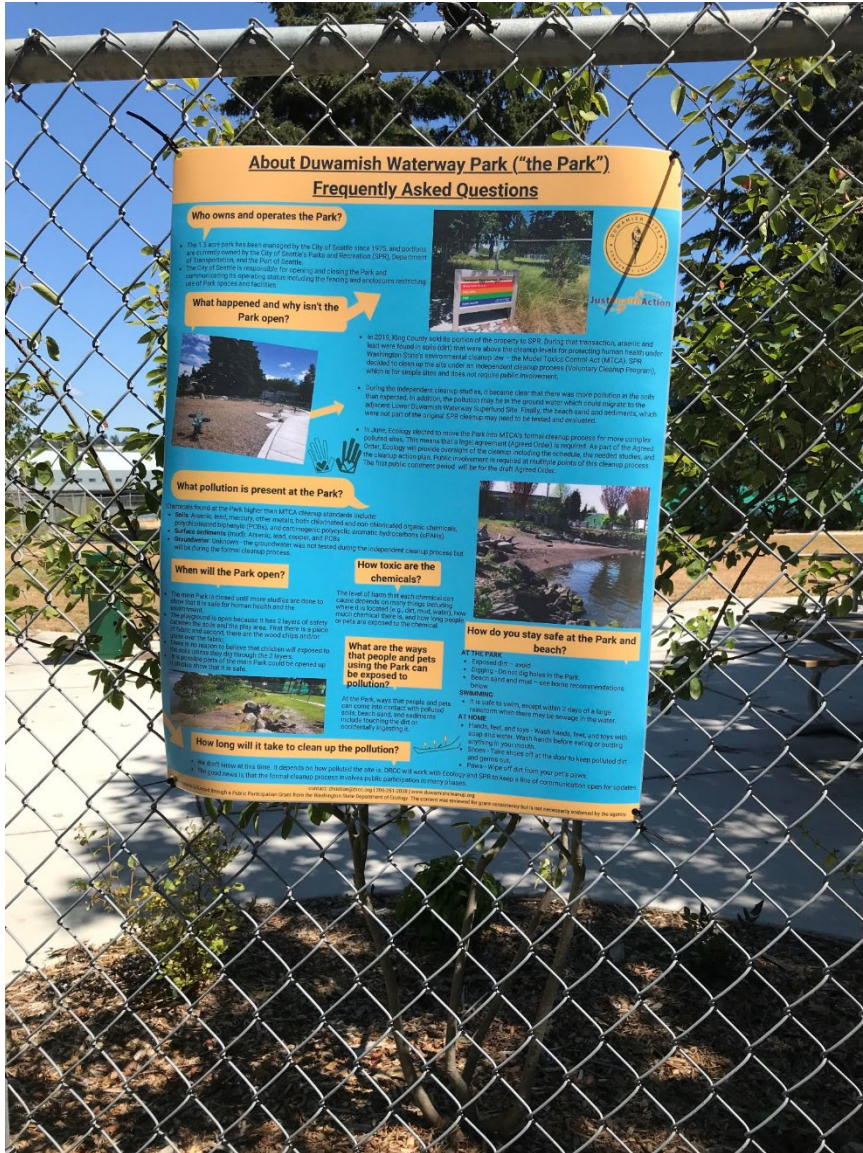
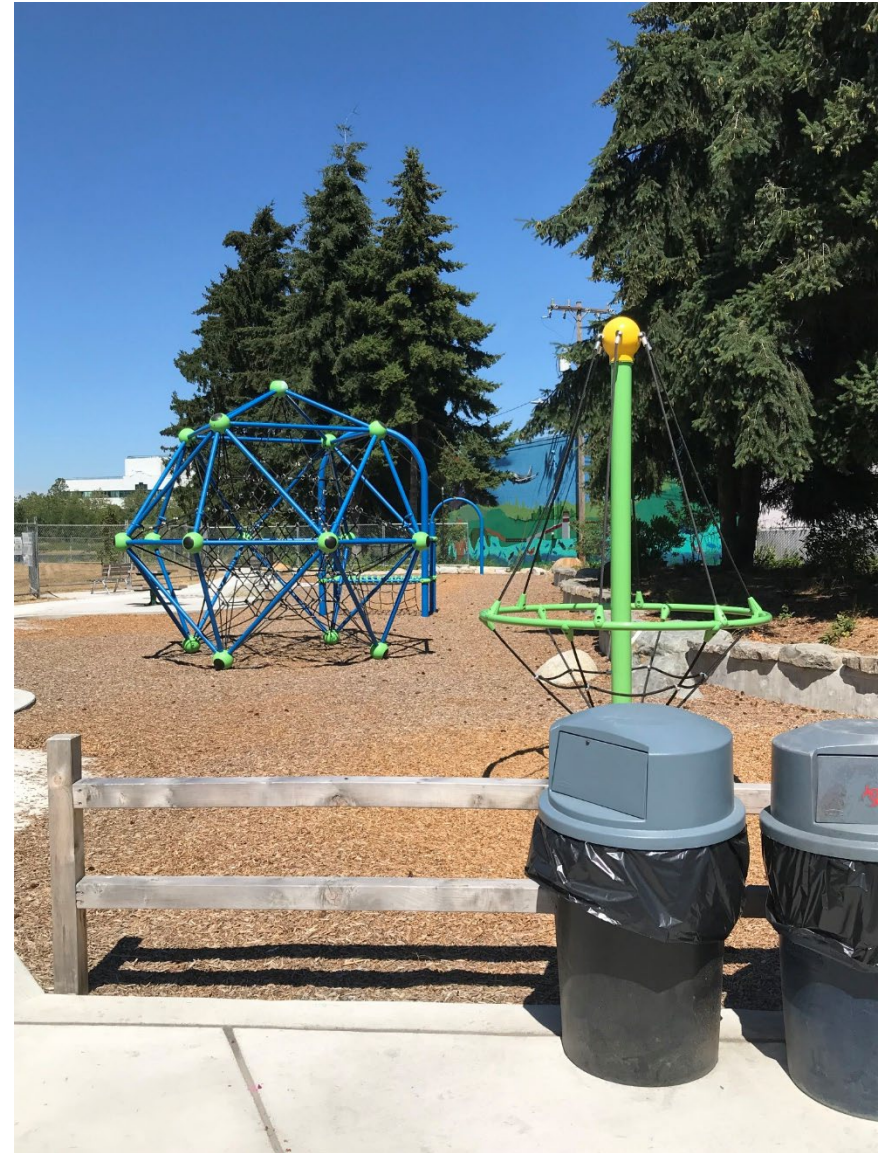
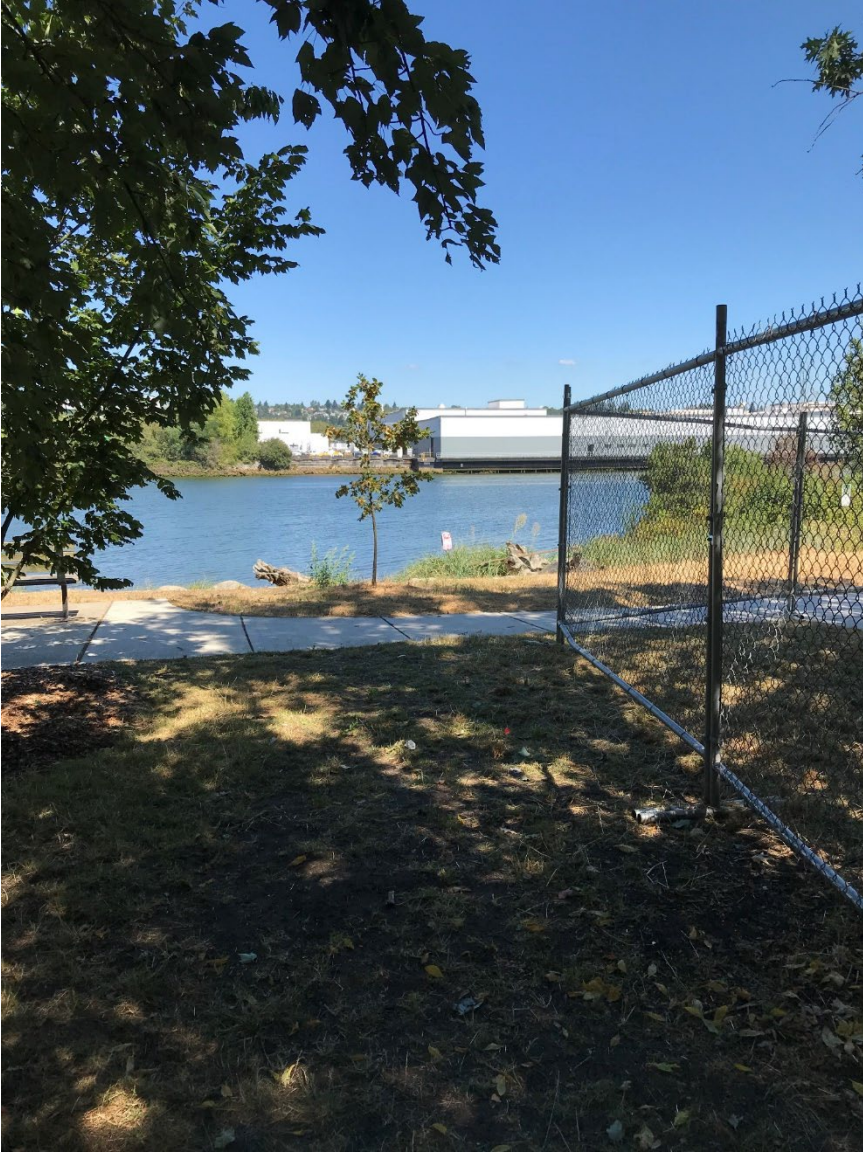
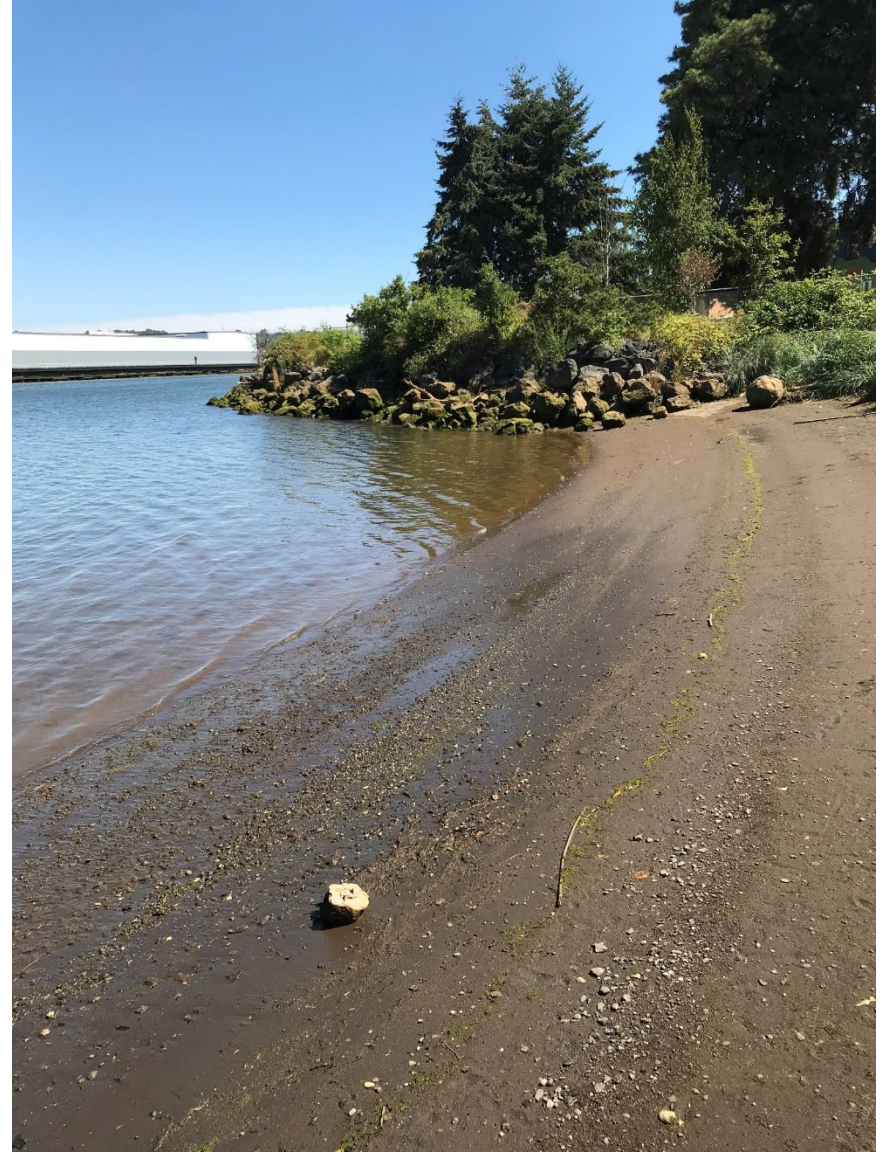
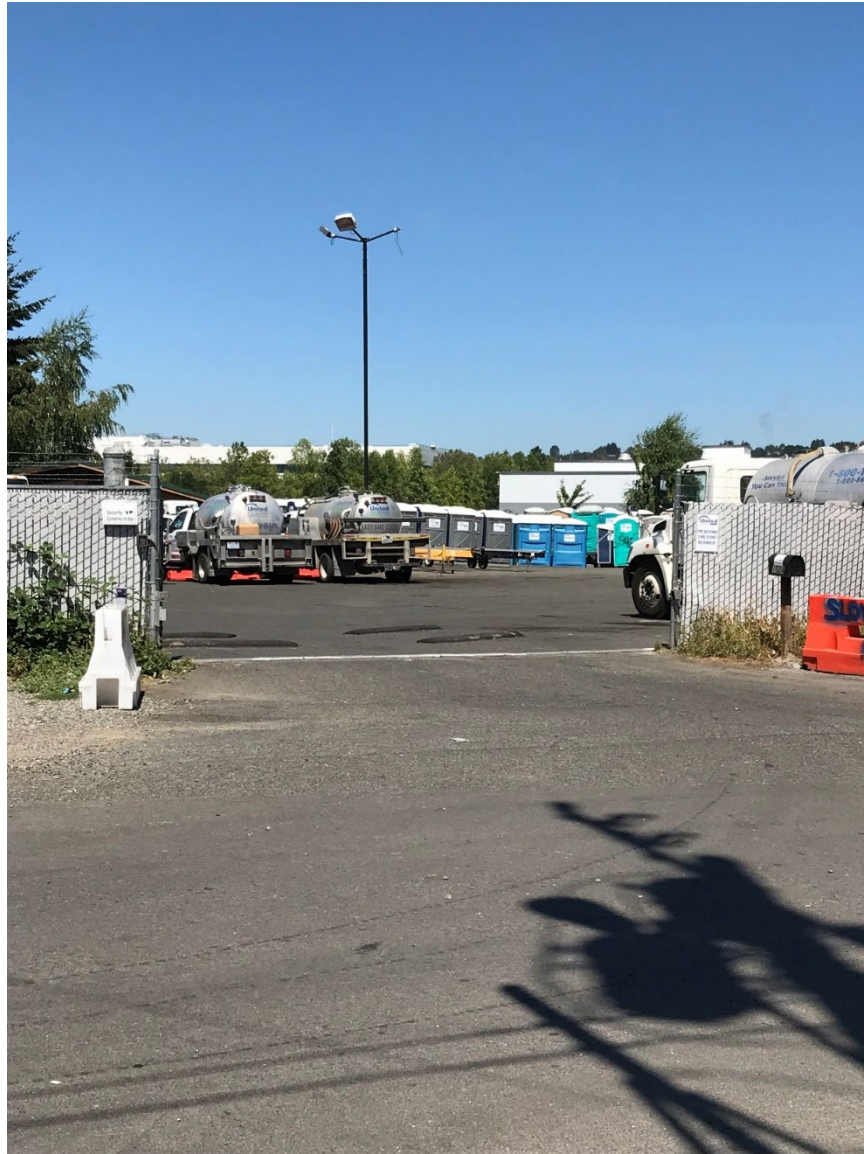
The Assessor visited the Site on the afternoon of August 5, 2022. The main grassy area of the Park was closed to the public until additional cleanup is completed. This area was fenced off, with signs on the fencing explaining the reason for the Park closure in multiple languages. The Beach Area, including the bench closest to the Beach, and the playground area were open to the public. Commercial activities were occurring on the Park Addition property, and the assessor observed trucks coming in to the business. Photos from the visit are included below in Figure 13.

Figure 13 (a through g). Photos taken by Ecology Assessor on 8/5/22 site visit. The main grassy area of the Park was fenced to prevent public access ((a), taken from the north fenceline looking south). Signage was present on the fence to explain the reason for the Park closure ((b, c); photos are of English language versions, but signage in multiple languages was present). The playground area in the southeast portion of the Park was open for public use ((d), taken from S Elmgrove St sidewalk looking north). The Beach Area was also open ((e), taken from northwest corner of fenceline looking toward Beach; (f), taken from western end of Beach looking upriver). United Site Services was operating on the Park Addition property ((g), taken from across S Elmgrove St looking north).
