# STATE OF WASHINGTON DEPARTMENT OF ECOLOGY

• Site Name: Protective Coatings, Inc.

• Site Address: 1215 2<sup>nd</sup> Avenue N, Kent, WA

# Enclosure A Description and Diagrams of the Site

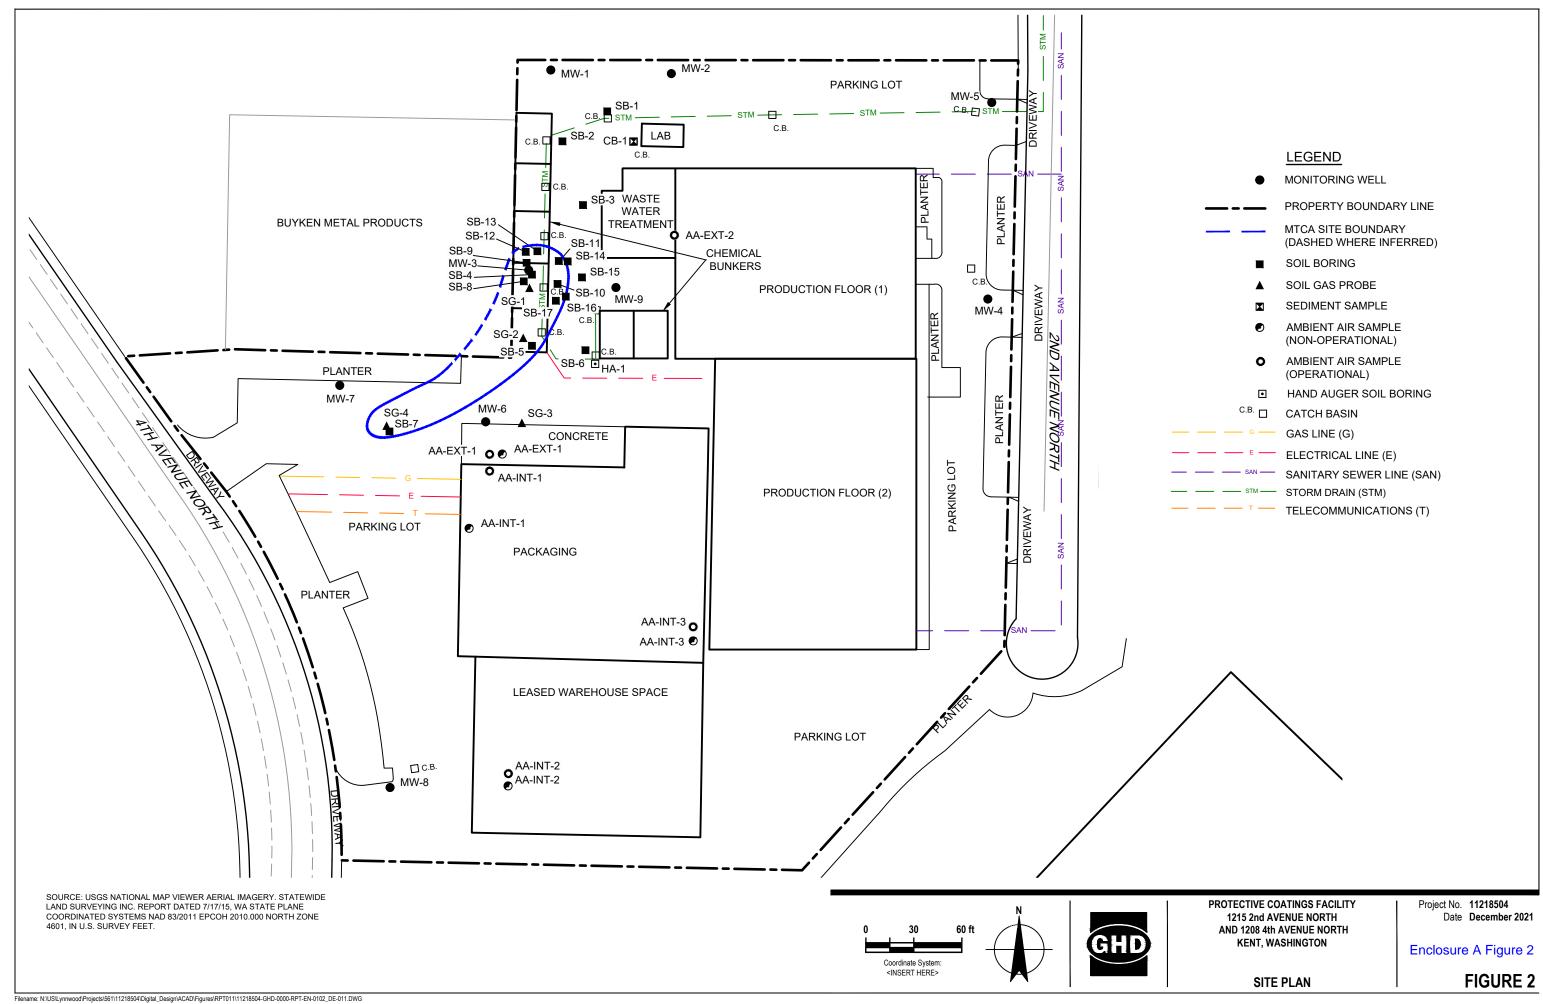
Soil containing cadmium above the MTCA Method A cleanup level for industrial use remains in the vicinity of HA-1, SB-6, and MW-9 from depths of 0.5 to 5 feet bgs (Enclosure A, Figure 2, Figure 3). The extent of cadmium contamination has not been delineated to the north, south, or east of these locations. Based on the concentration of chromium VI in groundwater, discussed below, a release to soil is possible. Soil samples collected from borings HA-1, SB-6, and MW-9 contained concentrations of total chromium above the average of other soil samples collected from the Site. Ecology recommends additional soil investigation in this area to delineate the extent of cadmium and chromium VI concentrations in soil above the Method A cleanup level for industrial use.

<u>Sources of Contamination</u>: Documented chemical wastes generated during painting and plating operations at the Property include halogenated and nonhalogenated solvents, cadmium, chromium, and electroplating bath solutions. The source of TCE contamination detected in soil, groundwater, and ambient air is the result of a release from the chemical storage bunker in the immediate area of MW-3 (**Figure 2**). According to interviews with the

<u>Ground Water</u>: From 2008 to 2018, 10 monitoring wells (MW-1 to MW-10, MW-3R; **Figure 2**, **Figure 4**) were installed on the Property. Monitoring well MW-3 was decommissioned in 2018 during remedial excavation activities since it was within the excavation limits. These monitoring wells were installed with 10-foot screens from 5 to 17 feet bgs. Monitoring well locations are shown on **Figure 2 and Figure 4**.

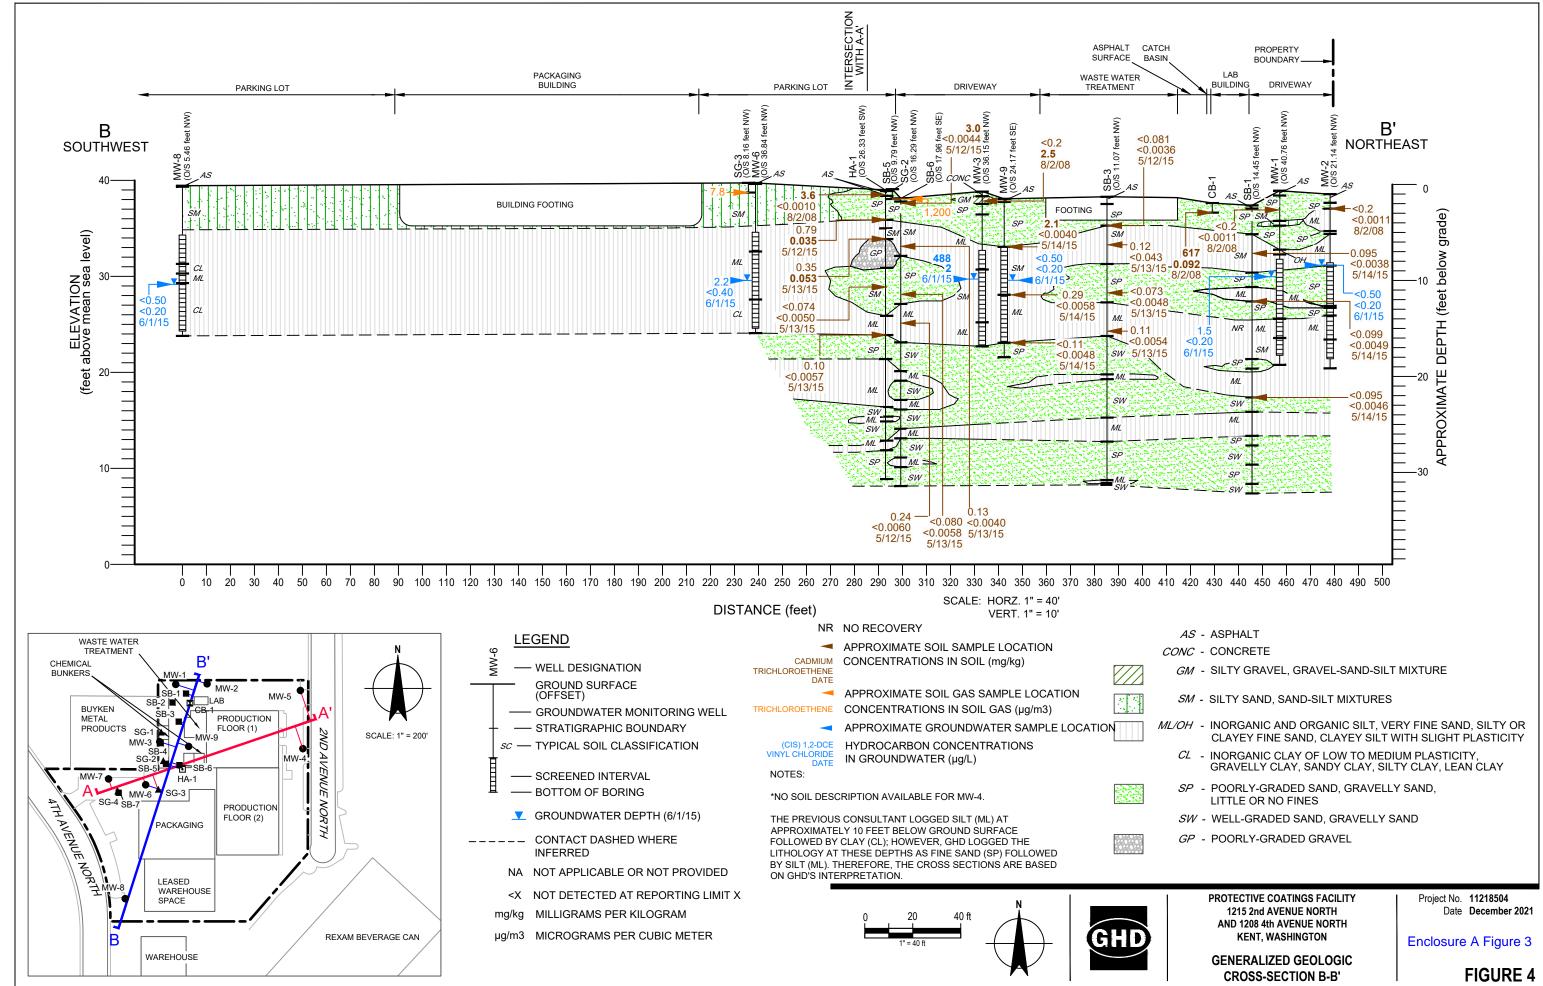
**Geology:** The geologic map of the area<sup>8</sup> indicates that the Site is underlain by quaternary alluvium, an unconsolidated succession of sand, silt, and clay deposited by the Green and White Rivers. The Property is underlain by fill materials to a maximum depth of 8 feet below ground surface (bgs). Fill materials are underlain by dense sands and silts to the maximum explored depth of 30 feet bgs. Silts and sands occur in apparently discontinuous layers from 6 inches to 10 feet in thickness, interpreted to be quaternary alluvium (**Figure 3**).

Please include updated cross sections showing the extent of remedial excavation and confirmation sample locations.

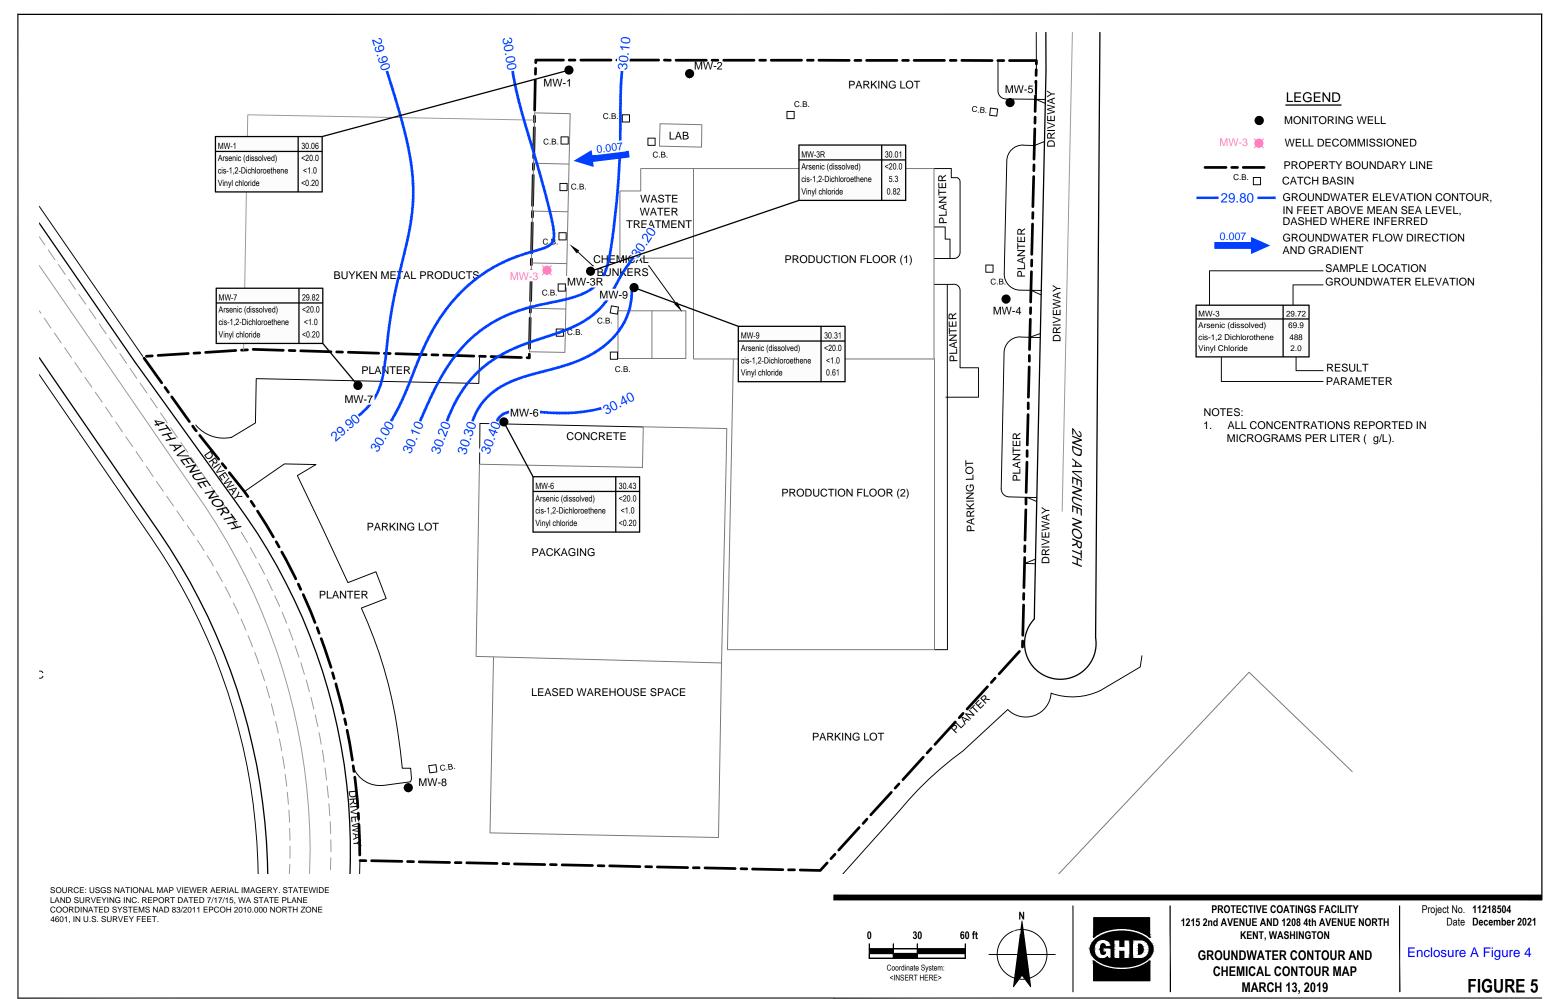
Shallow groundwater is present at the Site at depths ranging from approximately 6.5 to 10 feet bgs (33.5 to 30 feet amsl). Groundwater flow is oriented roughly to the west with an average hydraulic gradient of 0.004 feet per foot (**Figure 4**).

- Please include a Rose diagram along with future potentiometric surface diagrams to show historical magnitudes and directions of groundwater flow at the Site.

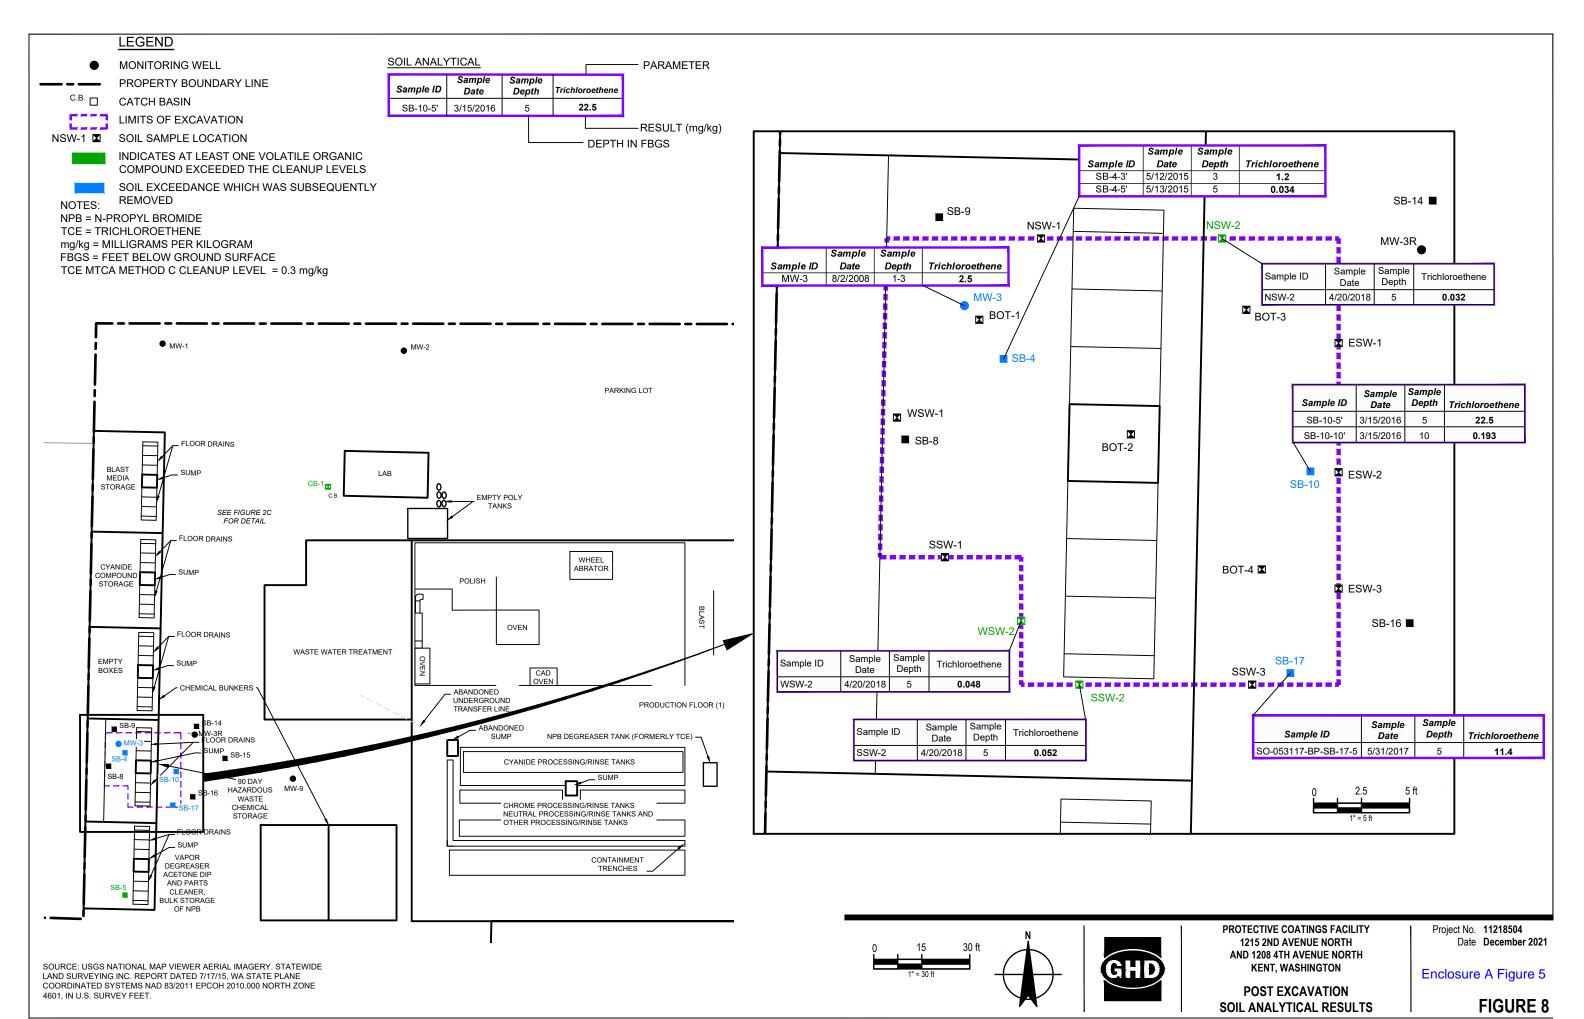
Soil containing TCE above the MTCA Method C cleanup level remains at 5 feet bgs in the northeast and southwest walls of the remedial excavation and at 3 to 5 feet bgs in SB-5 (Enclosure A, Figure 5). The extent of contaminated soil has been defined vertically and laterally to the north, south, and east. The extent of contaminated soil to the southwest of the remedial excavation beneath the west-adjacent building has not been defined. As discussed in section 1 below, Ecology recommends installing an additional monitoring well west of the chemical storage bunker in the west-adjacent Property. Soil samples collected from this boring will help constrain the western extent of contaminated soil at the Site.
