## **Periodic Review**

WA Parks North Head Lighthouse  
Fort Canby State Park  
Ilwaco, WA 98624

Facility Site ID#: 5040  
Cleanup Site ID#: 11743

July 2022

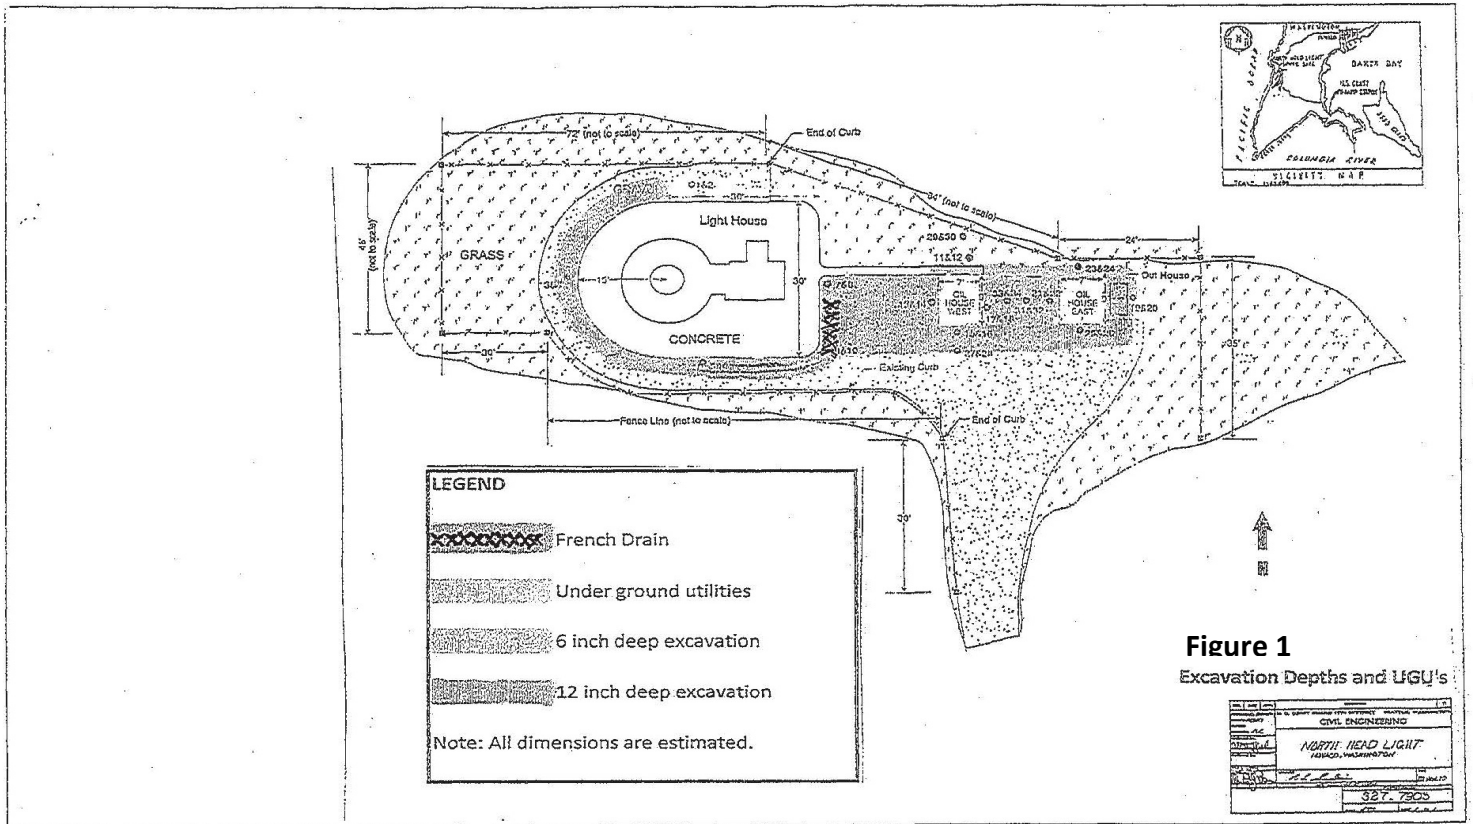
### 6.1 6.1 Site Plan

The lead in soil was characterized before and after excavation in 2012 via x-ray fluorescence (XRF) field screening and laboratory analysis. The extent of lead contamination was delineated around the lighthouse and two small oil houses located east of the lighthouse. The area of contamination is shown in Figure 1 in Section 6.1.

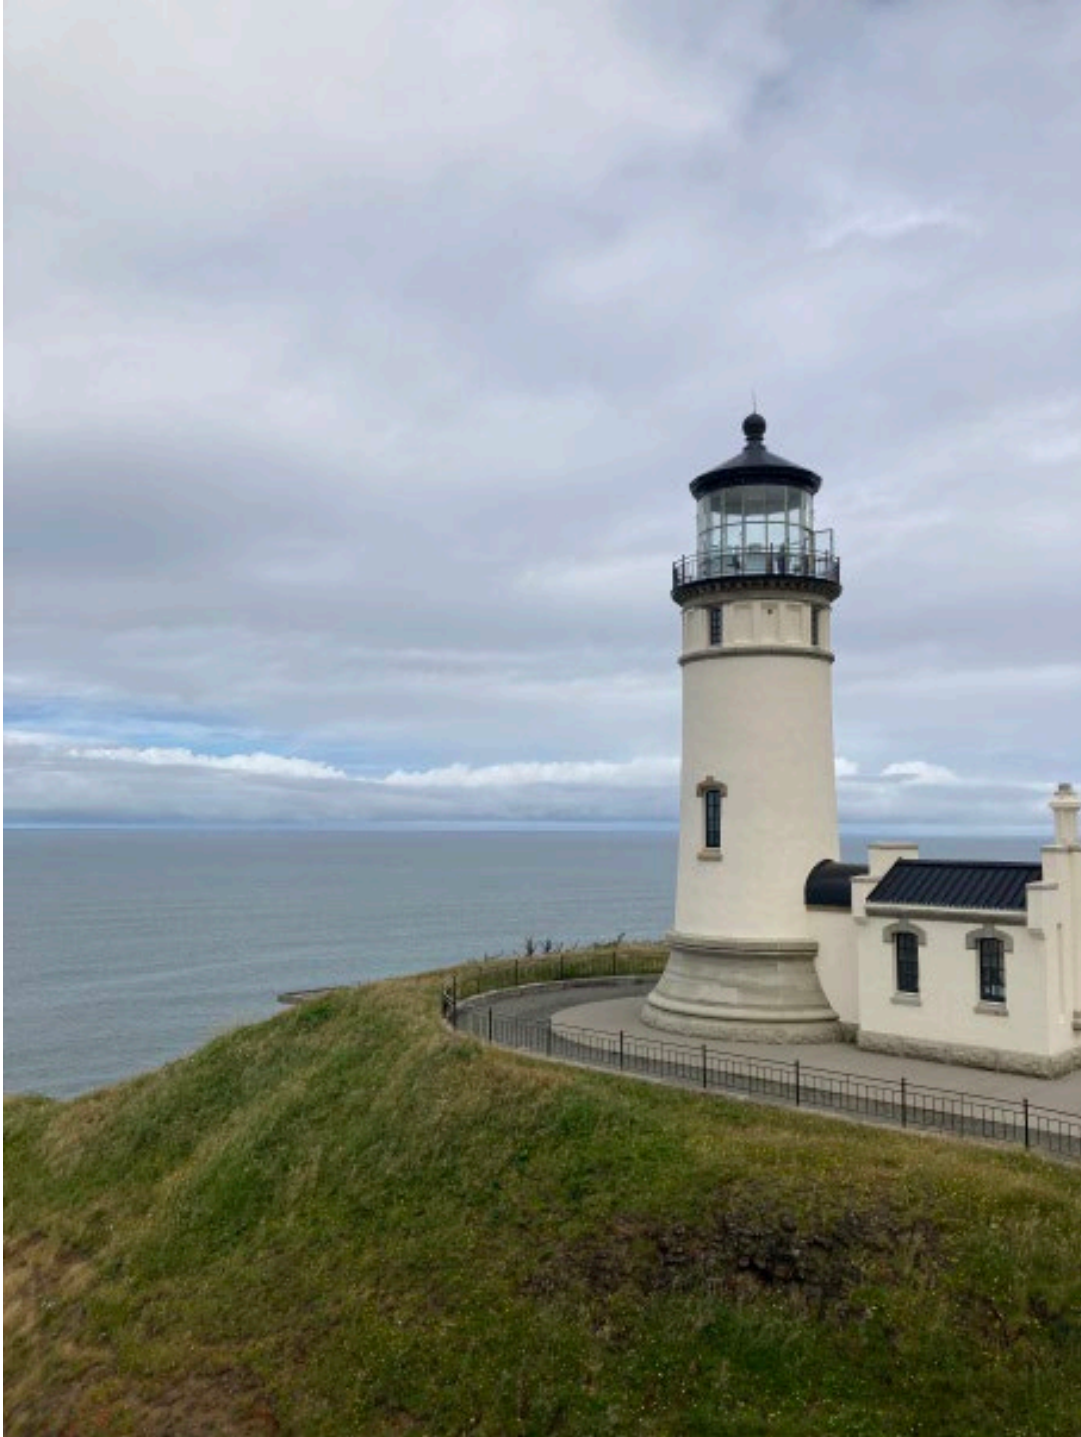
Photo 1: View of the Lighthouse from the Southeast (view to the northwest)

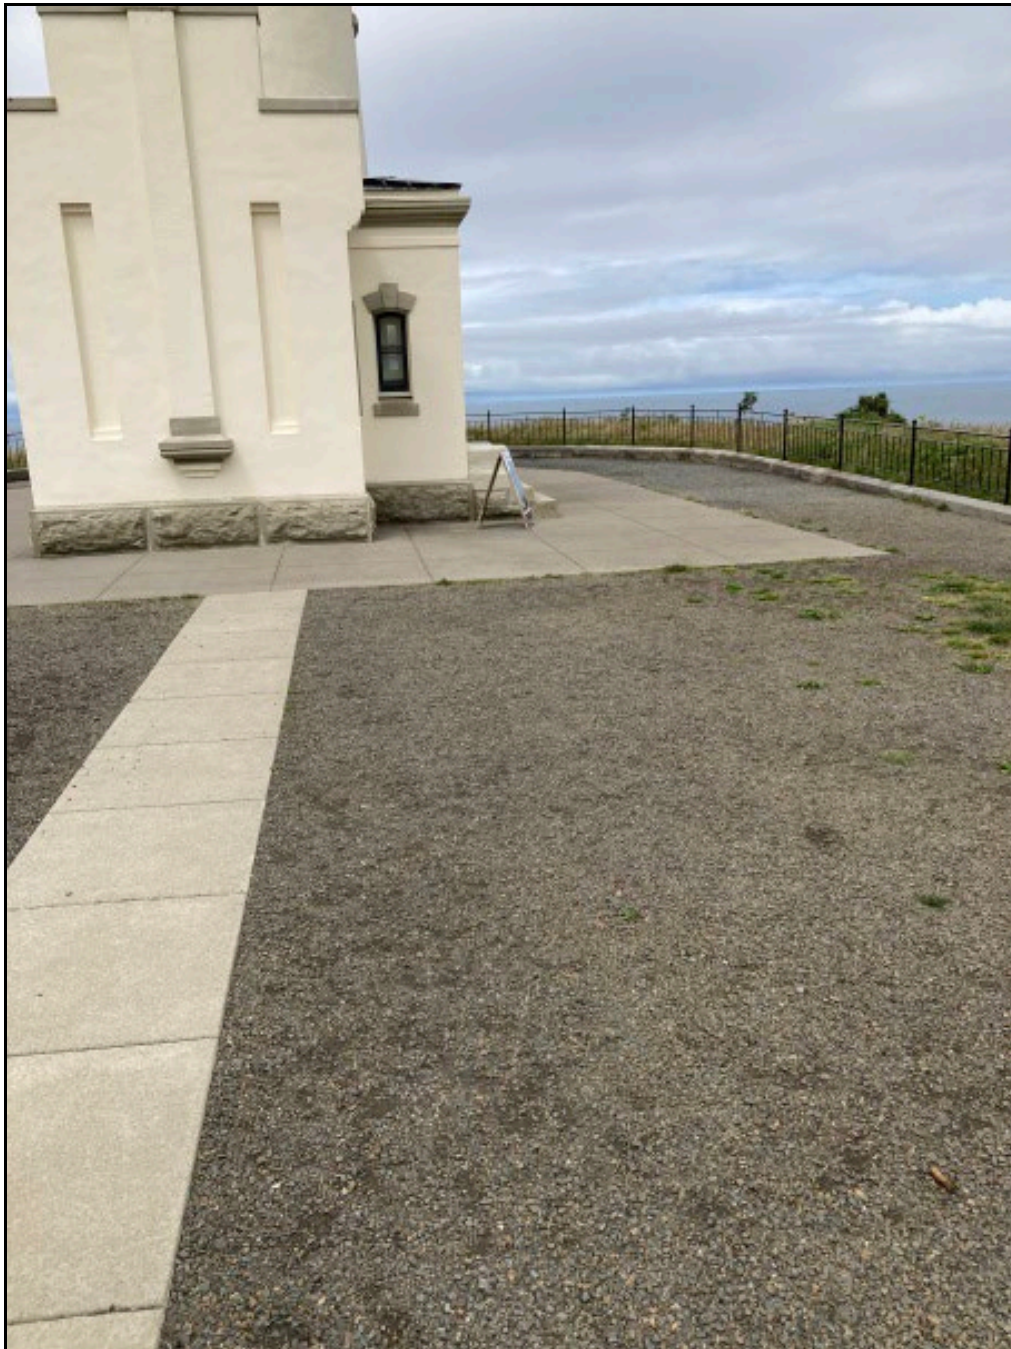
Evans Roberts verified that the area of interest has a gravel surface that is periodically supplemented/maintained to keep it as a smooth and dry walking surface. The photographs provided by Evan Roberts are in Appendix 6.2. Based upon the inspection conducted on July 7, 2022, the institutional controls for soil at the Site continue to prevent exposure to contaminated soil by ingestion and direct contact. Ecology recommends that the gravel surface in the area of interest be regularly inspected and maintained as needed.

Photo 2: Gravel area to the East of the Lighthouse (view to the west)

The institutional controls implemented for soil at the Site continue to prevent exposure to lead contaminated soil by ingestion and direct contact. However, based on the above observations made during a Site inspection and photographs, Ecology recommends that the gravel surface in the area of interest be regularly inspected and maintained as needed.

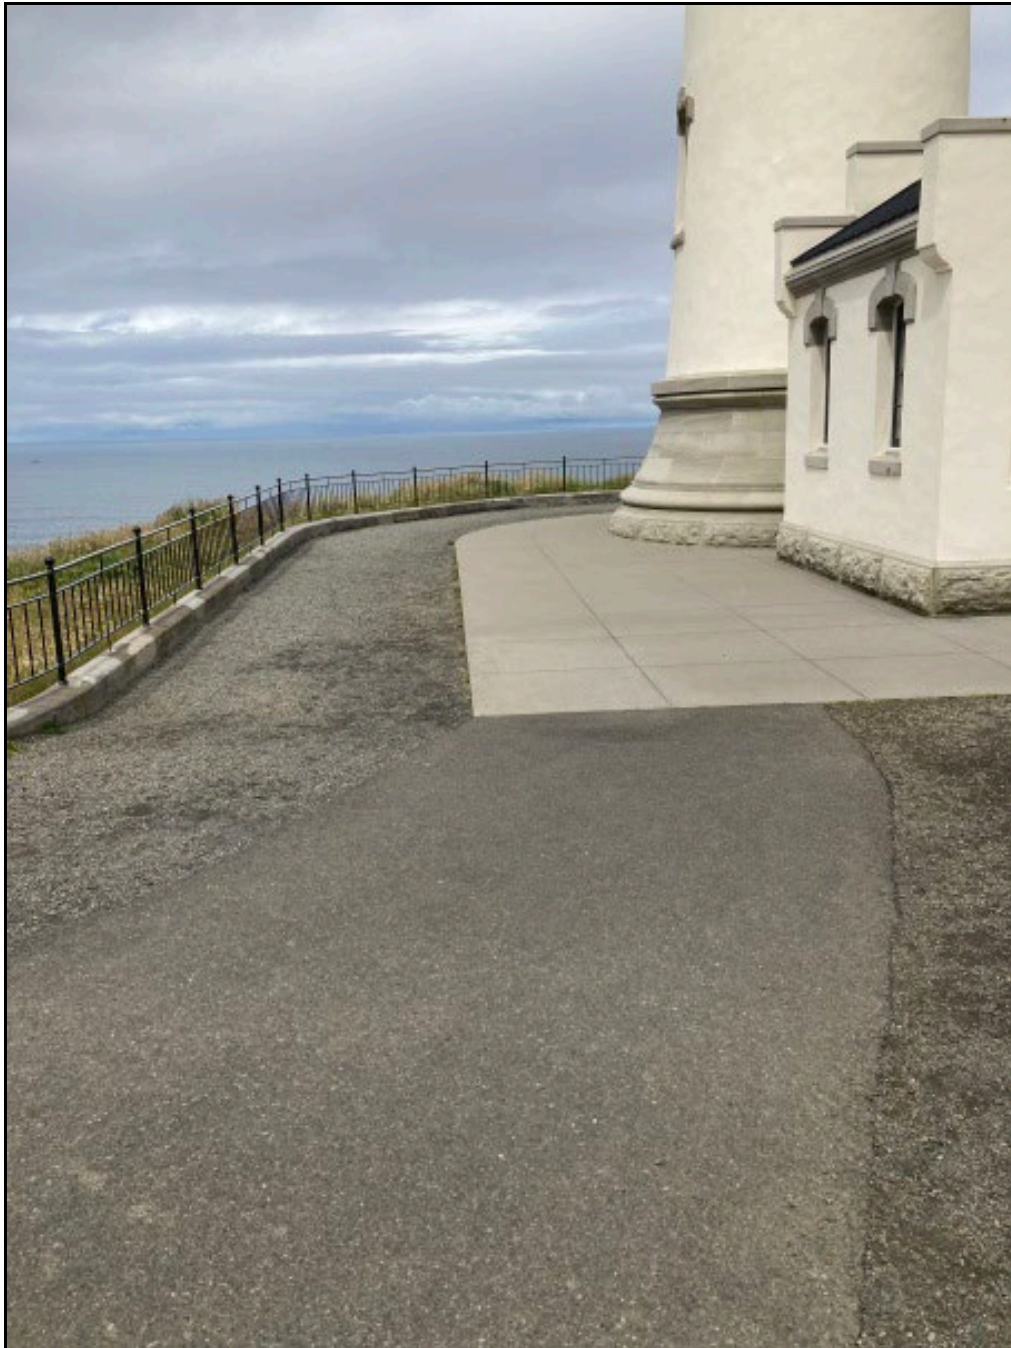
Photo 3: Paved Path and Gravel to the East of the Lighthouse (view to the west)

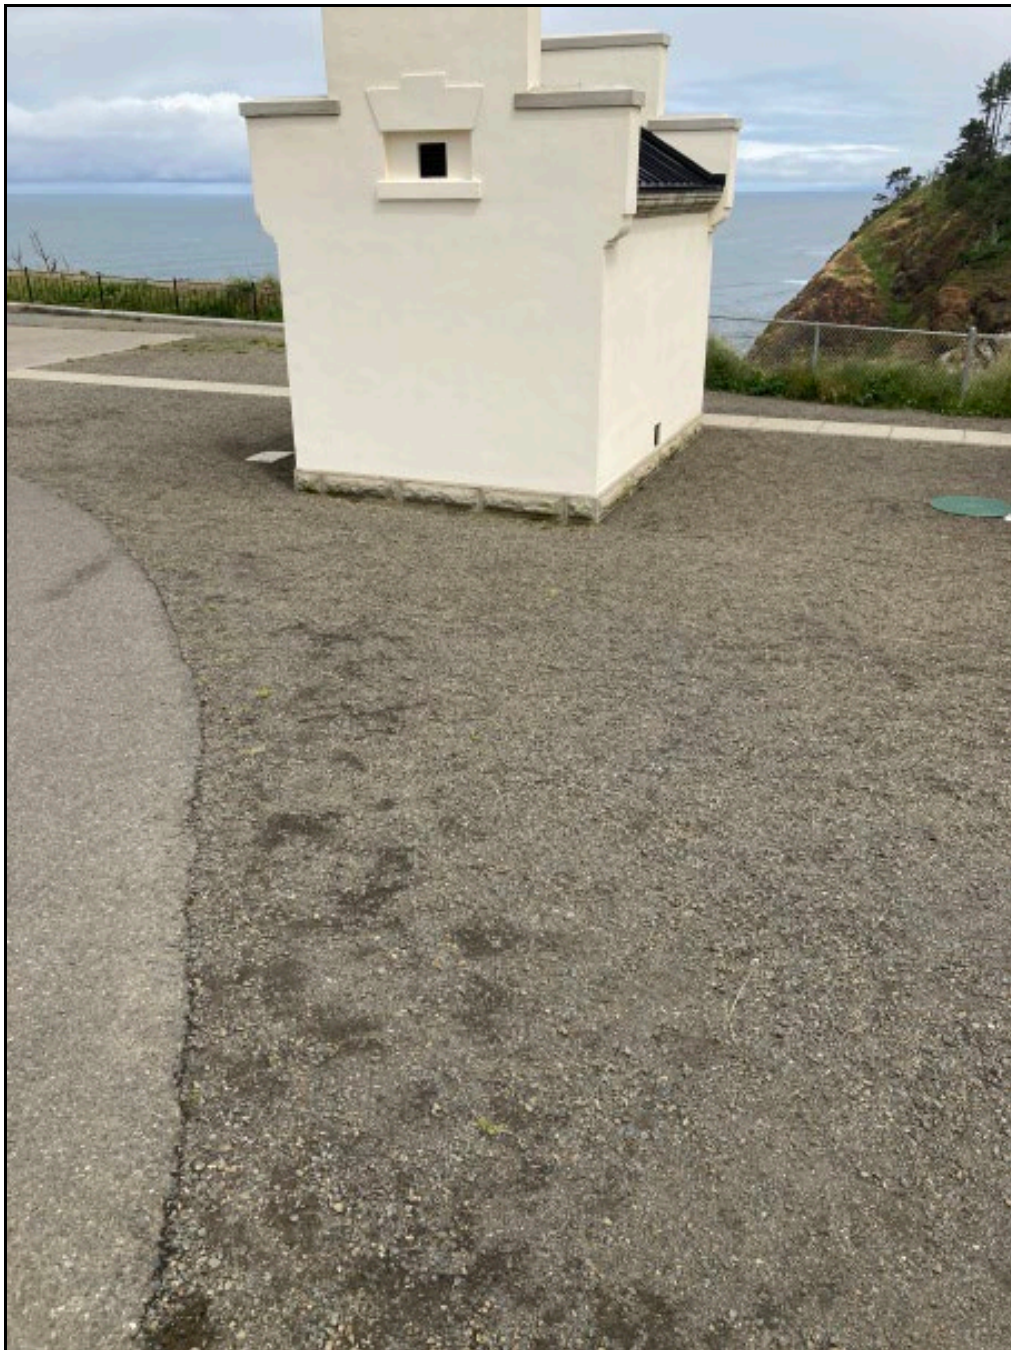
Photo 4: Gravel Surface East of the Lighthouse (view to the north)

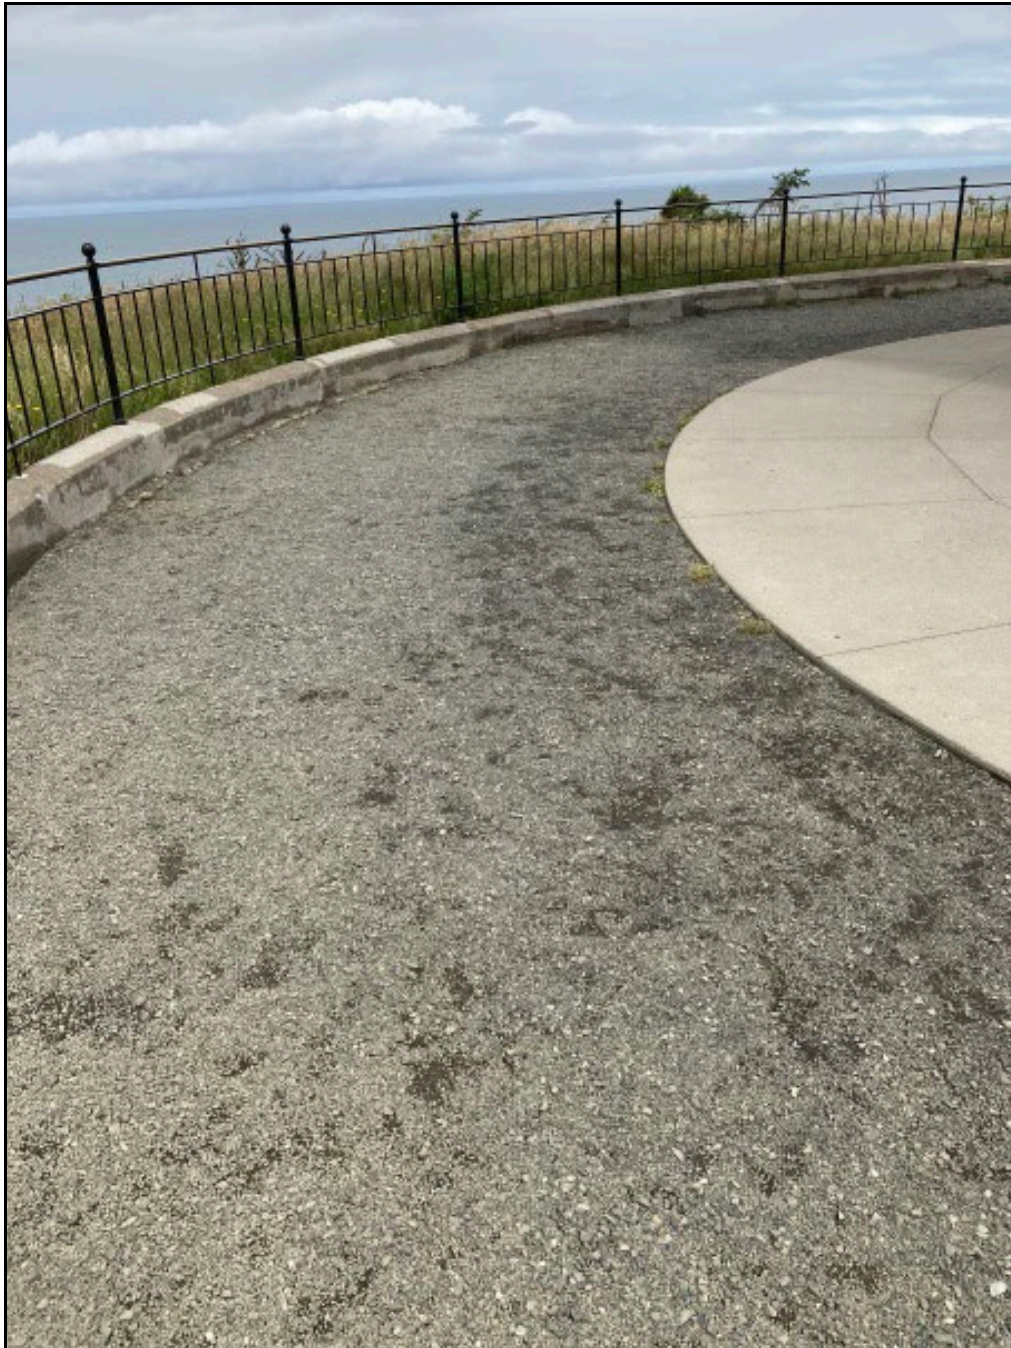
Photo 5: Gravel Surface West of the Lighthouse (view to the west)
