REMEDIAL INVESTIGATION REPORT

Site Name: **Lake Chelan Community Hospital -
New Construction**

Prepared By:
Dave Schettler, P.E.
Construction Special Inspections
1250 N Wenatchee Ave Suite H135
Wenatchee, WA 98801

Date: **Pre-Final Draft 11/22/2022**

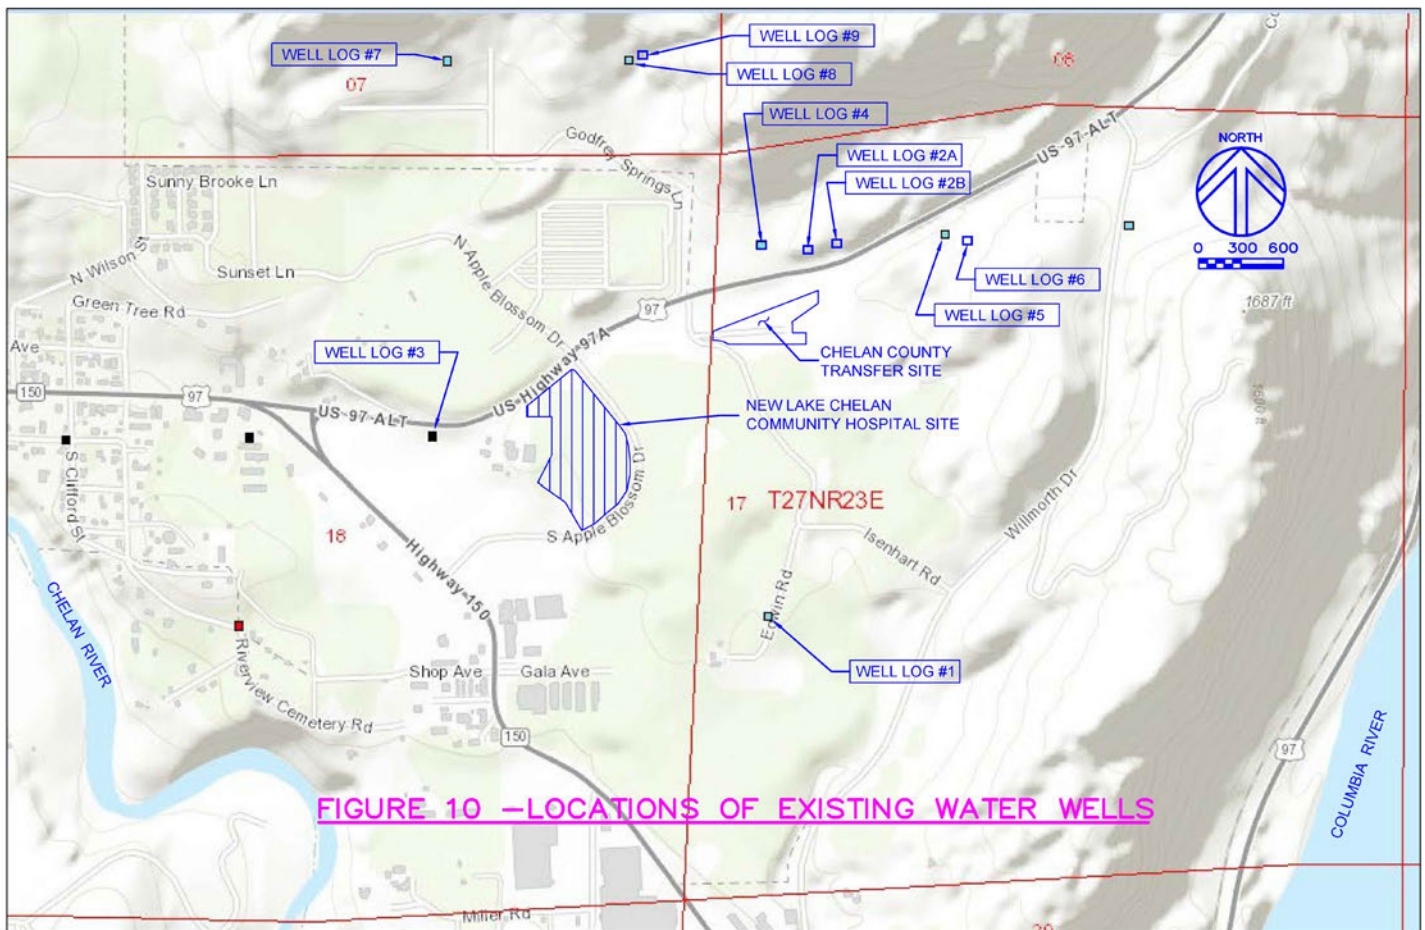
FIGURE 10 –LOCATIONS OF EXISTING WATER WELLS

Although static water levels for these wells are shallower and range 41 ft to 220 ft, it is not a indicator of geologic water strata but the piezometric height of water in the well that can be from higher ground that the aquifer connects to from the well. Thus,

it can be concluded from this well study that depths to water in the geologic strata around the new Lake Chelan Community Hospital site are deeper and not less than approximately 100 feet.

Groundwater in this area flows towards the Chelan River on the east side of the City of Chelan which is a little over a 1/2 mile away at its closest point. The only water well that is downhill and hydraulically down gradient from the study site is directly west about 970 feet away and has its depth to groundwater about 600 feet deep with its static water level of 105 ft. With this well location having its ground elevation = 1238 ft, then the static water depth of 105 ft below = 1133 ft elevation. Comparing this well's static water elevation to the grade elevations of the new Lake Chelan Community Hospital site grade elevations that range from about 1277 feet to 1284 feet. Then, using 1277 feet grade and subtracting it from the static water elevation in the well of 1133 feet the approximate elevation of aquifer water below the site (if connected hydraulically) would be about **144 feet deep**.

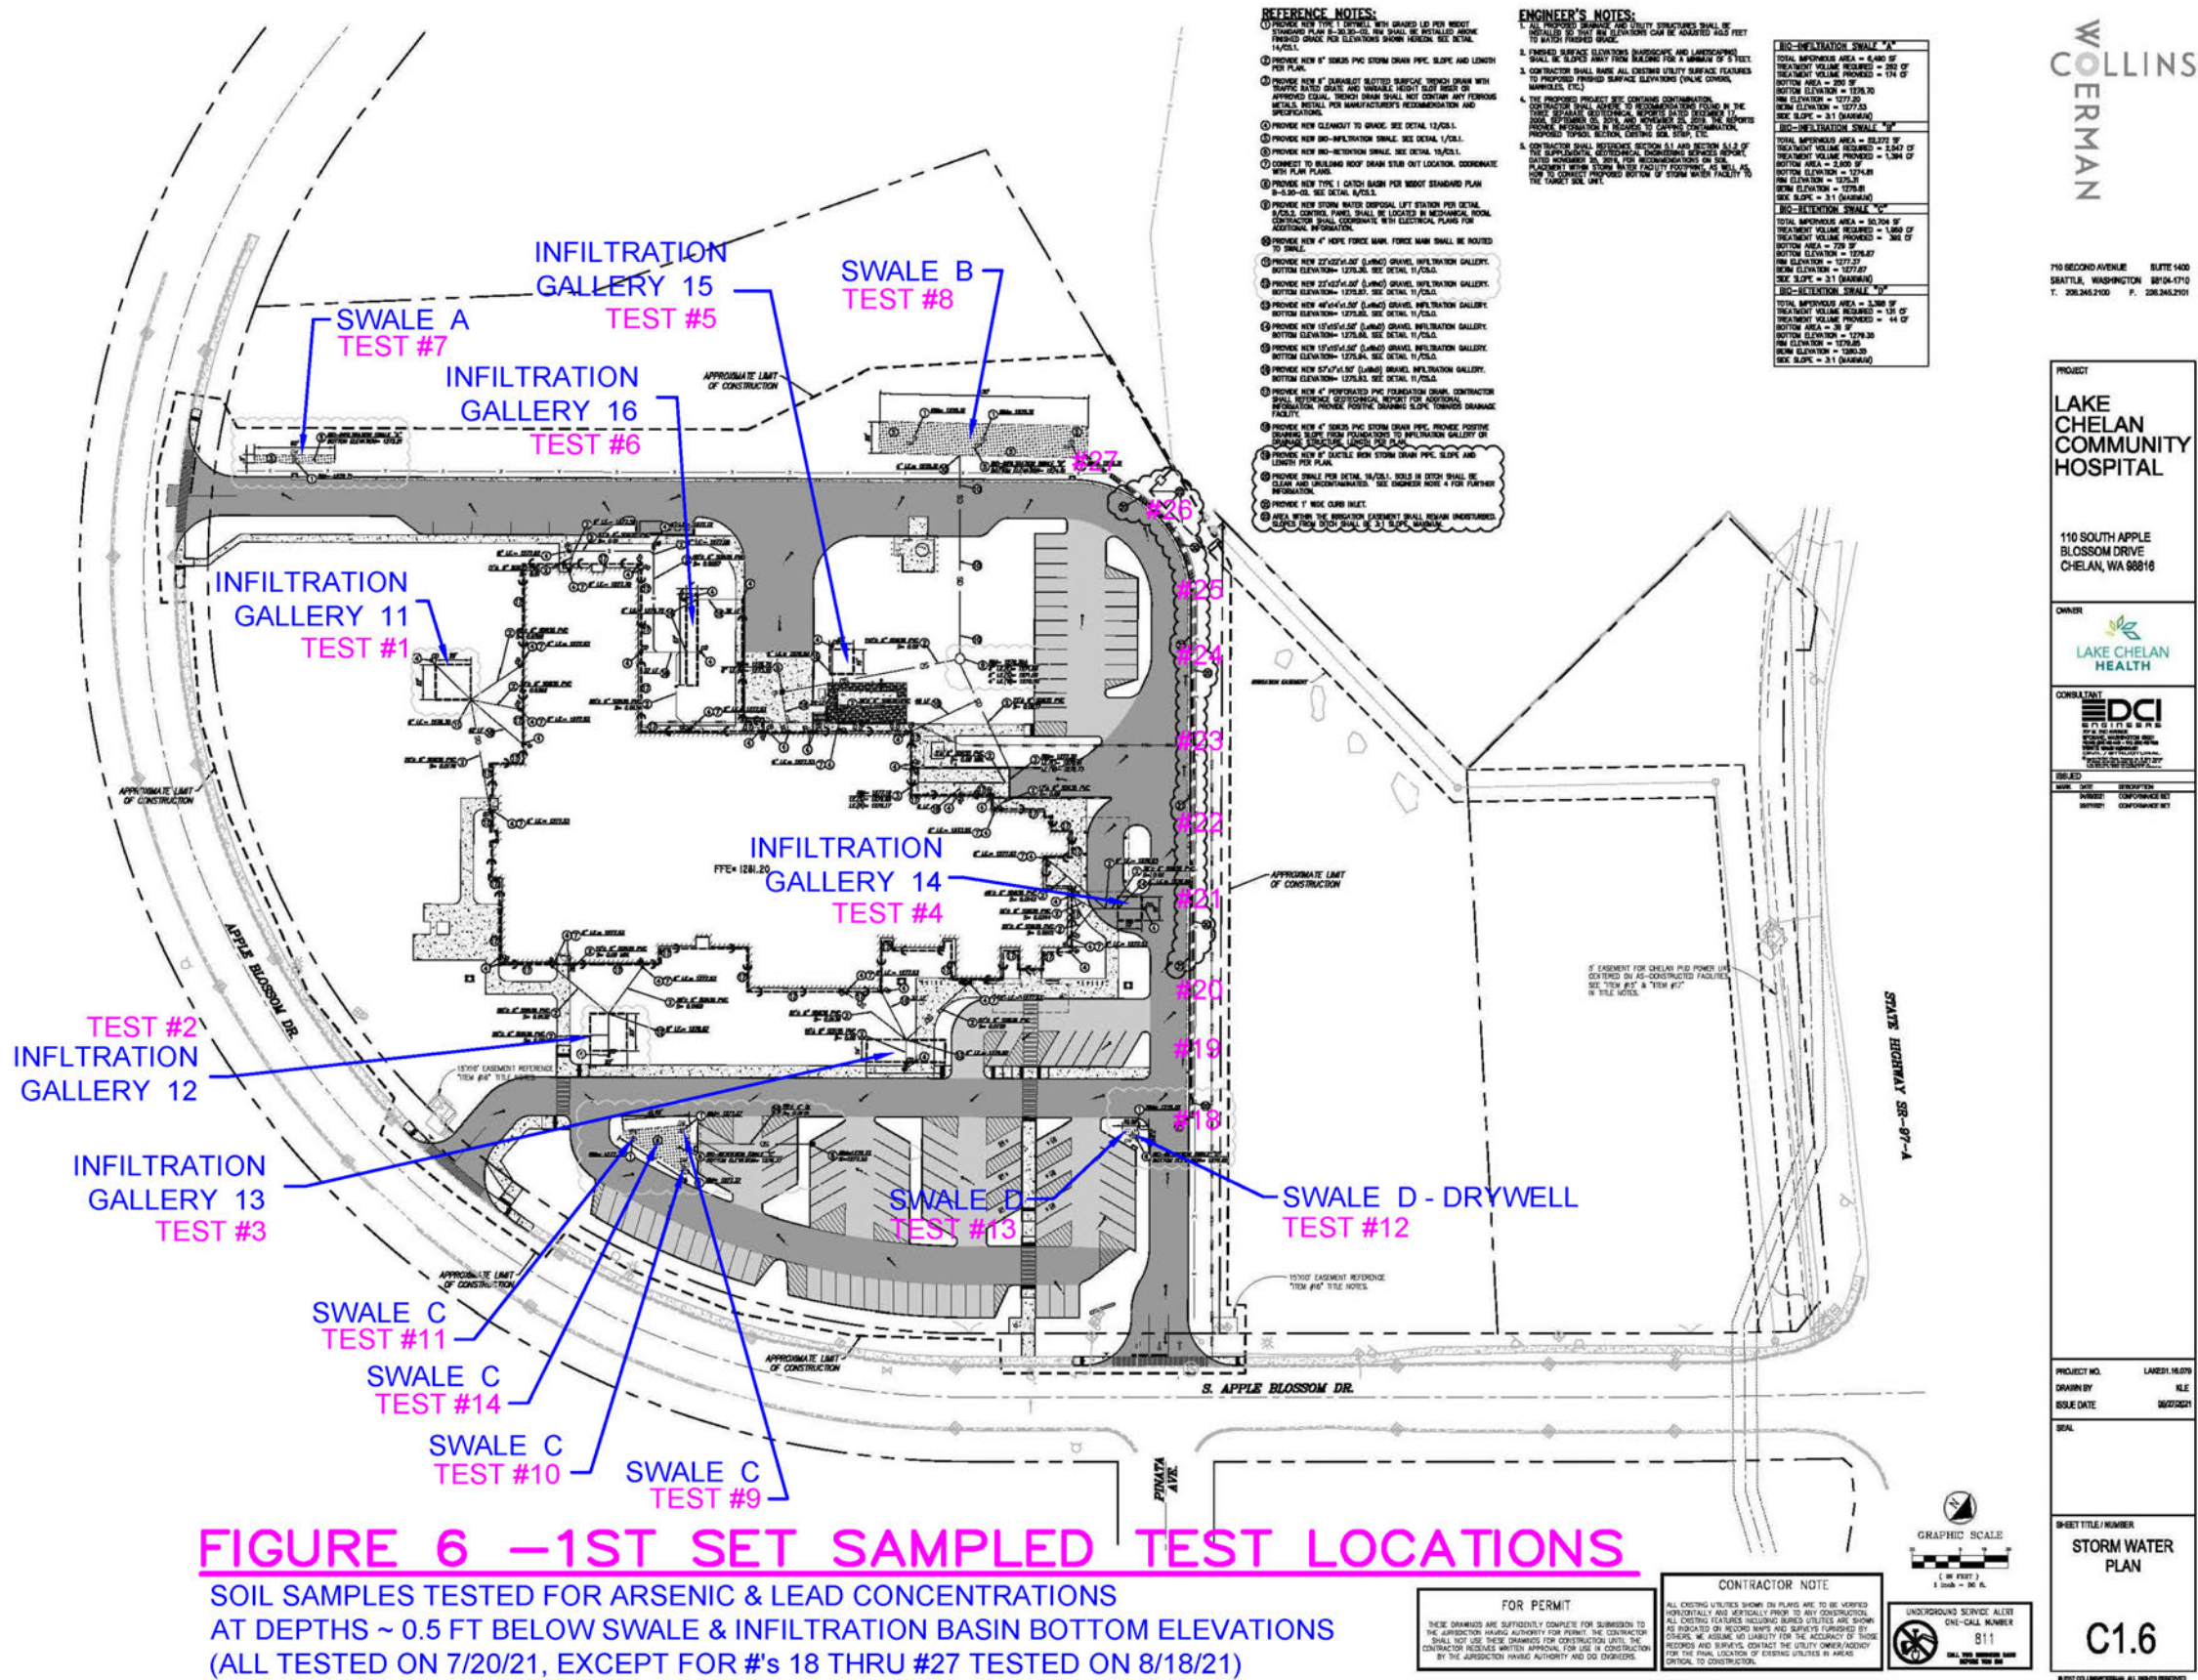
FIGURE 6

#1	Gallery 11	585	89			628	96	0.65	0.45	Test 3 took place on 9/8 with an XRF device by Jeff Newschwander at approximately -1.5' below contract subgrade, accepted.
		FAIL	FAIL			FAIL	FAIL	PASS	PASS	A sample was taken from this location and sent off for TCLP testing. The TCLP sample was taken approximately - 6.5' from current grade at the center of the infiltration gallery with Lead reading at 628mg/kg and Arsenic reading 96mg/kg.

#2	Gallery 12	545	127.5	302	88					"Just NE Gallery" for 2nd test results per Roy email
		FAIL	FAIL	FAIL	FAIL					
#3	Gallery 13	94	36.9	79	32.3					"Just NW Gallery" for 2nd test results per Roy email
		PASS	FAIL	PASS	FAIL

#4	Gallery 14	408	111.5	428	101					"West Gallery" for 2nd test results per Roy email
		FAIL	FAIL	FAIL	FAIL					
#5	Gallery 15	170	79							
		PASS	FAIL

#6	Gallery 16	89.5	95.5							
		PASS	FAIL							
#7	Swale A	96.5	34.55			250	45	0.56	0.11	Test 3 took place on 9/8 with an XRF device by Jeff Newschwander and did not pass. A sample was taken from this location and sent off for TCLP testing. The TCLP sample was taken approximately -3' from current grade one the west side of the excavation with Lead reading at 250mg/kg and Arsenic reading 45mg/kg.
		PASS	FAIL			FAIL	FAIL	PASS	PASS

#8	Swale B	94.5	37.75	246	73.5					Infiltration location tested.
		PASS	FAIL	PASS	FAIL					
#9	Swale C North	5.2	2.5							Drywell locations tested.
		PASS	PASS

#12	Swale D	20.2	18.95							Drywell locations tested.
		PASS	PASS							
#13	NE Corner Gallery			64.5	34.5					Swale C Infiltration per Roy email...Swale C Drywells passed, it is assumed that excavating the 3 drywells will get the gallery down to the depth of the drywells and require fill to get back up to the gallery elevation.
				PASS	FAIL

#14	NW Corner Gallery			57	43.9					Swale D Infiltration per Roy email...Swale D Drywell passed, it is assumed that excavating the 3 drywells will get the gallery down to the depth of the drywells and require fill to get back up to the gallery elevation.
				PASS	FAIL
