OPERATIONS, MAINTENANCE, AND MONITORING PLAN

Parcel 15 (Portac) Cleanup Phase 1

Prepared for: Port of Tacoma

Re: RCC Cap Inspection Technical Memorandum (FINAL)

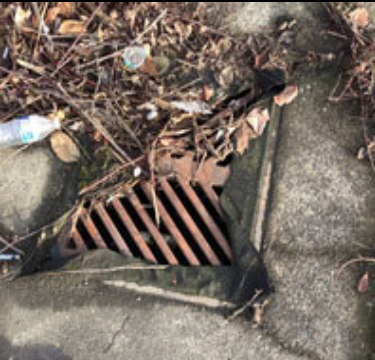
Location ID	Type of Structure	Observed Condition	Sediment Accumulation (inches)	Additional Observations	Recommended Actions	Photos
CB9	catch basin	could not locate	nm	none	none	na
CB10	catch basin	functioning normally	less than 1	water level approximately 8 in. from top of structure	remove accumulated debris, continue to maintain catch basin under stormwater permit

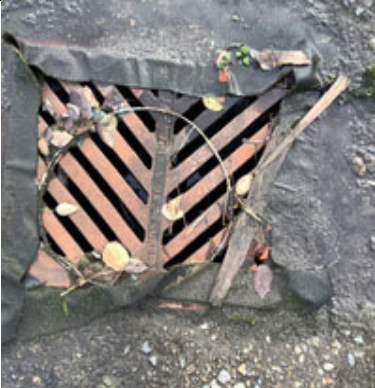
CB11	catch basin	functioning normally	approx. 2	none	remove accumulated debris, continue to maintain catch basin under stormwater permit

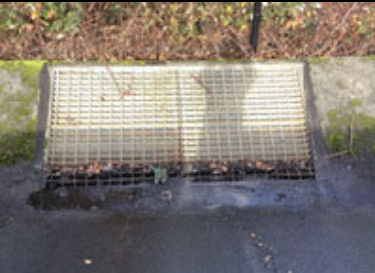
CBMH1	catch basin manhole	functioning normally	nm; none in surface basin	none	continue to maintain structure under stormwater permit

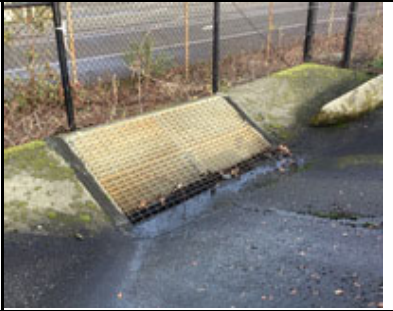
Location ID	Type of Structure	Observed Condition	Sediment Accumulation (inches)	Additional Observations	Recommended Actions	Photos
CBHM2	catch basin manhole	functioning normally	nm, none in surface basin	none	continue to maintain structure under stormwater permit

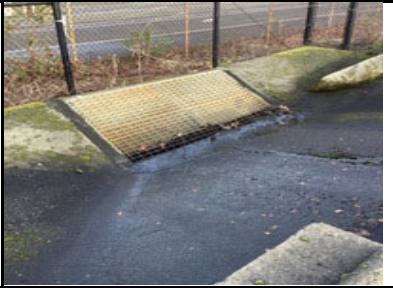
CBMH3	catch basin manhole	functioning normally	approx. 3; some debris noted (see additional observations)	organic debris, vegetation, and sediment accumulation in catch basin	remove accumulated sediment and debris; continue to maintain structure under stormwater permit

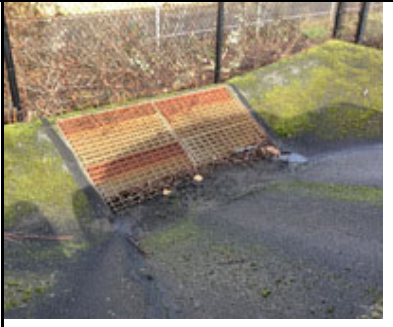
CBMH4	catch basin manhole	functioning normally	approx. 2; some debris noted (see additional observations)	organic debris, plastic debris, and sediment accumulation in catch basin; standing water of approximately 1/2 in. depth on south side of basin	remove accumulated sediment and debris; continue to maintain structure under stormwater permit

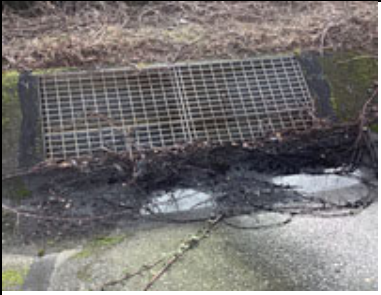
CBMH6	catch basin manhole	functioning normally	approx. 4; some debris noted (see additional observations)	organic debris and sediment accumulation in basin; standing water of approximately 1/2 in. depth on west side of basin	remove accumulated sediment and debris; continue to maintain structure under stormwater permit

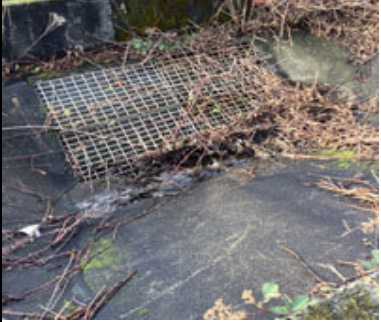
CBMH8	catch basin manhole	functioning normally	none in surface basin; some debris noted (see additional observations)	organic debris in basin; vegetation growing around perimeter of basin; standing water of approximately 1 in. depth on south side of basin	remove accumulated debris and vegetation; continue to maintain structure under stormwater permit

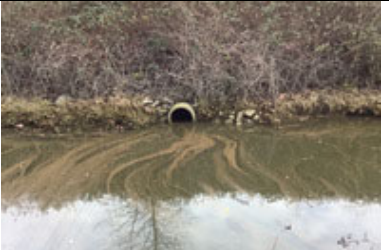
Location ID	Type of Structure	Observed Condition	Sediment Accumulation (inches)	Additional Observations	Recommended Actions	Photos
OF1	outfall	functioning normally; unable to observe structure due to tide	na	unable to access outfall due to tide	observe structure during next inspection

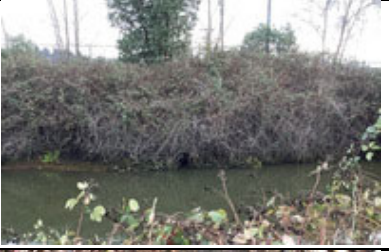
OF2	outfall	functioning normally; unable to observe structure due to tide	na	unable to access outfall due to tide	observe structure during next inspection

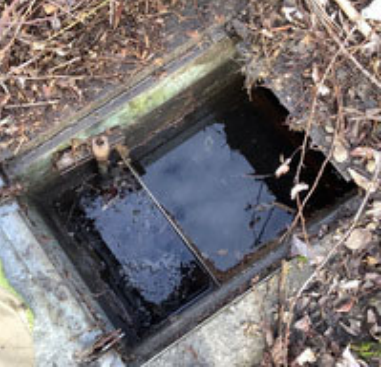
OWS	oil/water separator	structurally sound, functioning normally	less than 1	less than 1 in sediment accumulation in center of vault/under lid; no sediment accumulation away from center of vault	continue to maintain structure under stormwater permit

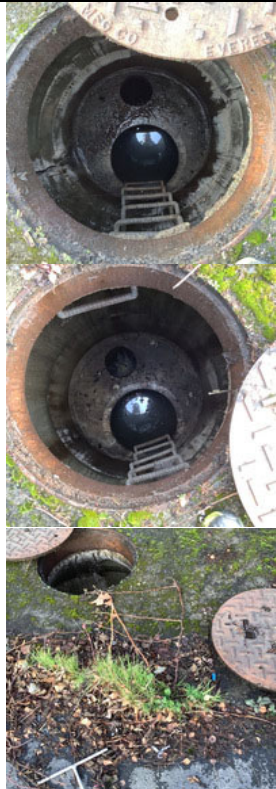
Location ID	Type of Structure	Observed Condition	Sediment Accumulation (inches)	Additional Observations	Recommended Actions	Photos
SV1	spill containment vessel	appears to be functioning normally	nm (confined space entry required to probe vault bottom)	vegetation growing between manhole and pavement on south side; foam and floatables in east chamber	to be removed during Phase 1 construction, no maintenance required

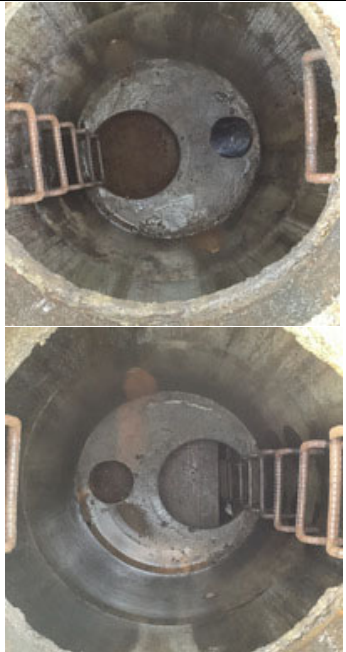
Location ID	Type of Structure	Observed Condition	Sediment Accumulation (inches)	Additional Observations	Recommended Actions	Photos
SV2	spill containment vessel	appears to be functioning normally	nm (confined space entry required to probe vault bottom)	slight foam in west chamber	to be removed during Phase 1 construction, no maintenance required

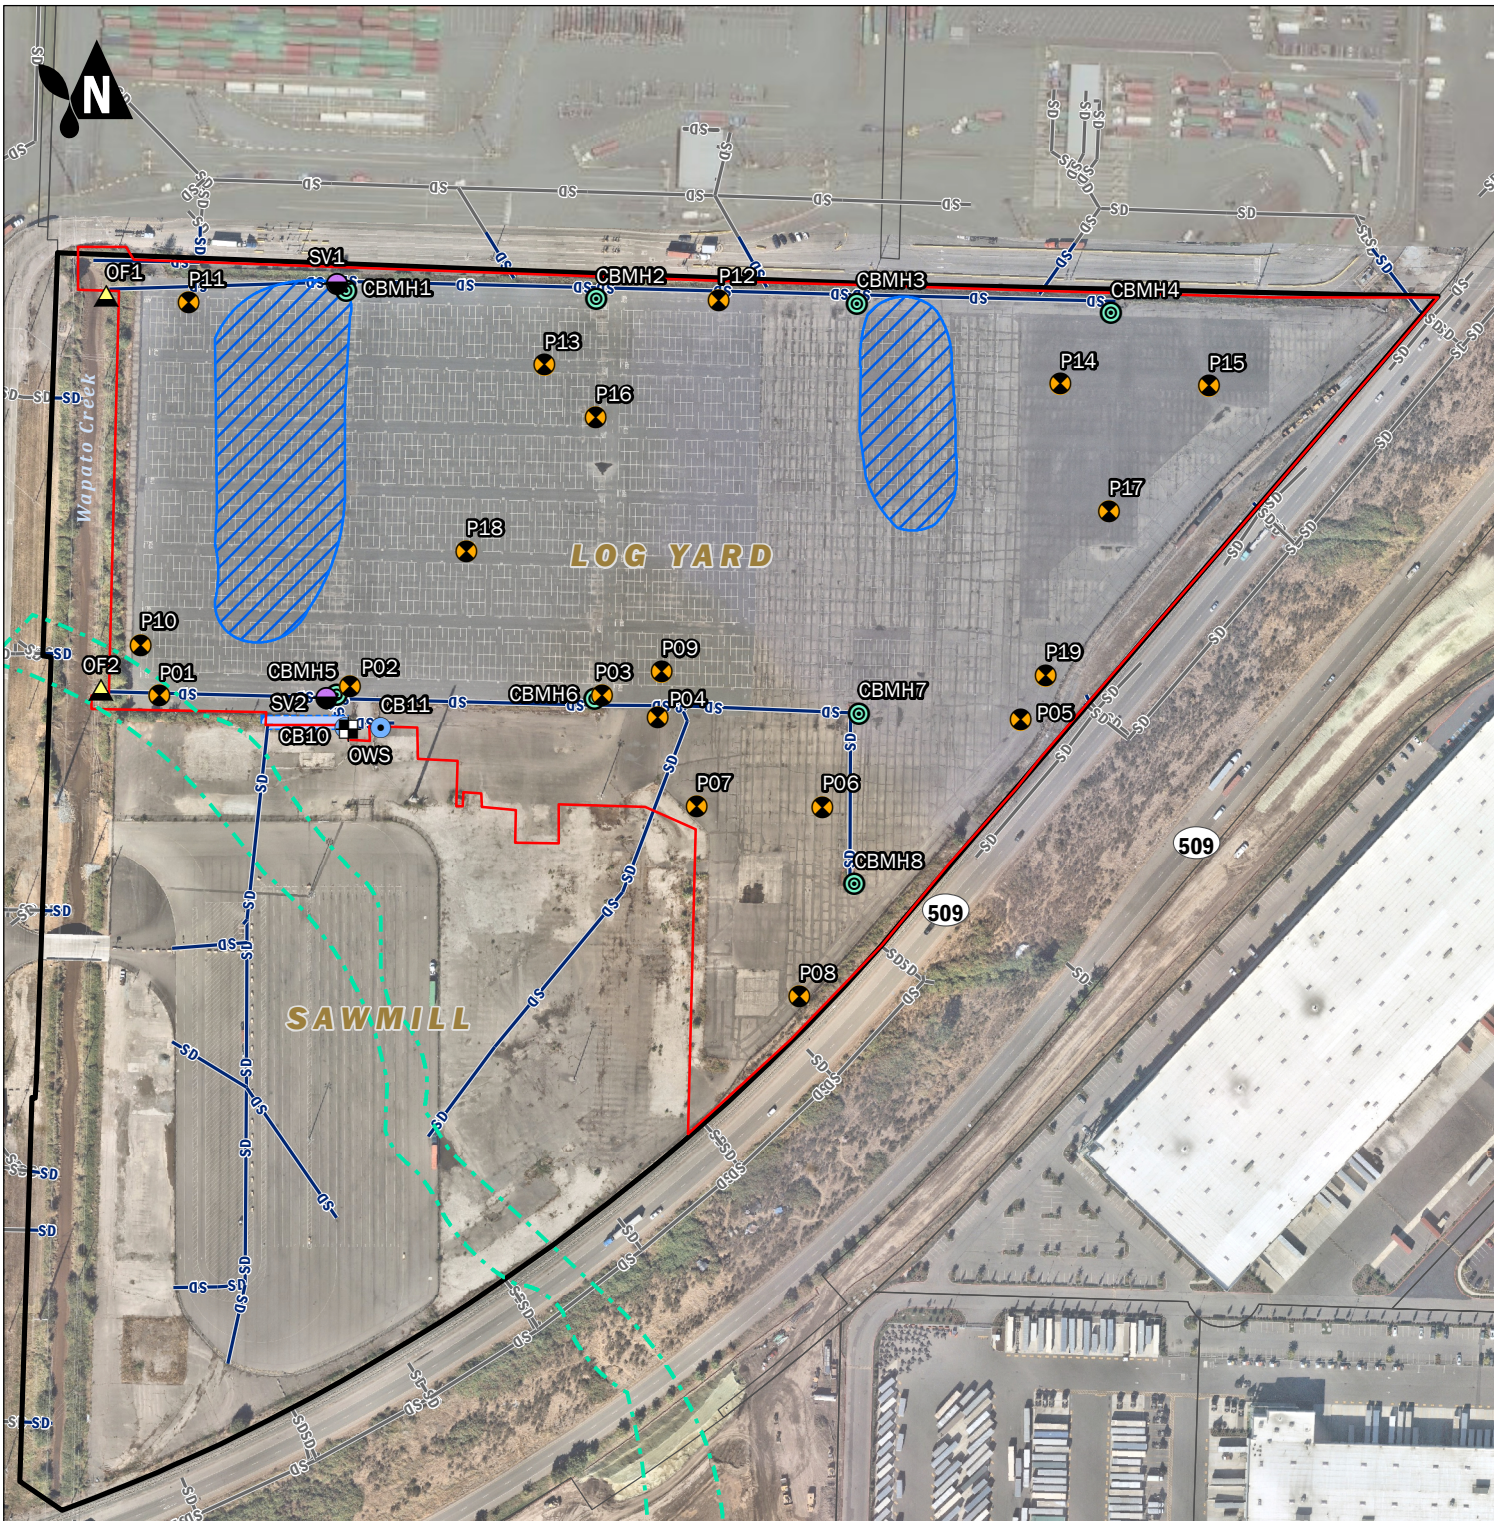
Cap Inspection Location (Dec 2021)

Required Inspection Elements	Observed Condition	Recommended Actions
Presence of cracks wider than 1/8 inch	Cracks wider than 1/8 inch were observed throughout the cap.	See Figure 2 and Table 2 for the locations of cracks. It is recommended that these cracks are observed at the next inspection, and that channels at P15, P16, and P17 are cleaned out
Sub-base material exposed	No sub-base material was exposed.	None
Pavement edge deterioration	No pavement edge deterioration was observed.	None
Degradation, subsidence, general appearance	No degradation or subsidence was observed.	None

All cracks wider than 1/8 inch and any gouges in the slurry overlay have been identified as specified in Table 2 and shown on Figure 2. Because these cracks are not expected to result in leakage, continued monitoring of the cracks is recommended at the next inspection event. The channels at P15, P16, and P17 should be cleaned out to allow water to flow out of areas with ponding. Pursuant to the Agreed Order with Ecology and the CAP, maintenance activities including regular inspections, periodic crack repair, and resurfacing using a suitable overlay shall be completed.

All stormwater structures will continue to be maintained under the Port’s Phase 1 Municipal Stormwater permit (MS4). It is recommended that accumulated sediment and debris be removed from inside and around the catch basins CB10, CB11, CBMH4, CMH6, CBMH7, and CBMH8 before the next inspection (Figure 2; Table 3).
