# STATE OF WASHINGTON DEPARTMENT OF ECOLOGY

RE: No Further Action opinion for the following Property associated with a contaminated Site

**Site name:** Legion Memorial Golf Course

Property address: 413 Rockefeller Avenue, Everett, Washington

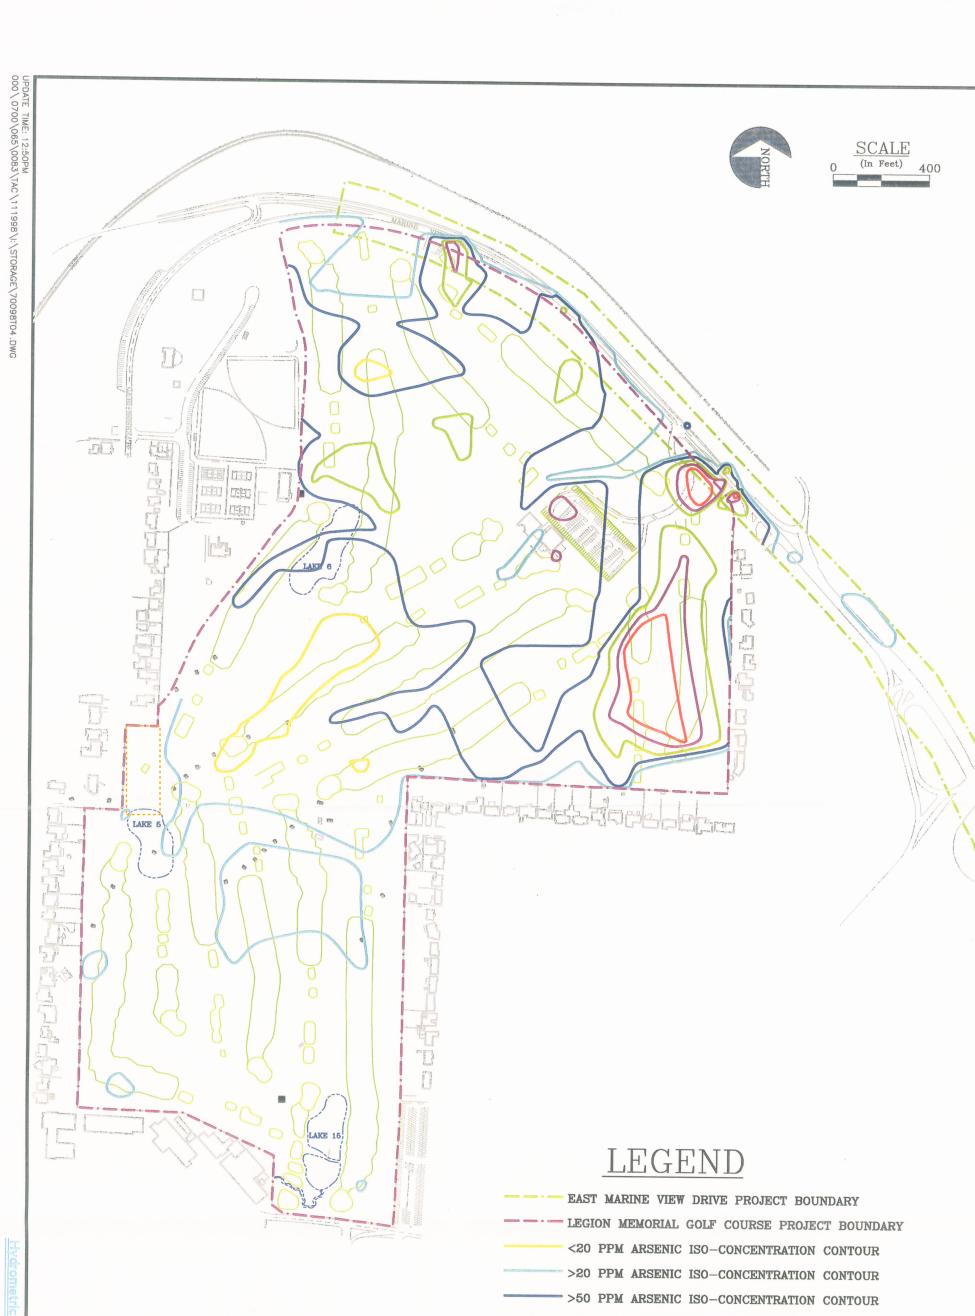
Enclosure C Figure 2

According to reports described in the 2022 CAR, fill soils were stored on the Property during retention pond construction to the south (Lake 5, **Figure 2**). Following a removal of a portion of the stockpiled fill material from the Property, samples were collected from shallow soil around the area of the stockpile. One soil sample, reportedly collected from the north side of the stockpile contained arsenic above the Method A cleanup level. A sampling report was not generated for this work; the precise location of this sample is unknown.

ARSENIC ISOCONTOURS OF 0-6 INCHES BASED ON PRE-REMEDIAL SAMPLING

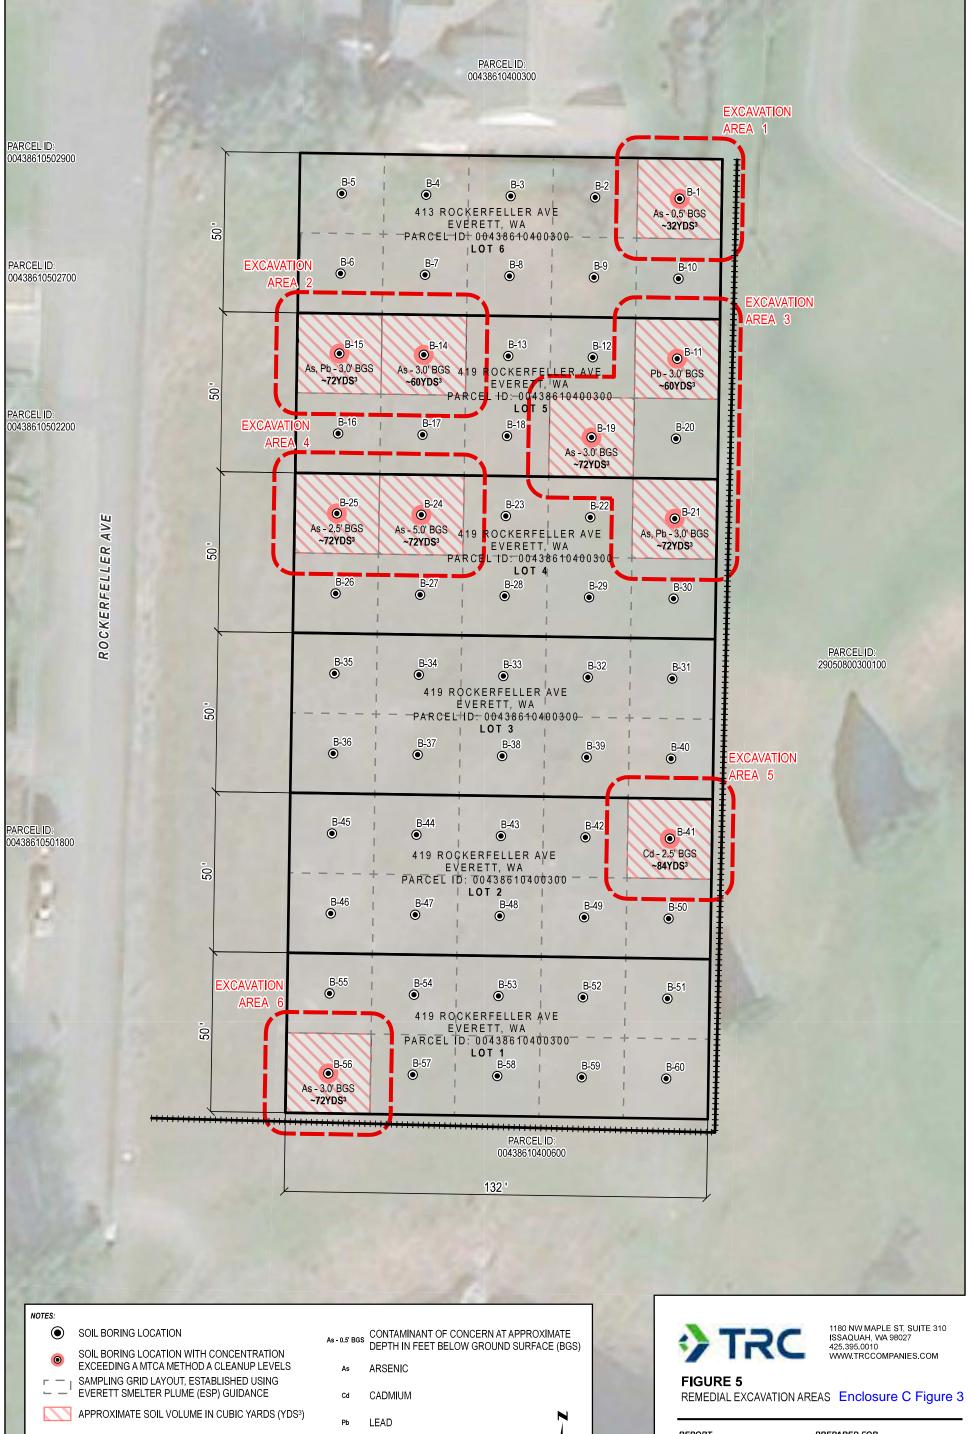
TOTAL ESTIMATED SOIL VOLUME ~670 YDS3

APPROXIMATE REMEDIATION AREAS

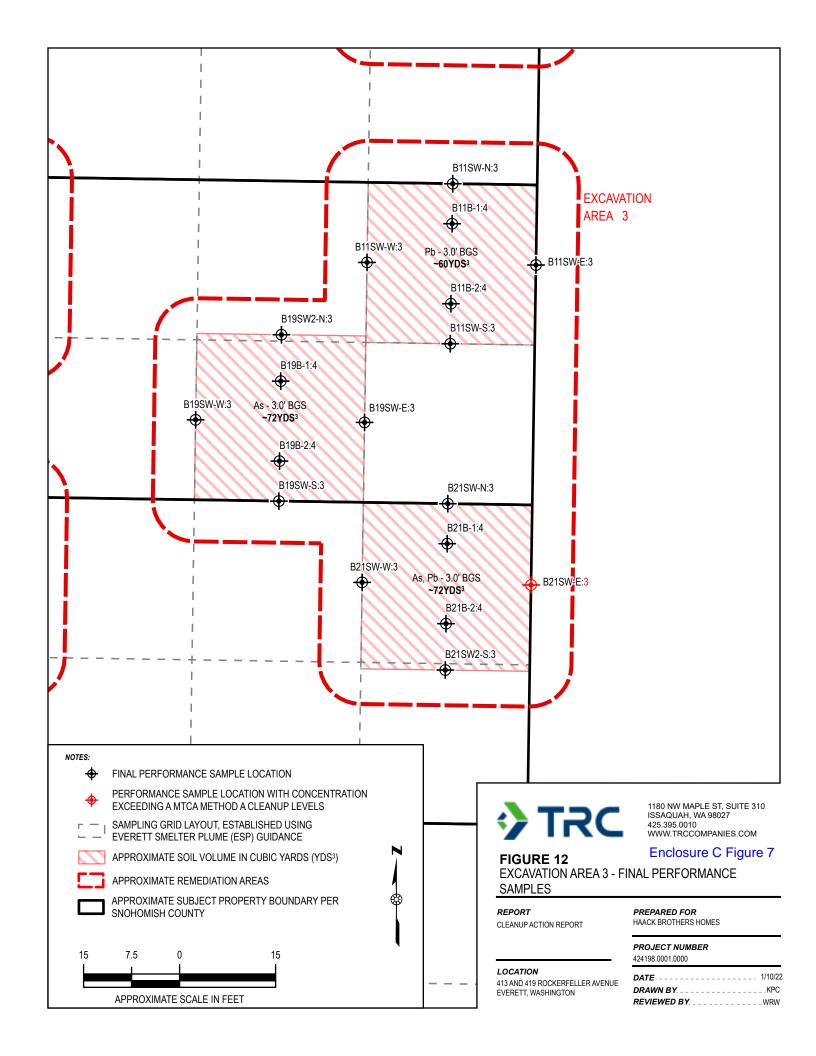
One soil sample collected from the eastern sidewall of Excavation 3 contained arsenic above the Method A cleanup level (Enclosure C, Figure 7). This sample was collected along the eastern Property boundary with LMGC and is representative of conditions on that parcel. Due to the complete removal of all soils containing arsenic, lead, and cadmium above cleanup levels from the Property, no further action is needed to ensure cleanup standards are met on the Property.

With the exception of B21SW-E:3 (Excavation Area 3; **Table 2**; **Figure 7**), all confirmation soil samples did not contain arsenic, lead, or cadmium above the Method A cleanup levels. Sample B21SW-E:3 was collected from the eastern sidewall of Excavation Area 3 along the eastern Property boundary with the LMGC.
