## MEMORANDUM

**Subject:** Annual Inspection Summary  
Former Harbour Pointe Cleaners Lynnwood (Facility Site ID 41352598)

**Project No.:** C3163

**Former Harbour Pointe Cleaners Lynnwood  
13619 Mukilteo Speedway, Lynnwood, WA 98037  
Photographs from 2022 Annual Inspection**

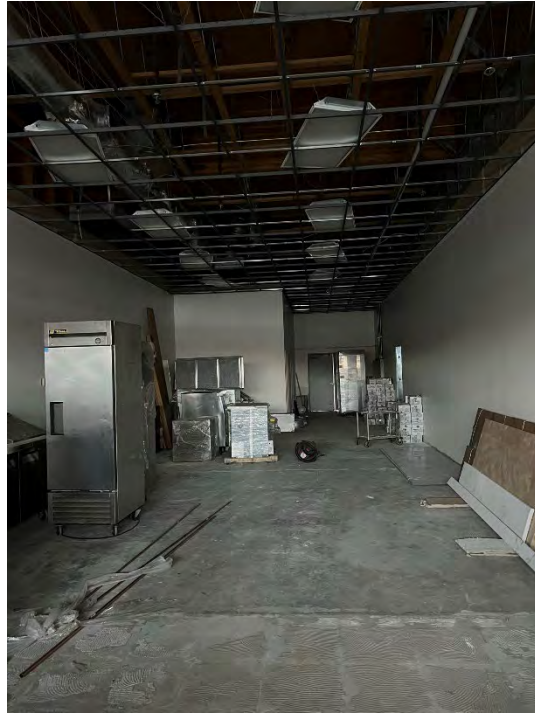
Photograph 1. Floor Slab in Former Harbour Pointe Cleaners (Suite B6)  
(December 19, 2022)

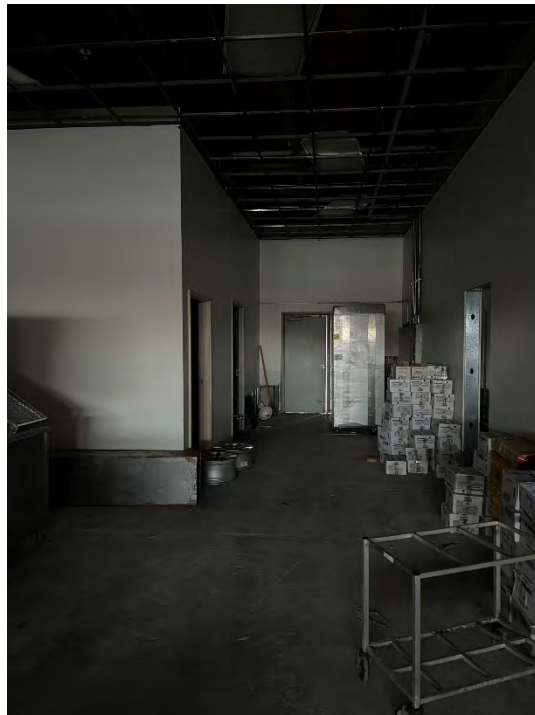
Photograph 2. Floor Slab in Rear of Former Harbour Pointe Cleaners (Suite B6)  
(December 19, 2022)

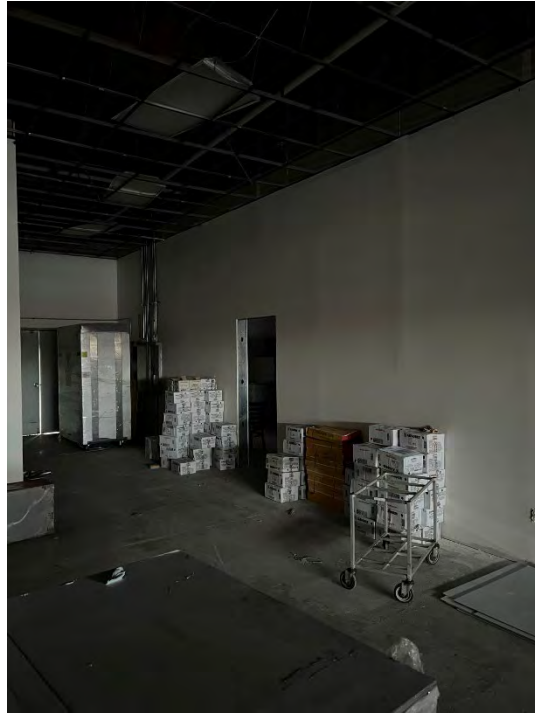
Photograph3. Floor Slab in Rear of Former Harbour Pointe Cleaners, Looking Toward Suite B7 (Suite B6) (December 19, 2022)

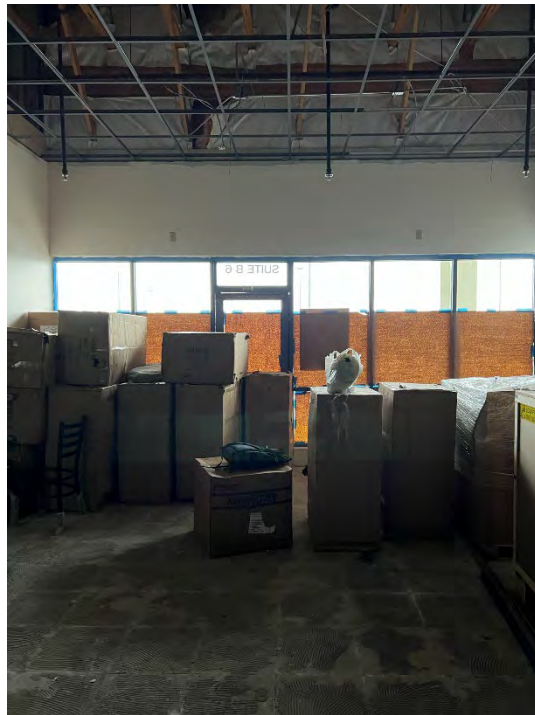
Photograph 4. Floor Slab in Front of Former Harbour Pointe Cleaners (Suite B6) (December 19, 2022)

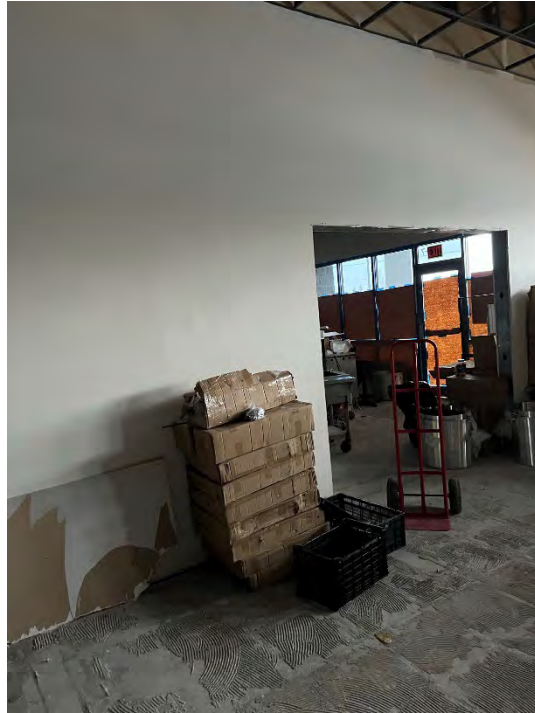
Photograph 5. Floor Slab in Front of Former Harbour Pointe Cleaners, Looking Toward Suite B7 (Suite B6) (December 19, 2022)

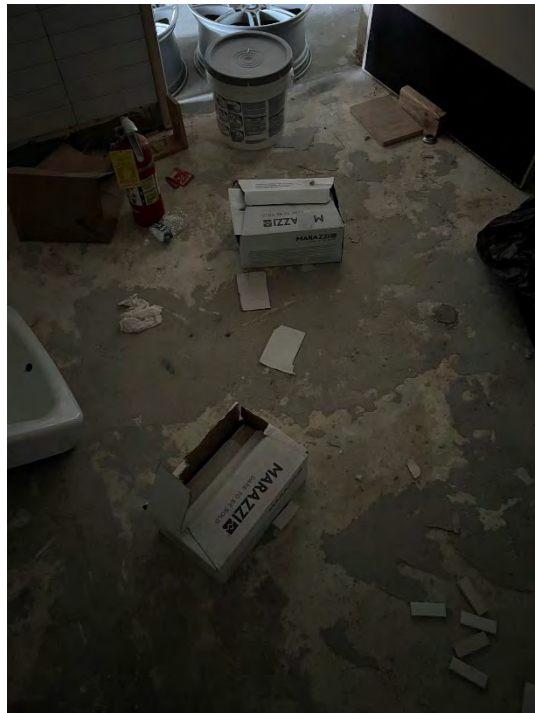
Photograph 6. Floor Slab in Bathroom of Former Harbour Pointe Cleaners (Suite B6) (December 19, 2022)

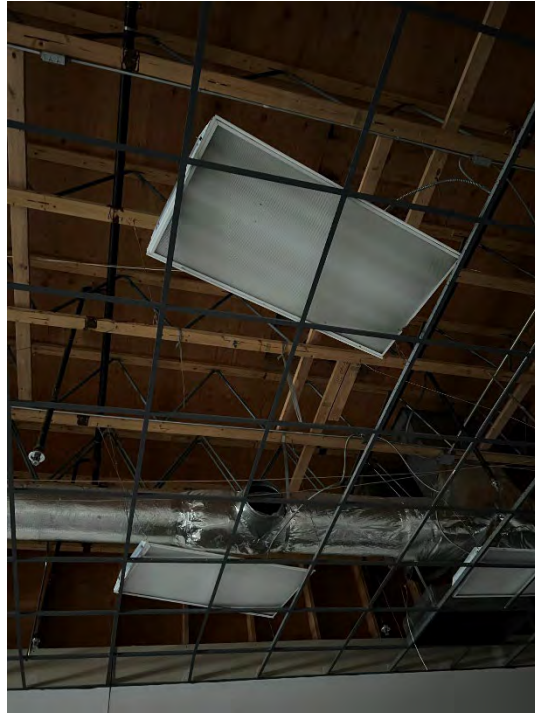
Suites B6, B7: No. Tenant spaces are unoccupied. HVAC will need to be made operational when a new tenant is found.

Photograph 7. Dismantled HVAC system of Former Harbour Pointe Cleaners (Suite B6) (December 19, 2022)

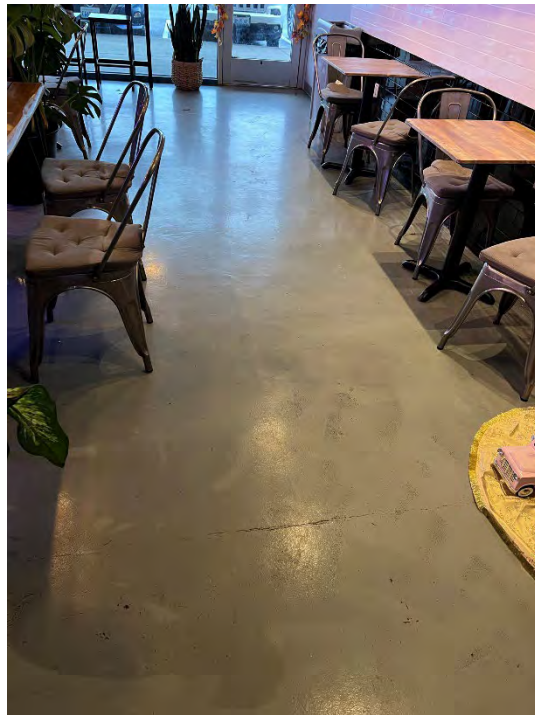
Photograph 8. Floor Slab in Adjacent-West Tenant Space (Suite B7) (December 19, 2022)

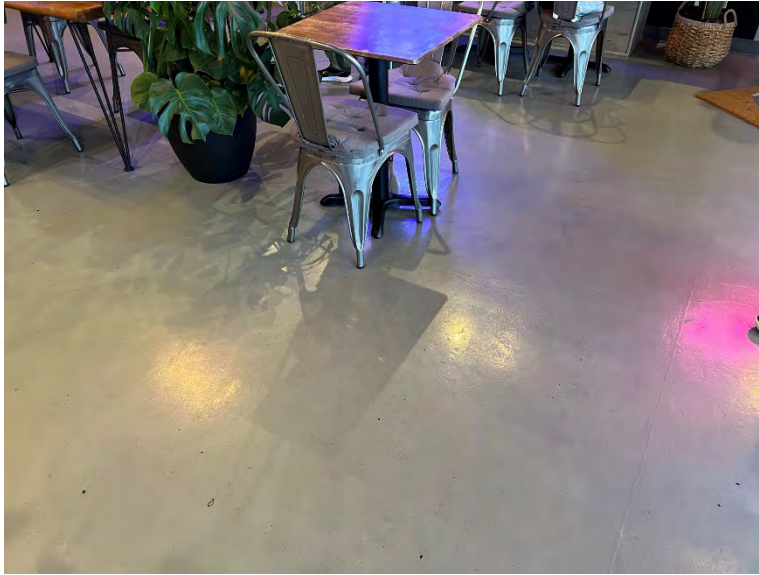
Photograph 9. Floor Slab in Adjacent-West Tenant Space (Suite B7)  
(December 19, 2022)

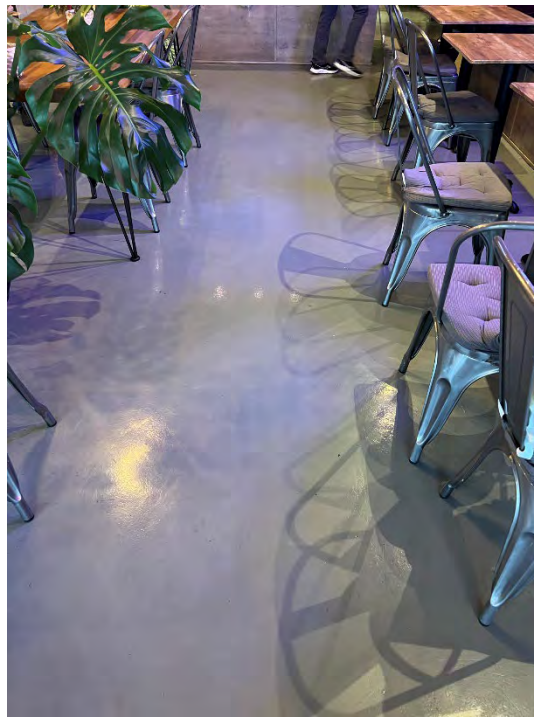
Photograph 10. Floor Slab in Adjacent-West Tenant Space (Suite B7)  
(December 19, 2022)

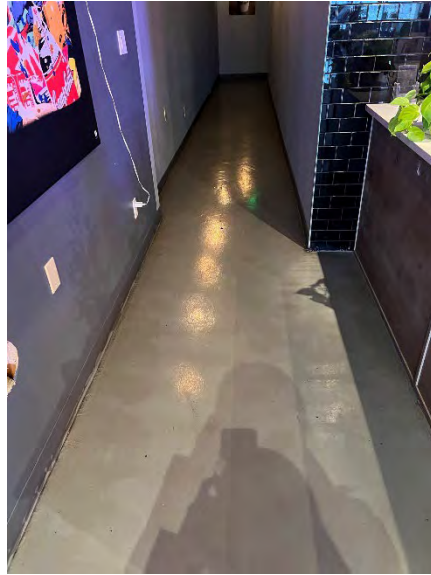
Photograph 11. Floor Slab in Adjacent-West Tenant Space (Suite B7)  
(December 19, 2022)

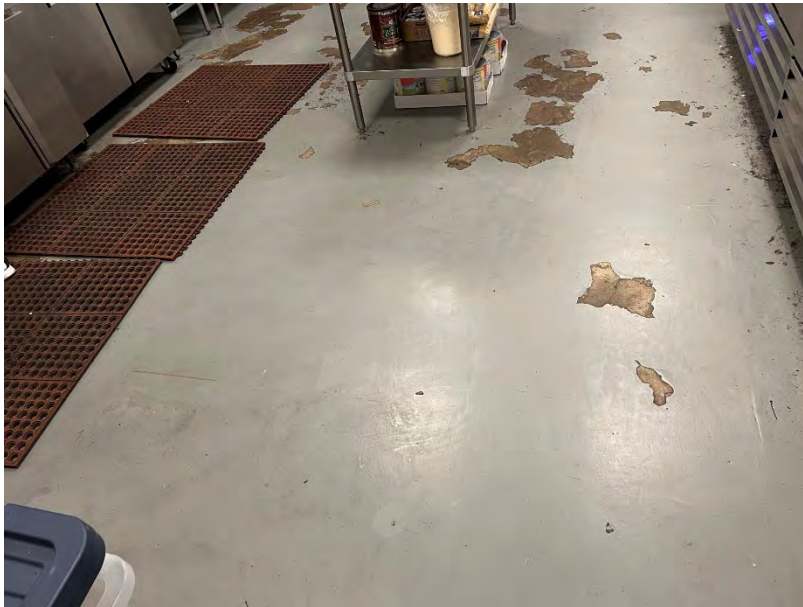
Photograph 12. Floor Slab in Kitchen of Adjacent-West Tenant Space (Suite B7)  
(December 19, 2022)

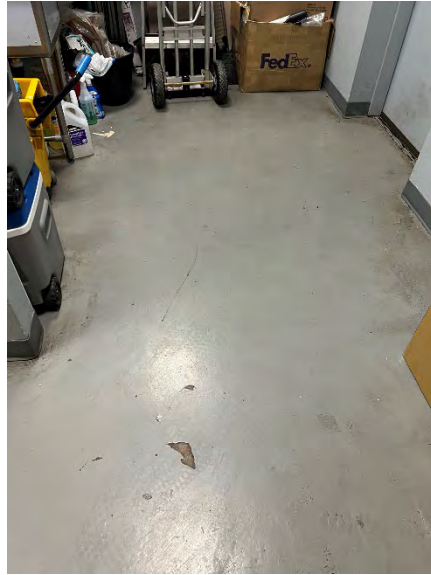
Photograph 13. Floor Slab in Hallway of Adjacent-West Tenant Space (Suite B7)  
(December 19, 2022)

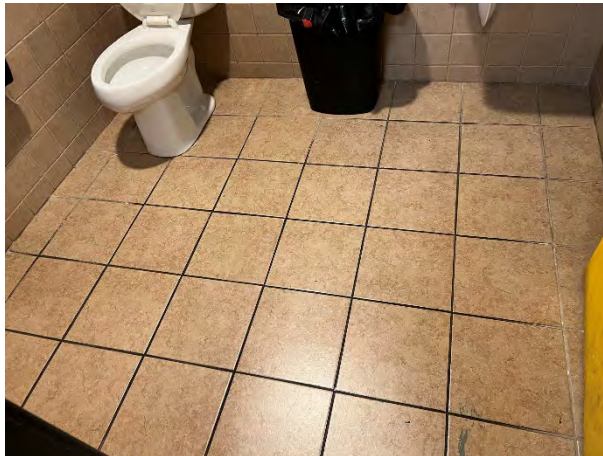
Photograph 14. Floor Slab in Bathroom of Adjacent-West Tenant Space  
(Suite B7) (December 19, 2022)

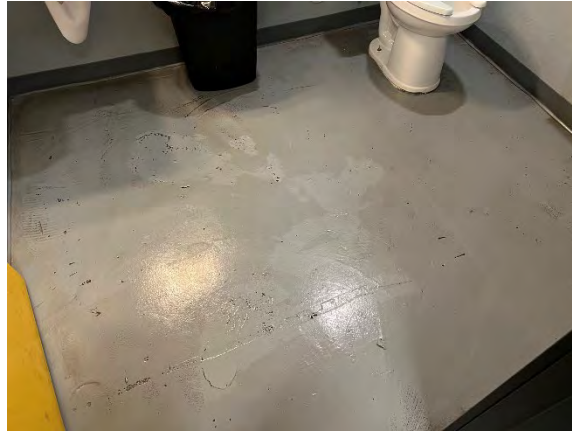
Photograph 15. Floor Slab in Bathroom of Adjacent-West Tenant Space (Suite B7) (December 19, 2022)

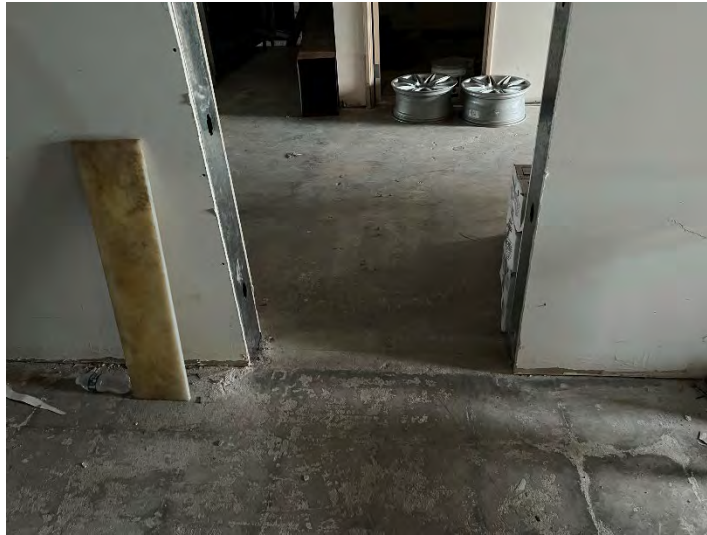
Photograph 16. Floor Slab in Suite B5, Looking into Former Harbour Pointe Cleaners (December 19, 2022)

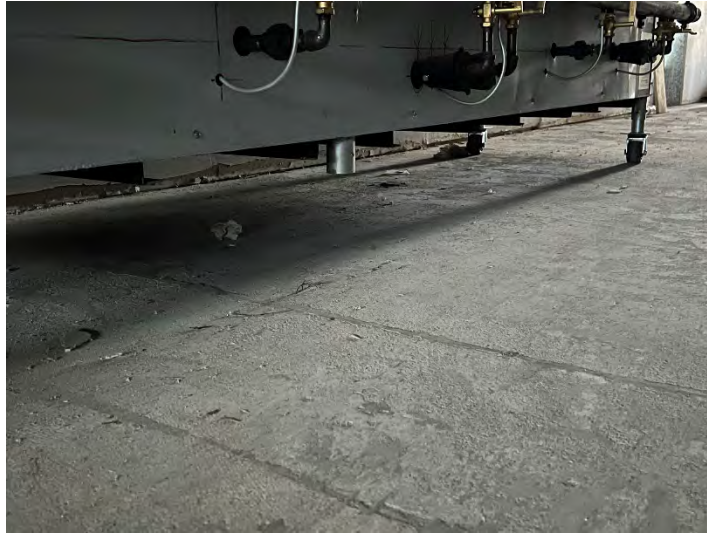
Photograph 17. Floor Slab in Suite B5, Along Shared Wall with Former Harbour Pointe Cleaners (December 19, 2022)

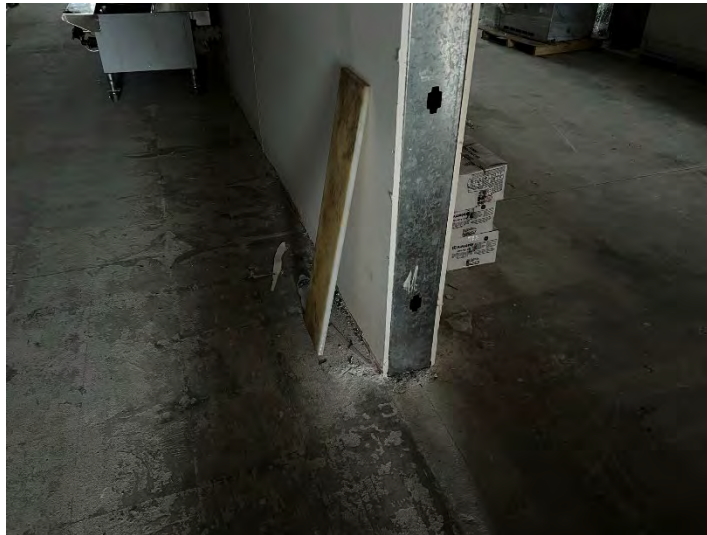
Photograph 18. Floor Slab in Suite B5, Along Shared Wall with Former Harbour Pointe Cleaners (December 19, 2022)

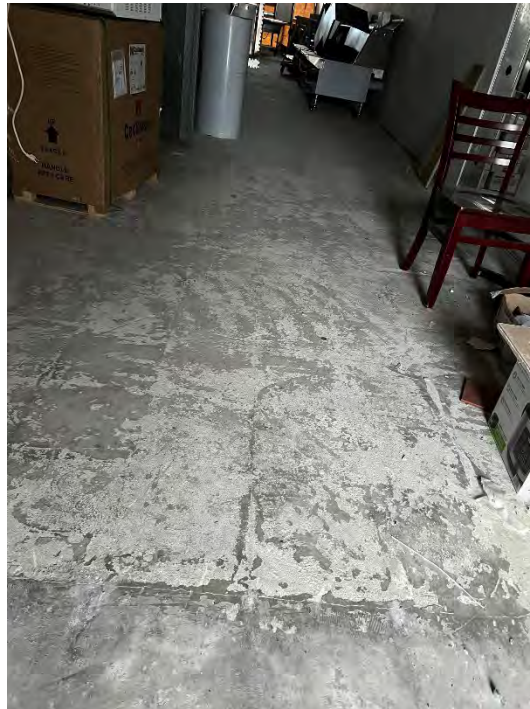
Suite B5 (Moustache Milk Tea): No. Tenant has been in the unit for 3 to 4 years. Tile was installed in the bathroom over one year ago. The floor slab was painted in the past and superficial paint chipping was noted, but no modifications or repairs have been made.

Photograph 19. Floor Slab in Suite B5 (December 19, 2022)
