**Subject: ERTS INSPECTION REPORT**

Assessor Pin: 29050700100300  
Site Name: BAYWOOD INDUSTRIAL  
Site Location: 200 W MARINE VIEW DR  
Inspection Date: 10/12/2022

**Inspection Report Photos – 200 W Marine View Dr (Baywood) -10/12/2022**

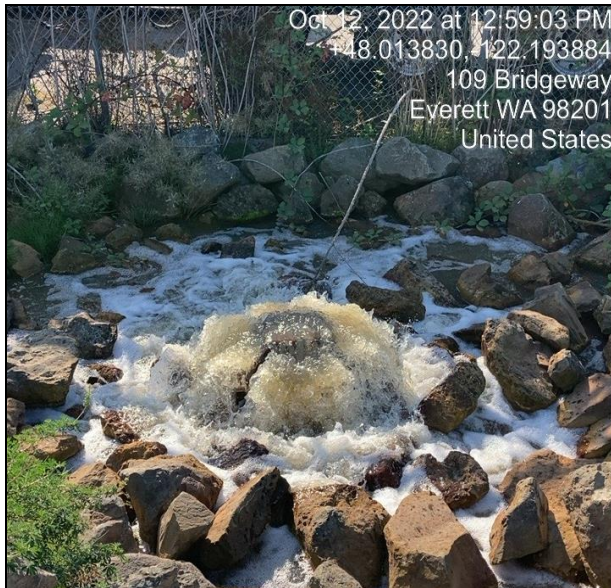
1. Water purging from the most inland catch basin. It appears that the pump station discharge to CB 1 is on the opposite side than what is shown on the plans.

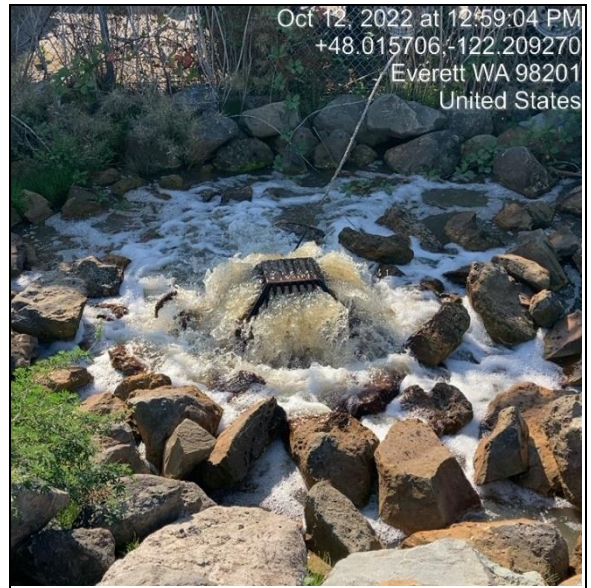
2. Water purging from the most inland catch basin. It appears that the pump station discharge to CB 1 is on the opposite side than what is shown on the plans.

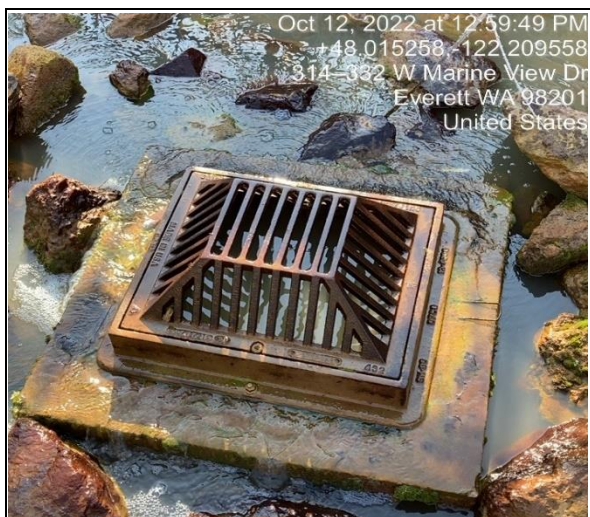
3. The end of the pump station purging process. SWM staff did not notice a petroleum smell, however, a small sheen was visible inside the catch basin approximately 30 minutes after this photo was taken.

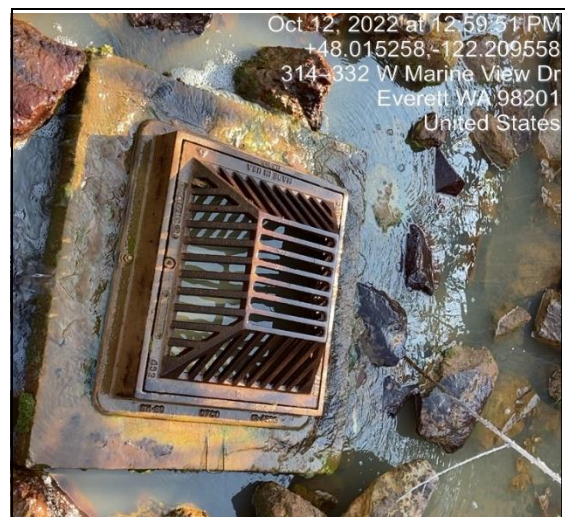
4. SWM staff measured the conductivity of this CB after the purging process at >1900 us/cm. SWM staff pulled a water quality sample from this catch basin for Oil and Grease, Metals, and Ammonia-N. Currently waiting on the lab results.

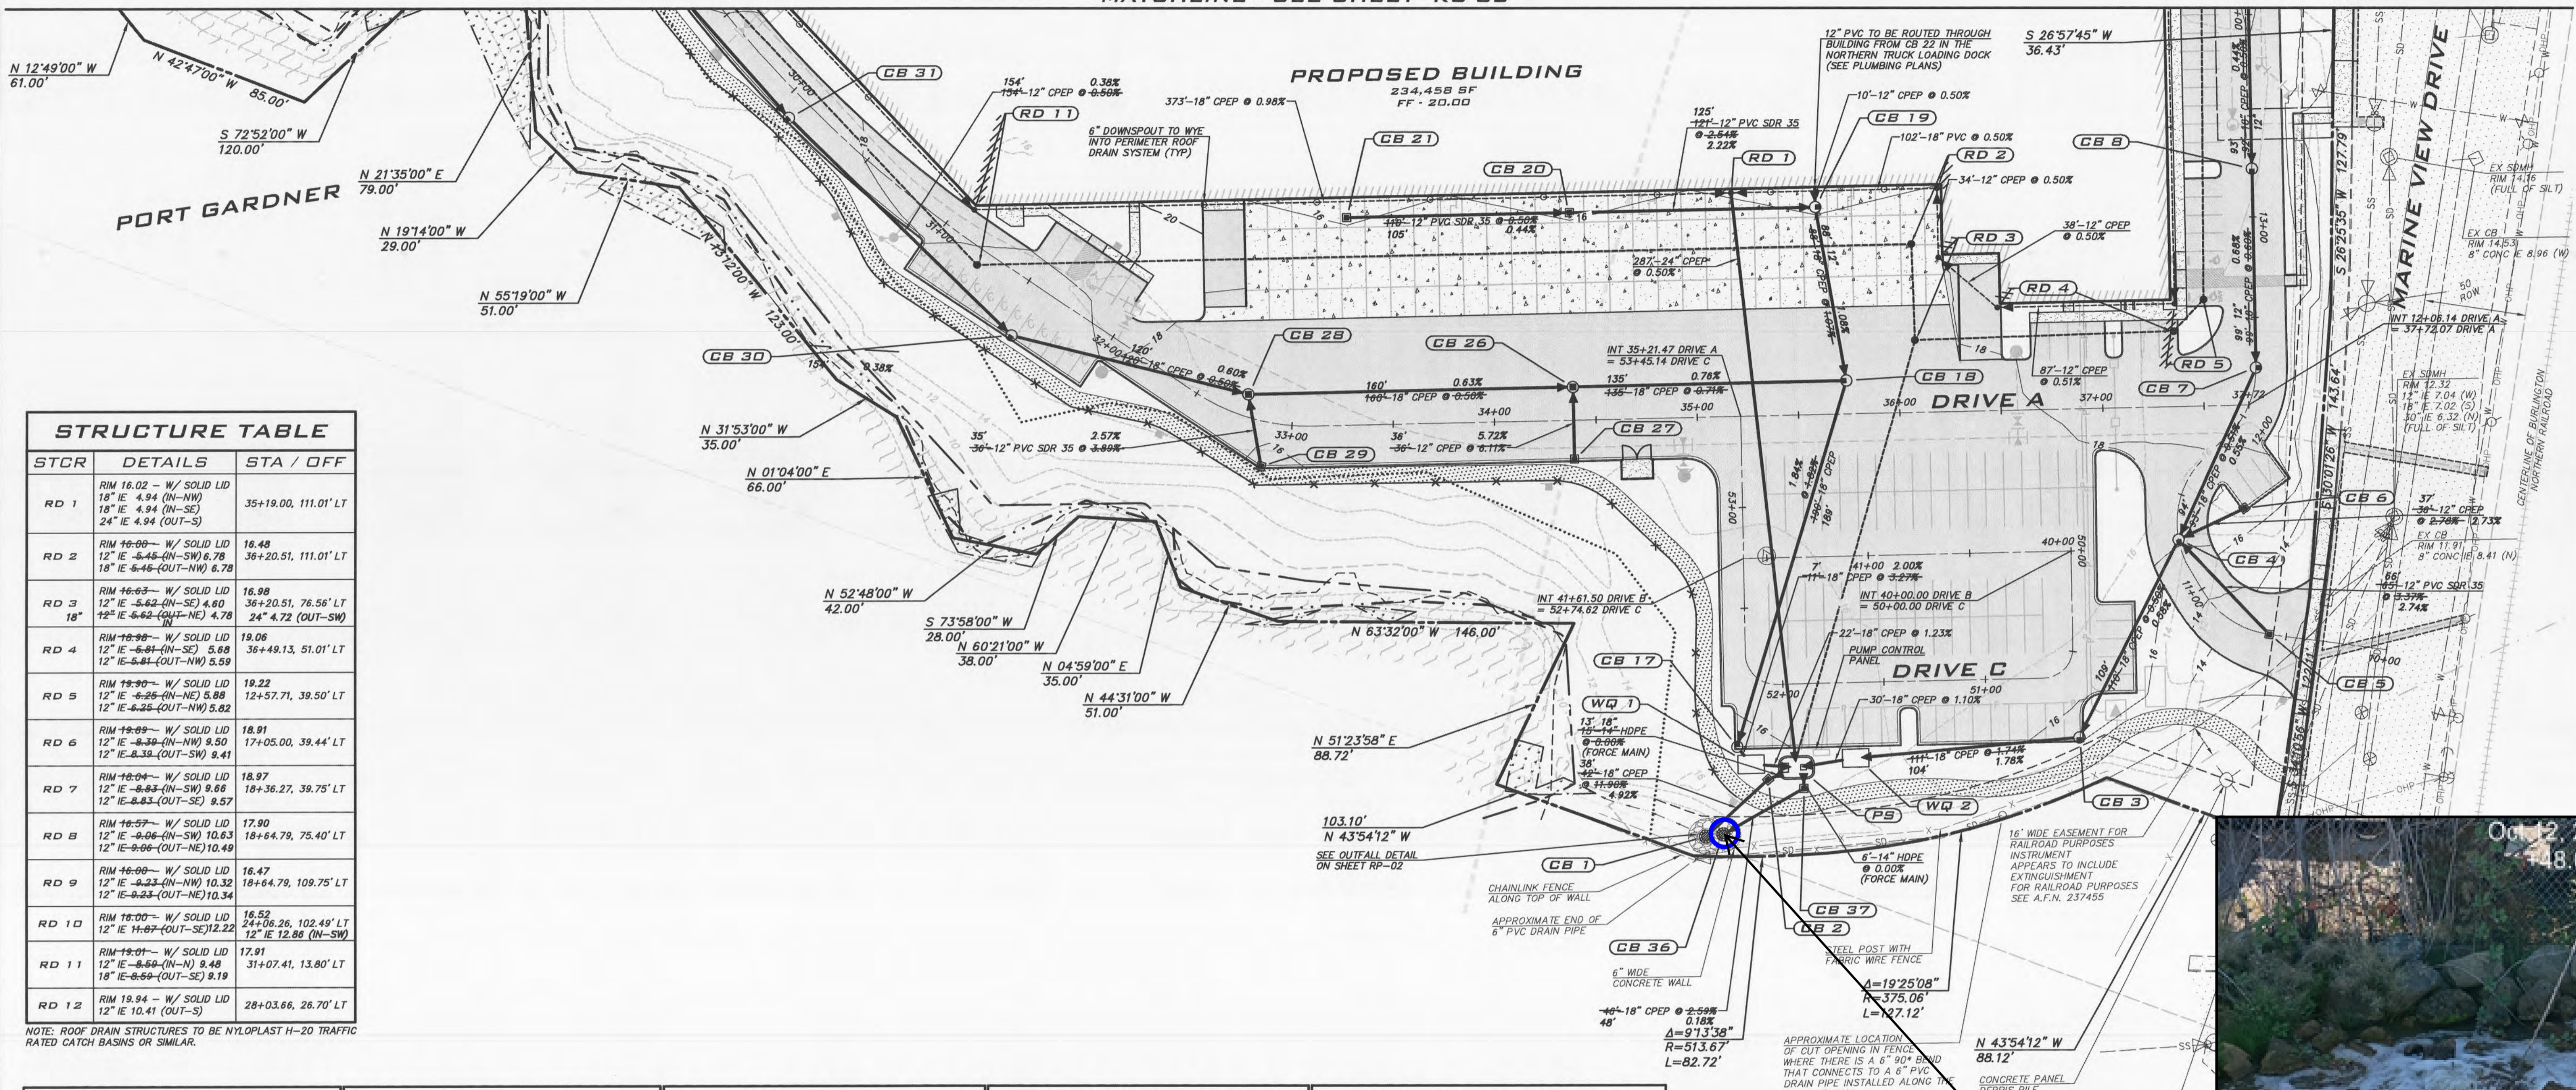
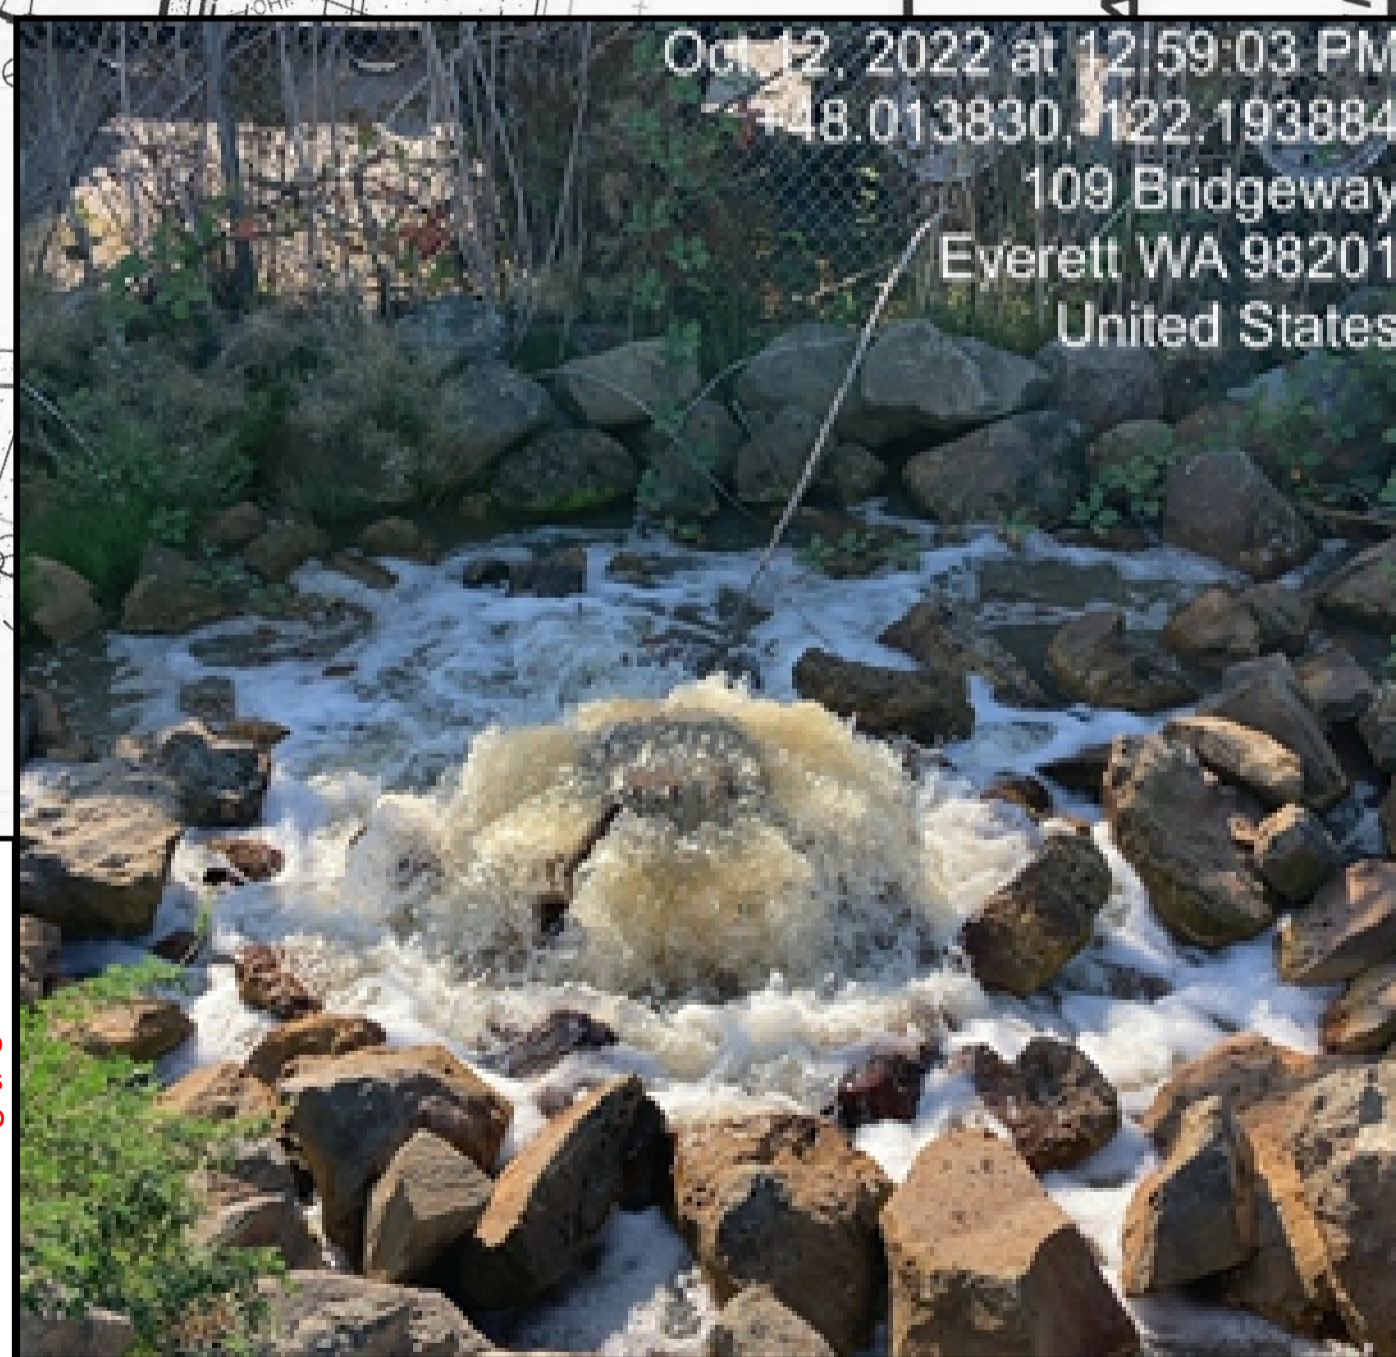
3/11/21  
 JOB NUMBER:  
**18-137**  
 SHEET NAME:  
**RS-01**  
 SHT **12** OF **20**

SWM's field inspection verified that the two outfalls appear to have been switched, per what is shown on the site's construction plans. Per the site plans, the force main was supposed to be the most seaward discharge location and the gravity overflow outfall was supposed to be the most inland. However, field observations have shown that CB #1 and #36 are opposite of what is shown on the plans.

On Wednesday, October 12, 2022, SWM staff (Cindy Cullen and Devin Bradford) went to the Baywood site to evaluate which outfall was associated with the pump station's force main, and which outfall is connected to the pump station's gravity overflow. Immediately upon arrival, SWM staff noticed that the most inland catch basin was purging water (see photo). SWM's field inspection verified that the two outfalls appear to have been switched, per what is shown on the site's construction plans. Per the site plans, the force main was supposed to be the most seaward discharge location, and the gravity overflow outfall was supposed to be the most inland. However, field observations have shown that CB #1 and #36 are opposite of what is shown on the plans. SWM staff collected water quality samples for oil and grease, metals, and ammonia analysis from this catch basin.
