Gas Works Sediment Area

Joint Source Control Evaluation

Appendix A Shoreline Facilities Evaluation

ECOLOGY REVIEW DRAFT

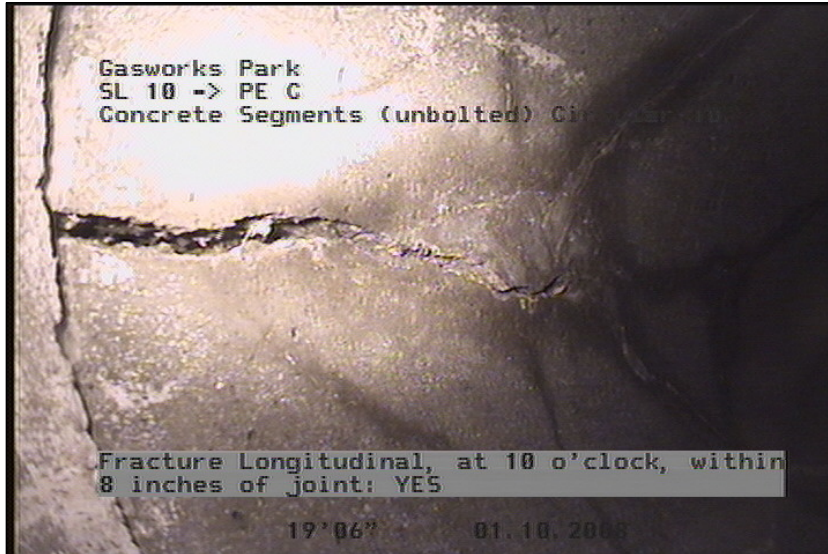
Photo: SL 10_PE C_100108_103546_A.JPG, VCR #: GS-10.1.08
19.54FT, Fracture Longitudinal, at 10 o'clock, within 8 inches of joint: YES

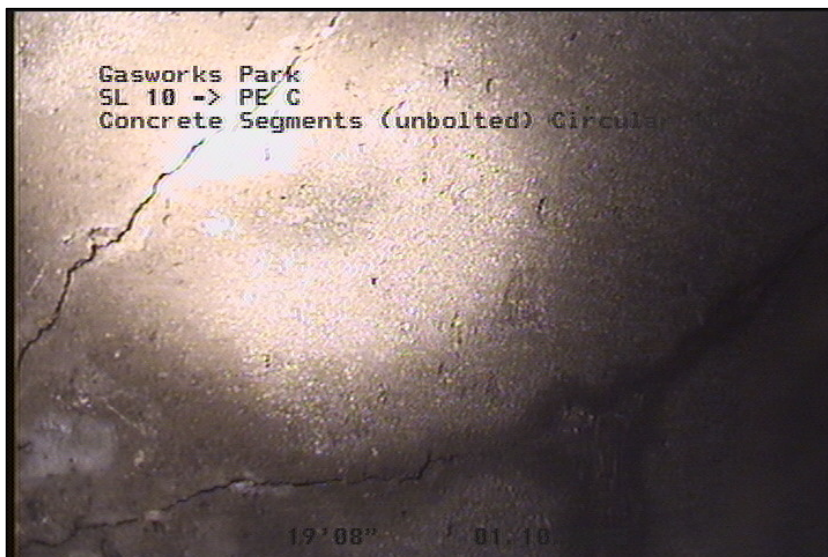
Photo: SL 10_PE C_100108_103638_A.JPG, VCR #: GS-10.1.08
19.64FT, Crack Multiple, from 09 to 01 o'clock, within 8 inches of joint: YES

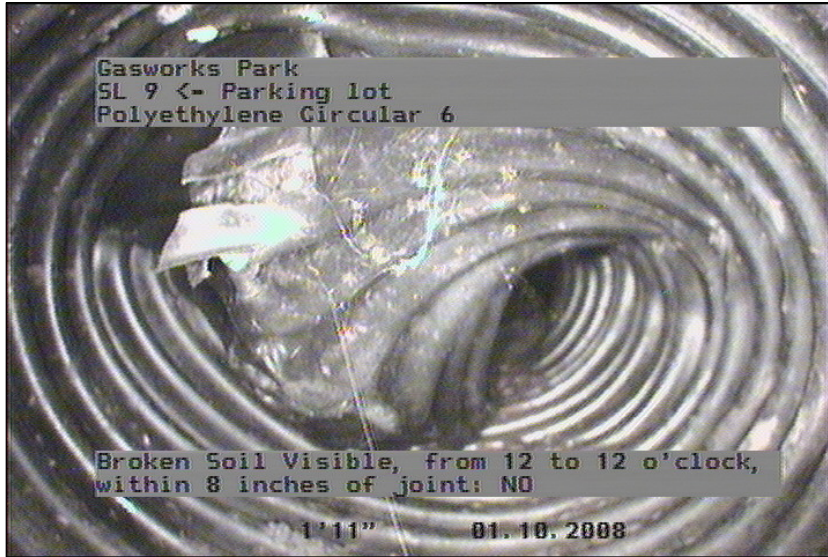
Photo: SL 9_Parking lot_100108_120211_A.JPG, VCR #: GS-10.1.08
1.91FT, Broken Soil Visible, from 12 to 12 o'clock, within 8 inches
of joint: NO

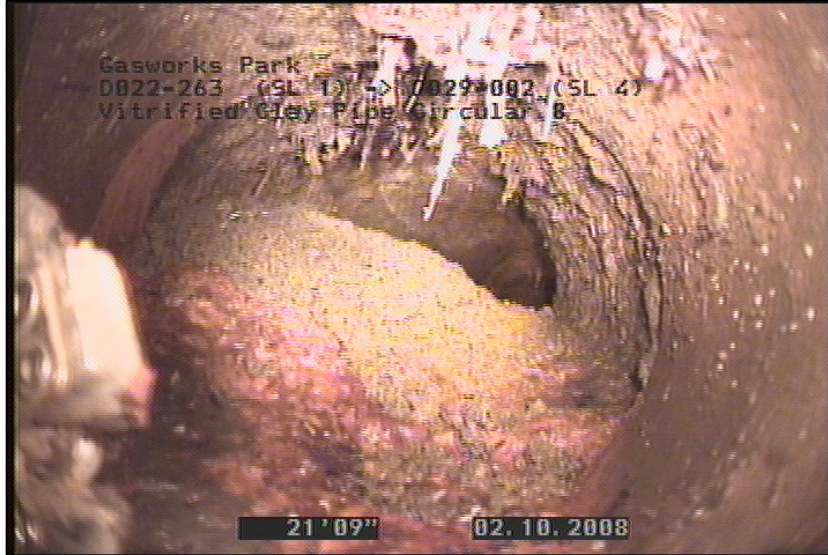
Photo: D022-263 (SL 1)_D029-002 (SL 4)_100208_092533_A.JPG,
 VCR #: GS-10.1.08
 21.76FT, Tap Factory Made Defective, at 09 o'clock, 6", within 8
 inches of joint: NO, REMARK: Debris

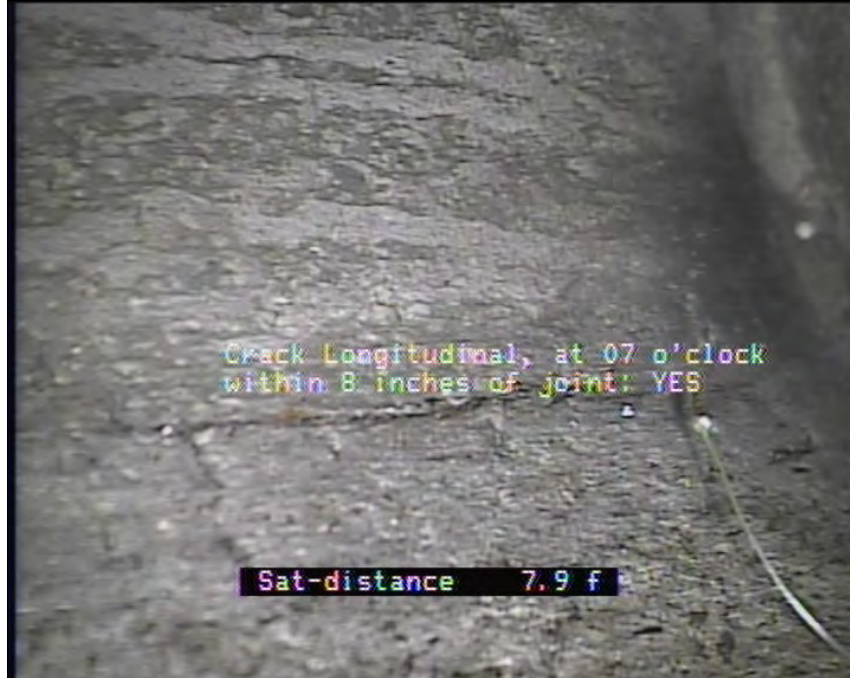
Photo: PA-CB-07_Discharge Point095517_25062010_A.JPG, VCR No.: Floyd/Gas Works 06.25.2010
7.9FT, Crack Longitudinal, at 07 o'clock, within 8 inches of joint: YES

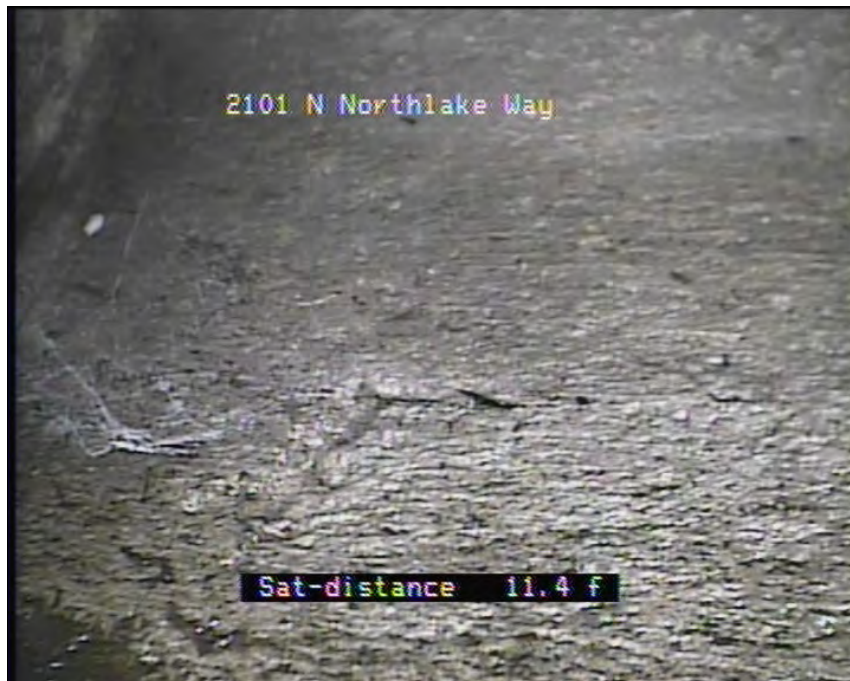
Photo: PA-CB-07_Discharge Point095656_25062010_A.JPG, VCR No.: Floyd/Gas Works 06.25.2010
11.4FT, Crack Longitudinal, at 05 o'clock, within 8 inches of joint: YES

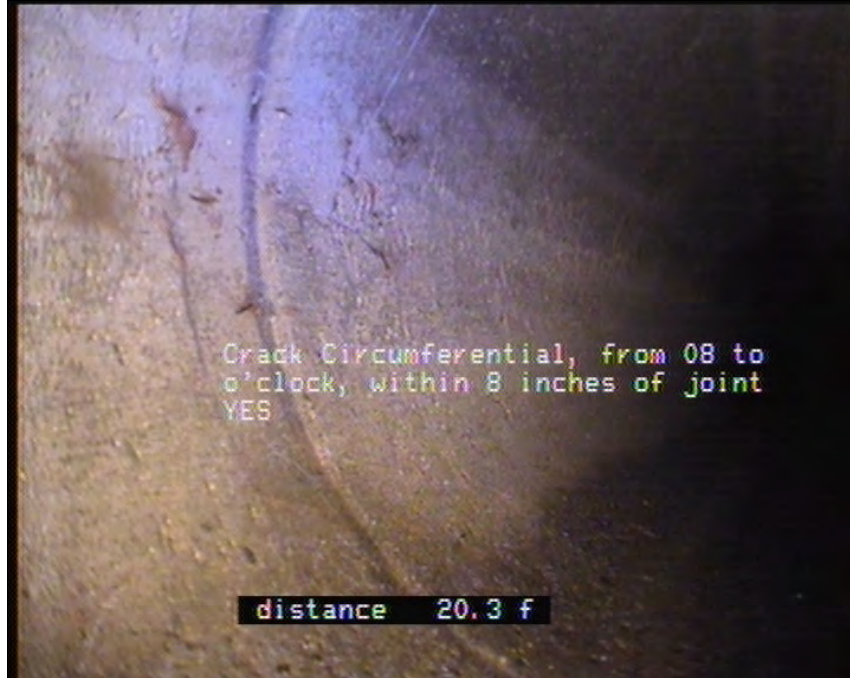
Photo: Mainline MH 2_Mainline MH104104_25062010_A.JPG, VCR No.:
Floyd/Gas Works 06.25.2010
20.3FT, Crack Circumferential, from 08 to 12 o'clock, within 8 inches of
joint: YES

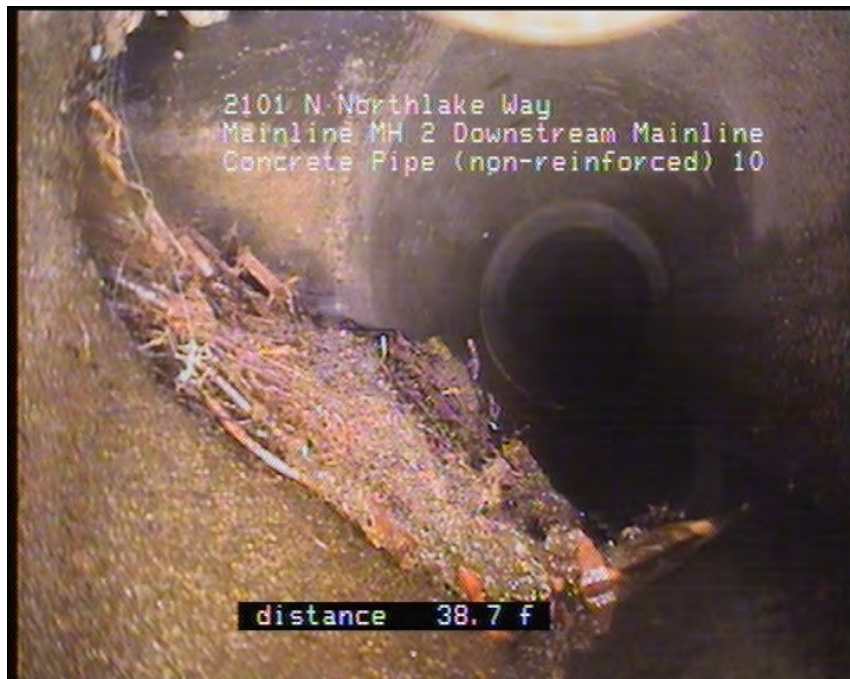
Photo: Mainline MH 2_Mainline MH104331_25062010_A.JPG, VCR No.:
Floyd/Gas Works 06.25.2010
38.7FT, Roots Fine Lateral, from 03 to 09 o'clock

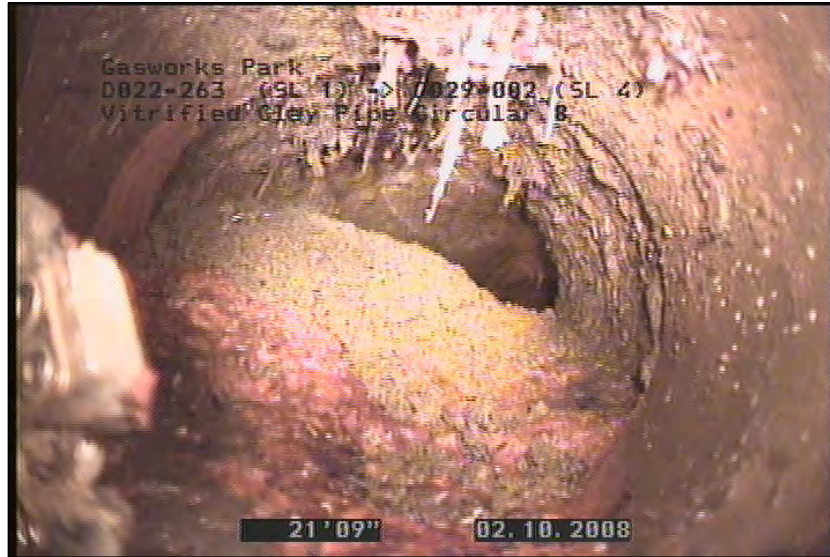
Photo: D022-263 (SL 1)_D029-002 (SL 4)_100208_092533_A.JPG,
 VCR #: GS-10.1.08
 21.76FT, Tap Factory Made Defective, at 09 o'clock, 6", within 8
 inches of joint: NO, REMARK: Debris

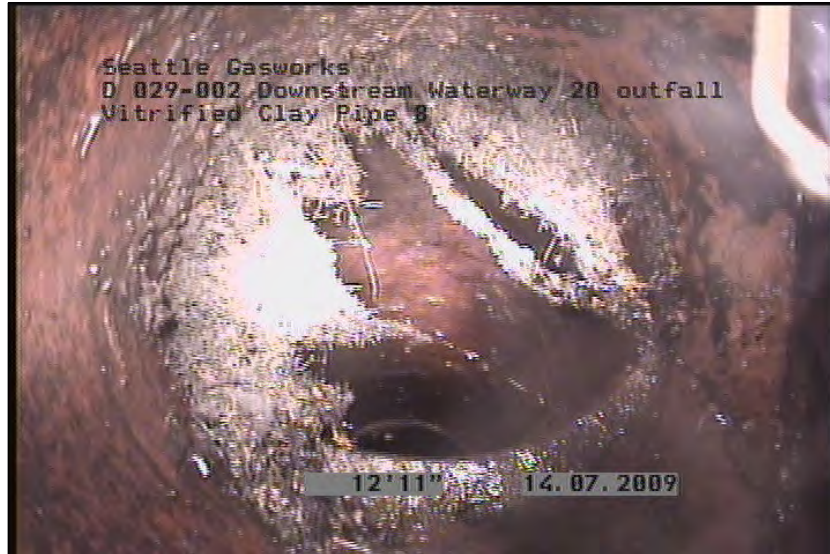
Photo: D 029-002_Waterway 20 outfall_071409_104654_A.JPG,
 00:02:05

12.89FT, Tap Factory Made Defective, at 03 o'clock, 6", within 8 inches of joint: NO, REMARK: roots

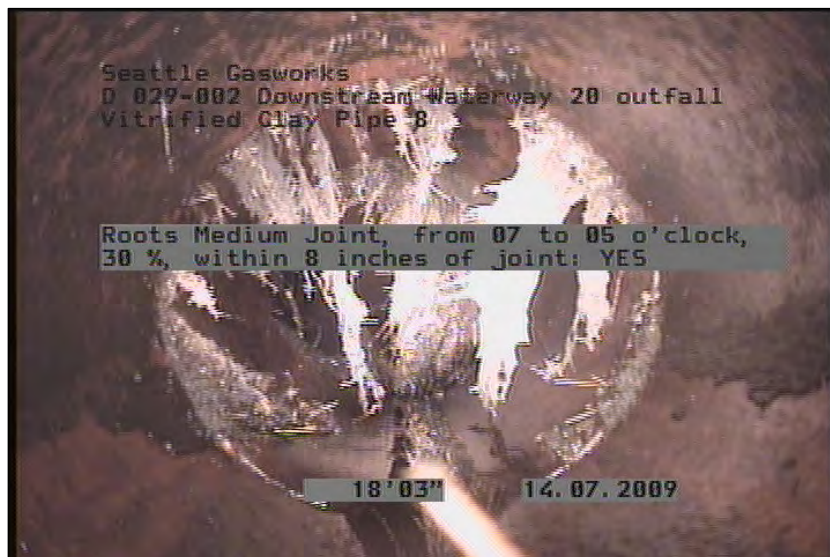
Photo: D 029-002_Waterway 20 outfall_071409_104739_A.JPG,
 00:02:46

18.23FT, Roots Medium Joint, from 07 to 05 o'clock, 30 %, within 8 inches of joint: YES

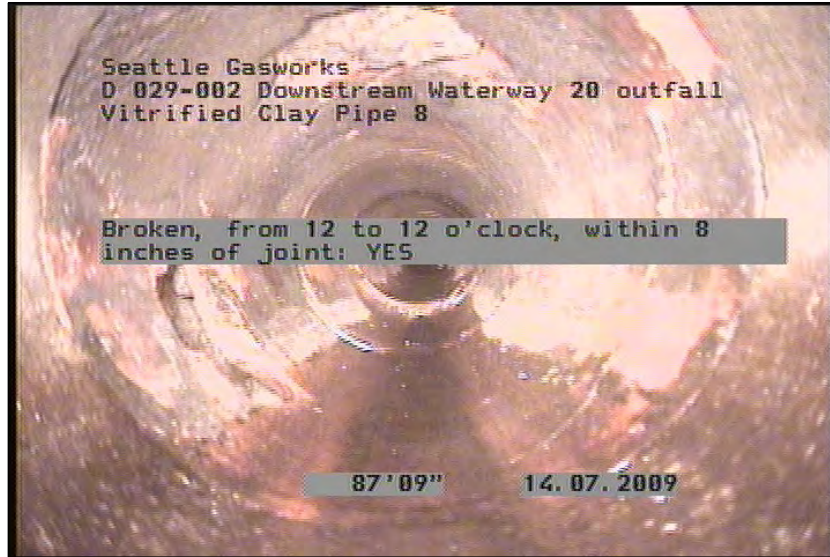
Photo: D 029-002_Waterway 20 outfall_071409_105449_A.JPG,
 00:08:17
 87.73FT, Broken, from 12 to 12 o'clock, within 8 inches of joint:
 YES

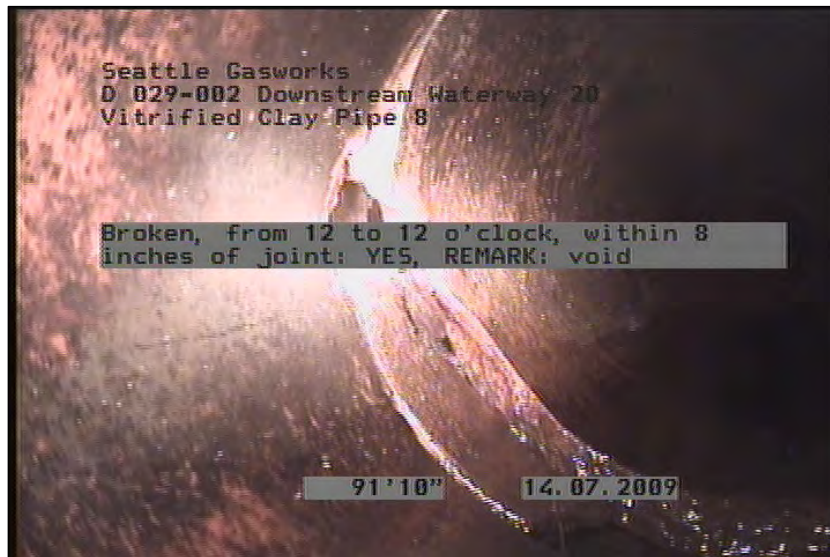
Photo: D 029-002_Waterway 20 outfall_071409_105707_A.JPG,
 00:10:10
 91.86FT, Broken, from 12 to 12 o'clock, within 8 inches of joint:
 YES, REMARK: void

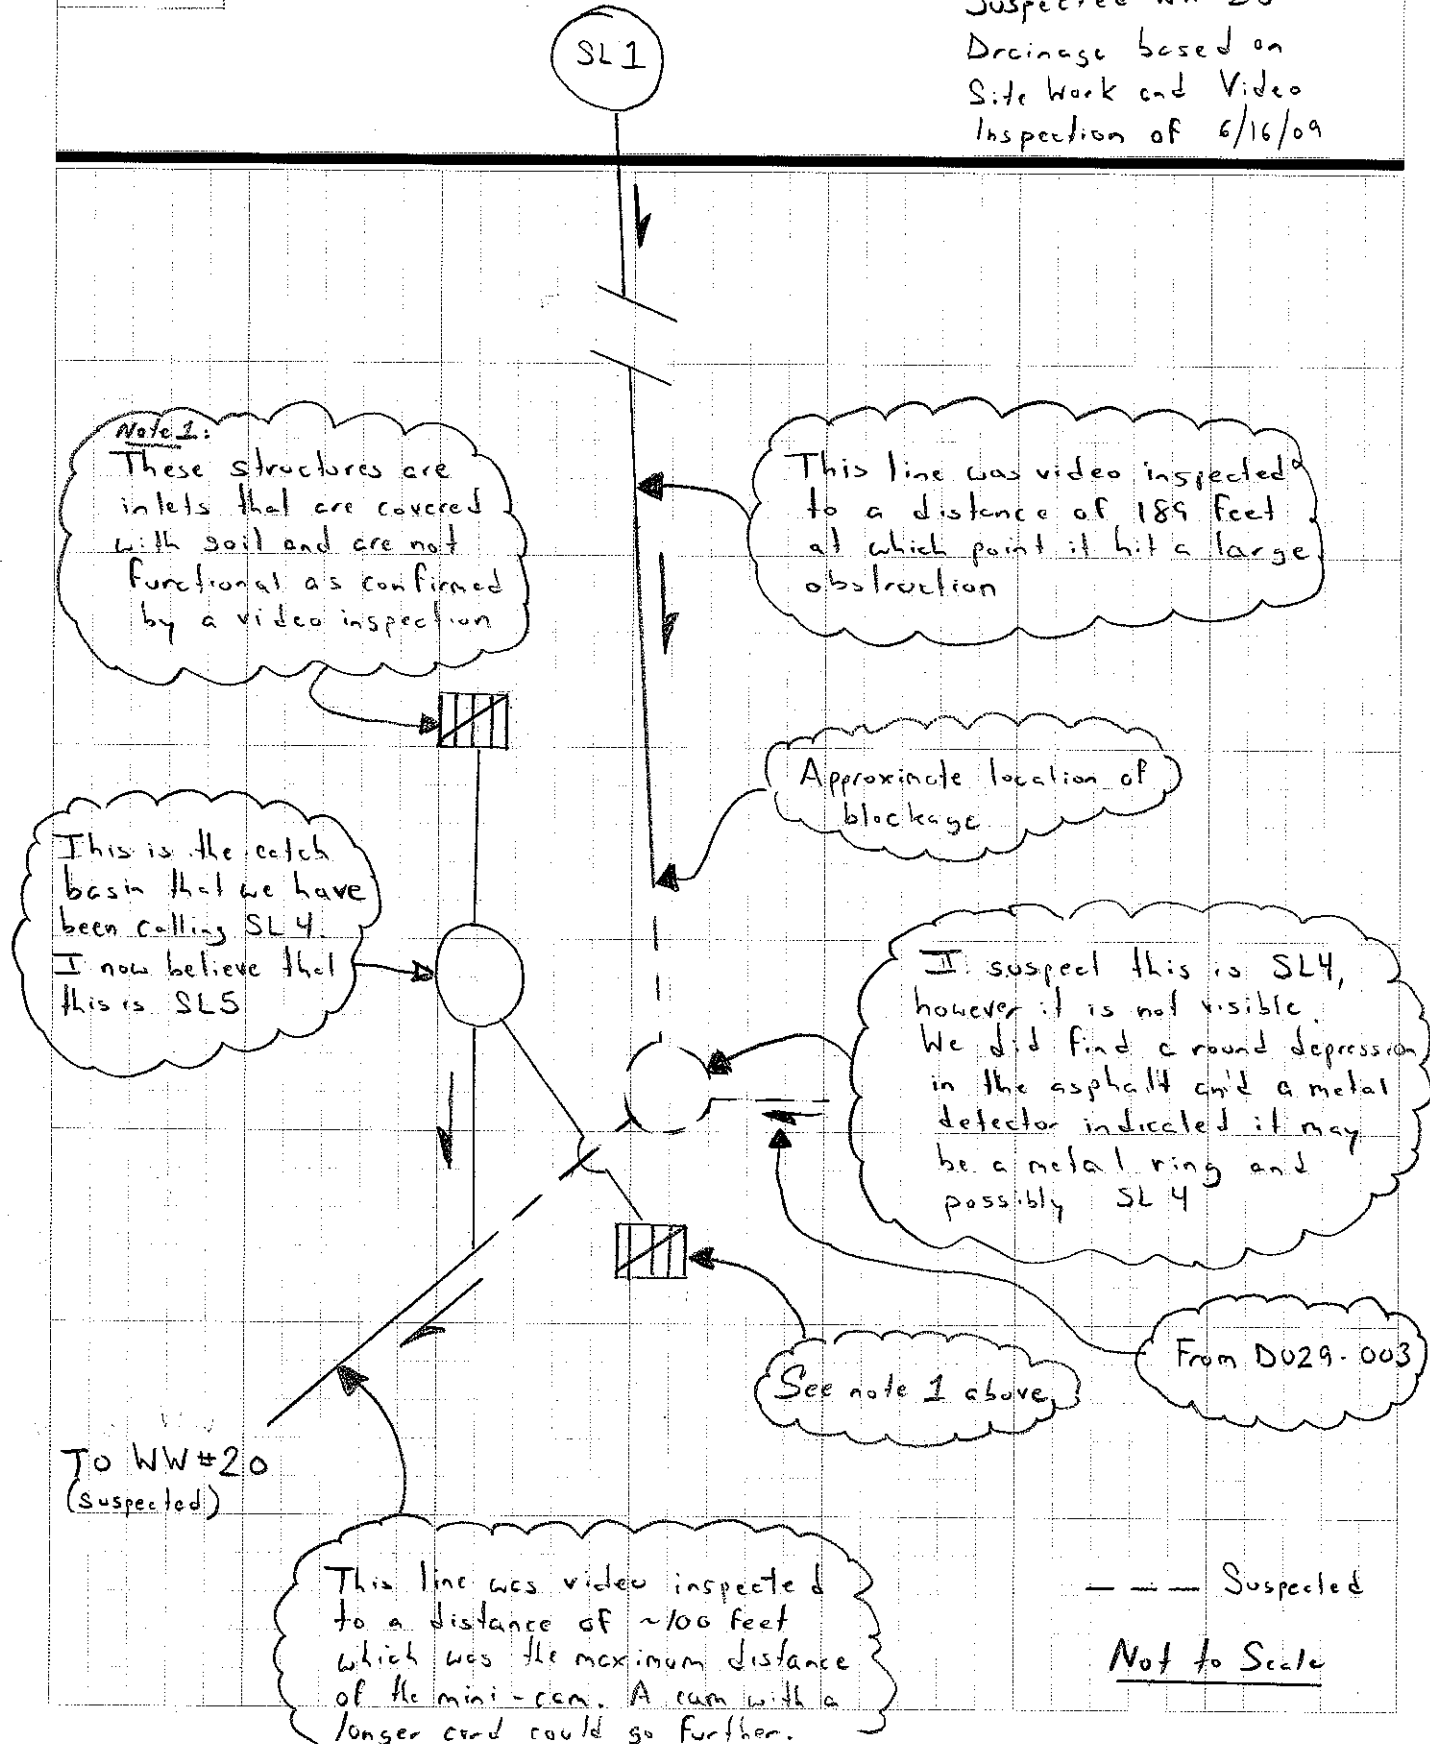
Suspected WW#20
 Drainage based on
 Site Work and Video
 Inspection of 6/16/09

This line was video inspected to a distance of 189 feet at which point it hit a large obstruction

Approximate location of blockage

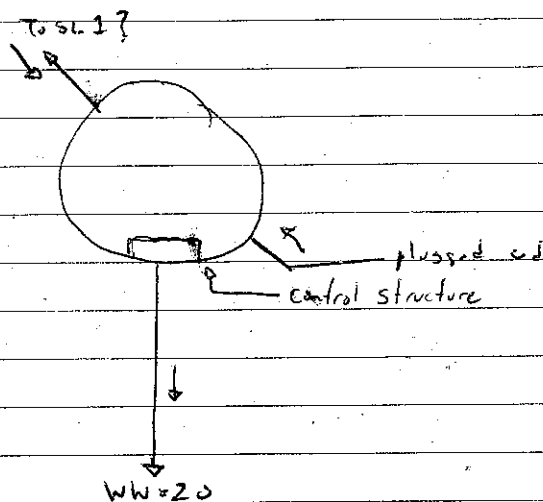
The manhole that goes to WW#20

We went up the line to SL1, but it was very clogged, got about 9' and found ~~what~~ appeared to be a new structure. Line was too clogged to continue further. This line appears so clogged it is hard to believe it is used?!?

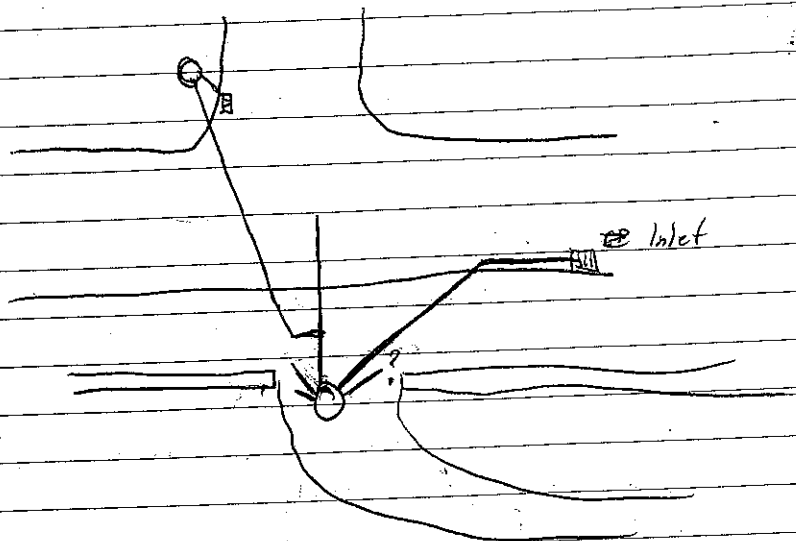
1430 Put camera in inlet along N. Nankleby
 At ~20' it entered brick structure
 likely the same structure that the pipe
 from SL1 entered. (ventilated clay pipe)
 Measured with sound within ~3' of other
 sound locate
