2022 ANNUAL CAP INSPECTION REPORT

BNSF Northport Site

NOVEMBER 18, 2022

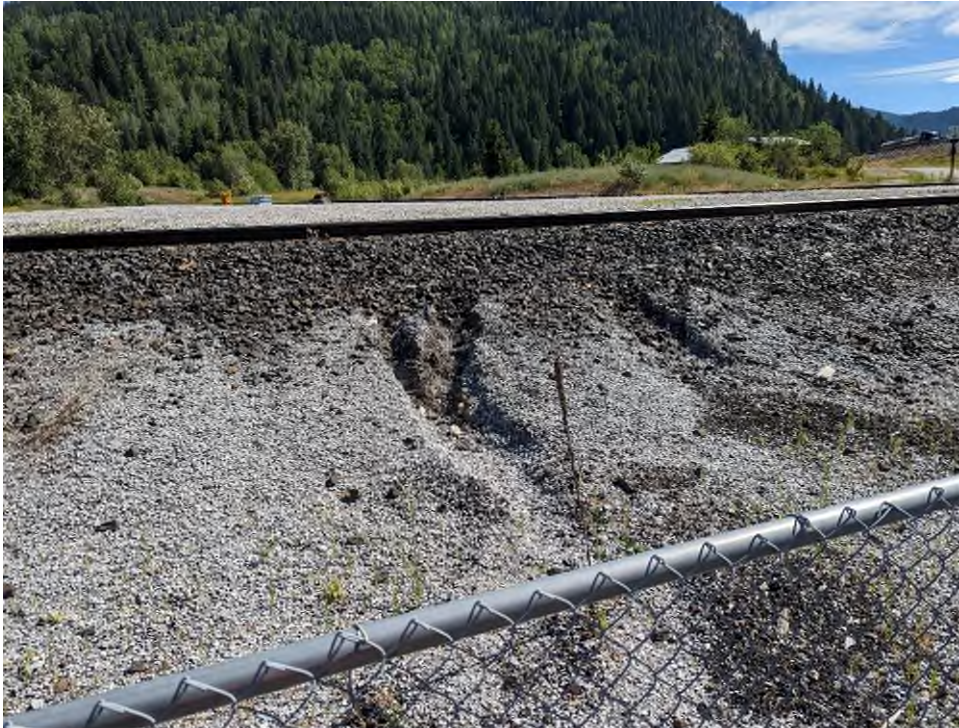
Inspection Point: 001

Description:
Erosional feature along northern rail subgrade

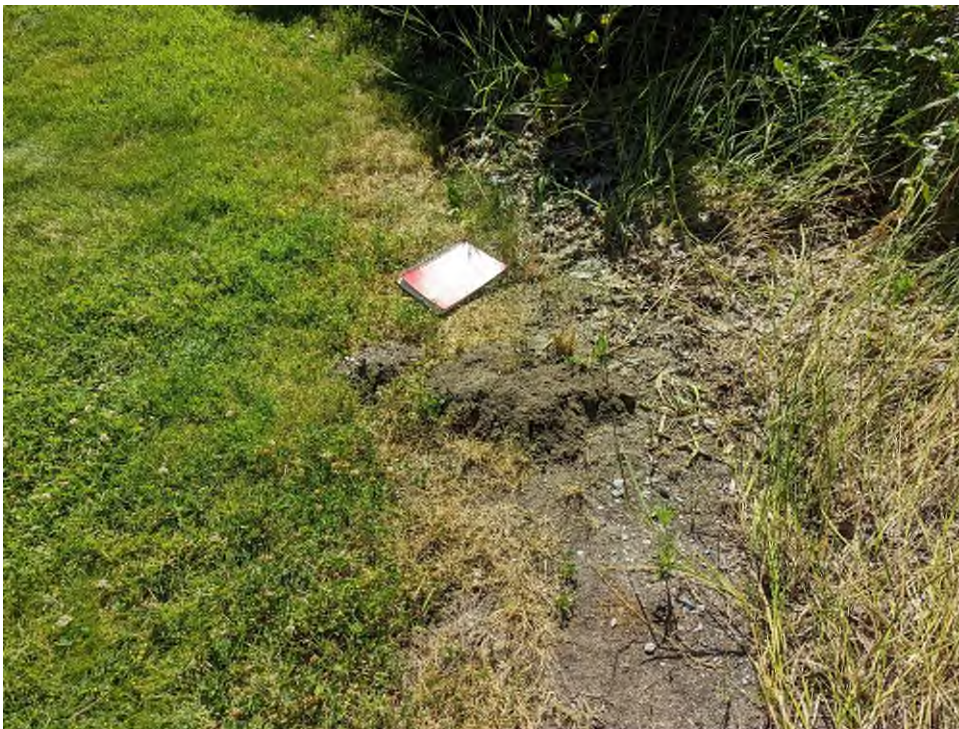
Inspection Point: 002

Description:
Possible burrows in northwest area of park

The low spots identified during the cap inspection were addressed through the application of additional gravel cover. Animal burrows will be addressed by filling the burrows and a subcontracted exterminator. The vegetation present along the fence line will be addressed through the application of an herbicide spray prior to the start of the next growing season or by physical removal. Disturbed areas will be amended as needed as soon as is feasible. The next cap inspection will occur in 2023.

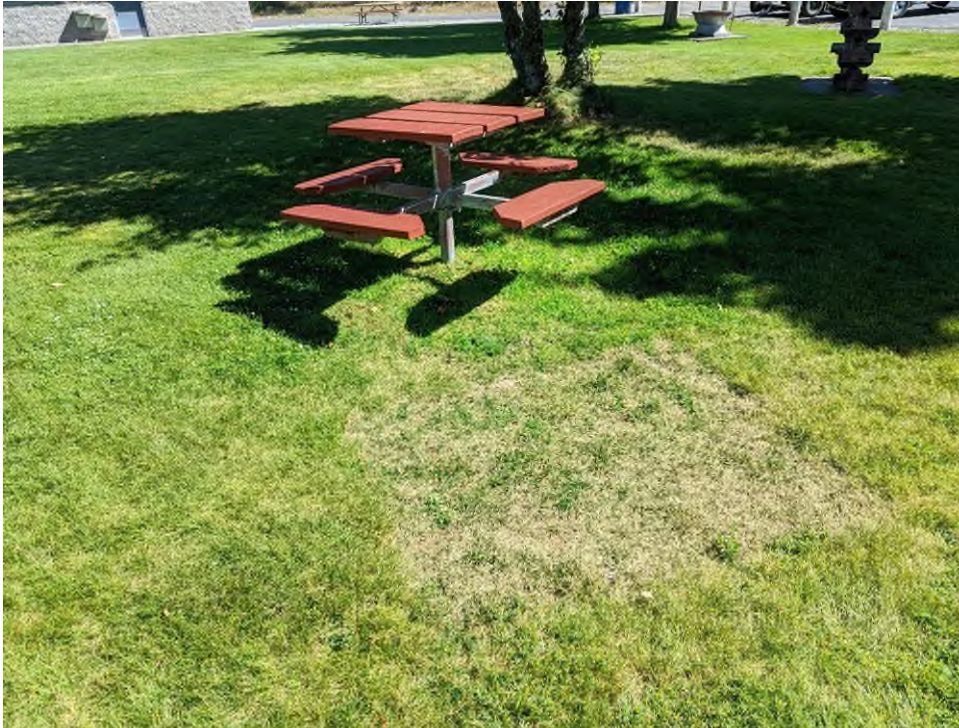
Inspection Point: 003

Description:
Sod condition within park

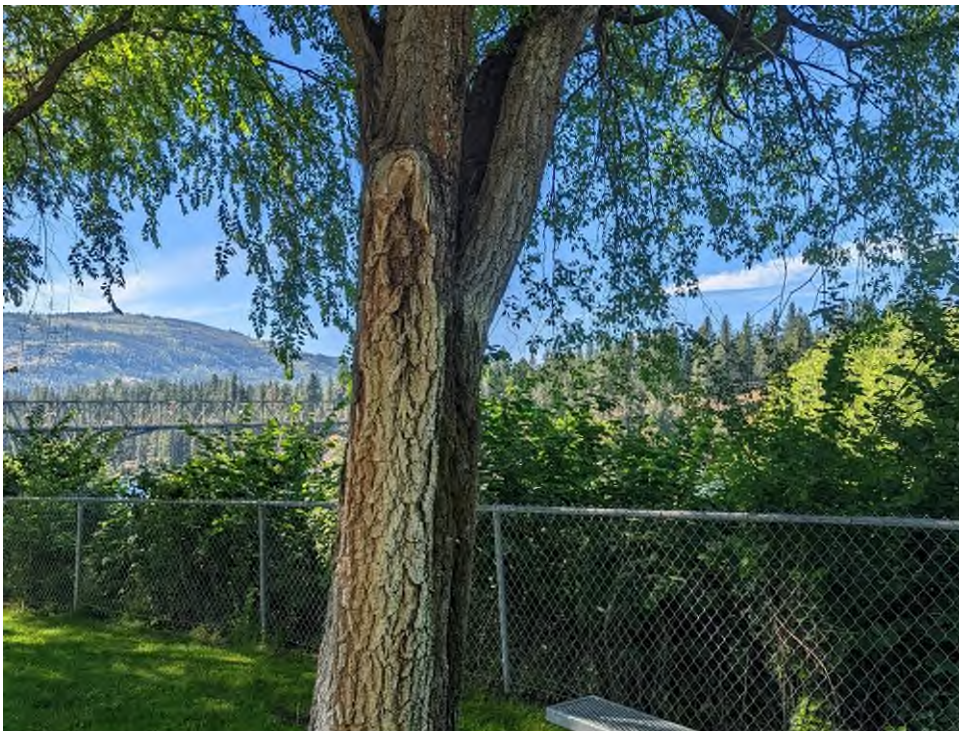
Inspection Point: 004

Description:
Tree condition in park

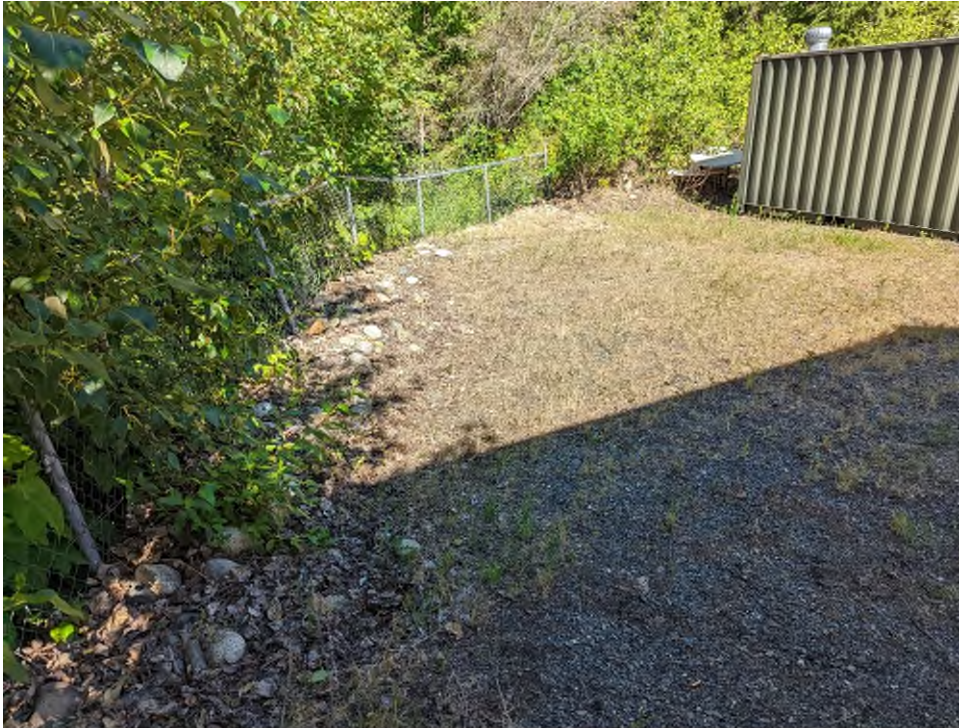
Inspection Point: 005

Description:
Site condition in NE
area of park near
Conex

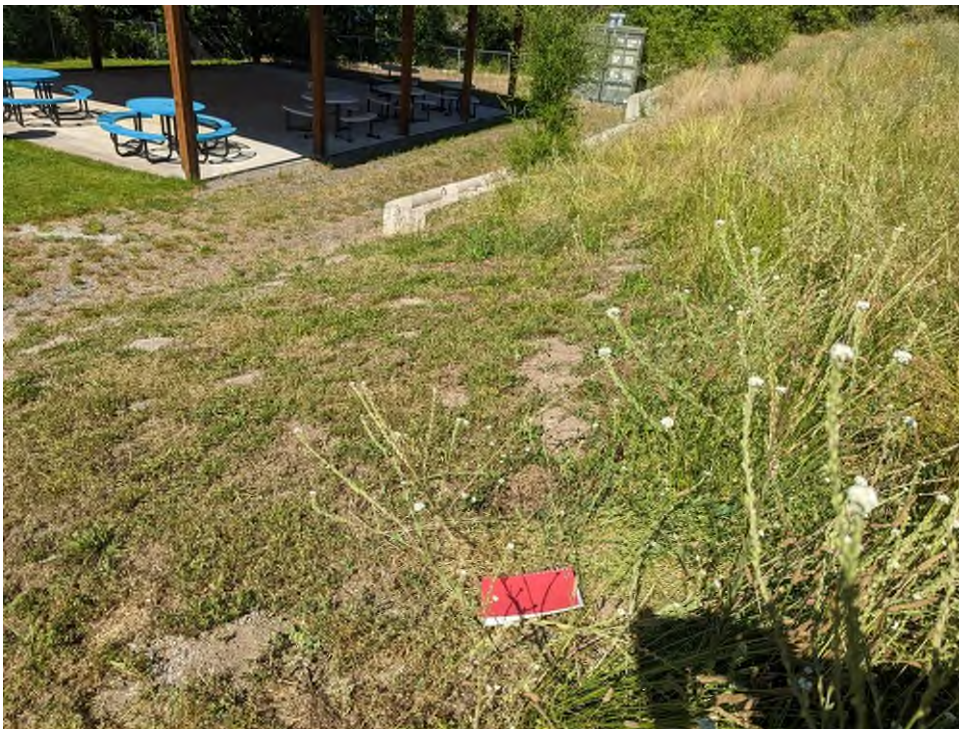
Inspection Point: 006

Description:
Possible burrows on rail
embankment south of
pavilion area

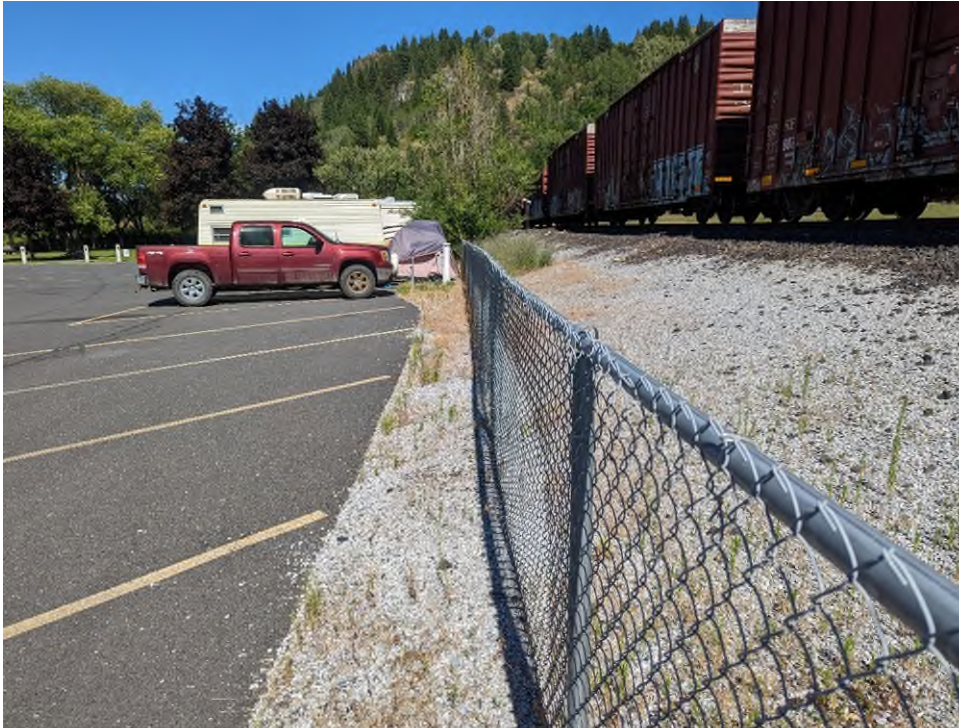
Inspection Point: 007

Tent camping adjacent to parking lot

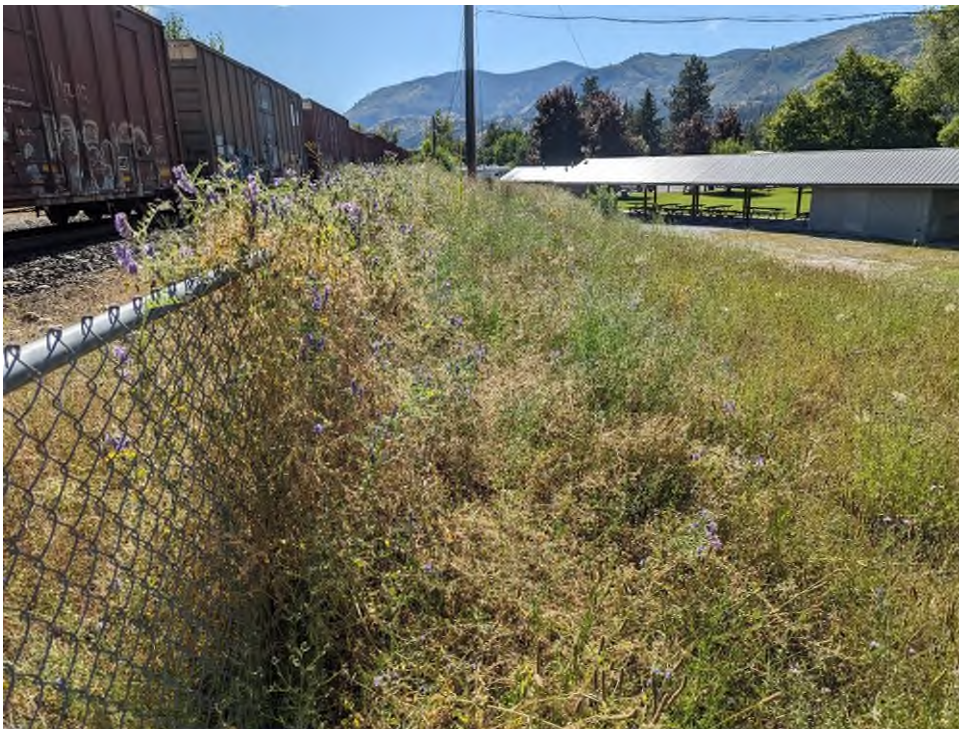
Inspection Point: 008

Minor vegetation along fence and embankment adjacent to park

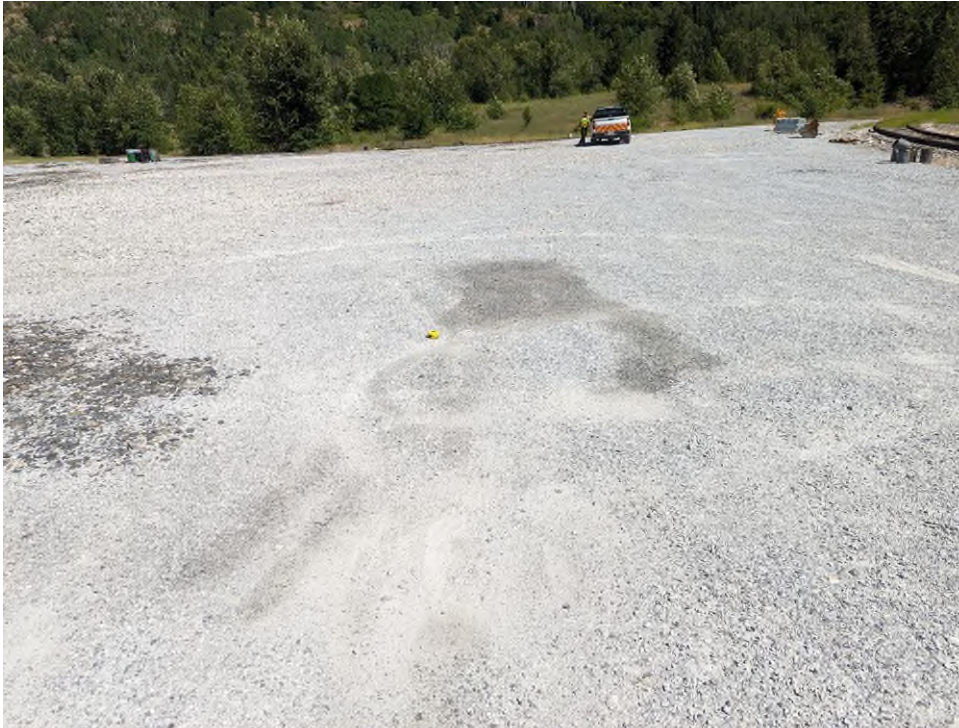
Inspection Point: 009

Description:
Low spot in gravel near entrance to capped area (<4 inches deep)

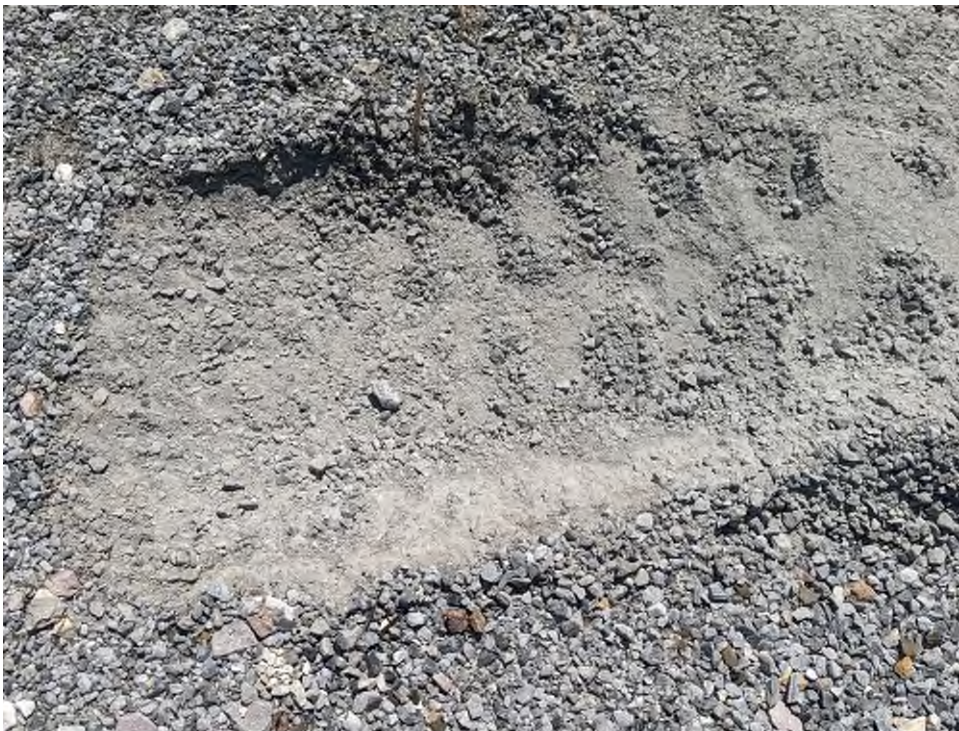
Inspection Point: 010

Description:
Minor disturbance from tracked equipment (<6 inches deep)

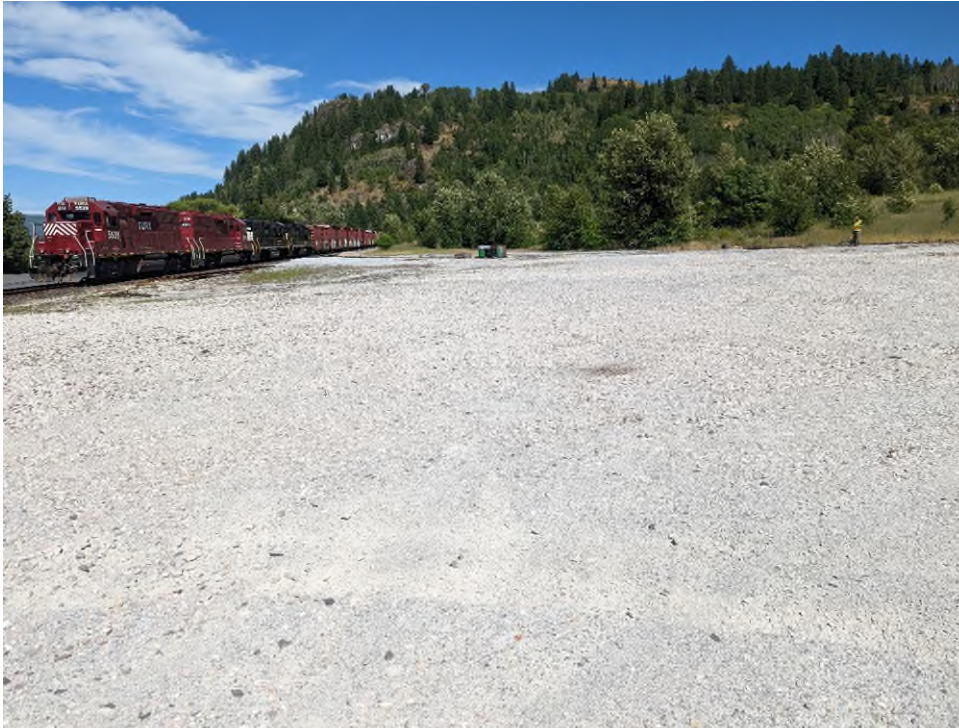
Inspection Point: 011

Description:
New gravel placed on pad
