ASPHALT INSPECTION FORM

Darling Ingredients - Tacoma, Washington Facility

Facility No.: 25455514, Cleanup Site No.: 8475, VCP Project No.: SW1317

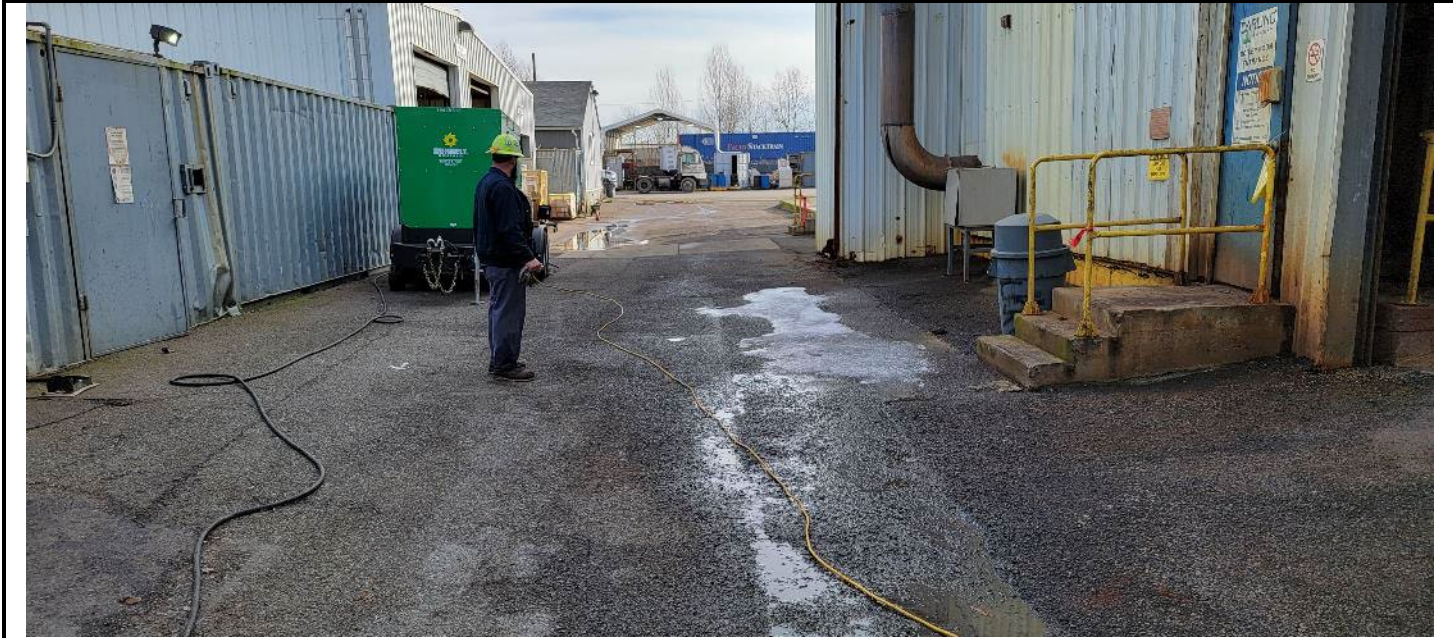
4. Potholes identified?	<input type="checkbox"/> Yes <input checked="" type="checkbox"/> No
How many potholes were identified? <i>One area with three or four very small, shallow pits in asphalt observed adjacent to the concrete between office building and rendering building. The pits were in asphalt – no soil or gravel present.</i>	# of Areas <u> 1 </u>
List the location(s) of the potholes identified and describe the condition observed. Locate the potholes on the map. <i>Adjacent to concrete pad between the office building and rendering plant.</i>

Area between office and rendering plant.

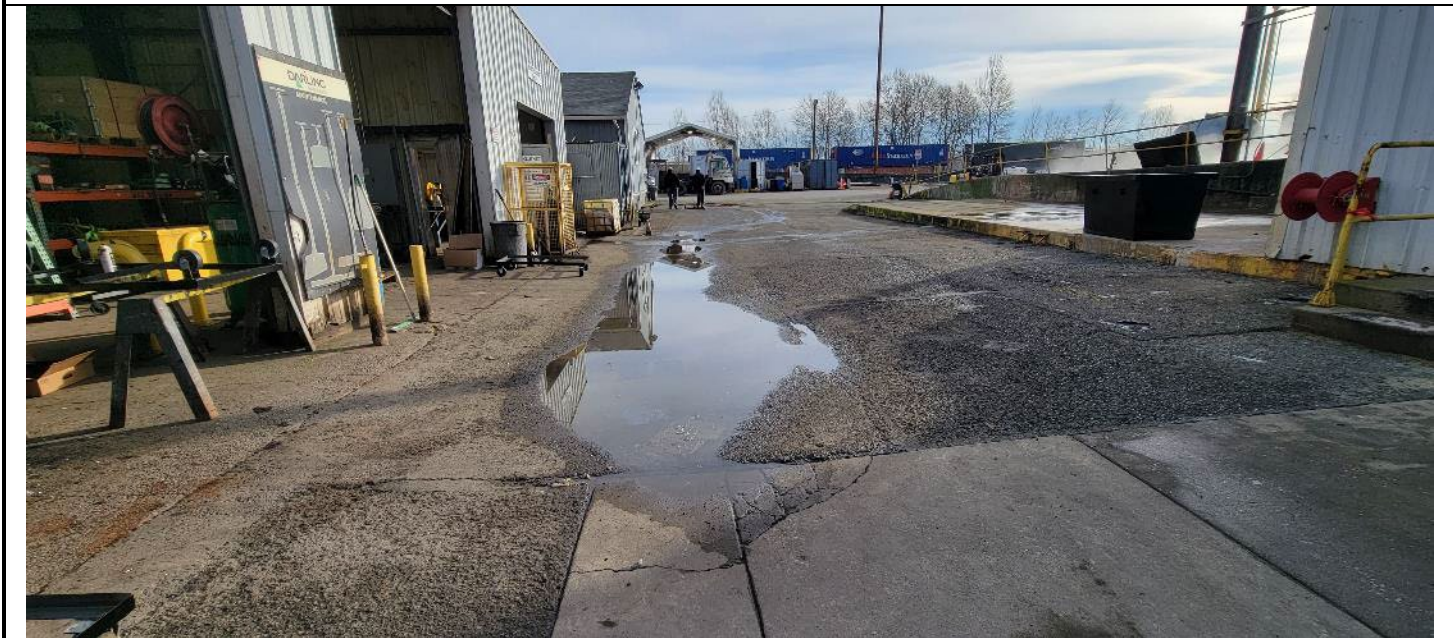
South drain area. Multiple concrete patches in area of drain.

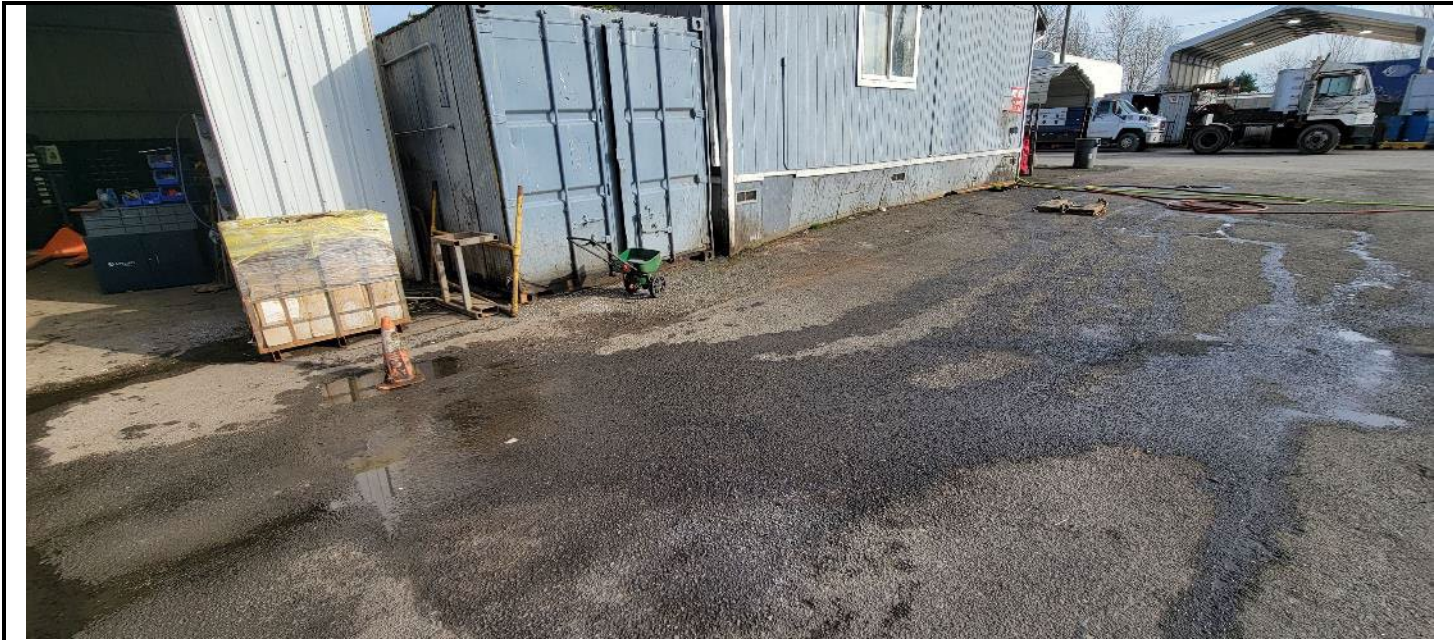
South side of lunchroom building.

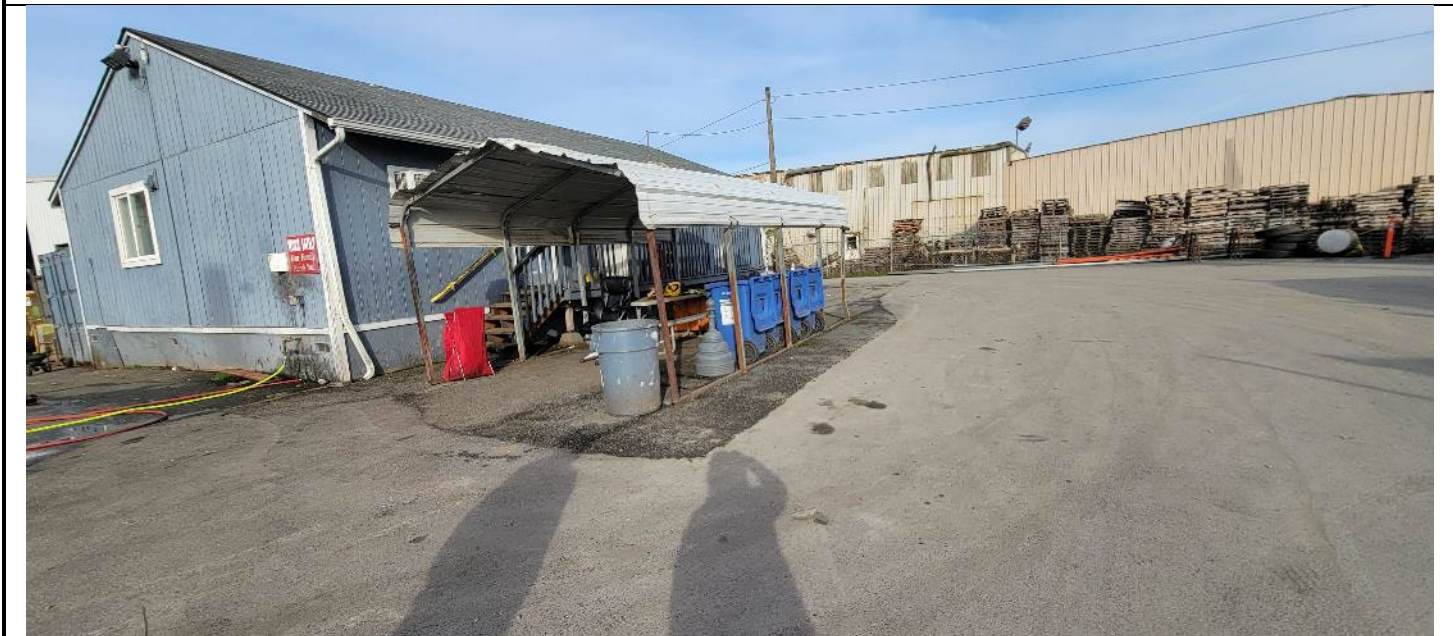
Looking southwest from near former MFG-3 well location. Older asphalt in area of lunchroom building and carport.

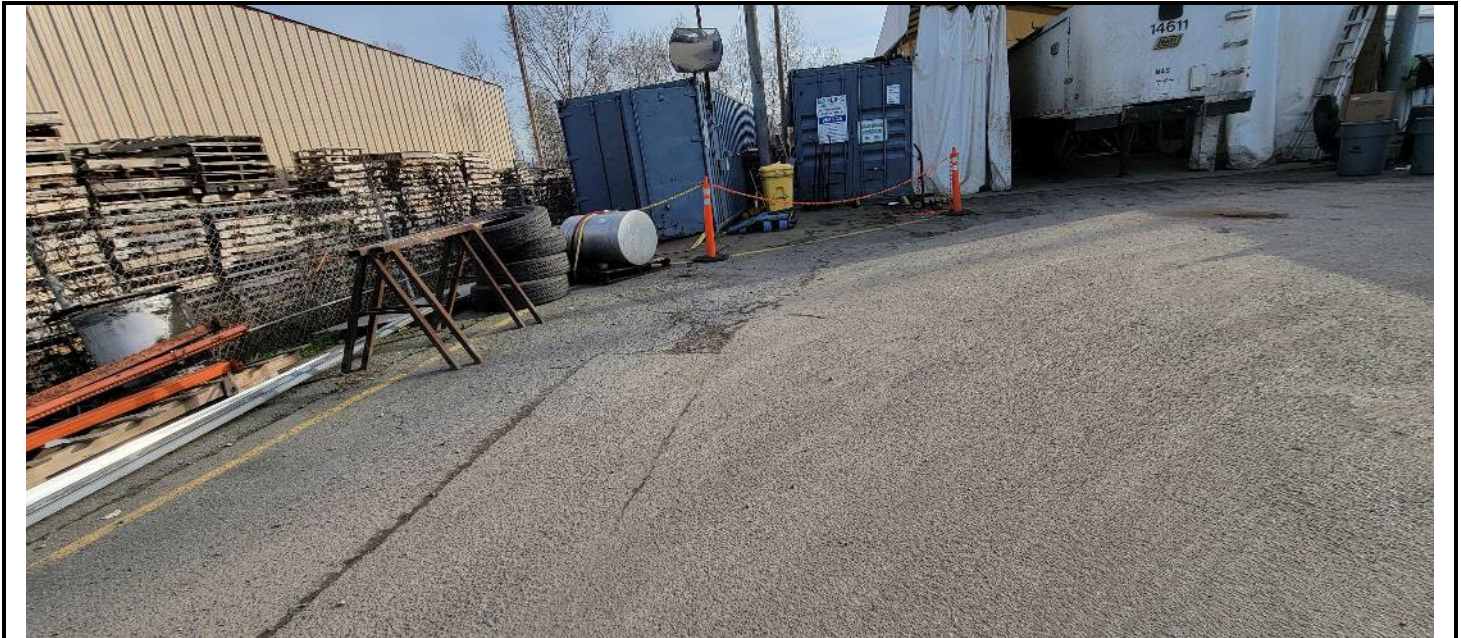
Small area of alligator cracking at end of concrete patch near truck shop.

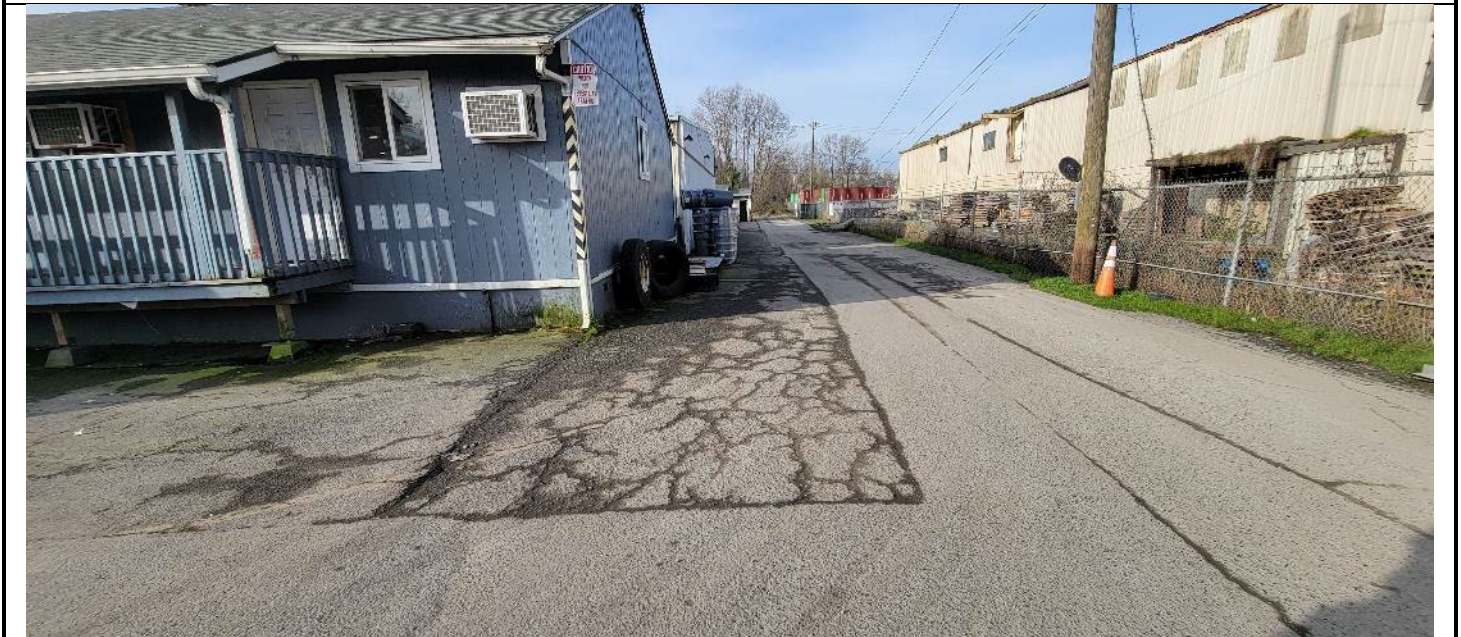
Alligator cracking northeast and north of lunchroom building. Multiple concrete patches in area.

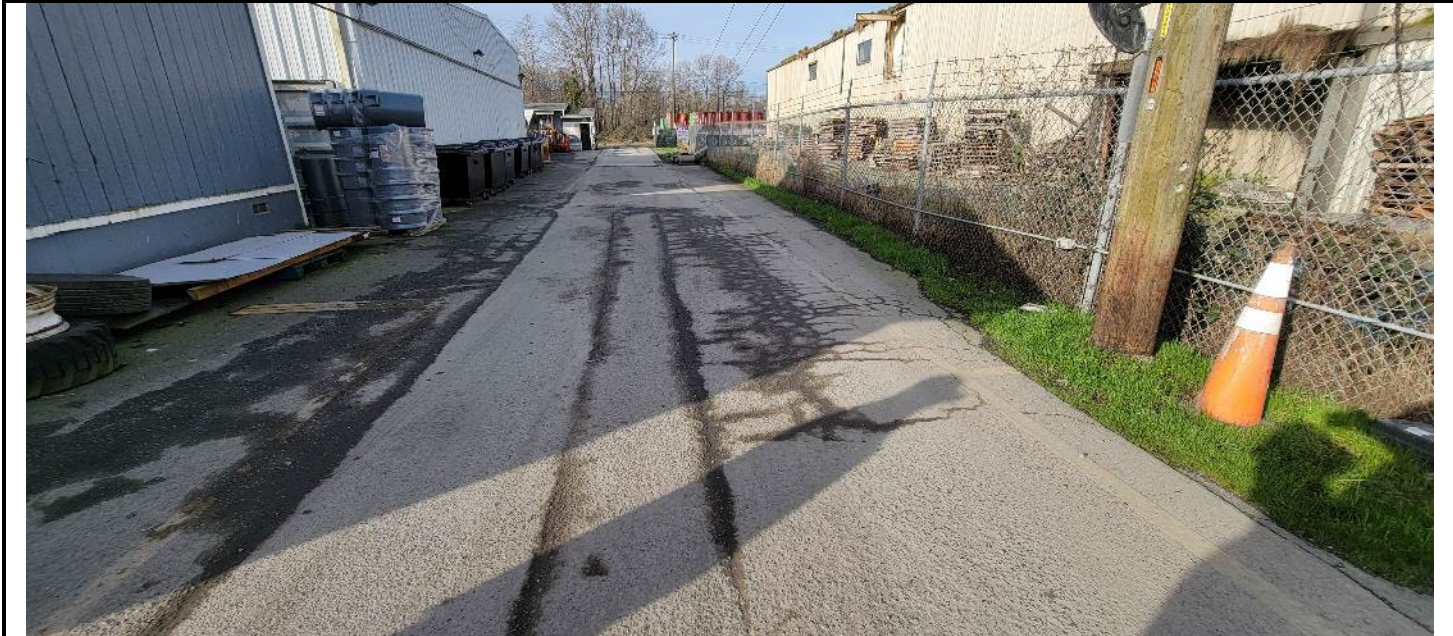
Alligator cracking on north side of shop along main truck route. Some cracking along north asphalt edge. Additional asphalt patch areas.

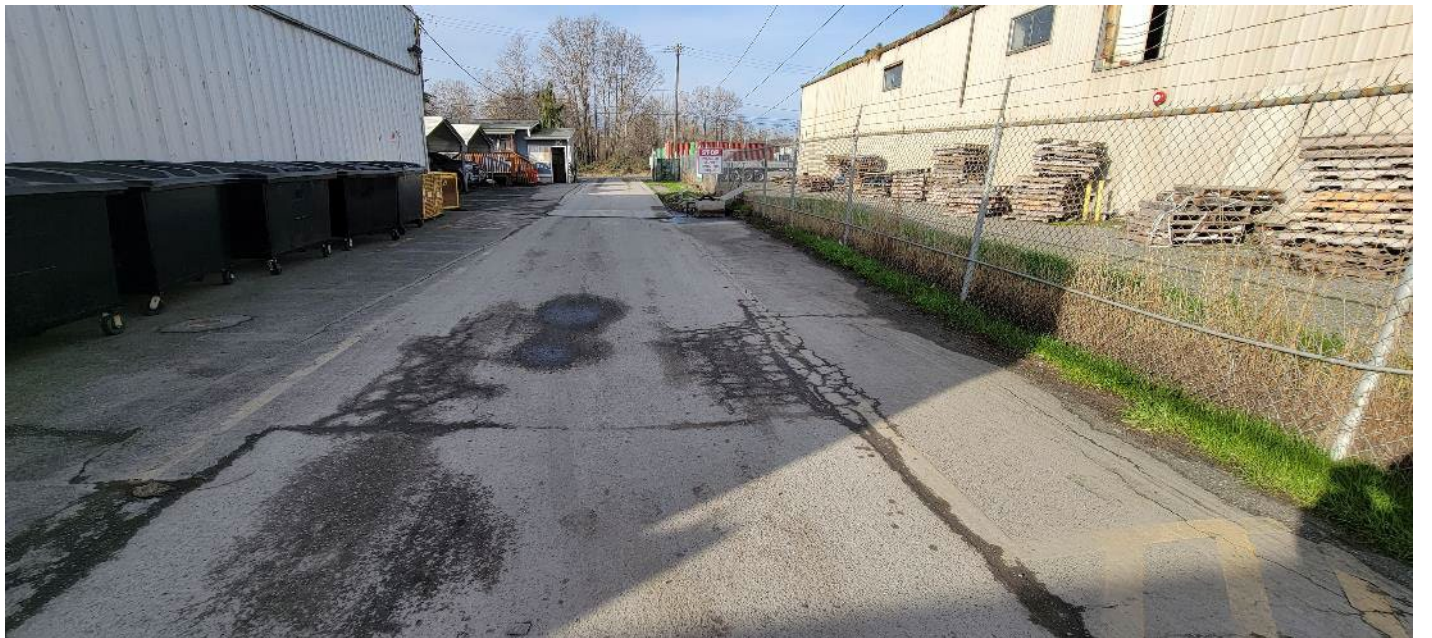
More alligator cracking along truck route north of shop.

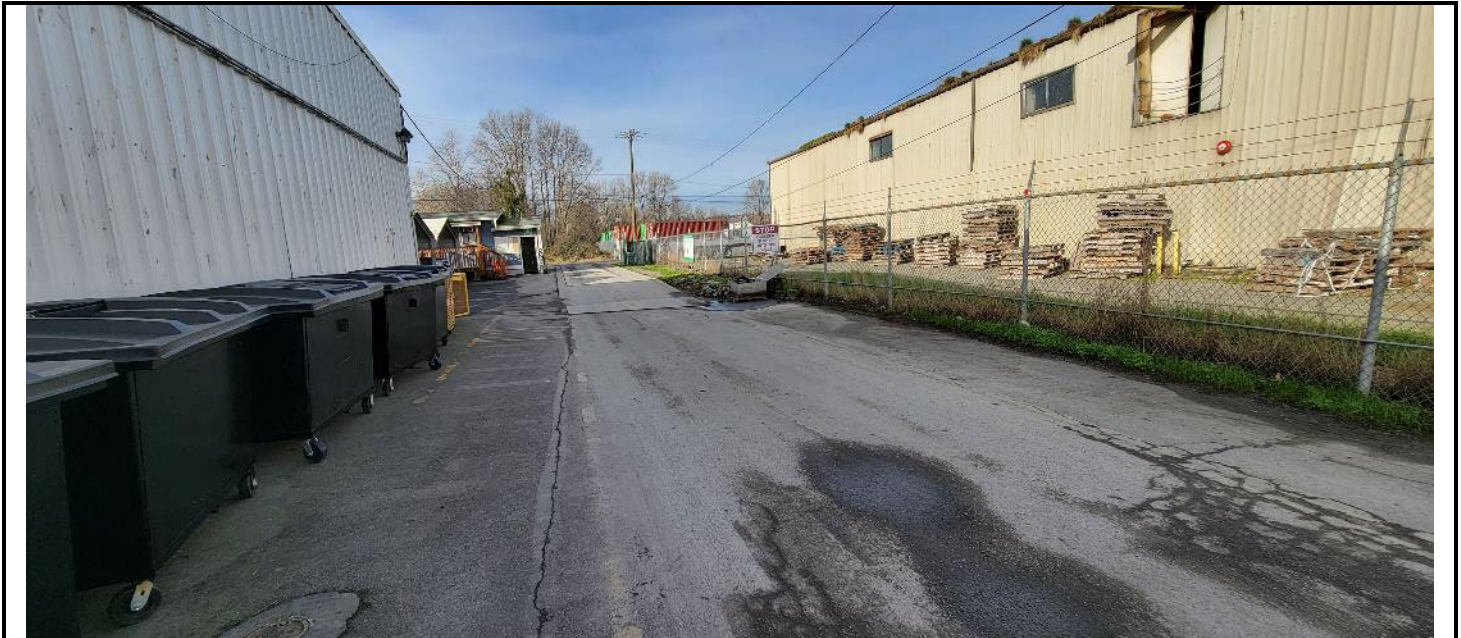
Linear crack that may have received patch material in the past; located n north side of shop near well MFG-1 (bottom left circular feature in photograph).

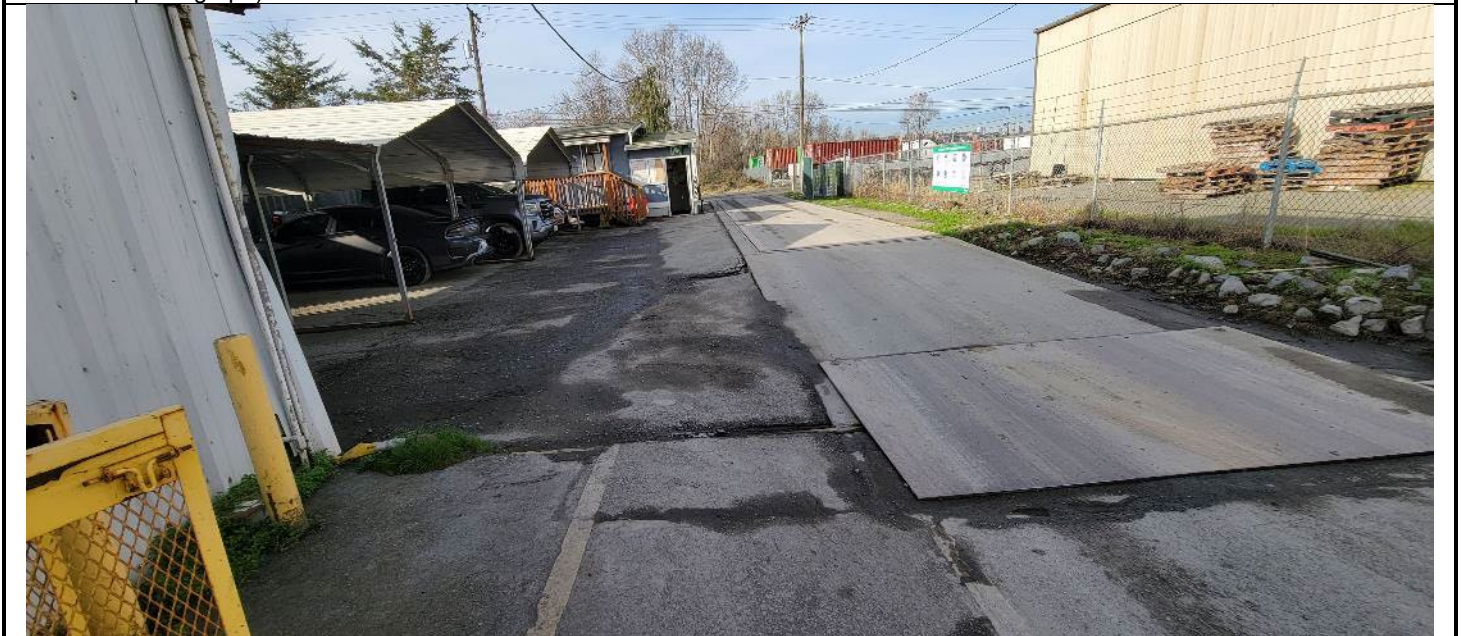
Miscellaneous small linear cracks near truck scale and car ports. Drain cut from building to weigh scale ramp in middle left of photograph.
