**PUBLIC REVIEW DRAFT  
REMEDIAL INVESTIGATION REPORT  
ICS/NWC RI/FS  
SEATTLE, WASHINGTON**

**REMEDIAL INVESTIGATION REPORT  
ICS/NWC  
SEATTLE, WASHINGTON**

SUBJECT: Results of Embayment Site Reconnaissance  
Work Plan Task EB-1  
Industrial Container Services, Seattle, Washington

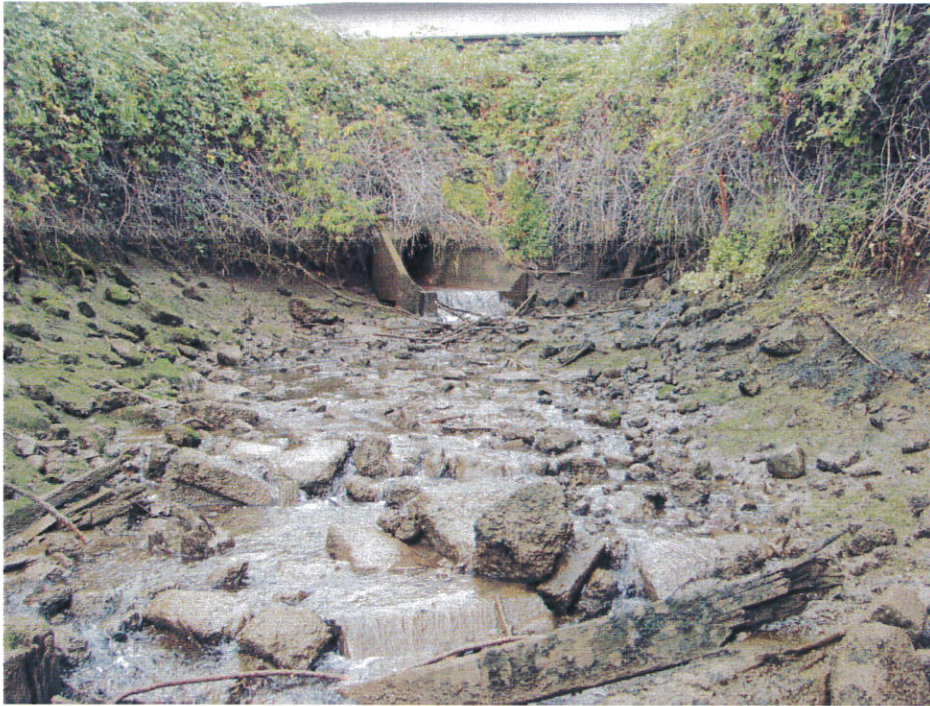
***West End (Head) of Embayment*** - The west end of the embayment is covered with broken concrete, rebar, wood and other debris (Figure 3, top photograph). The broken concrete appears to have been placed as a scour protection apron for discharges from a reservoir overflow outfall. The relatively steep bank walls are covered with blackberries and other vegetation.

West End of Embayment  
(view to west toward  
reservoir overflow  
outfall)

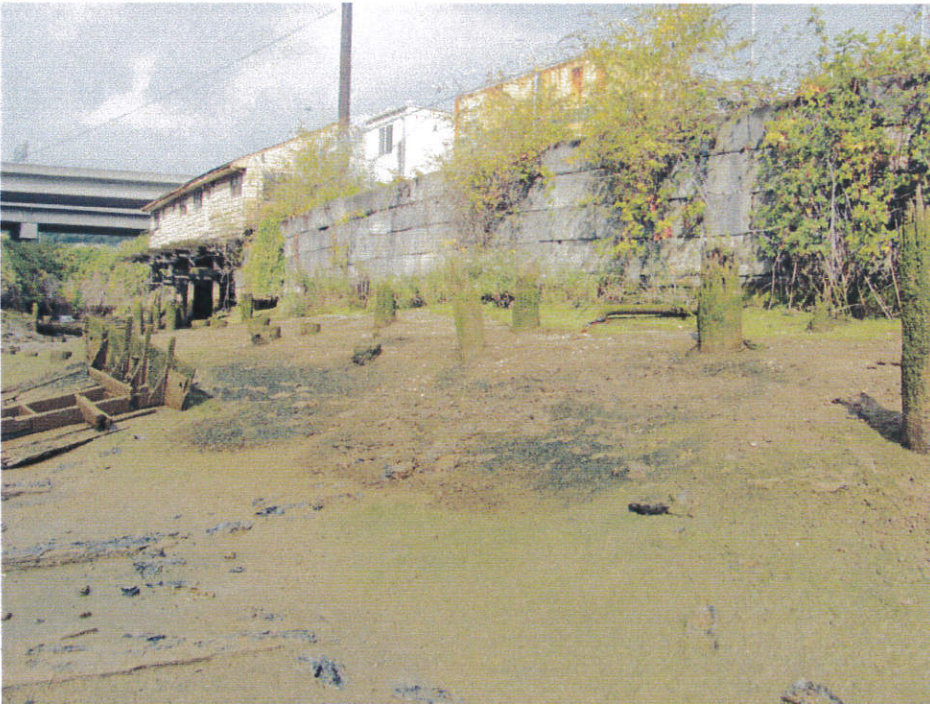
***North Embayment Shoreline (Bank)*** - Figures 3 (bottom photograph) to 10 show the general condition of the north embayment shoreline. A partially pile supported wood frame structure and concrete ecology block wall are present along approximately 135 feet of shoreline (Figures 3, bottom photograph and 4). The north end of the structure is supported by fill, including large boulders. The top of the ecology block wall (composed of at least five levels of blocks) rises approximately eight to ten feet above the bottom sediment. A partially buried concrete truck drum was observed on the west end of the wood frame structure (Figure 4, top photograph).

West End of North  
Bank (view to  
northwest)

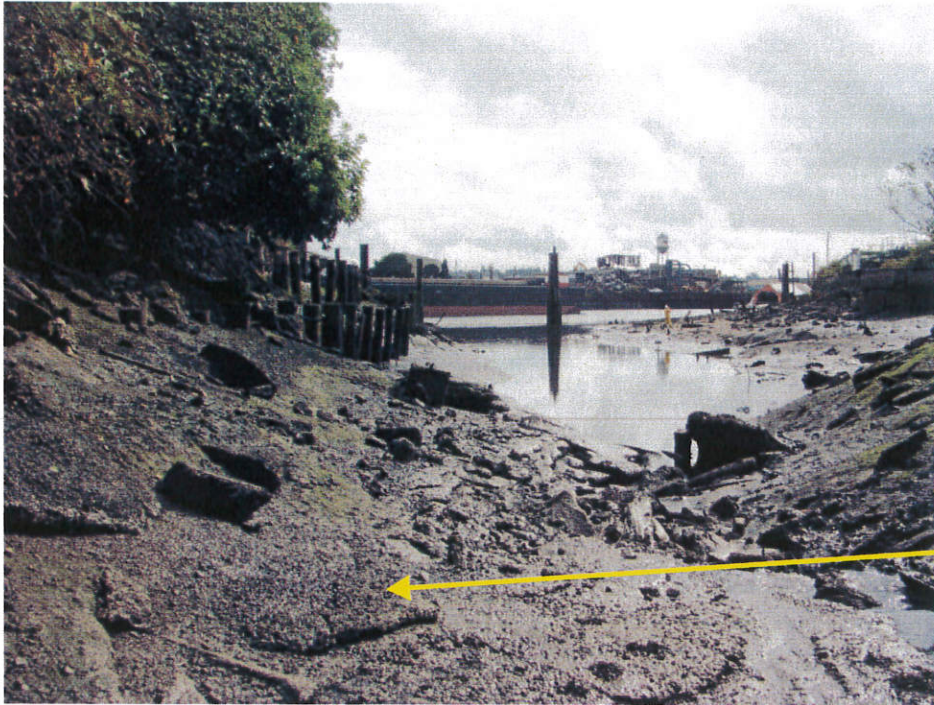
Mouth of Embayment  
North and South Banks  
(view to east)

*Waste Concrete  
Flows*

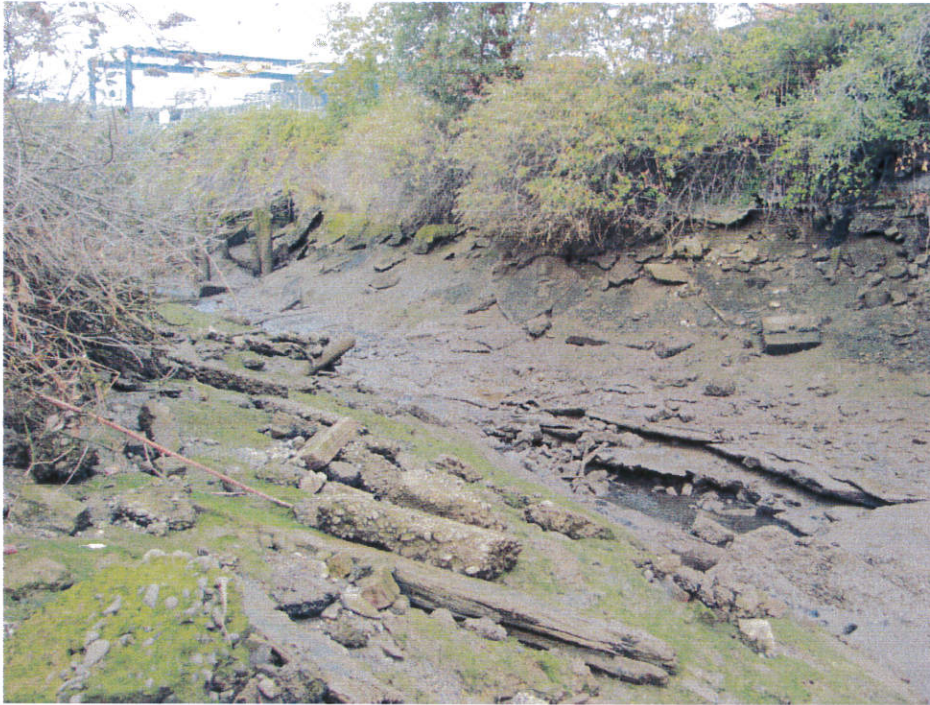
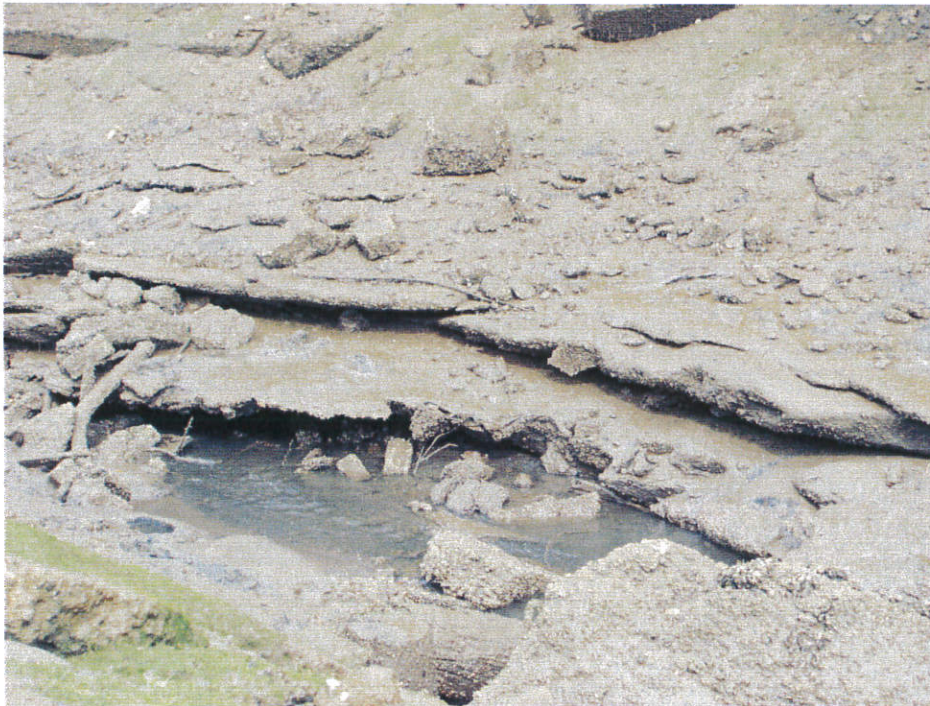
<b>ICS/Trotsky Property</b>		<b>FIGURE 7</b>
<b>Embayment Photographs - 9-7-10 (North Bank)</b>		
<i>SUM-008-00 (ICS)</i>	<i>Nov. 2010</i>	
<i>Dalton, Olmsted &amp; Fuglevand, Inc.</i>

Waste Concrete Flows -  
North Bank - East Side of  
Neck  
(view to northwest)

Waste Concrete Flows -  
North Bank - East Side  
of Neck  
(view to north)

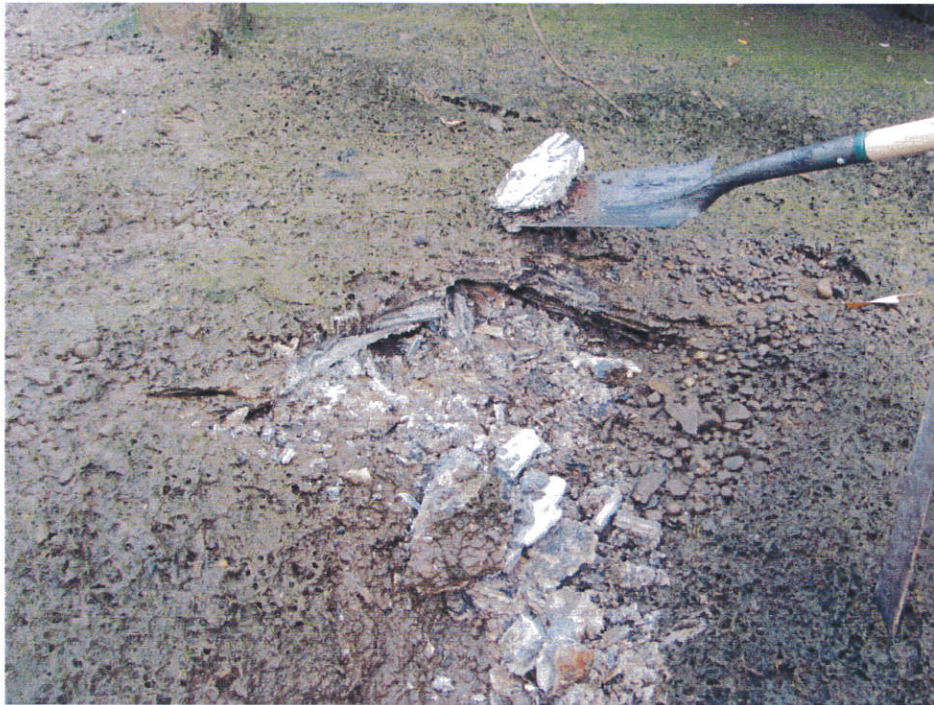
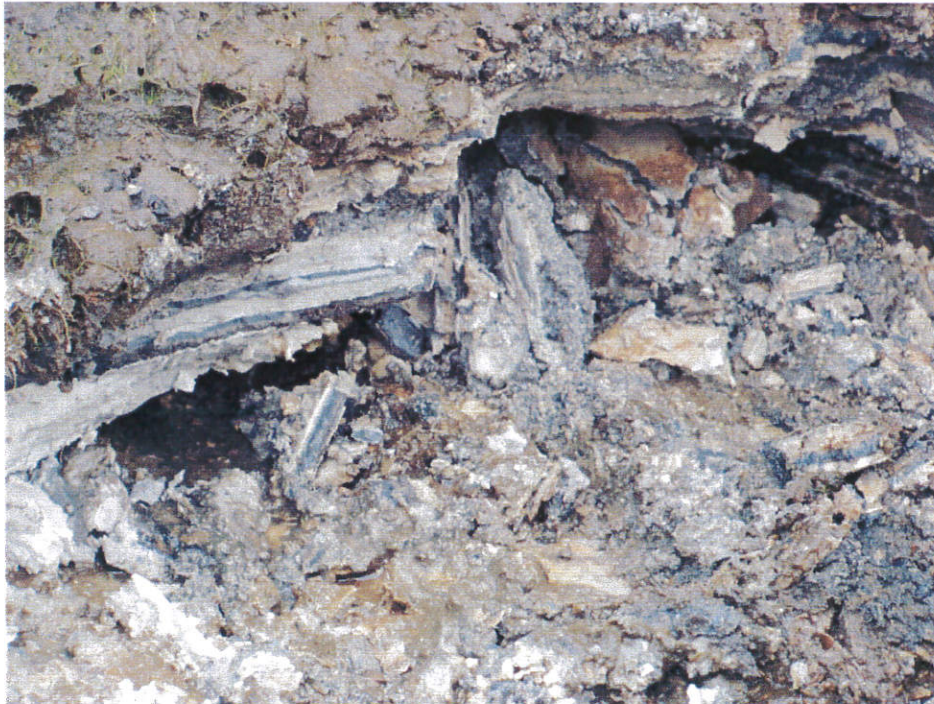
**FIGURE  
8**

Chemical Precipitate -  
North Bank -  
(view to north)

Chemical Precipitate -  
North Bank -  
(closer view)

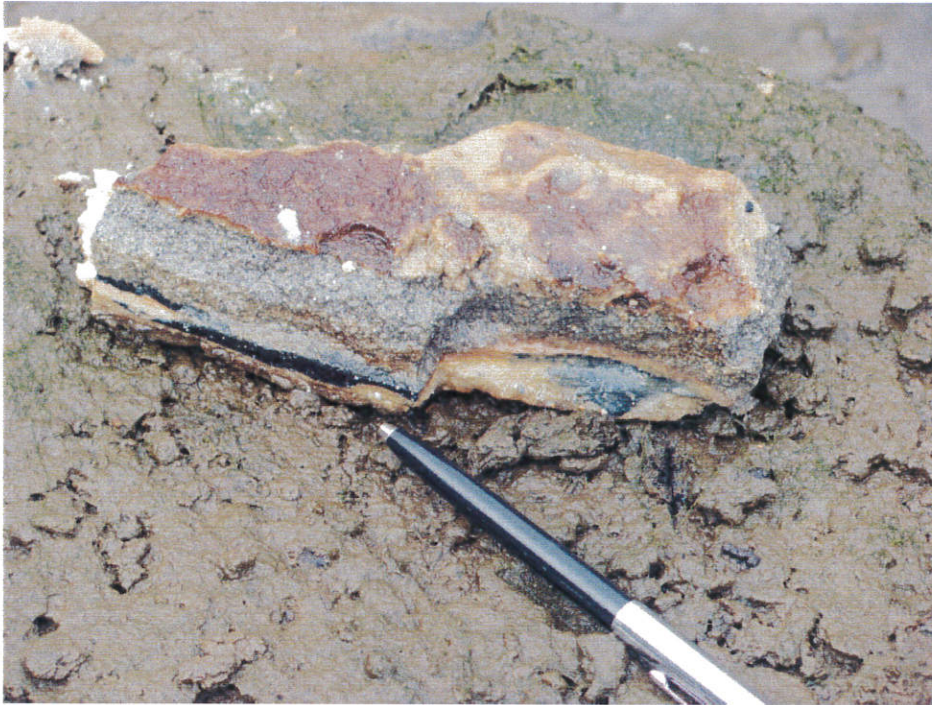
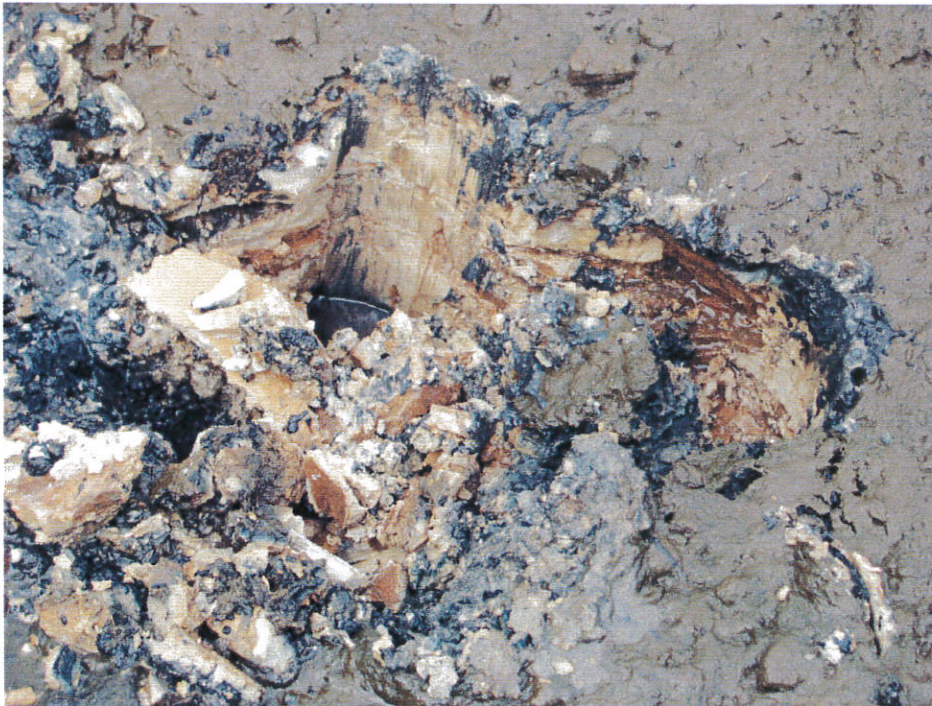
FIGURE  
9

Chemical Precipitate -  
North Bank -  
(cemented material)

Chemical Precipitate -  
North Bank -

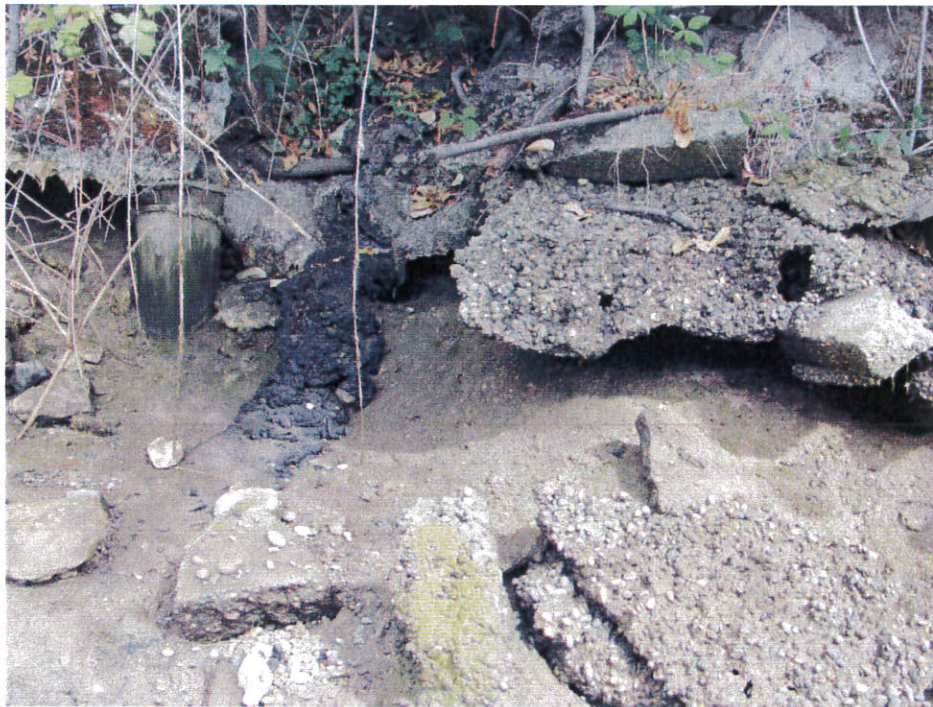
A small amount of asphalt-like material was observed within the neck area on the north bank (Figure 10). This material appears to have flowed out from the north bank.

Asphalt-Like Material  
North Bank  
(view to north)

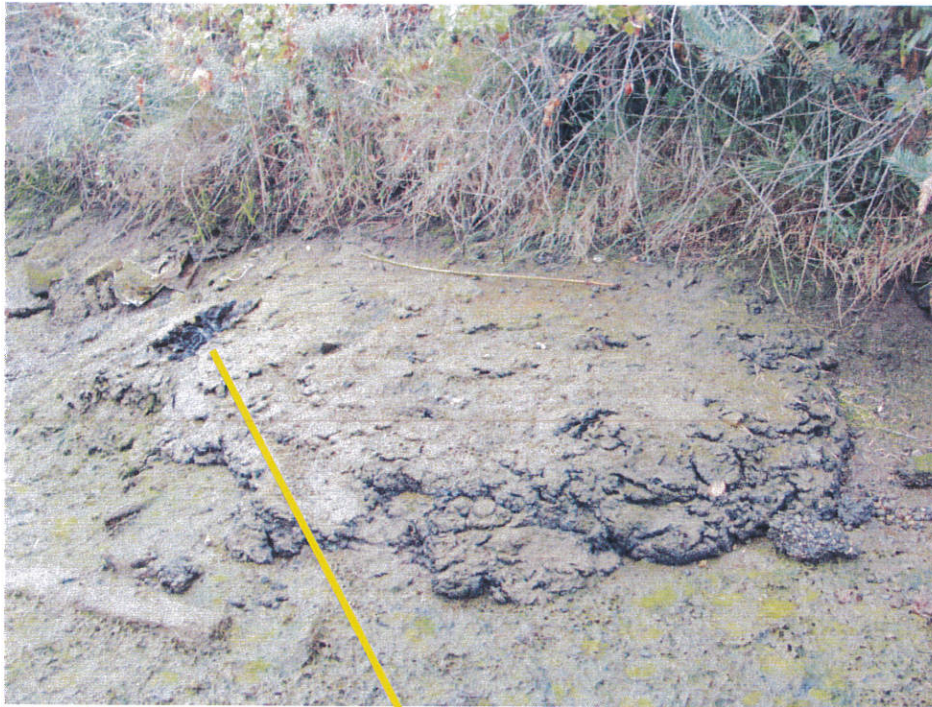
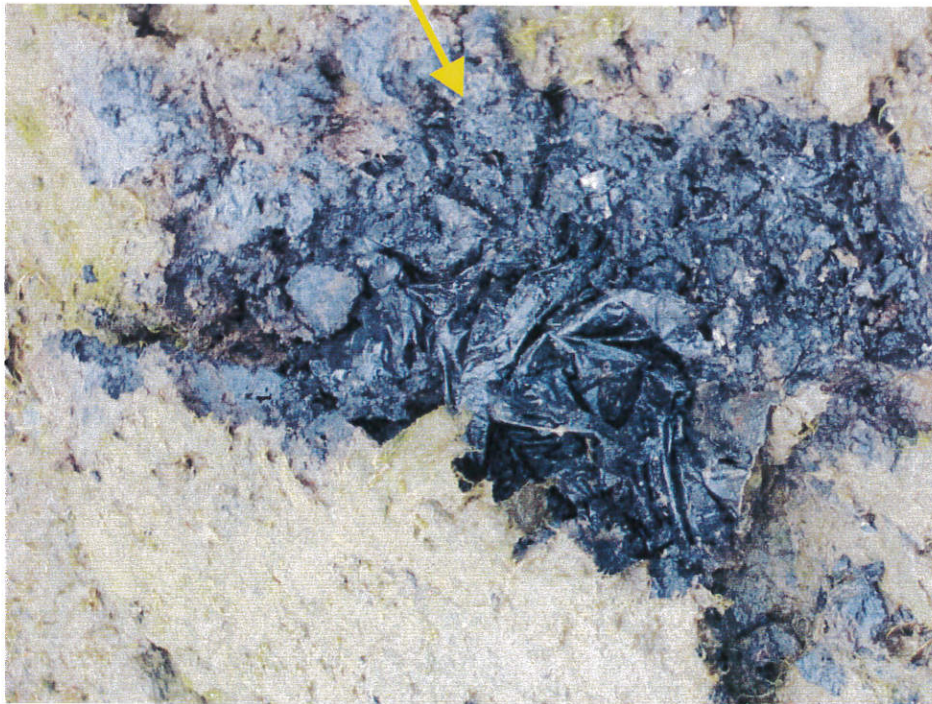
A asphalt-like material was observed on the west side of the neck and east of the 2nd Ave. Outfall, along the south shoreline (Figures 2 and 15). The deposit appears to be a localized, surface feature. Plastic sheeting/bag material was observed to be entrained in the matrix.

Asphalt-Like Material  
South Bank  
(view to south)

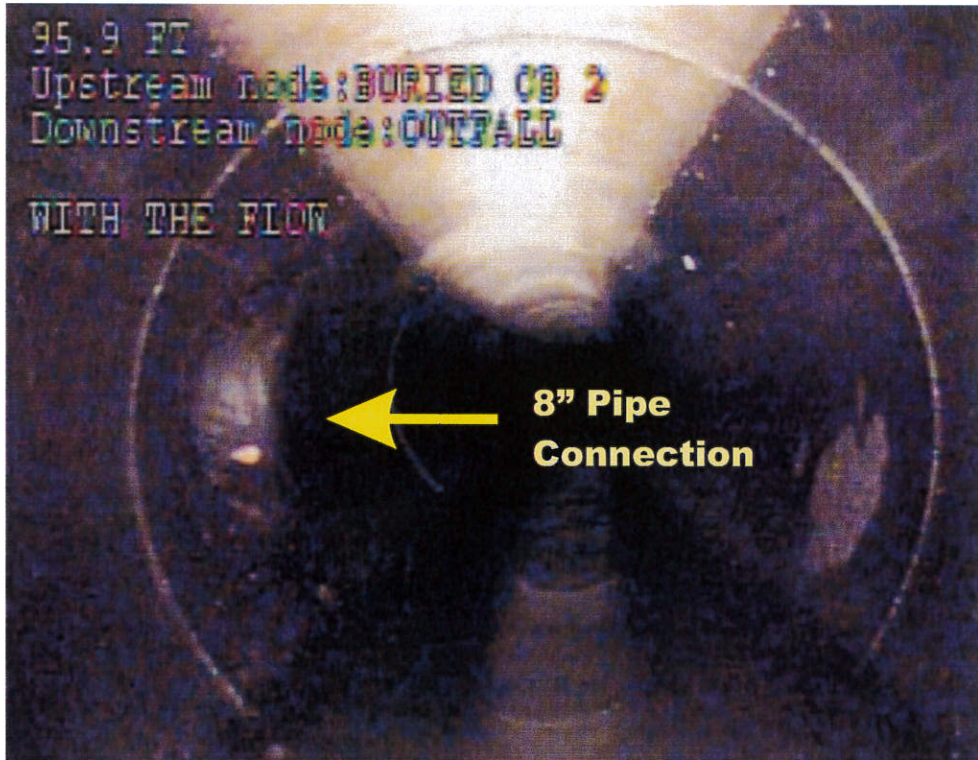
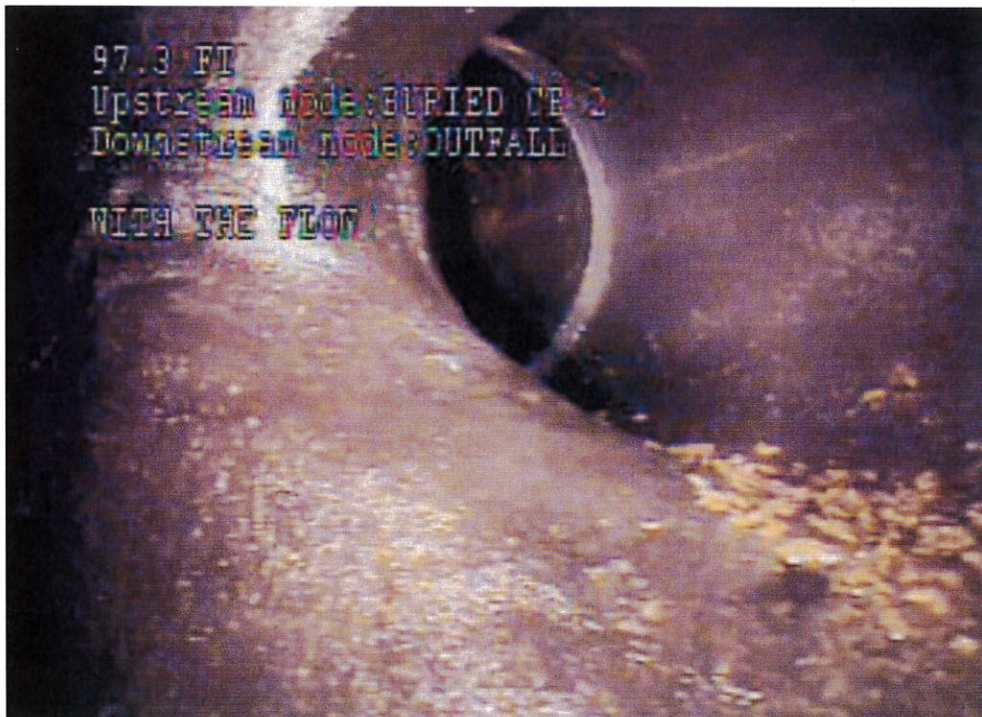
SUM-008-00 **FIGURE 2** October 2013  
Dalton, Olmsted & Fuglevand, Inc.

- An 8-inch diameter lateral pipeline was observed on the west side at station +97 to +98 feet (Figure 2). This likely represents the connection to the former outlet box. The location was marked on the surface (shown on Figure 1). Horizontal coordinates are included in Attachment B.

**Outlet Box Pipe Connection  
to 24-Inch RCP**

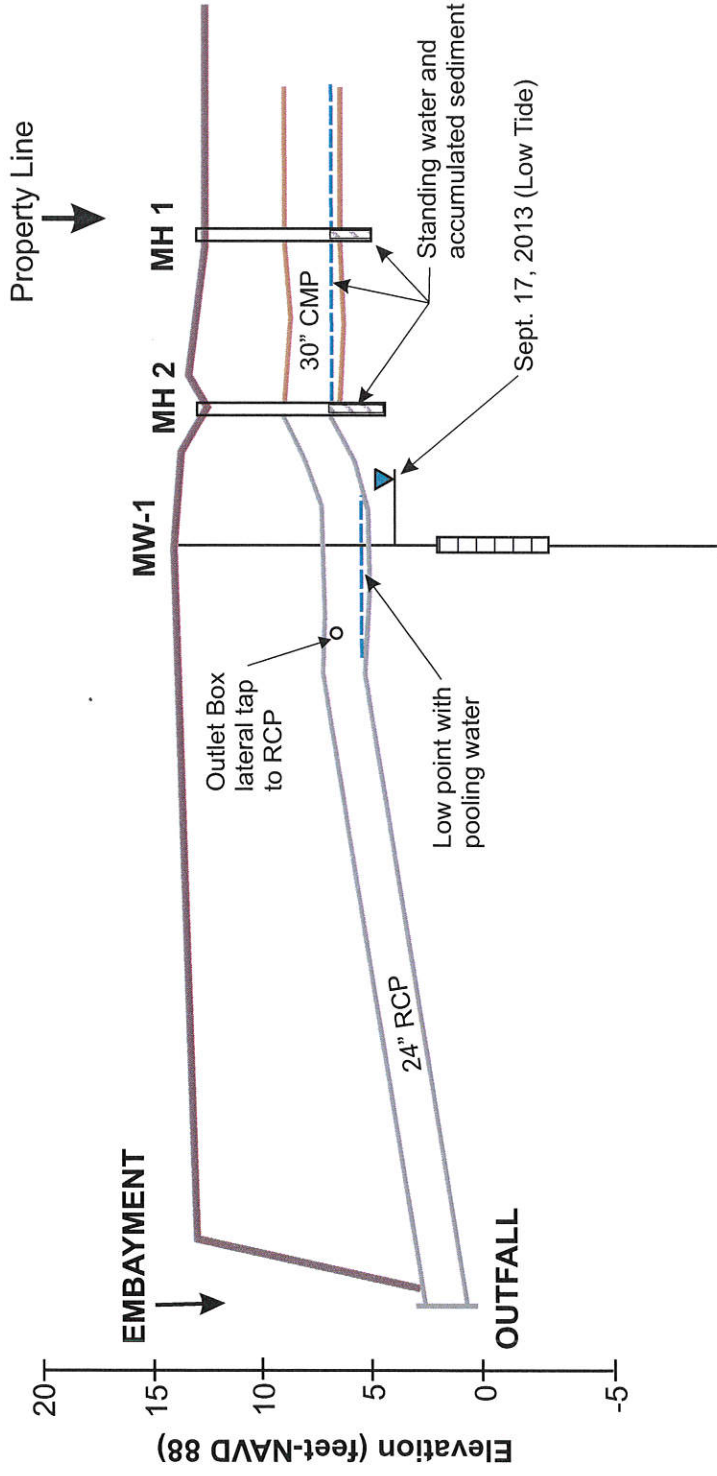
ICS/NW Cooperage Site  
**Storm Sewer Section**  
SUM-008-00 **FIGURE 3** Oct. 2013  
Dalton, Olmsted & Fuglevand, Inc.

Observed pooling water (at low tide) in the 30-inch CMP located between MH1 and MH2, is governed by the invert of the 24-inch RCP as it exits MH2. The 24-inch pipe MH2 exit invert elevation is at a slightly higher elevation than the invert elevation of the 30-inch pipe inlet.

Pooling water was present in a low elevation portion of the 24-inch RCP, approximately 40 to 50 feet downstream of MH2. The cause of the pooling water appears to be pipe line settlement where joints have separated 1 to 2 inches. A water level measurement made in monitoring well DOF-MW1 located adjacent to the low elevation portion of the pipeline (Figure 1) indicated a water table elevation of 3.6 feet NAVD88. As shown on Figure 3, the water table was below the bottom of the pipeline at the time of the video survey.
