Periodic Review

North Marina Bayside ABW
1332 West Marine View Drive
Everett, WA 98201

Facility Site ID#: 9286485
Cleanup Site ID#: 2224
VCP Project No.: NW2842

June 2022

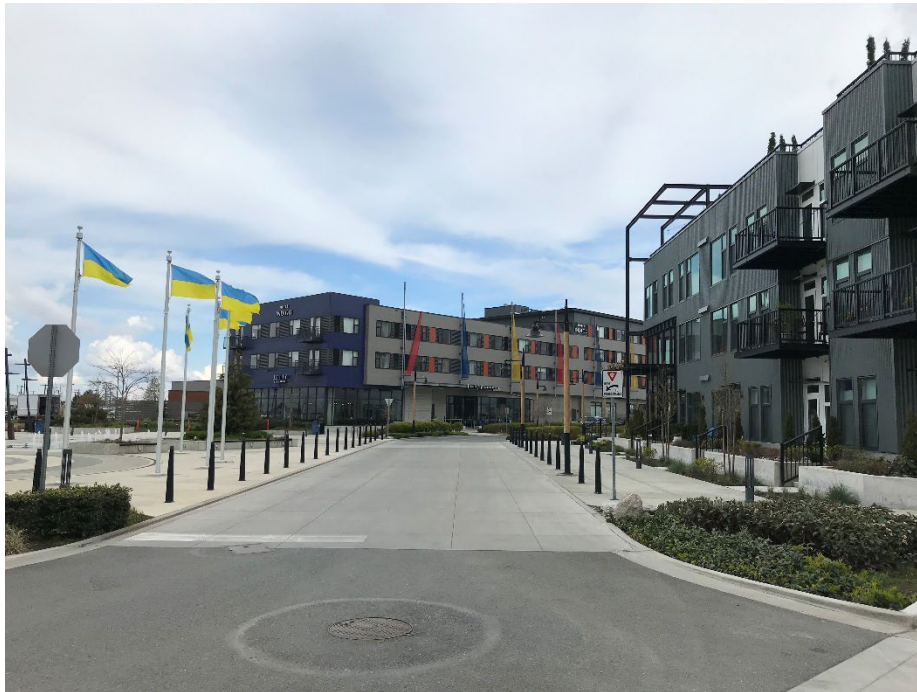
Photo 1: Southwest Corner of American Classic Homes Looking Northwest

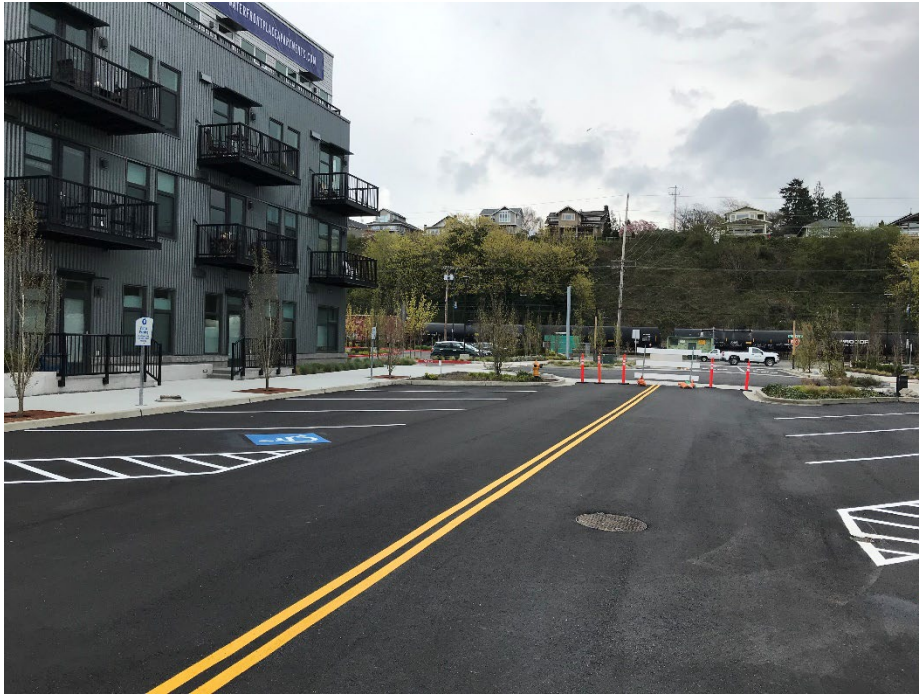
Photo 2: Southern Border looking East (14th Street)

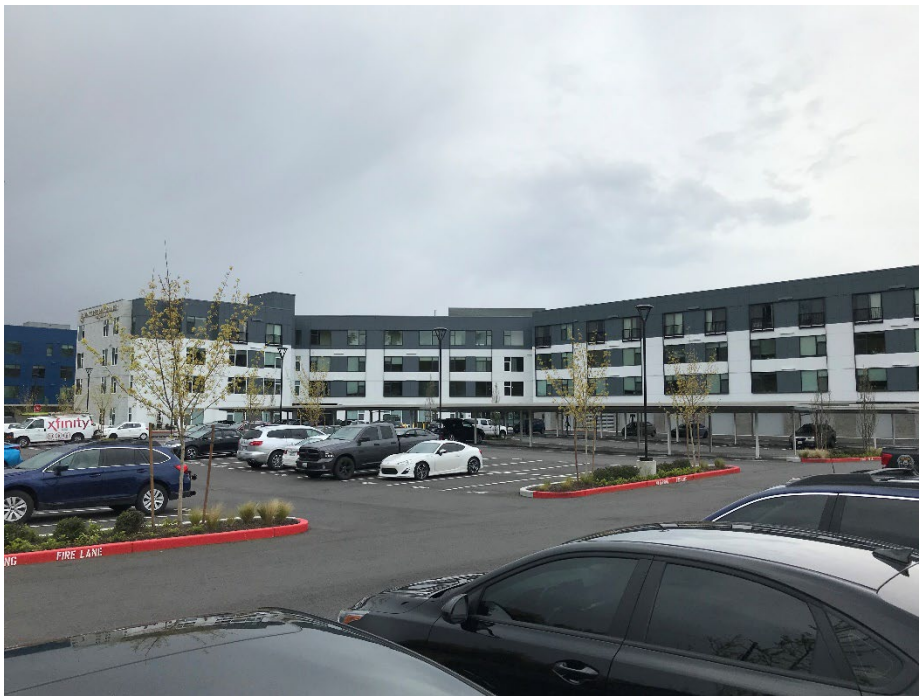
Photo 3: Northeastern Corner looking Southwest (American Classic Homes North Building and Parking Lot)

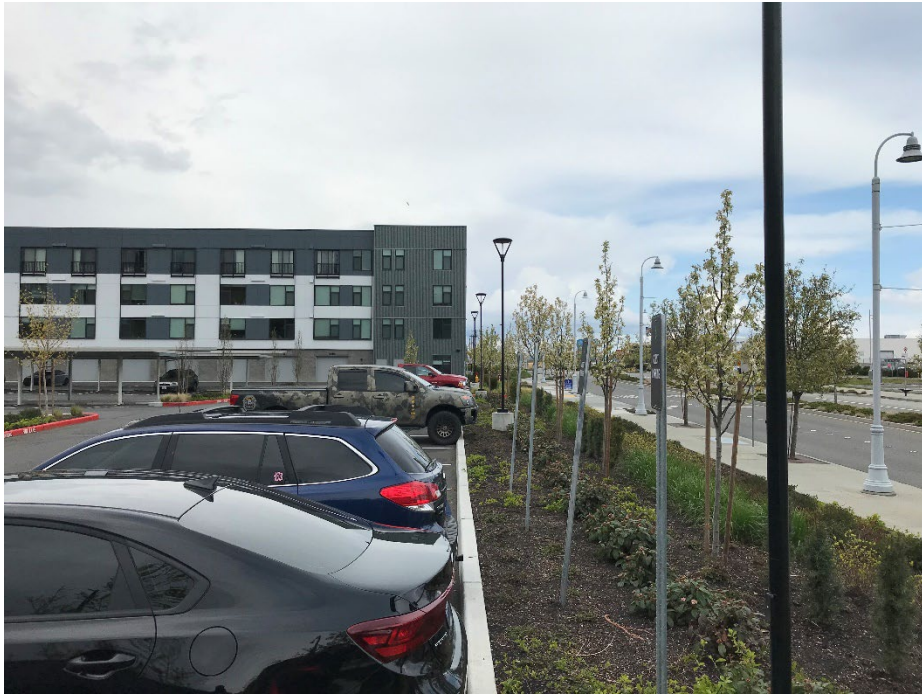
Photo 4: Northeastern Corner looking West (13th Street)

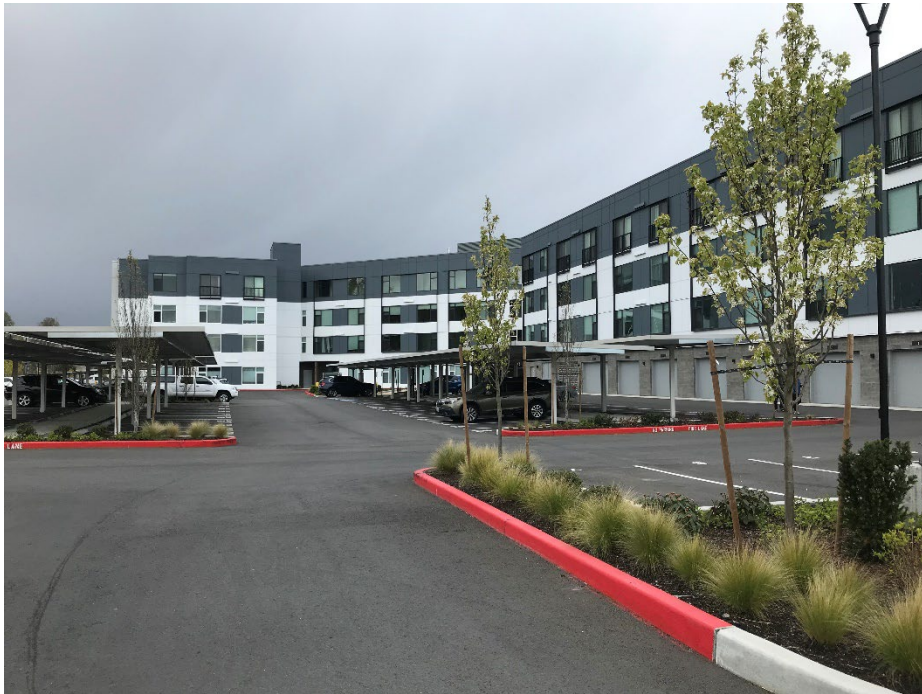
Photo 5: Northern Border looking South

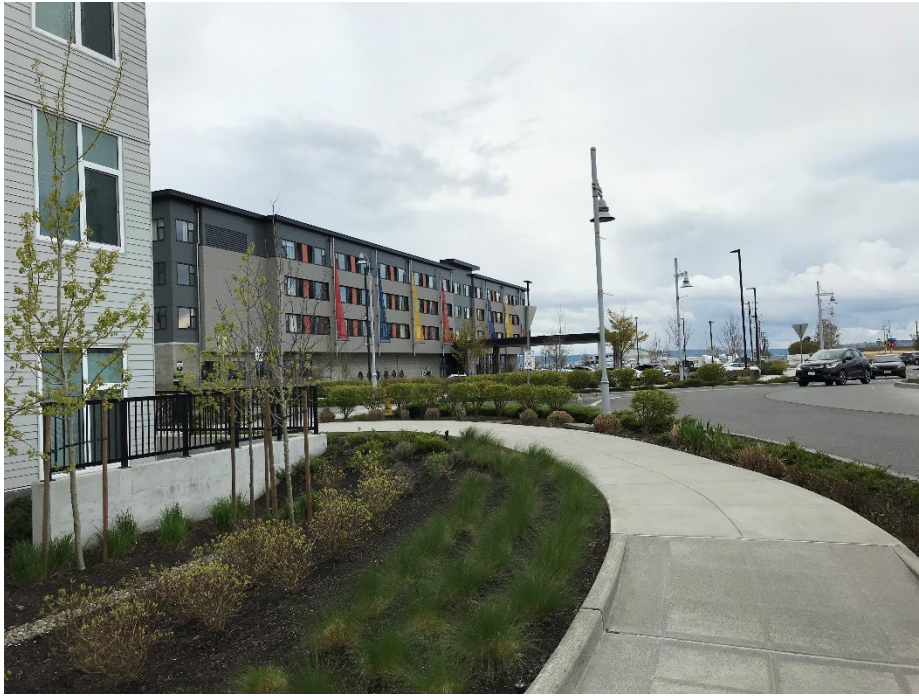
Photo 6: Northern Border looking West (13th Street and Seiner Dr)

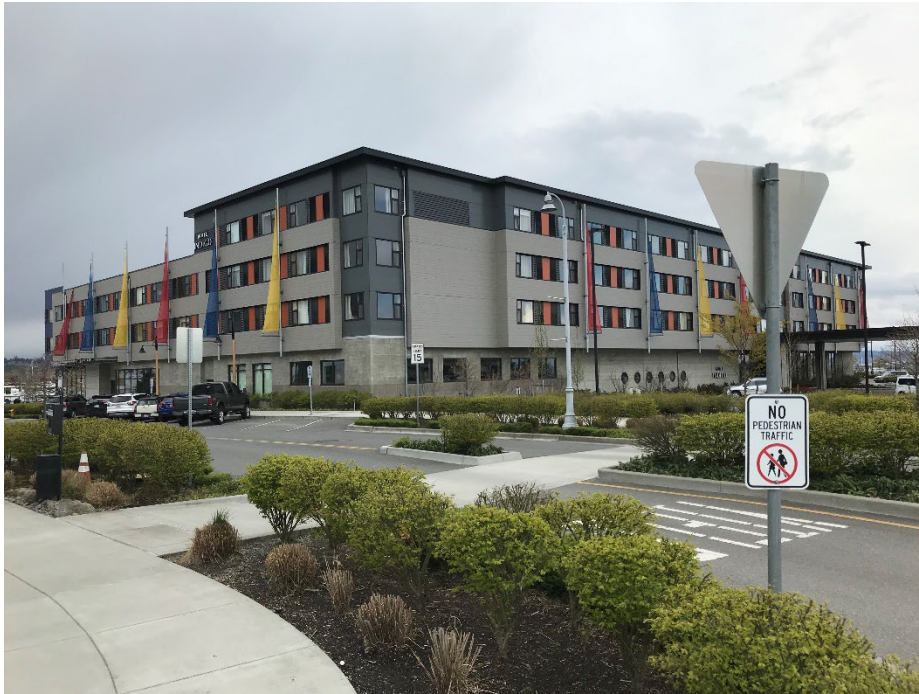
Photo 7: Seiner Drive and 13th Street looking South

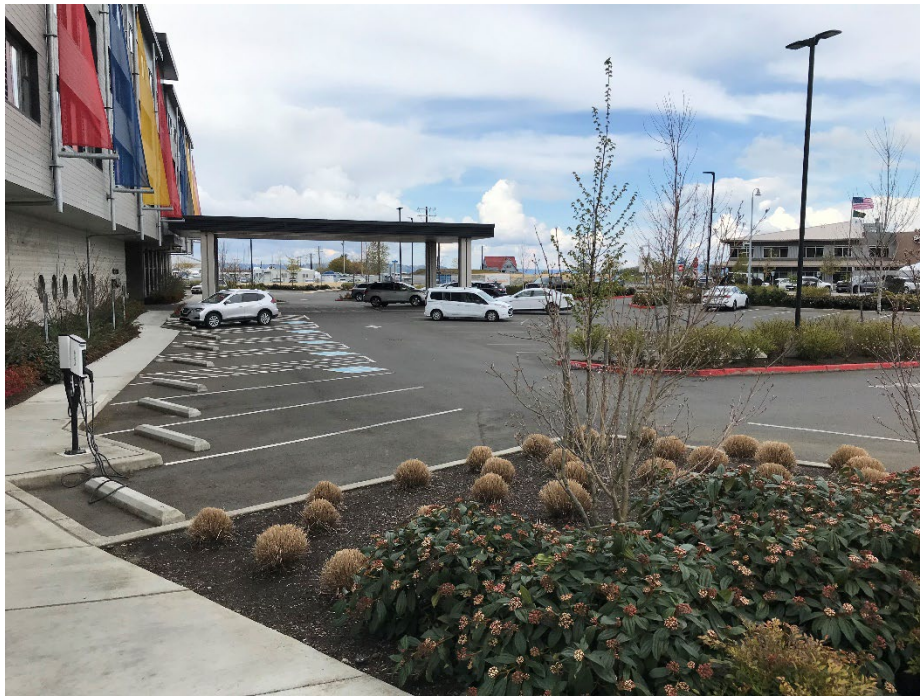
Photo 8: Seiner Drive looking West (Hotel Indigo Parking Lot)
