MEMORANDUM

RE: **Ground Penetrating Radar (GPR) Survey and
Limited Hazardous Building Material (HBM) Surveys
First and Thomas Property
300 to 318 First Avenue West and 301 Queen Anne Avenue North
19040-02**

RE: **Ground Penetrating Radar Survey Results**
First and Thomas Property
300 and 318 First Avenue West
Seattle, Washington
19040-02

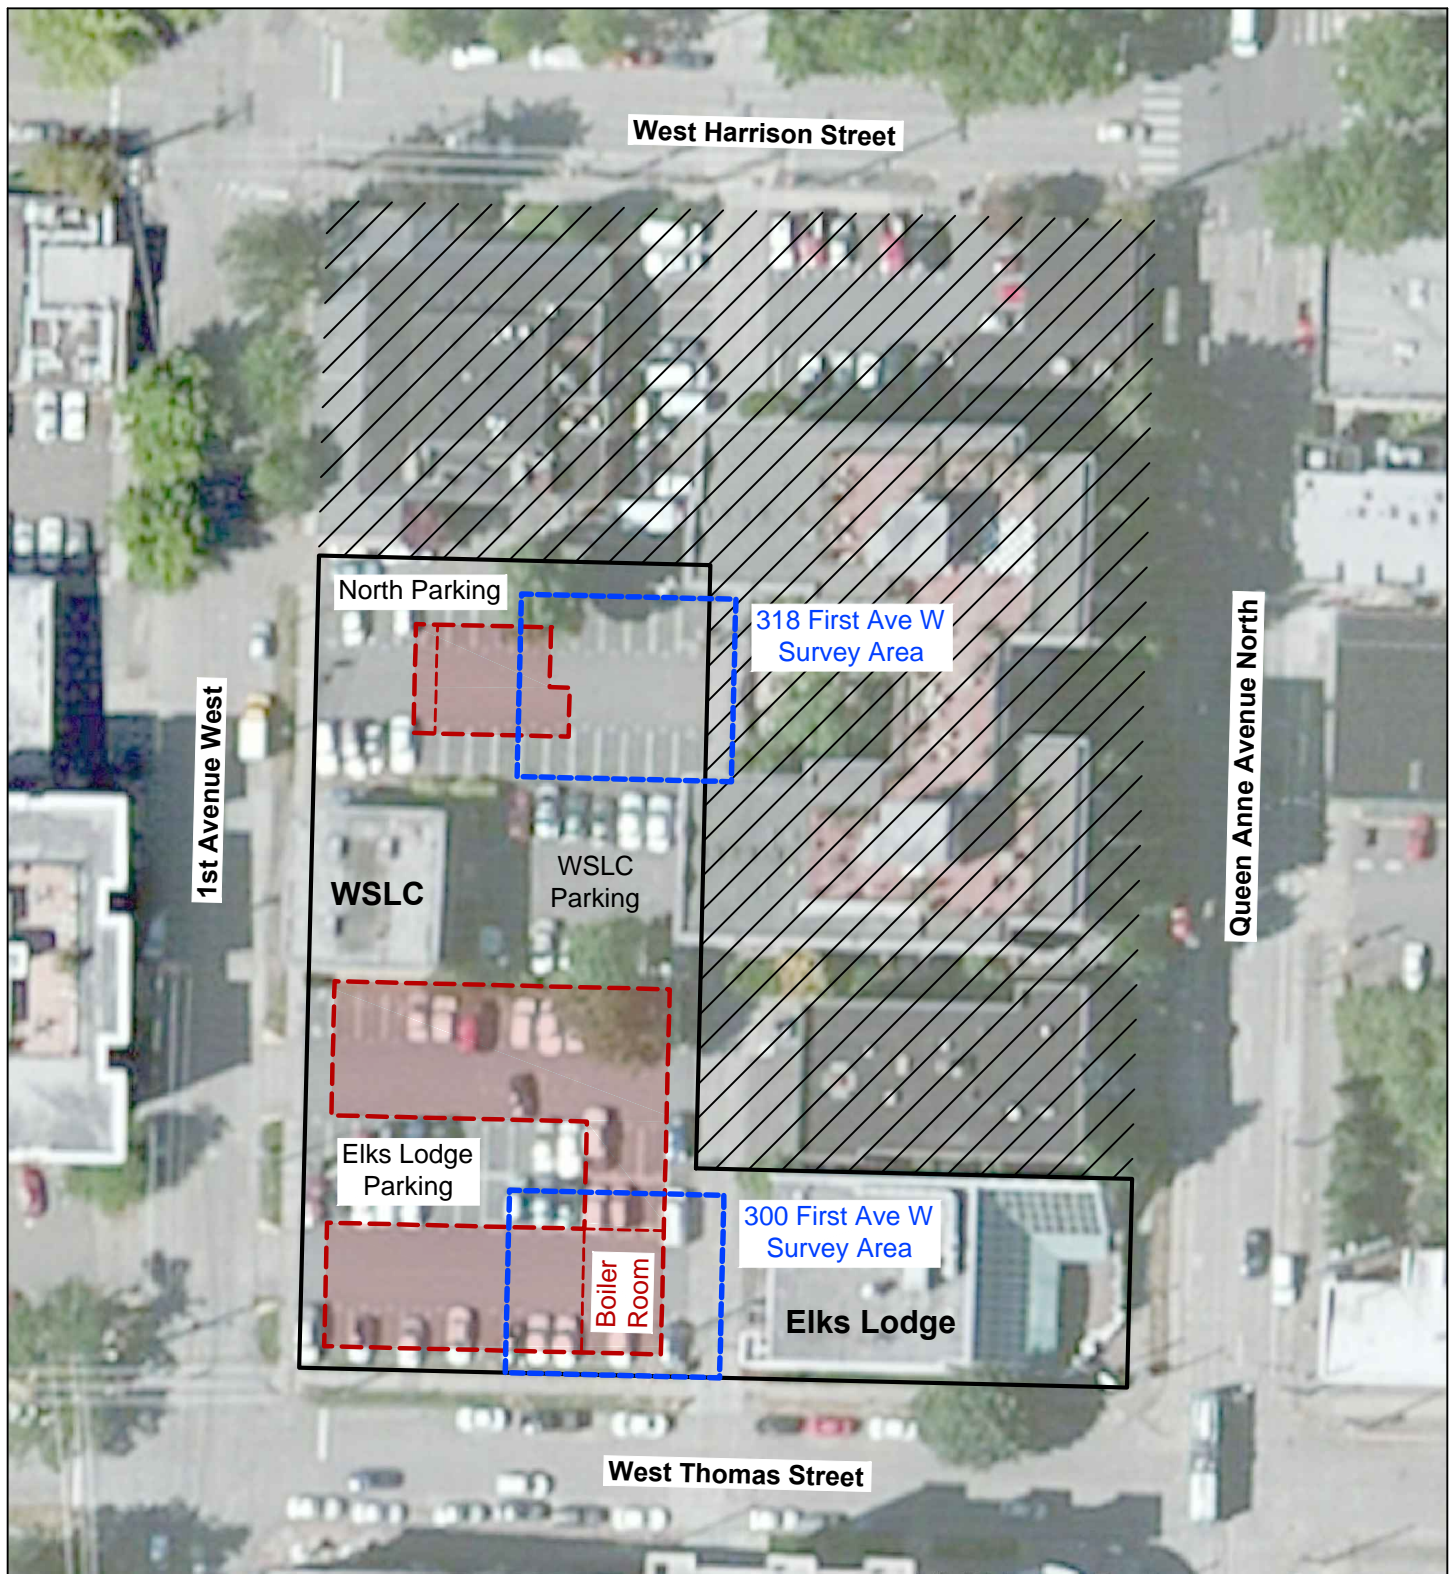
Site and GPR Survey Plan

On June 12, 2014, a GPR survey was conducted at both potential tank locations. The focus of the survey was to assess for possible USTs in the areas where they were most likely to be. One survey was conducted at the location of the former apartment house boiler room and along the alley at the 300 First Avenue West parking lot (formerly 306 First Avenue West, the apartment building address). The second survey was conducted along the east side of the 318 First Avenue West parking lot (former location of the dwelling at 318 First Avenue West), and the bordering alley. The GPR survey locations are shown on Figure 2 of the GPR Survey Report (Appendix A).

On June 12, 2014, two separate 3D GPR surveys were conducted at the 300 and 318 First Avenue West parking lots in Seattle, Washington. The surveys were conducted in order to locate suspected USTs associated with historical structures on the properties. The separate 56- by 63-foot survey areas were located along the eastern edge of the parking lots and encompassed the areas where the USTs would have likely been located.

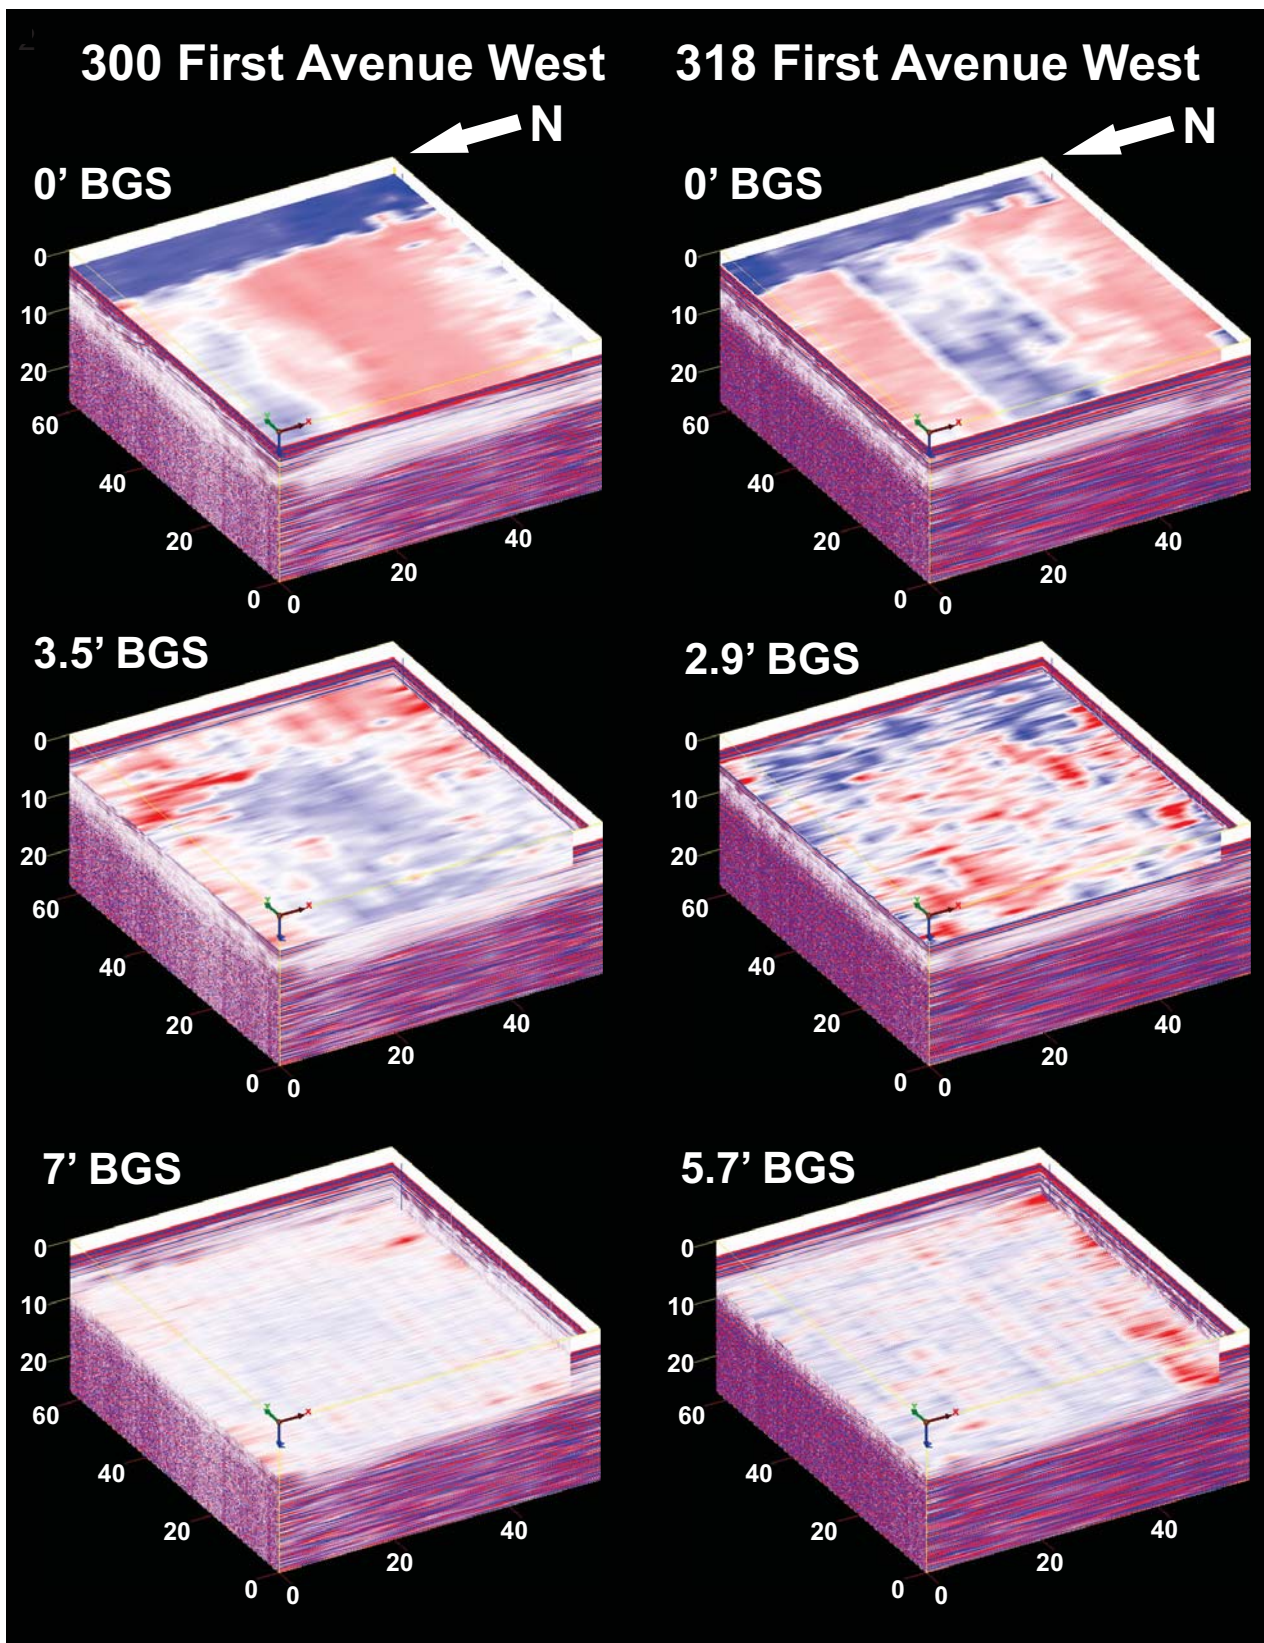
Ground Penetrating Radar Models

The GPR surveys looked for anomalies up to 7 feet below ground surface. No anomalies were observed that were consistent with USTs or structures. To confirm the GPR surveys, the length of the alley along the property line was subsequently surveyed with a metal detector, but no large anomalies were observed.

In the surface models, high amplitude reflections defining a north- to south-trending linear feature were observed along the eastern edge of both properties and is interpreted as the concrete alley (Figure 3). At the 300 First Avenue West parking lot, no anomalies consistent with a UST were observed from the surface down to 7 feet below the ground surface (bgs). At the 318 First Avenue West parking lot, no anomalies consistent with a UST were observed from the surface down to 5.7 feet bgs. USTs are generally located close to the surface, and these depths cover the range a UST would likely be located.
