PHASE I ENVIRONMENTAL SITE ASSESSMENT

BELLEFIELD OFFICE PARK

Bellevue, Washington

July, 1994

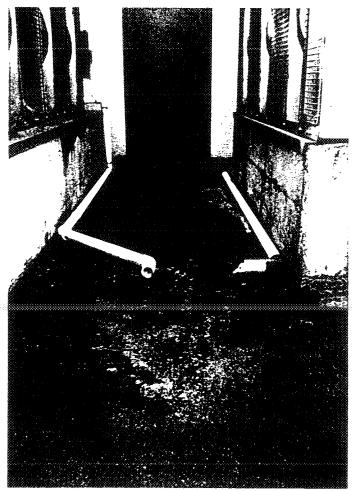
The exterior site reconnaissance revealed the presence of predominantly cinder block construction out buildings which housed one or two cooling towers, typically a large transformer, and a boiler room. Floor drains, within the concrete floors of the out-buildings were observed, and drain pipes from the cooling towers were directed toward these floor

drains. According to information provided by Mr. Randy Bartl of Great Western Bank, the drains discharge onto the ground surface beneath or adjacent to the buildings. Cooling tower water was the only liquid observed to be discharged into the drains.

Drains from cooling towers directed towards floor drain (typical)

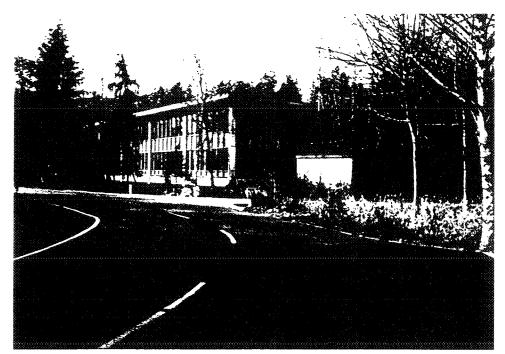
Arbor Building, looking southwest. Note outbuilding in foreground
