PHASE I ENVIRONMENTAL SITE ASSESSMENT

*Kimberly-Clark Worldwide, Inc.
Riverside Woodyard
Everett, Washington*

28 December 2005

Delta Project No. 0510545P

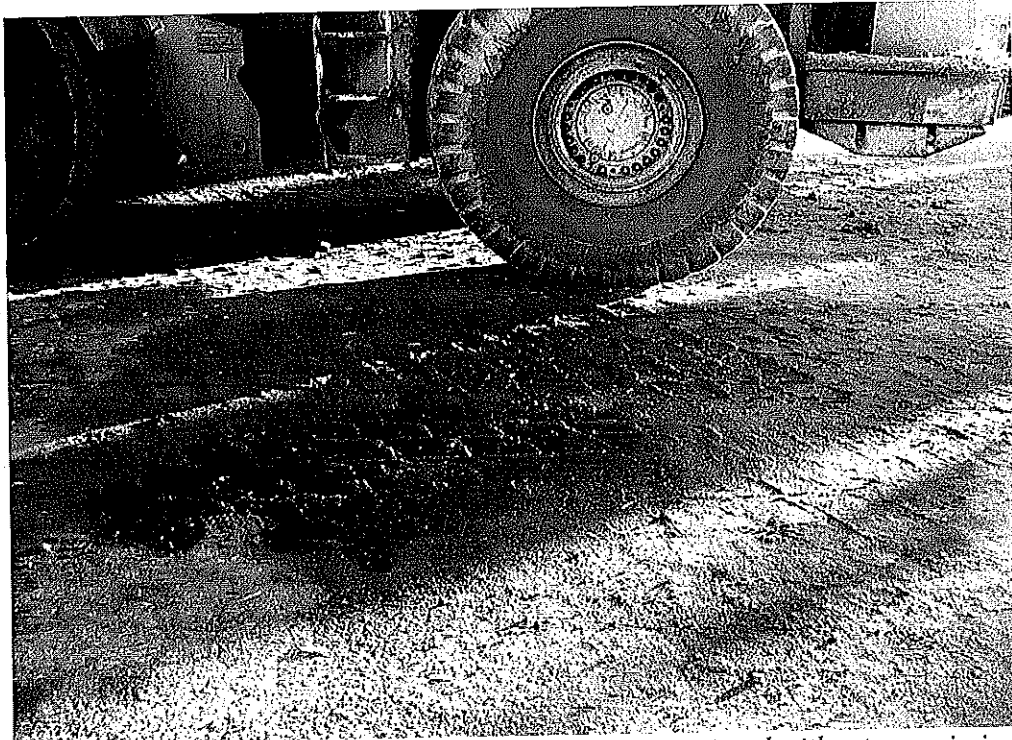
Photograph No. 1 Surficial petroleum staining associated with a transmission fluid leak from one of the KCWW loaders near the southeastern corner of the Mill Office.

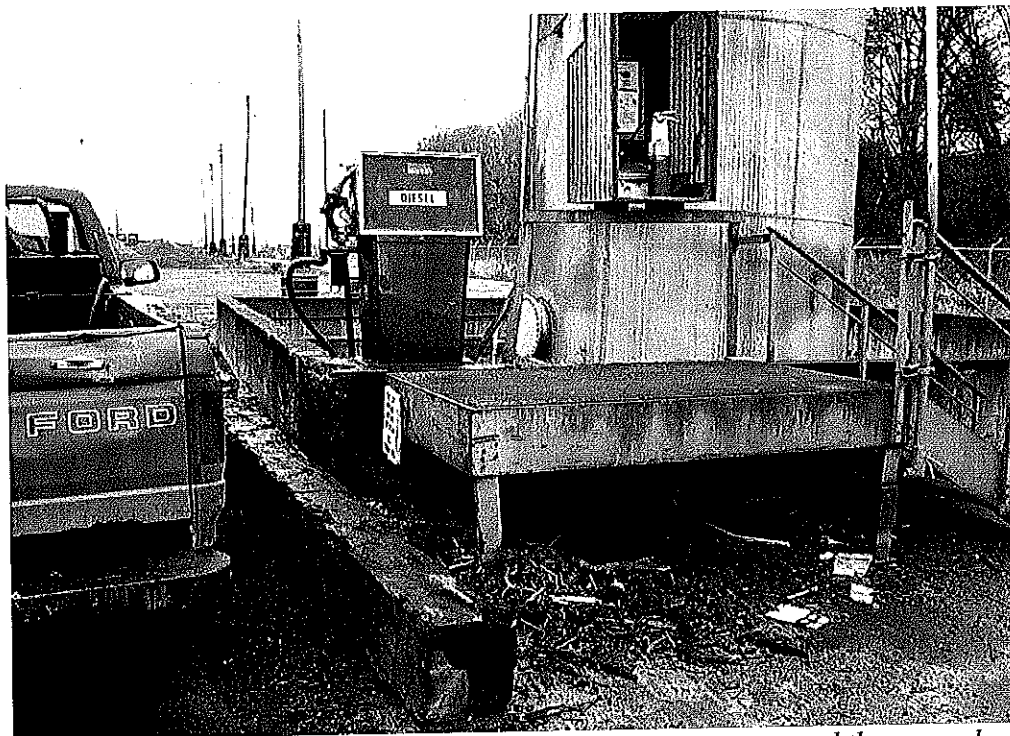
Photograph No. 2 Surficial petroleum staining on concrete and the ground on the northeastern corner of the diesel fuel AST containment structure.

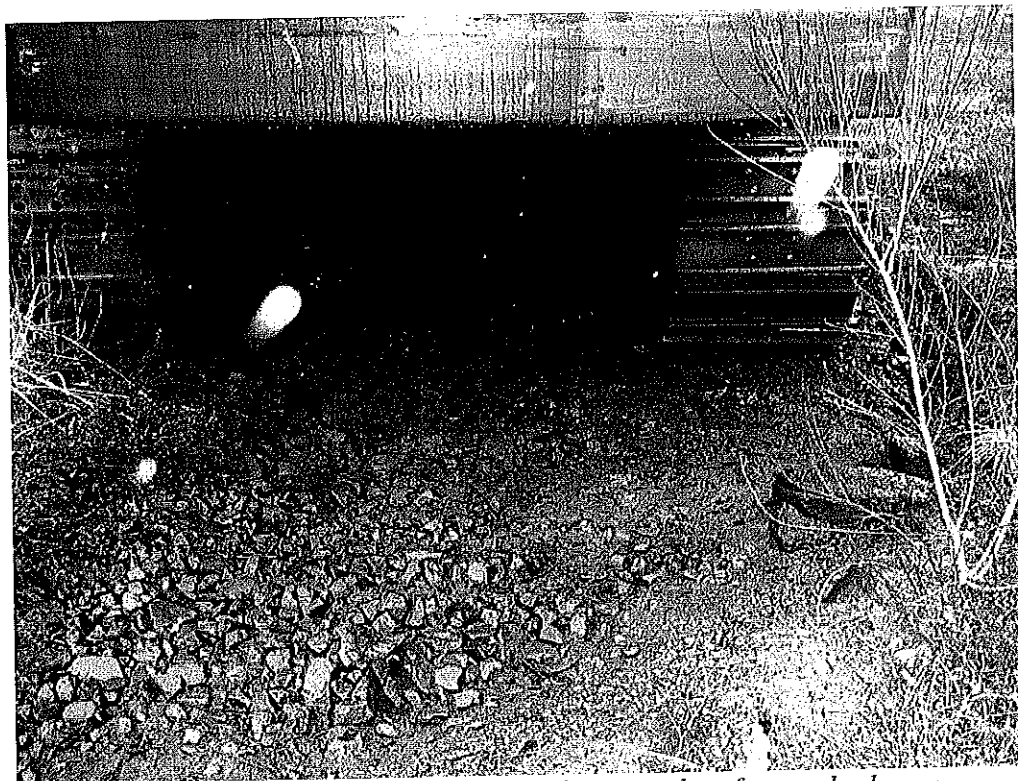
Photograph No. 3 Surficial staining on the ground surface under heavy equipment.

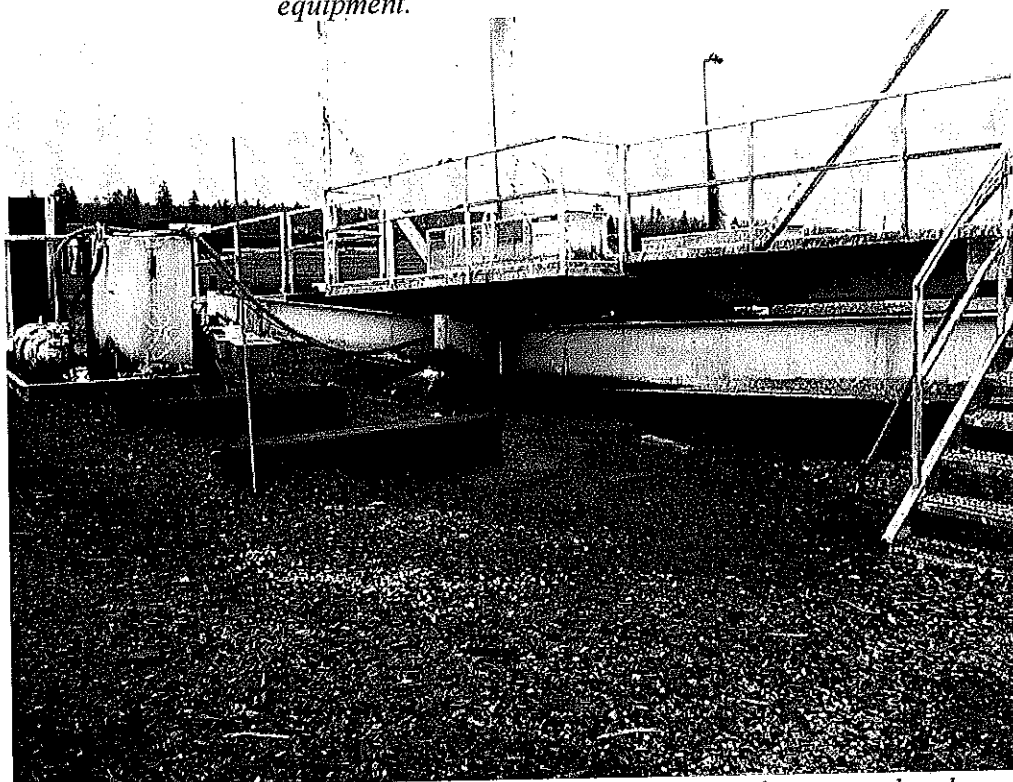
Photograph No. 4 Surficial petroleum on the ground surface around and beneath the truck lift.

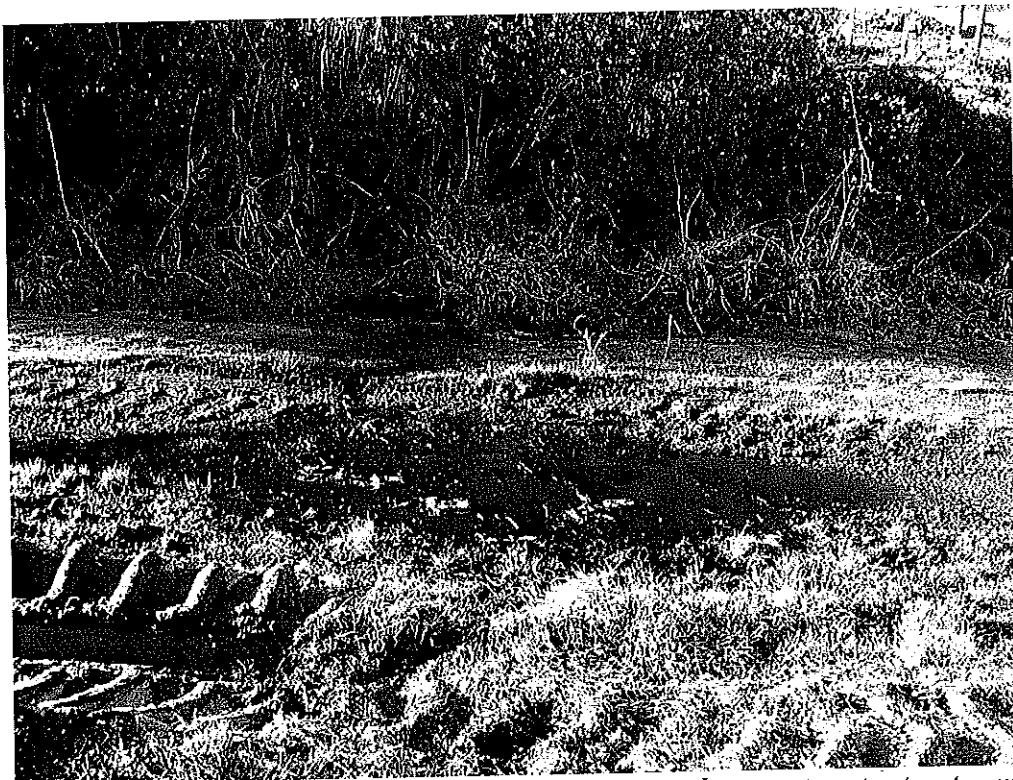
Photograph No. 5 Surficial staining from the secondary wastewater treatment plant sludge staged on the southeastern portion of the site.

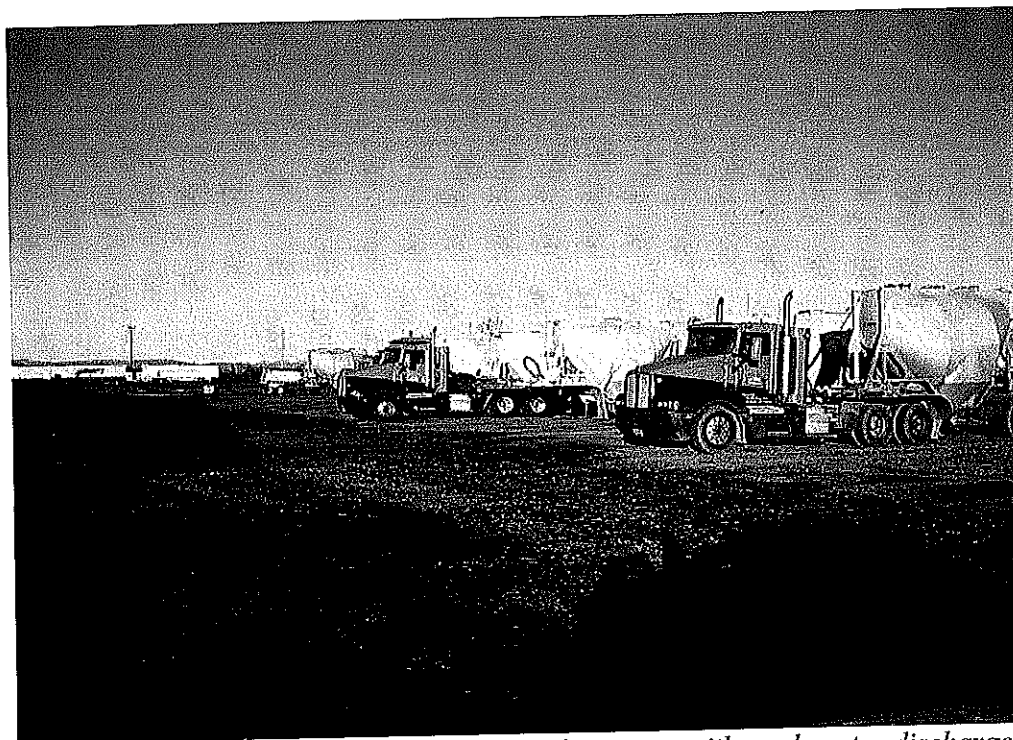
Photograph No. 6 View of the truck washing area with wash water discharged to the ground surface in area leased by Washington Trucking.

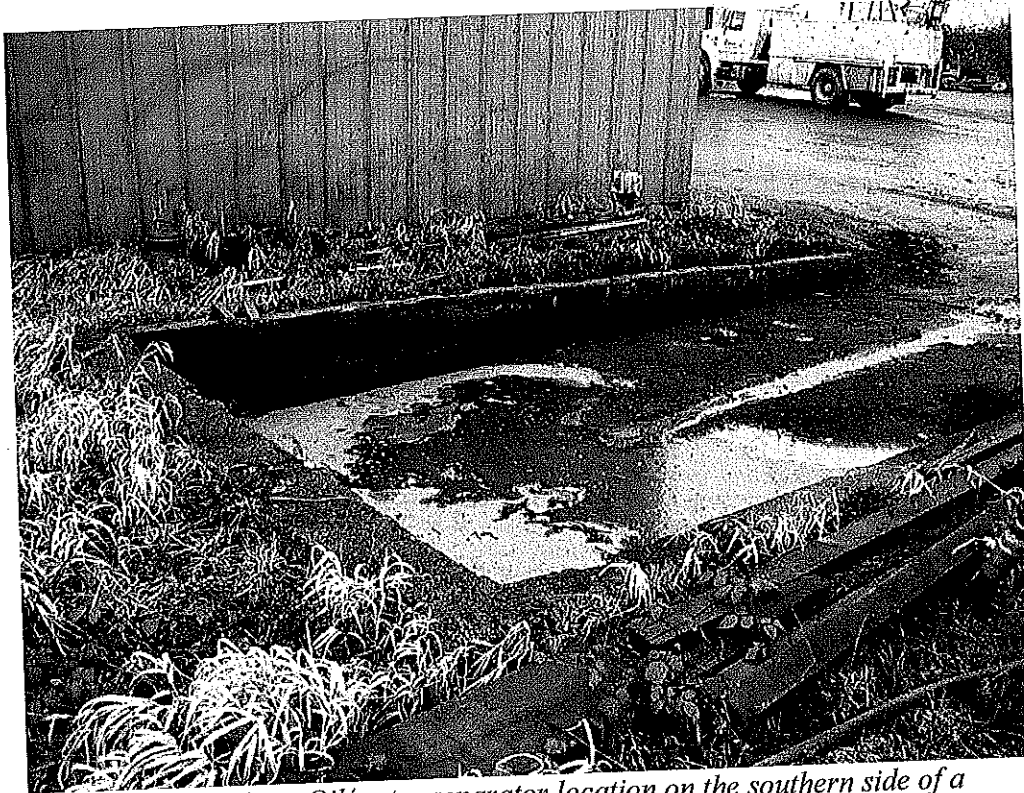
| <i>Photograph No. 7</i> | <i>Oil/water separator location on the southern side of a storage building (Building 16) in the northwestern portion of the site.</i> |

Photograph No. 7 Oil/water separator location on the southern side of a storage building (Building 16) in the northwestern portion of the site.

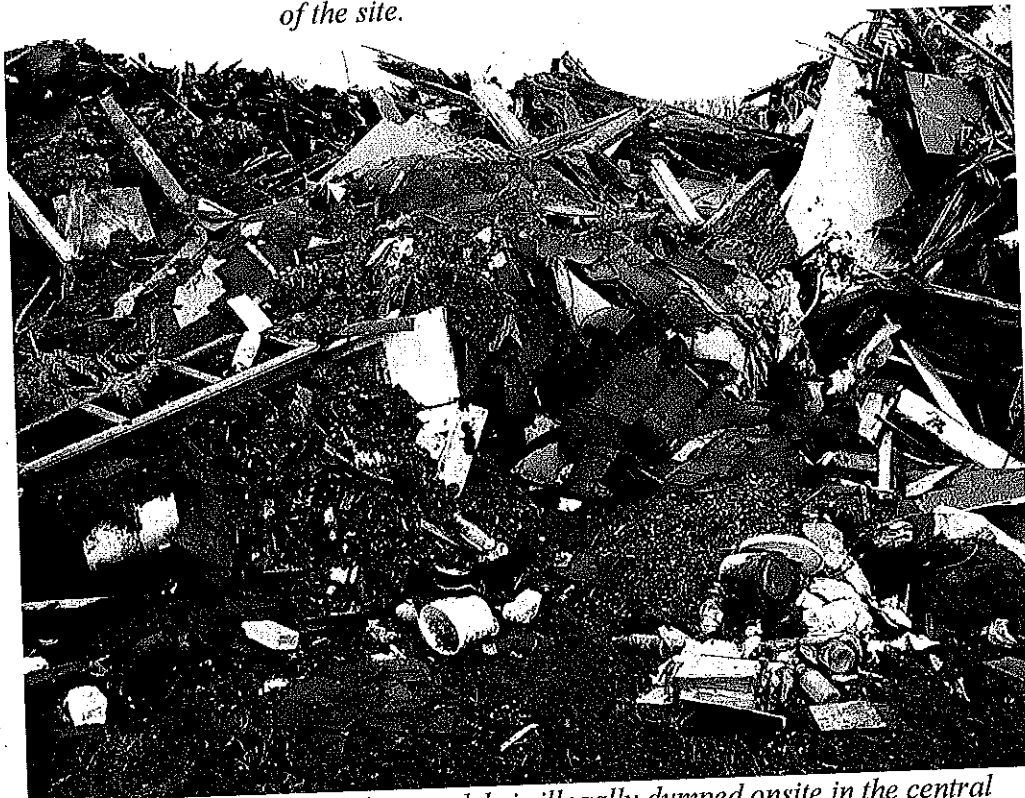
| <i>Photograph No. 8</i> | <i>Solid waste debris illegally dumped onsite in the central portion of the site.</i> |

Photograph No. 8 Solid waste debris illegally dumped onsite in the central portion of the site.
