Port of Anacortes  
**Engineering and Institutional Controls Report**  
Year 8 – 2022

Cap Sante Marine Site  
Anacortes, WA  
Ecology Consent Decree No. 9917

Subject: Engineering and Institutional Controls Monitoring Report – Year 8 – 2022  
Cap Sante Marine Site  
Anacortes, Washington  
Ecology Consent Decree No. 9917

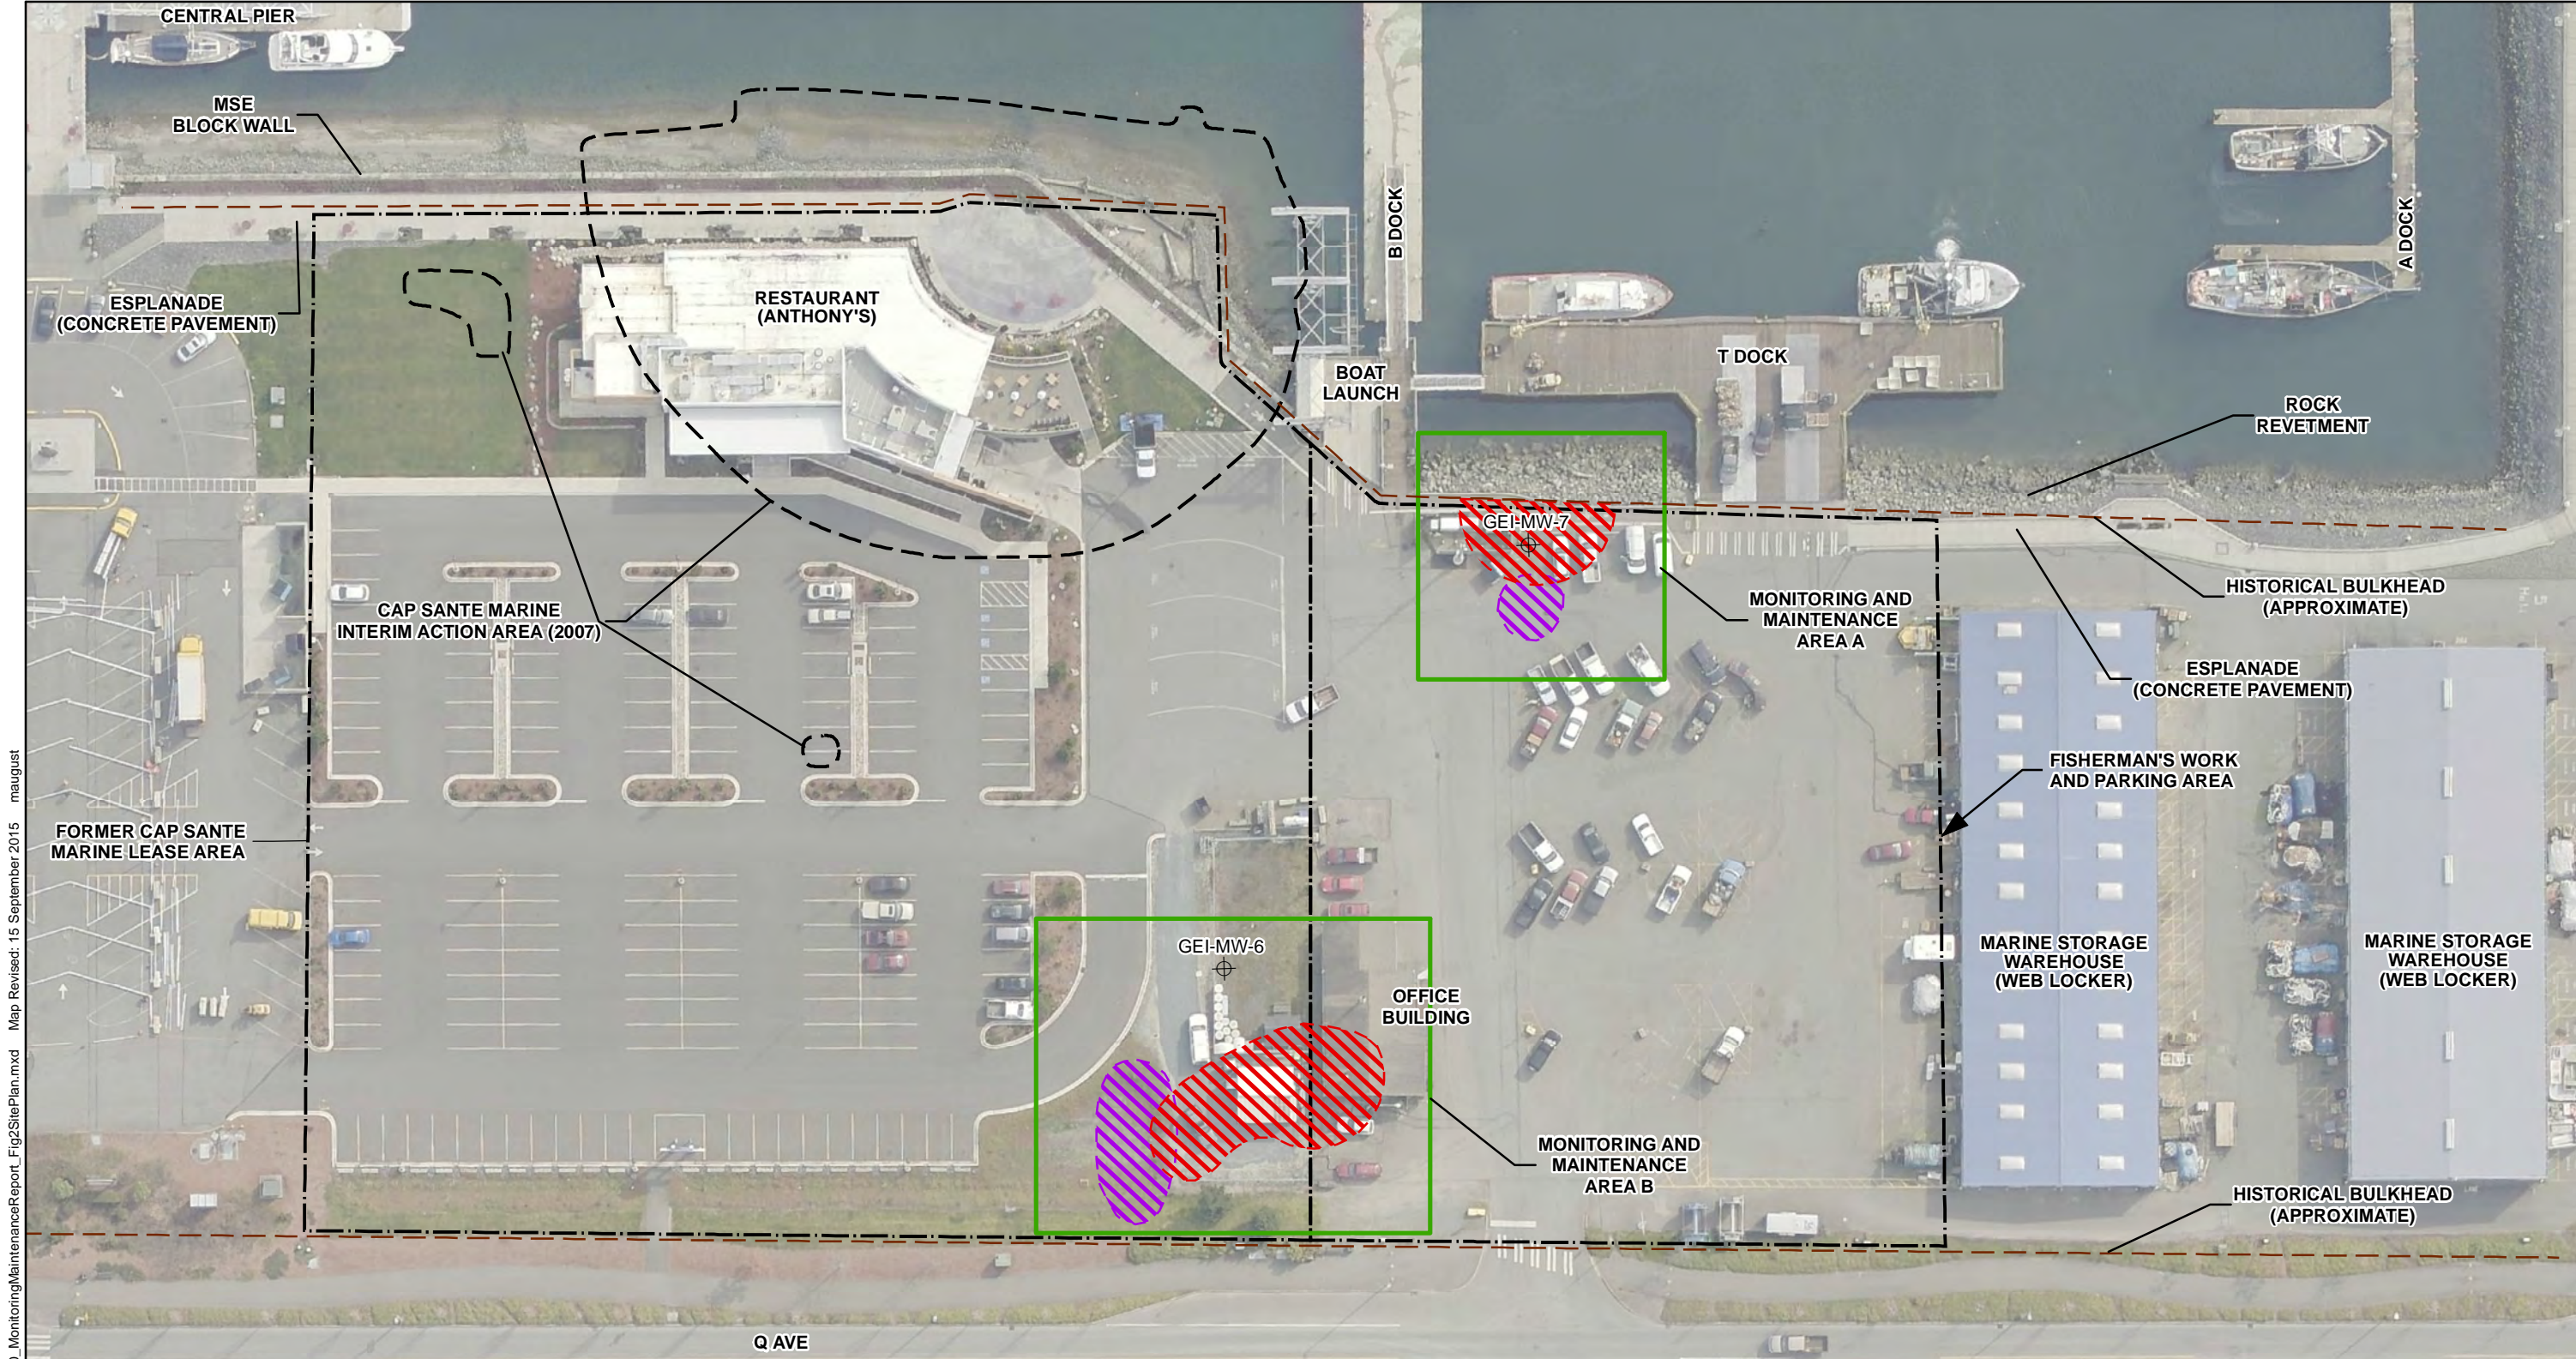
<b>Site Plan</b>	
Cap Sante Marine Site Anacortes, Washington	
	<b>Figure 2</b>

Conditions within Monitoring and Maintenance Area A and B were evaluated during the August 2022 (Year 8) monitoring event. In accordance with the monitoring and maintenance program, visual reconnaissance along the perimeter and transects with these area was performed. The condition of the Site and visual observations are documented in the attached Engineering and Institutional Monitoring and Maintenance Report Form dated September 30, 2022 (Appendix A) and are generally similar to the previous monitoring events. However, there have been some changes in use from prior years.

5. Corrective/Maintenance Action(s) Required: None Required			
6. Corrective/Maintenance Action Implemented: NA			
Date Implemented: _____			
7. Additional Comments: Construction materials are staged on-site as part of a dock repair project through February 2023. Current conditions are shown on the attached Site Plan (Figures 1 and 2). Photographs representing the current conditions of Monitoring and Maintenance Areas A and B are attached.			
Signature:

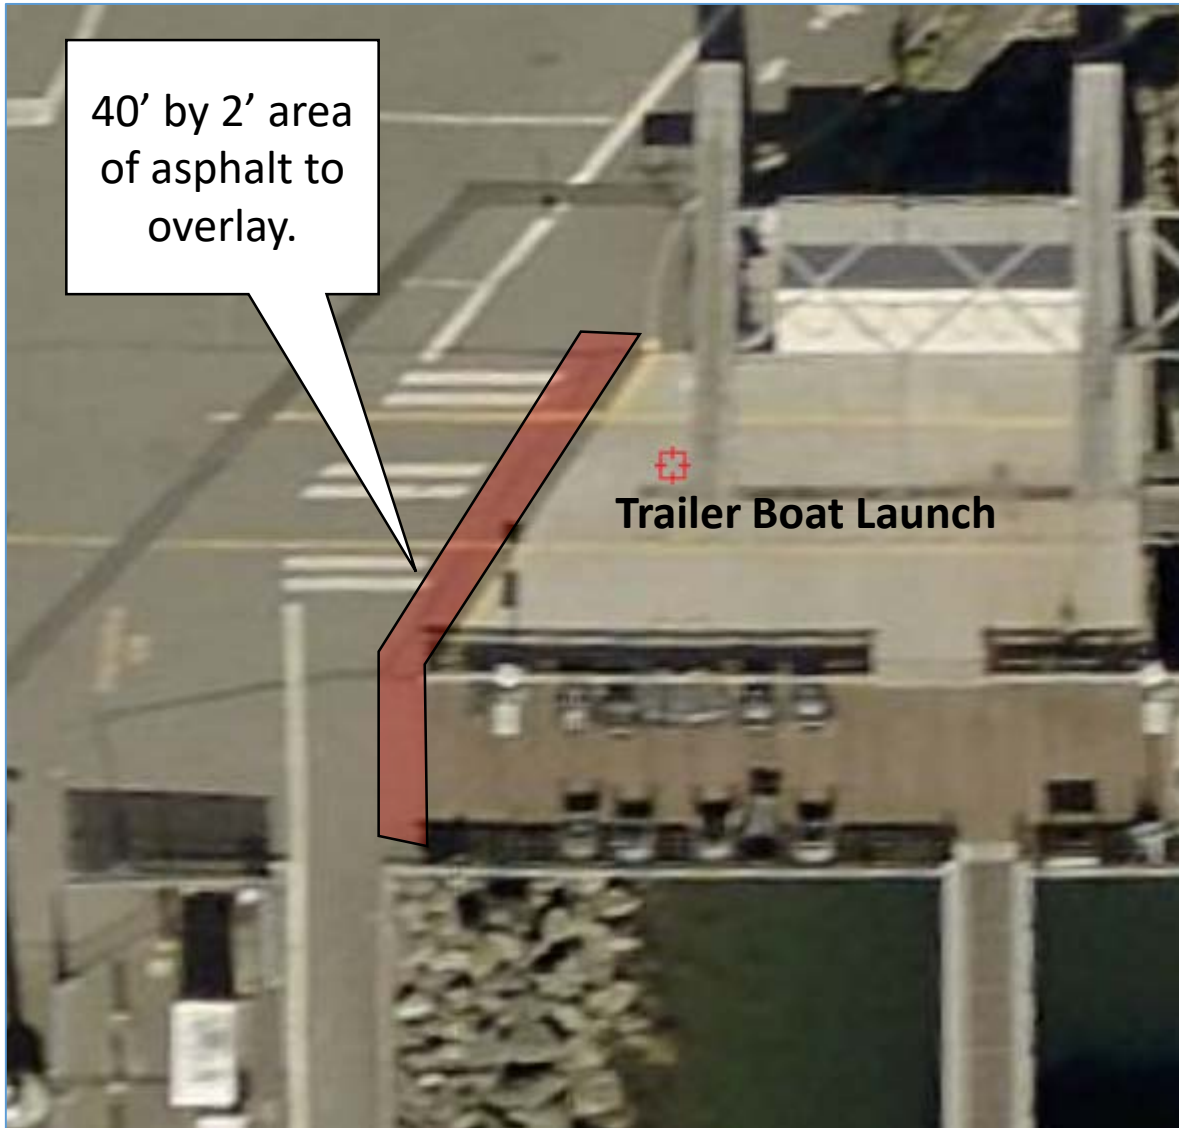
**Trail Boat Launch  
Asphalt Repair**

The Port of Anacortes proposes to repair a small section of sunken asphalt that has formed a grade break between the asphalt lot and the concrete pad of the trailer boat launch. An approximately 40 foot by 2 foot section of asphalt will be repaired with an overlay to restore the transition between the lot and the boat launch pad. The area is within the restrictive covenant for the Cap Sante Marine clean-up site. These asphalt repairs will not expose soils.

- Repair damaged asphalt with an overlay to restore the transition
- Work scheduled during a planned launch closure.
- Project. will not change usage at site

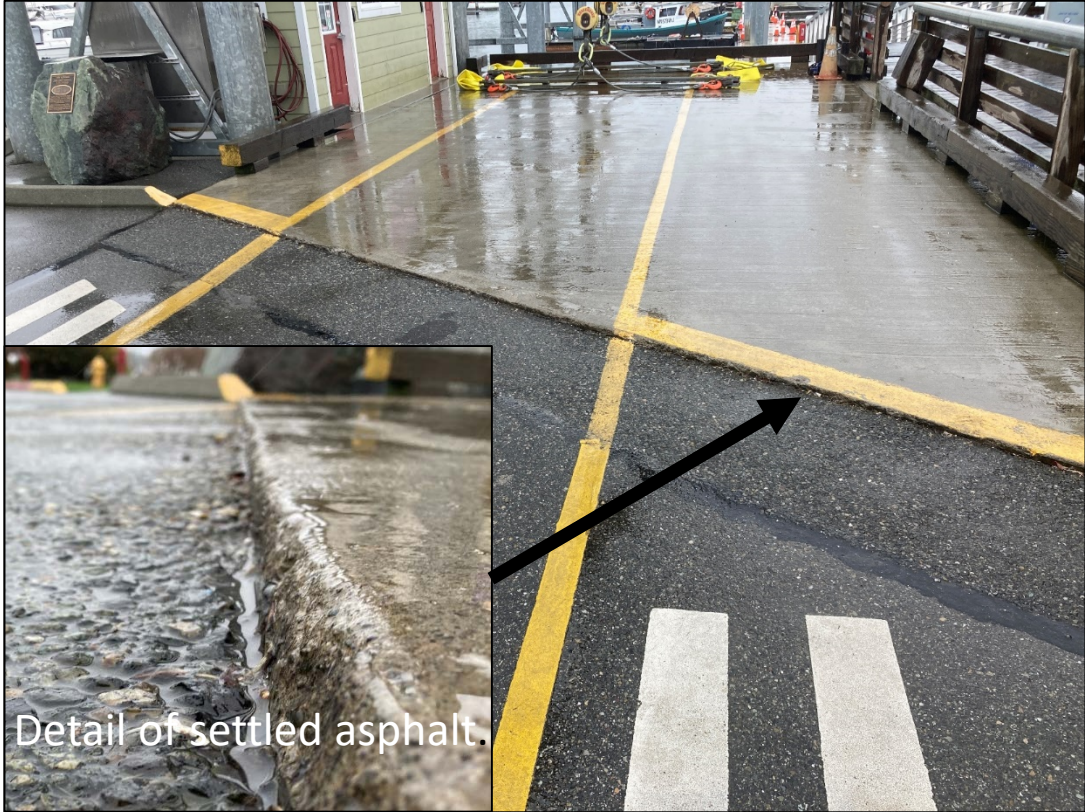
**CURRENT CONDITIONS**

- Details of settled asphalt
- A 1.5" lip has formed between the asphalt and concrete pad

Overlay damaged asphalt at the Trailer Boat Launch.
