RE: POM Present State Analysis – Historic Debris Field

Historic Debris Field Present State

POM-01-TMP

Project Description			
PROJECT NAME		PEND OREILLE MINE (POM): WBS 530 HISTORIC DEBRIS FIELD – PRESENT STATE	
DECISION No.	NA	REVISION No.	ORIGINAL
ORIGINATOR	POM TEAM	DISCIPLINE/GROUP	ENVIRONMENTAL

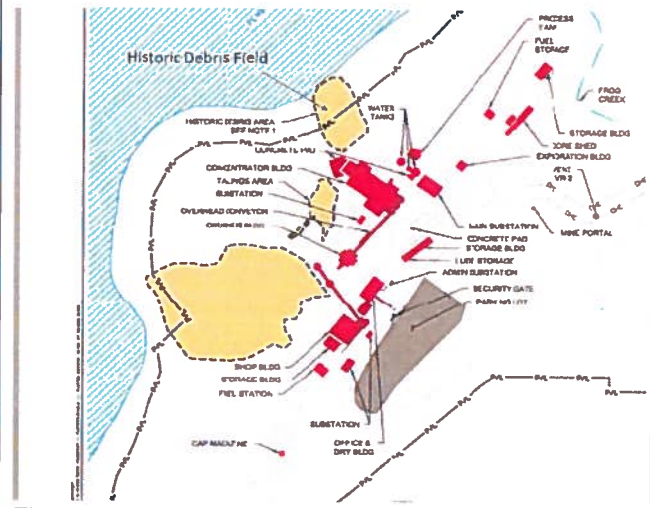
Figure 1: Base map

Very little is known about the origin of the HDF. The timing of the material placement occurred when other entities began operating the facility in the early 1950's up to 1967. Figure 1 shows the location and extent of the HDF. Some of the wood debris may be part of the launder chute system used to discharge tails from the mill to the river. The discharge point and the debris field location coincide. The launder chute system was abandoned in 1967.

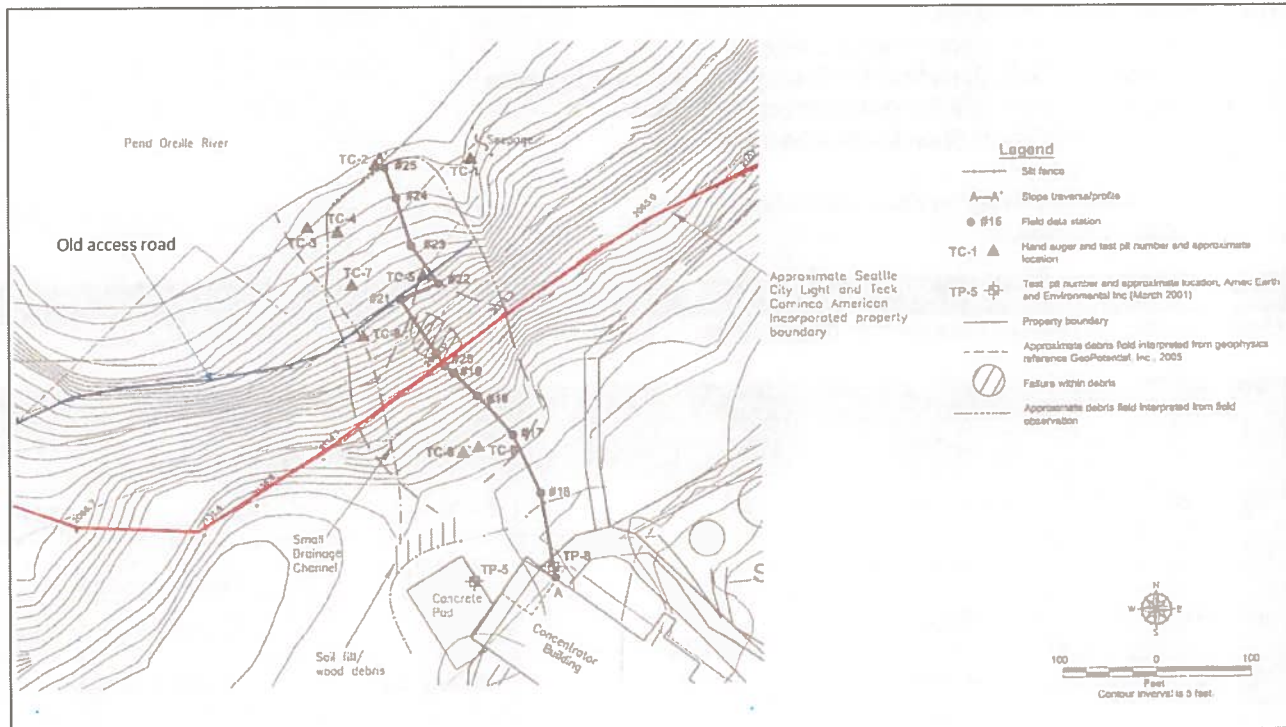
Figure 2: Surveyed extents and relevant features

The HDF is on a steep northwest facing slope, beginning at the top of the slope approximately 80 feet from the mill building and extending downslope to within 20-30 feet of the Pend Oreille River edge. Elevations range from 2,145 feet to 2,030 feet (see Figure 2). Roughly half of the HDF is on Teck property while the remainder is on Seattle City Light property. There is small slope failure halfway up the slope that occurred in a debris accumulated area. Vegetation within the HDF is a mixture of deciduous and coniferous trees. Understory vegetation consists of smaller trees, brush, and grasses. It appears that the area was cleared of larger trees in the past. There is a small seep at the base of the slope. No other seeps were present, and groundwater was not encountered in any of the test pits. The total area defining the debris field is about 1.5 acres.

Debris was visible on the surface, partially buried, or encountered in shallow shovel pits. The thickness of the debris is unknown but determined to be in the range of 5.5' thick to 20' thick. The debris is defined by:

- Vegetation consisting of smaller diameter trees and dense underbrush
- Surface debris consisting of metal drums, vehicle body and frame parts, various machine parts, cables, hoses, sheet metal, and wood debris
- Features indicative of past dumping of fill soil and debris.
