PHASE I
ENVIRONMENTAL SITE ASSESSMENT

Prepared for:
Everett Steel Companies

Prepared by:
ICF Kaiser Engineers

June 1992

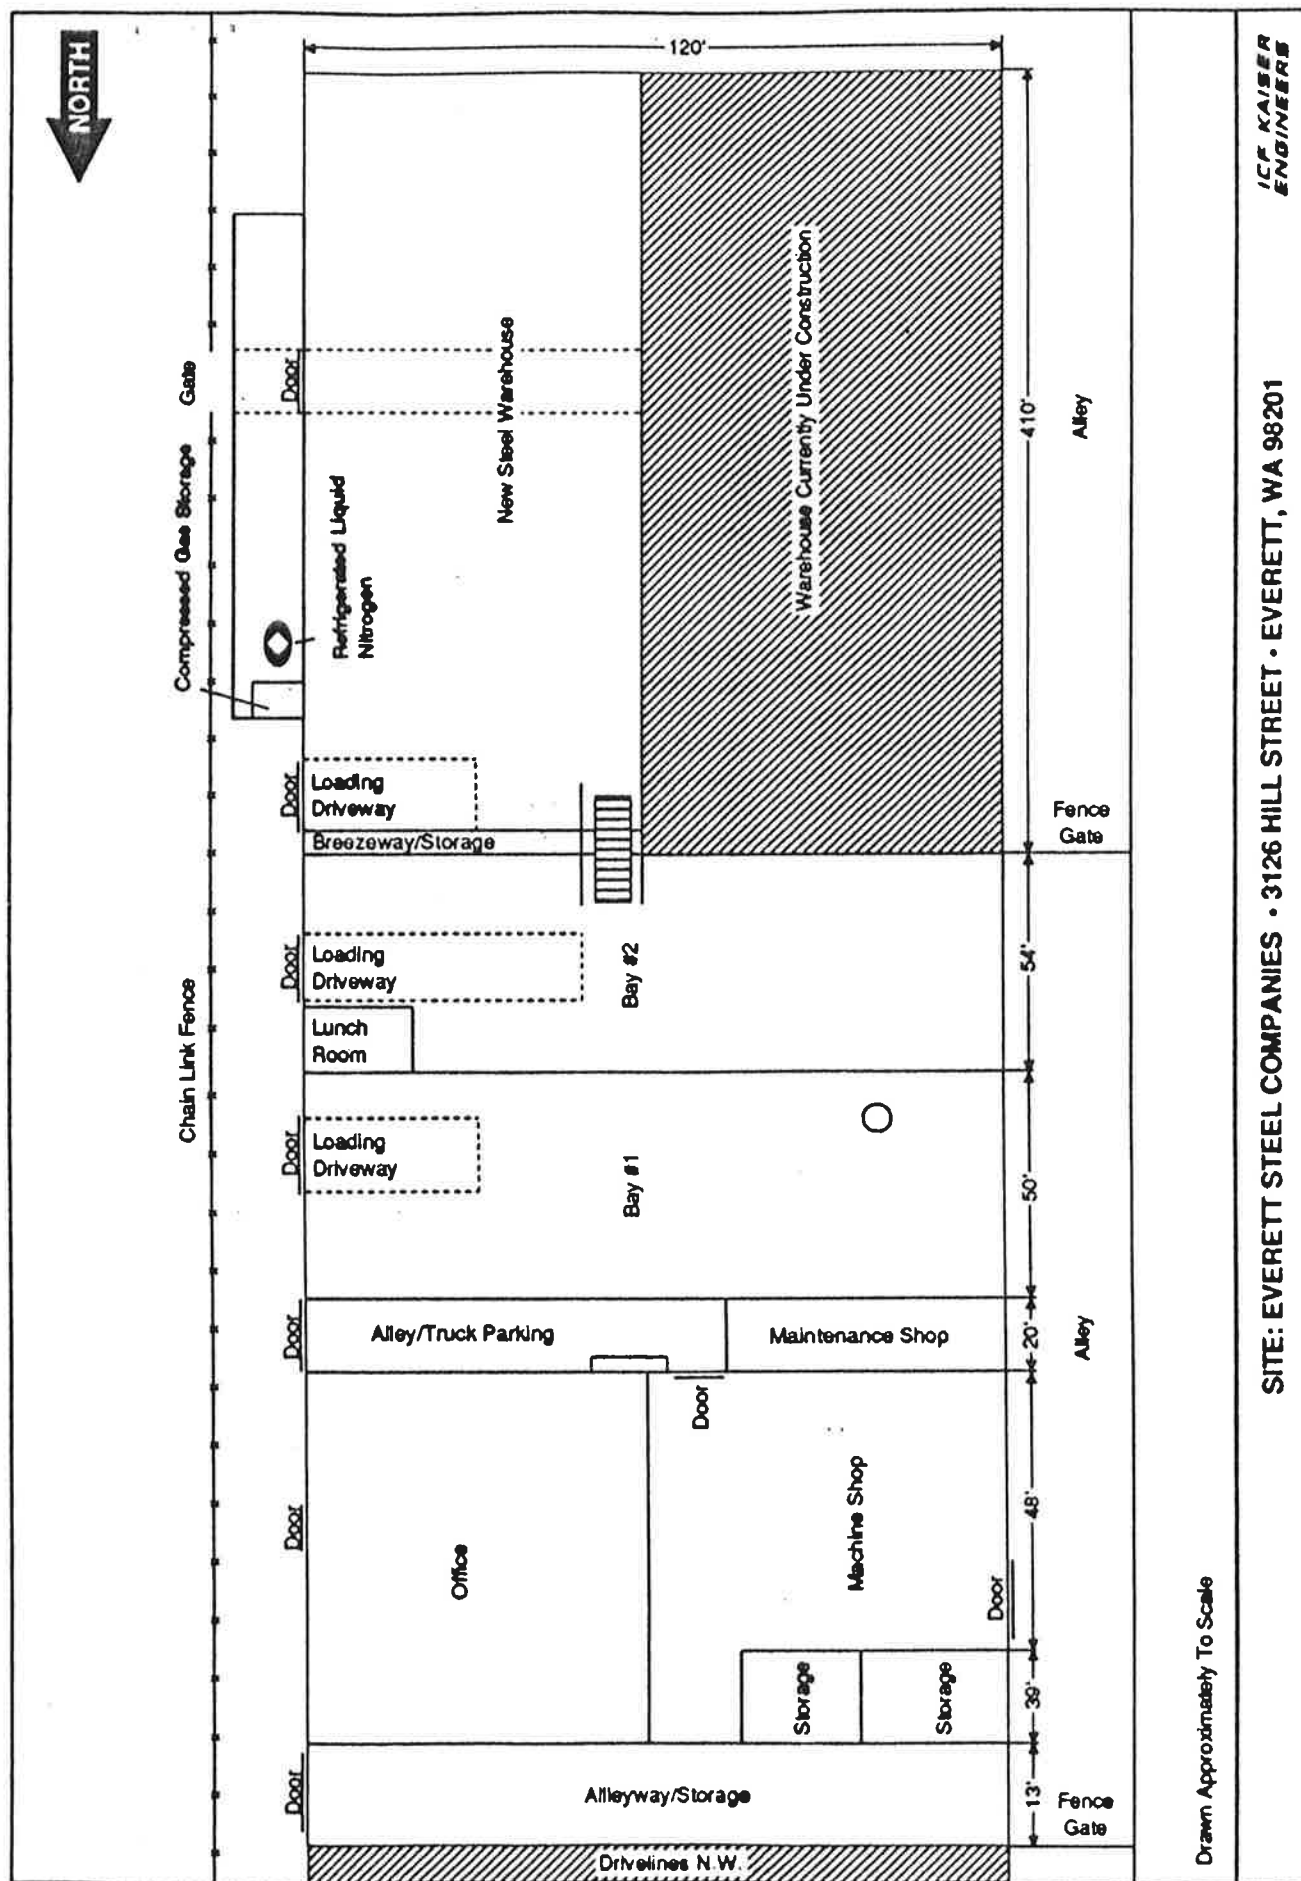
FIGURE 4. SITE PLAN OF WAREHOUSE AREA

| Location 1. | Maintenance and Alleyway Parking Area (between the new steel bays and the main office); |
| Location 2. | Maintenance and Machine Shop Area (between the new steel bays and the machine shop); |
| Location 3. | Bay #1 Chain Dipping Vat; and |
| Location 4. | Storage sheds adjacent to the Wheelabrator Building. |

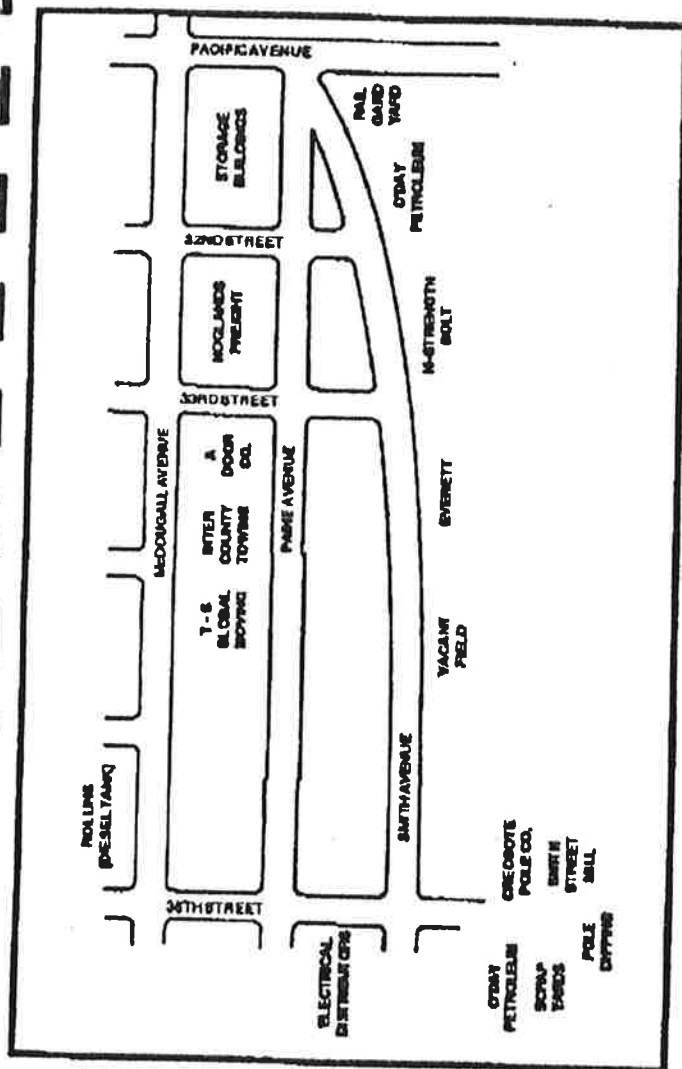
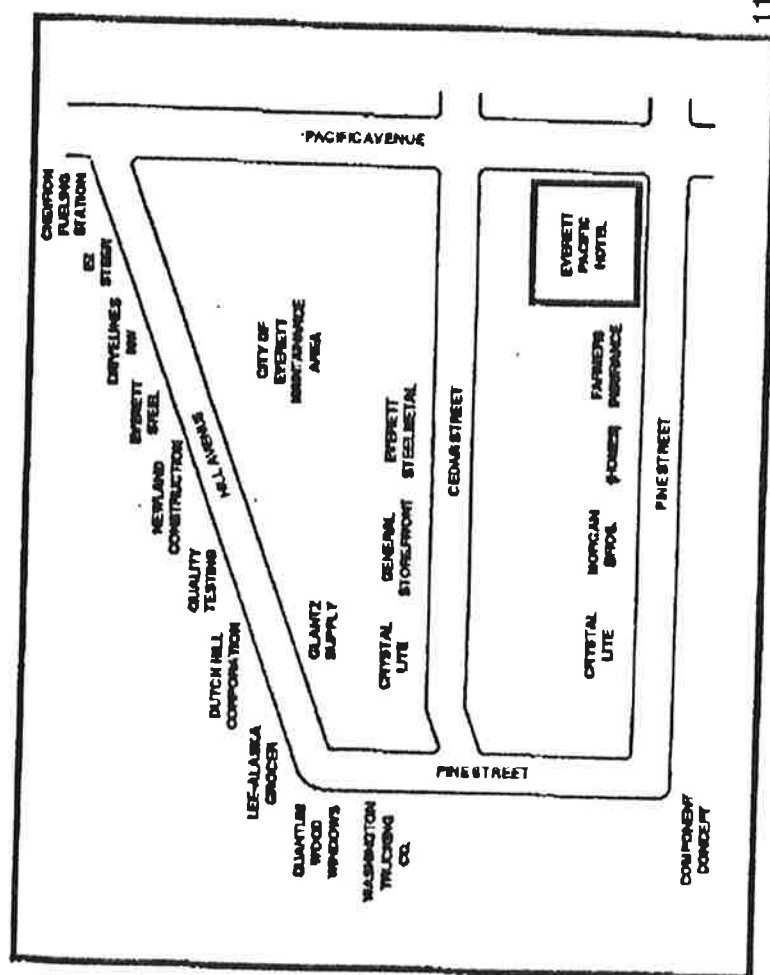
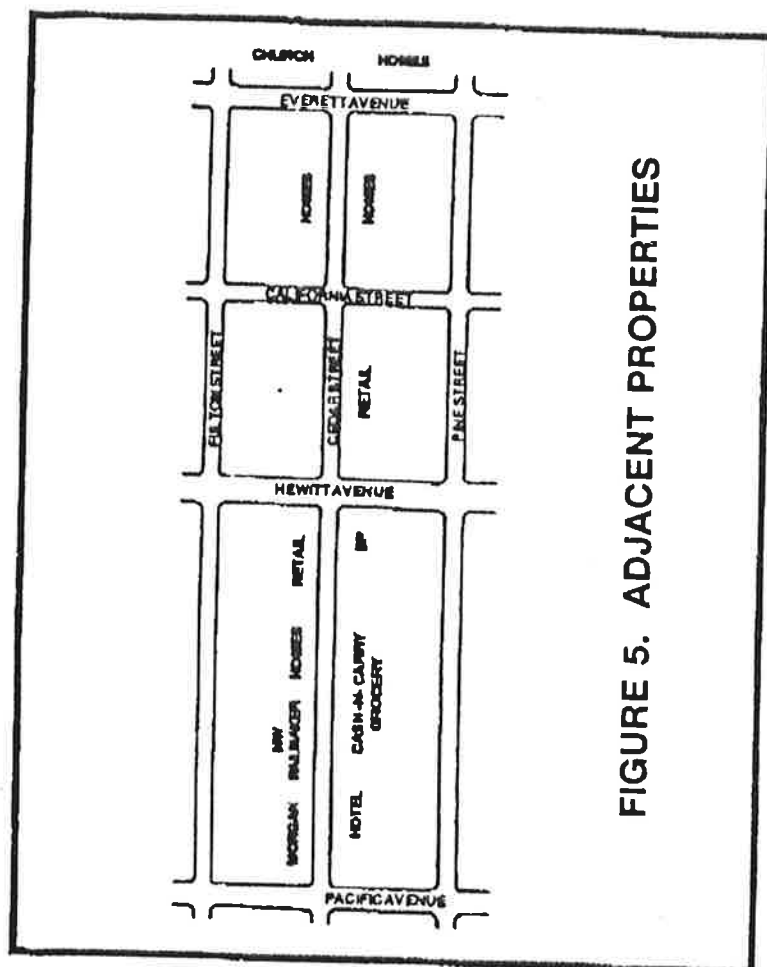
FIGURE 5. ADJACENT PROPERTIES

The Site is bordered by commercial areas in all directions, interspersed with residential homes. North of Everett Steel are commercial structures, including a Chevron Fueling Station at Hill and Pacific (Figure 5). Further North of Everett Steel are residential and retail areas. Commercial warehouses, homes, and hotels are located east of the Site. West of the Site are numerous commercial warehouses and industrial manufacturing facilities. During a survey of the area a number of facilities were observed which could be of concern to the Site. Within one mile of the Site, 8 properties are listed as containing leaking USTs, 18 facilities are listed as RCRA facilities, and 5 of the adjacent sites have had emergency response associated with hazardous material spills or mishandlings.
