STATE OF WASHINGTON
DEPARTMENT OF ECOLOGY

Re: Further Action at the following Site:

- **Site Name:** BLT Trucking
- **Site Address:** 8010 S 259th Street, Kent, Washington 98032
- **Facility/Site No.:** 60800
- **Cleanup Site ID:** 16551
- **VCP Project No.:** NW3338

Enclosure A

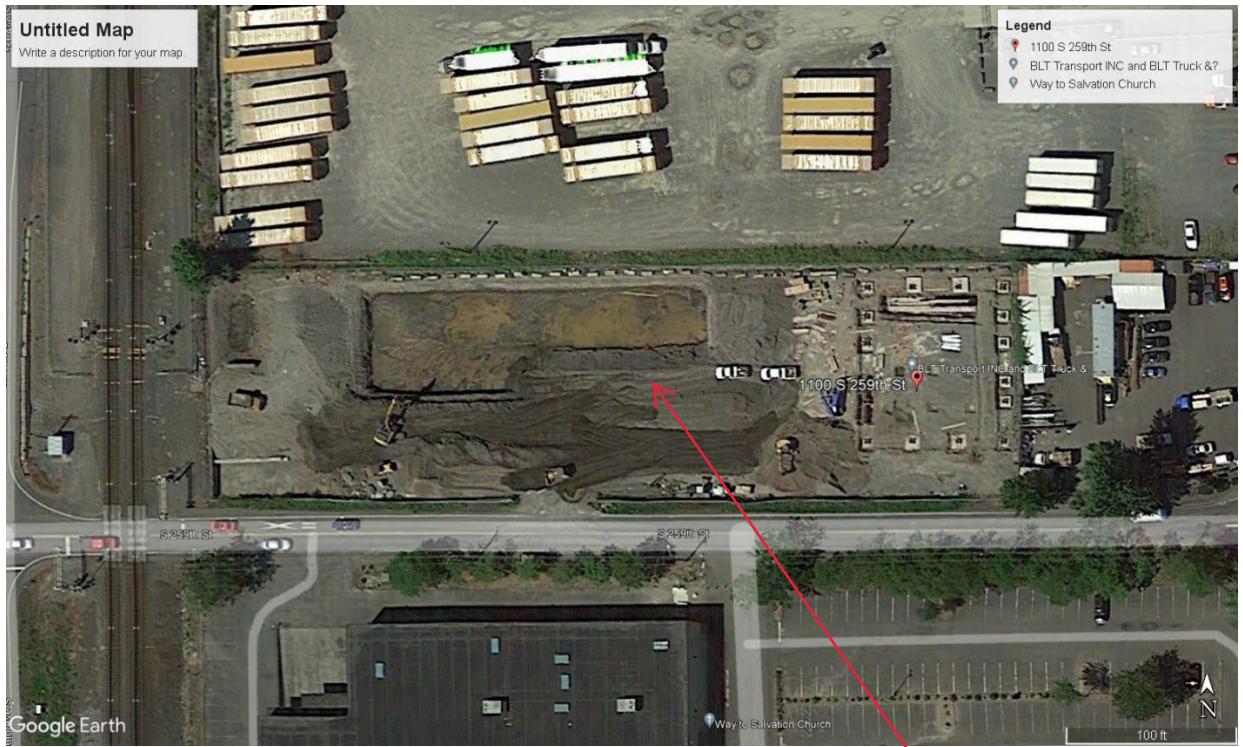
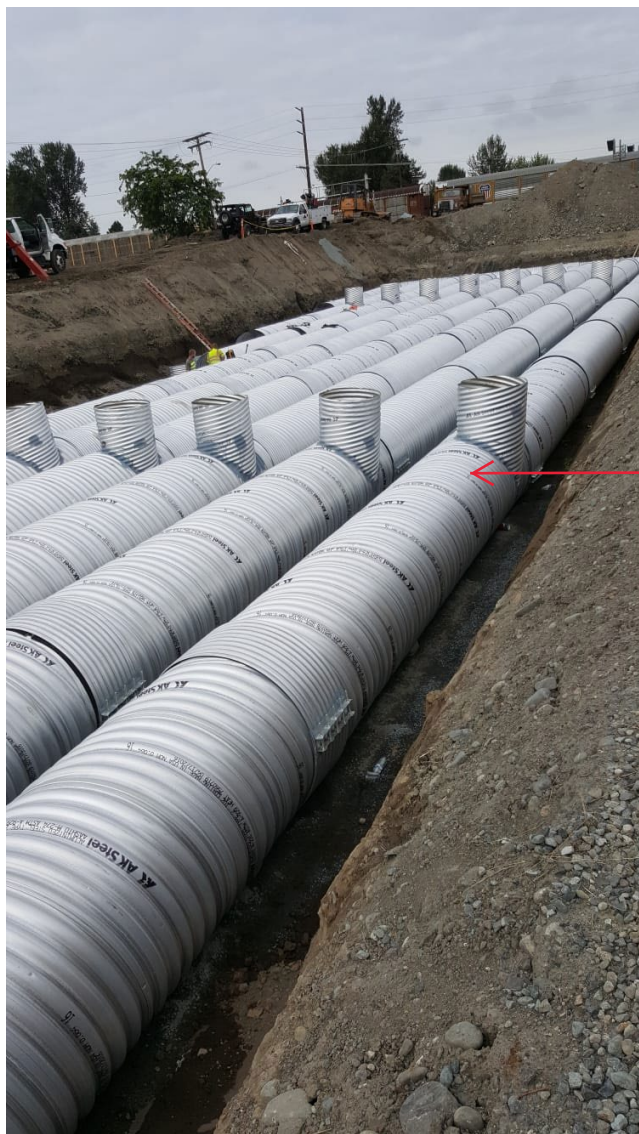
FIGURE 3
Photos of the Storm Water Detention Gallery (annotated by Ecology), October 2022.
Reference: Photos provided by ECI via Email on September 9, 2022.

All the wells (except MW-5) appear to be installed in or very near the former excavation area, so groundwater elevations may be influenced by the storm water detention gallery. Groundwater is expected to follow topography and flow toward the Green River to the southwest. **Figures 4 and 5** show the reported groundwater flow during the second and fourth quarters of 2021, respectively.

Excavation for storm water basin/storm water detention gallery, 2016.

Storm water detention gallery construction, 2016.

the groundwater is being influenced by the storm water detention gallery. The groundwater contour maps included in the report appear inconsistent and it is questionable whether the contours represent actual groundwater conditions.

Assess the groundwater flow beneath the Property and whether the groundwater is being influenced by the presence of the storm water detention gallery, especially during storm events. Evaluate the location of the wells in relationship to the former excavation and the piping for the storm water detention gallery. Site characterization requires an accurate investigation of groundwater flow to determine downgradient conditions.

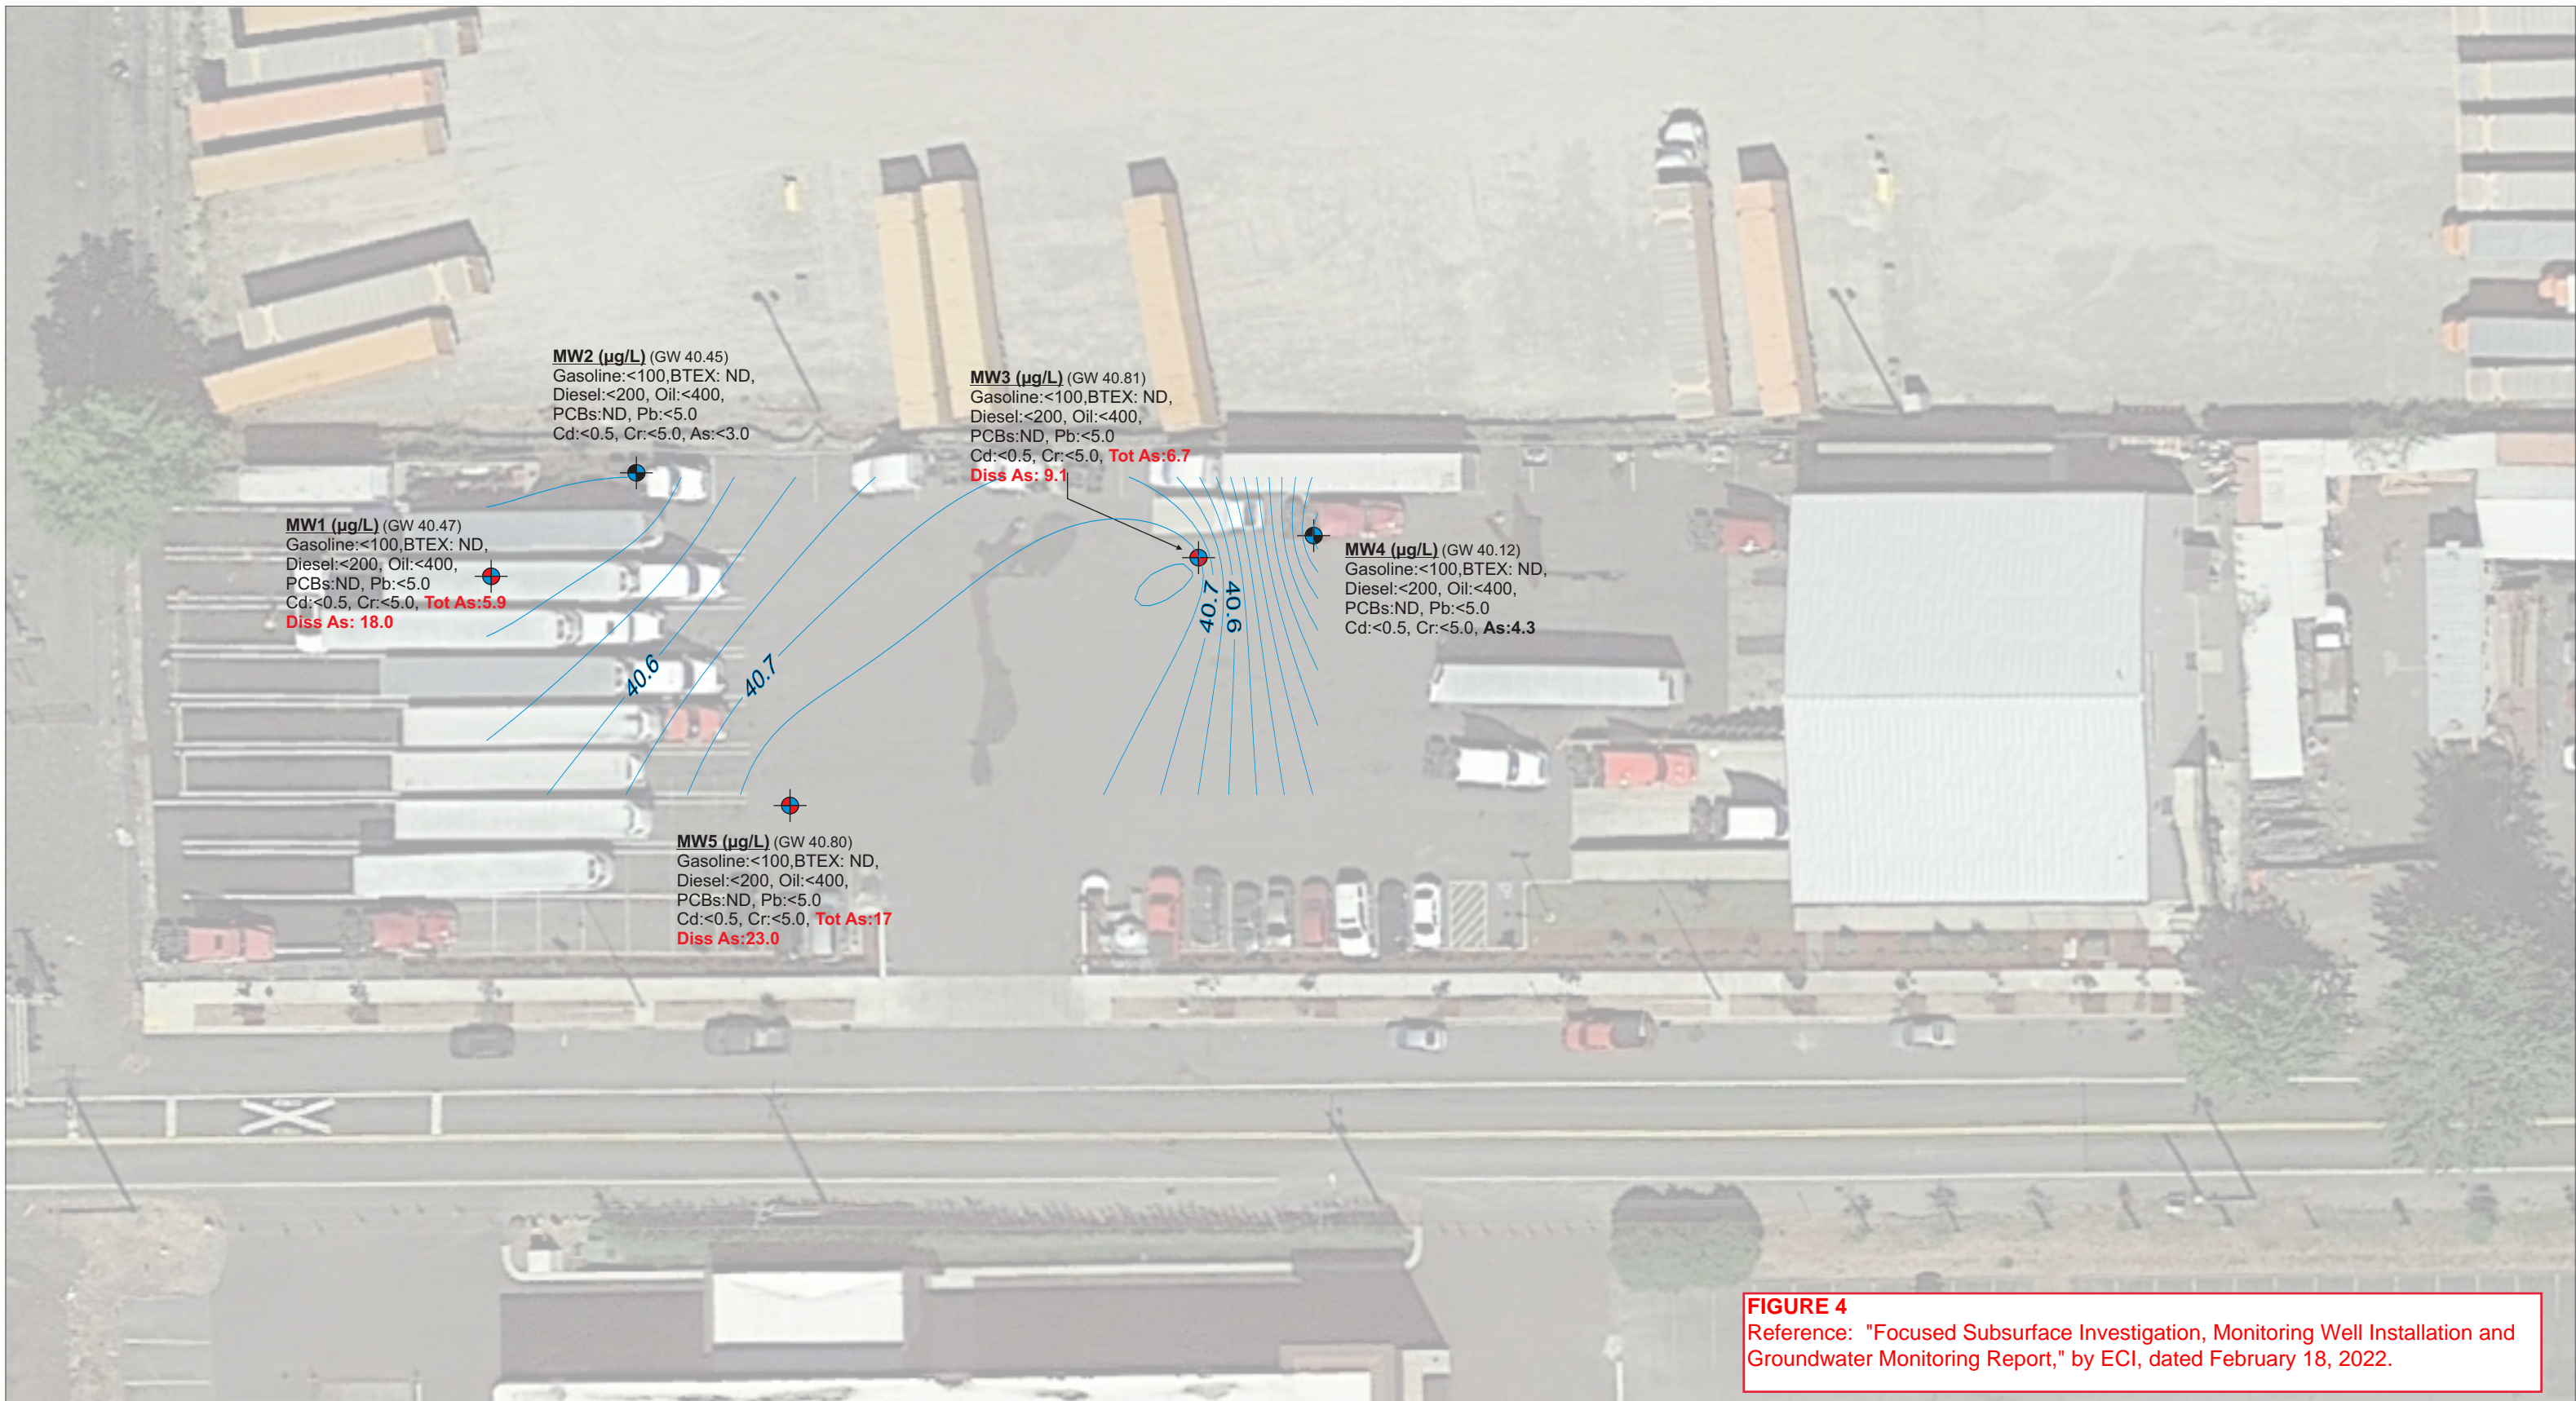
FIGURE 4
 Reference: "Focused Subsurface Investigation, Monitoring Well Installation and Groundwater Monitoring Report," by ECI, dated February 18, 2022.

Release and Extent of Contamination (Soil and Groundwater): Environmental assessments and investigations were conducted on the Property in 2016 and 2021. Soil sample locations and results for investigations conducted in 2016, including samples collected prior to excavation activities and confirmation samples collected after excavation activities are shown on **Figure 6**. Soil boring and groundwater monitoring wells from the 2021 investigation are shown on **Figure 7**. **Figure 7** also shows soil sample results. Groundwater results for the second and fourth quarters of 2021 are shown on **Figures 4 and 5**.

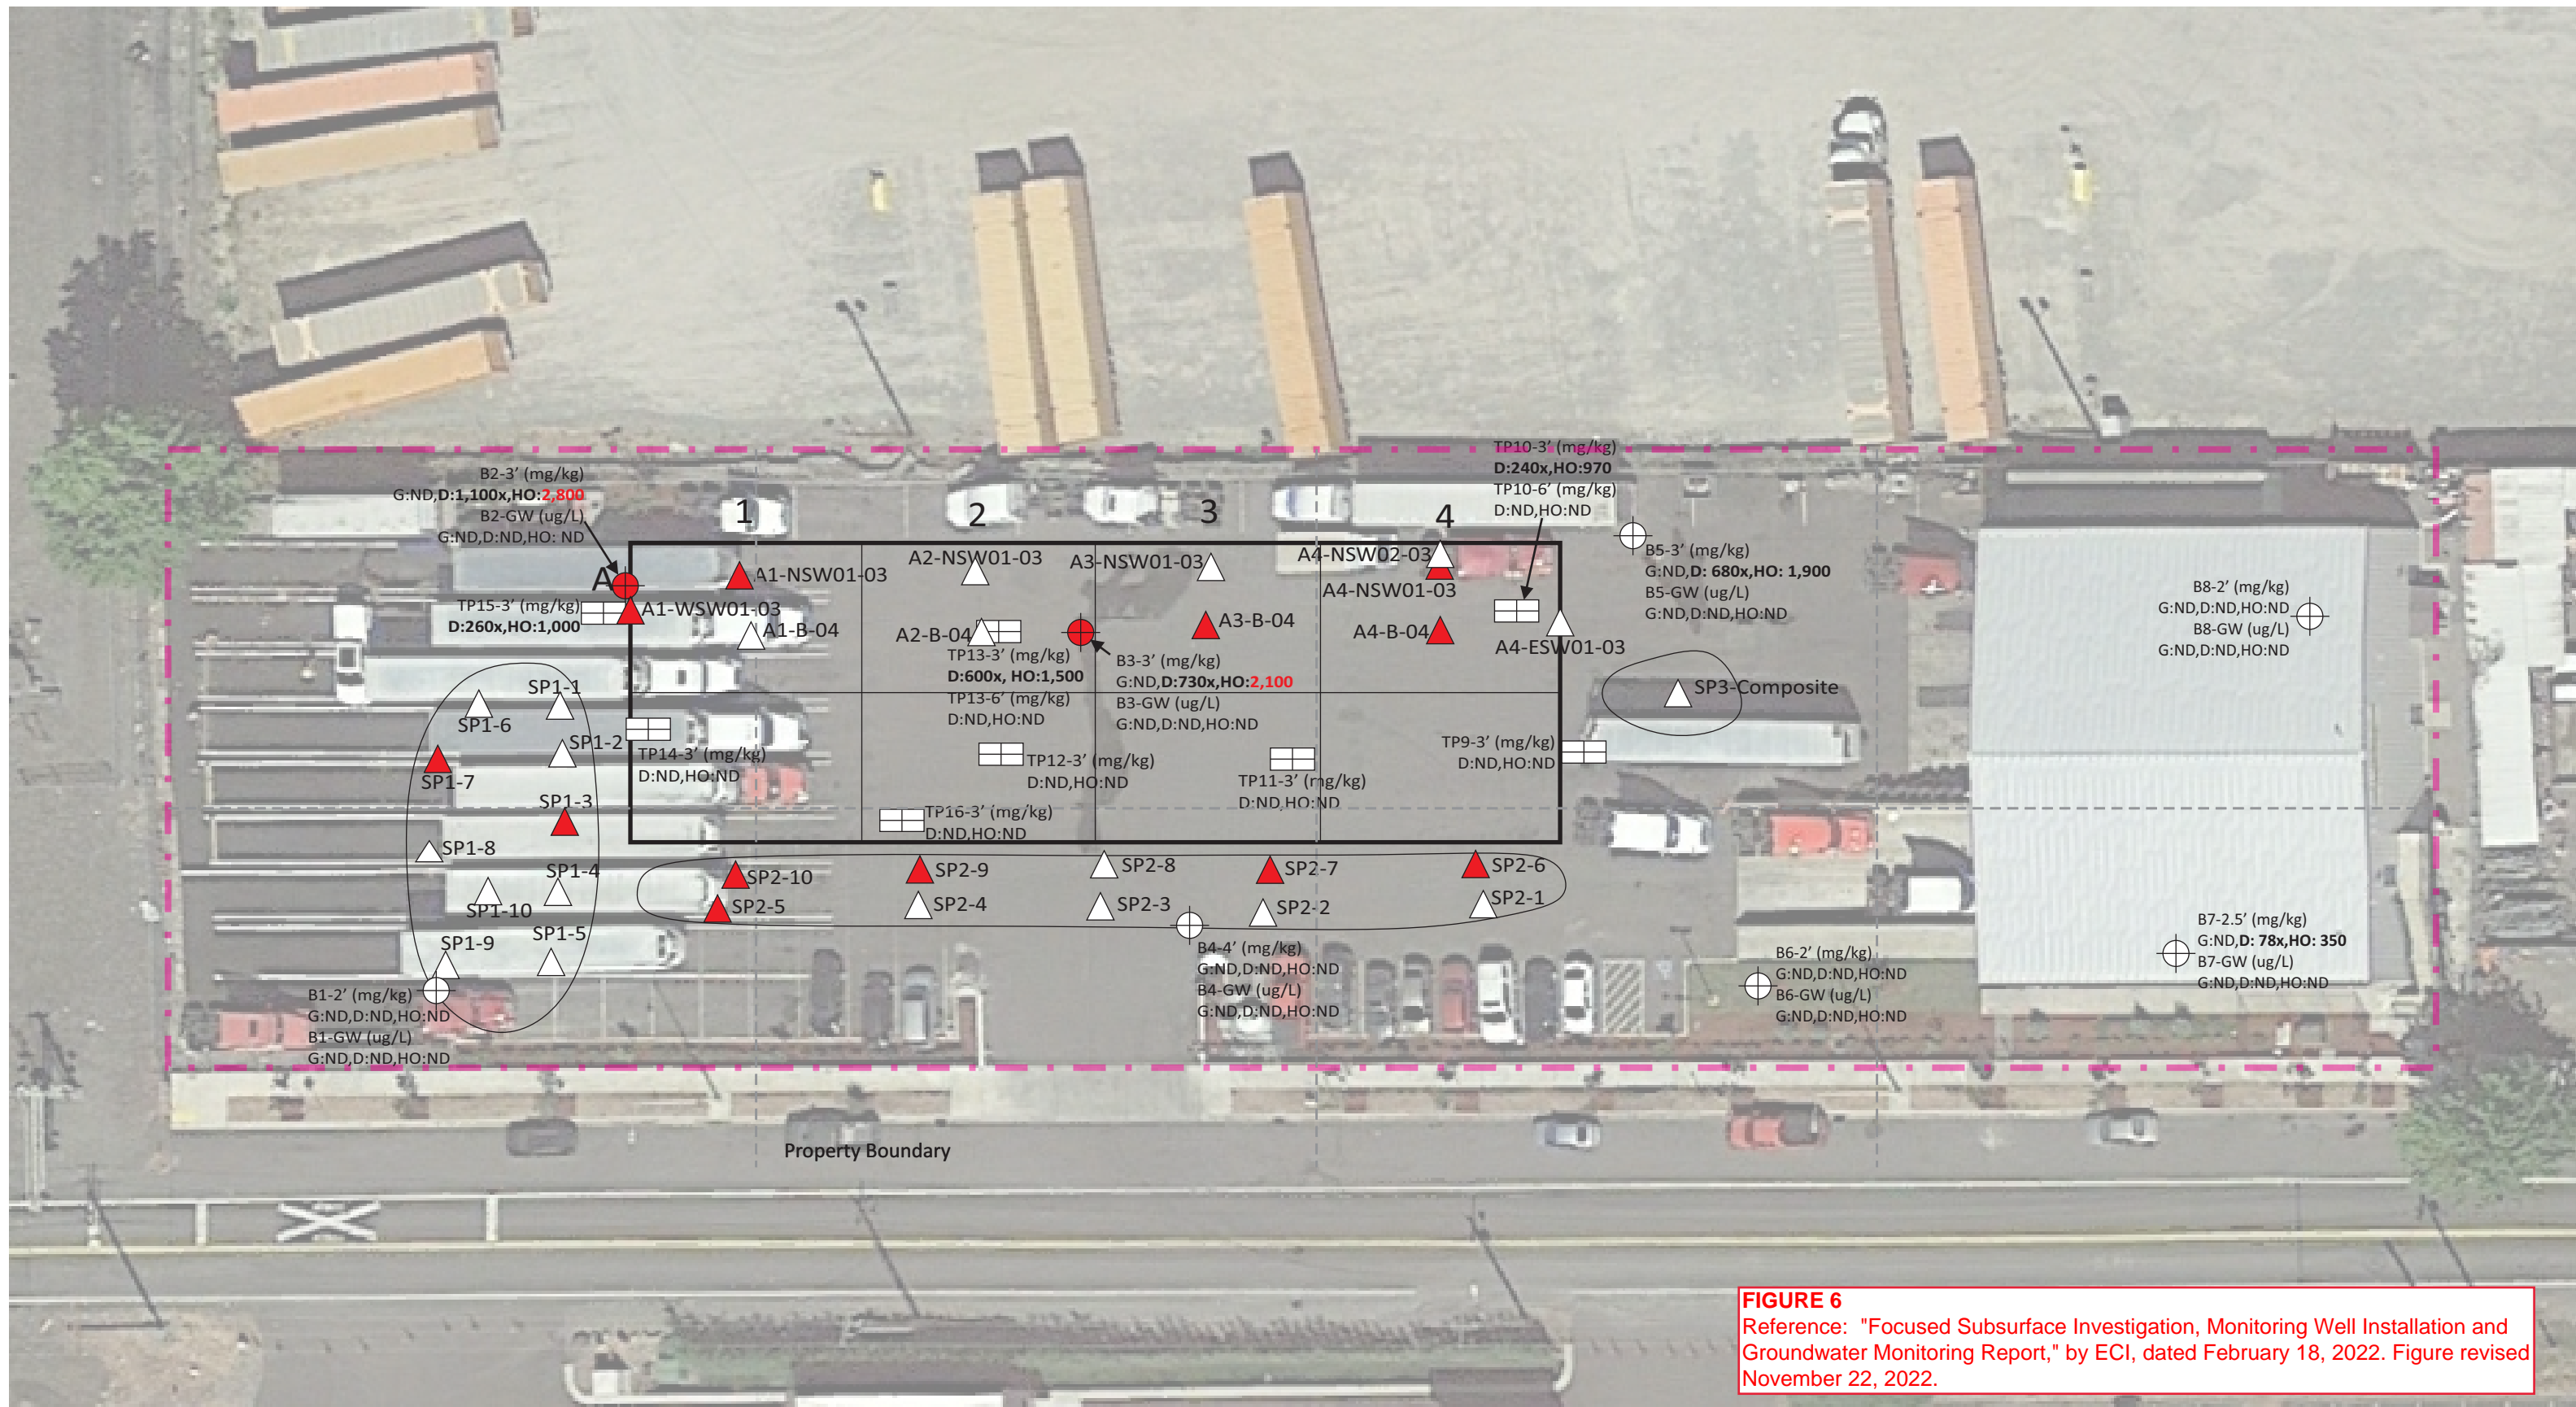
- In May and June 2016, eight borings (B1 through B8) were drilled and sampled across the Property (**Figure 6**). TPH-D + TPH-O concentrations were higher than the Method A cleanup levels in samples collected from 3 to 4 feet bgs in B3, B4, and B5. Cadmium and lead also exceeded the Method A cleanup level in the sample from B2. TPH-G was not detected above the MRLs. Ten test pits (TP9 through TP16) were excavated to approximately 3 feet bgs, except for TP10 and TP13, which were excavated to approximately 6 feet bgs. One test pit sample (collected from 3 feet bgs from TP3) contained TPH-D + TPH-O at a concentration exceeding the Method A cleanup level. Oil was detected in groundwater (NWTPH-HCID) from boring B2, B3, and B4.

- In June 2016, soil was excavated from the Property for the installation of a storm water detention gallery. The depth of the final excavation was approximately 6 to 8 feet bgs. Stockpile soil samples and excavation confirmation soil samples (up to 4 feet bgs) contained TPH-D + TPH-O, PCBs, cadmium, and lead at concentrations exceeding Method A cleanup levels. The report in 2022 stated the excavation extended to 6 to 8 feet bgs and that stockpiled soil was used as backfill. **Figure 6** shows the locations of the confirmation soil samples.
