**SITE CHARACTERIZATION
REPORT
FOR
CITY OF CLARKSTON**

**BRIDGE STREET SHOP SITE
1455 BRIDGE STREET
CLARKSTON, WASHINGTON**

**WDOE INCIDENT NO. 3666
WDOE SITE NO. 100255**

FEBRUARY 1993

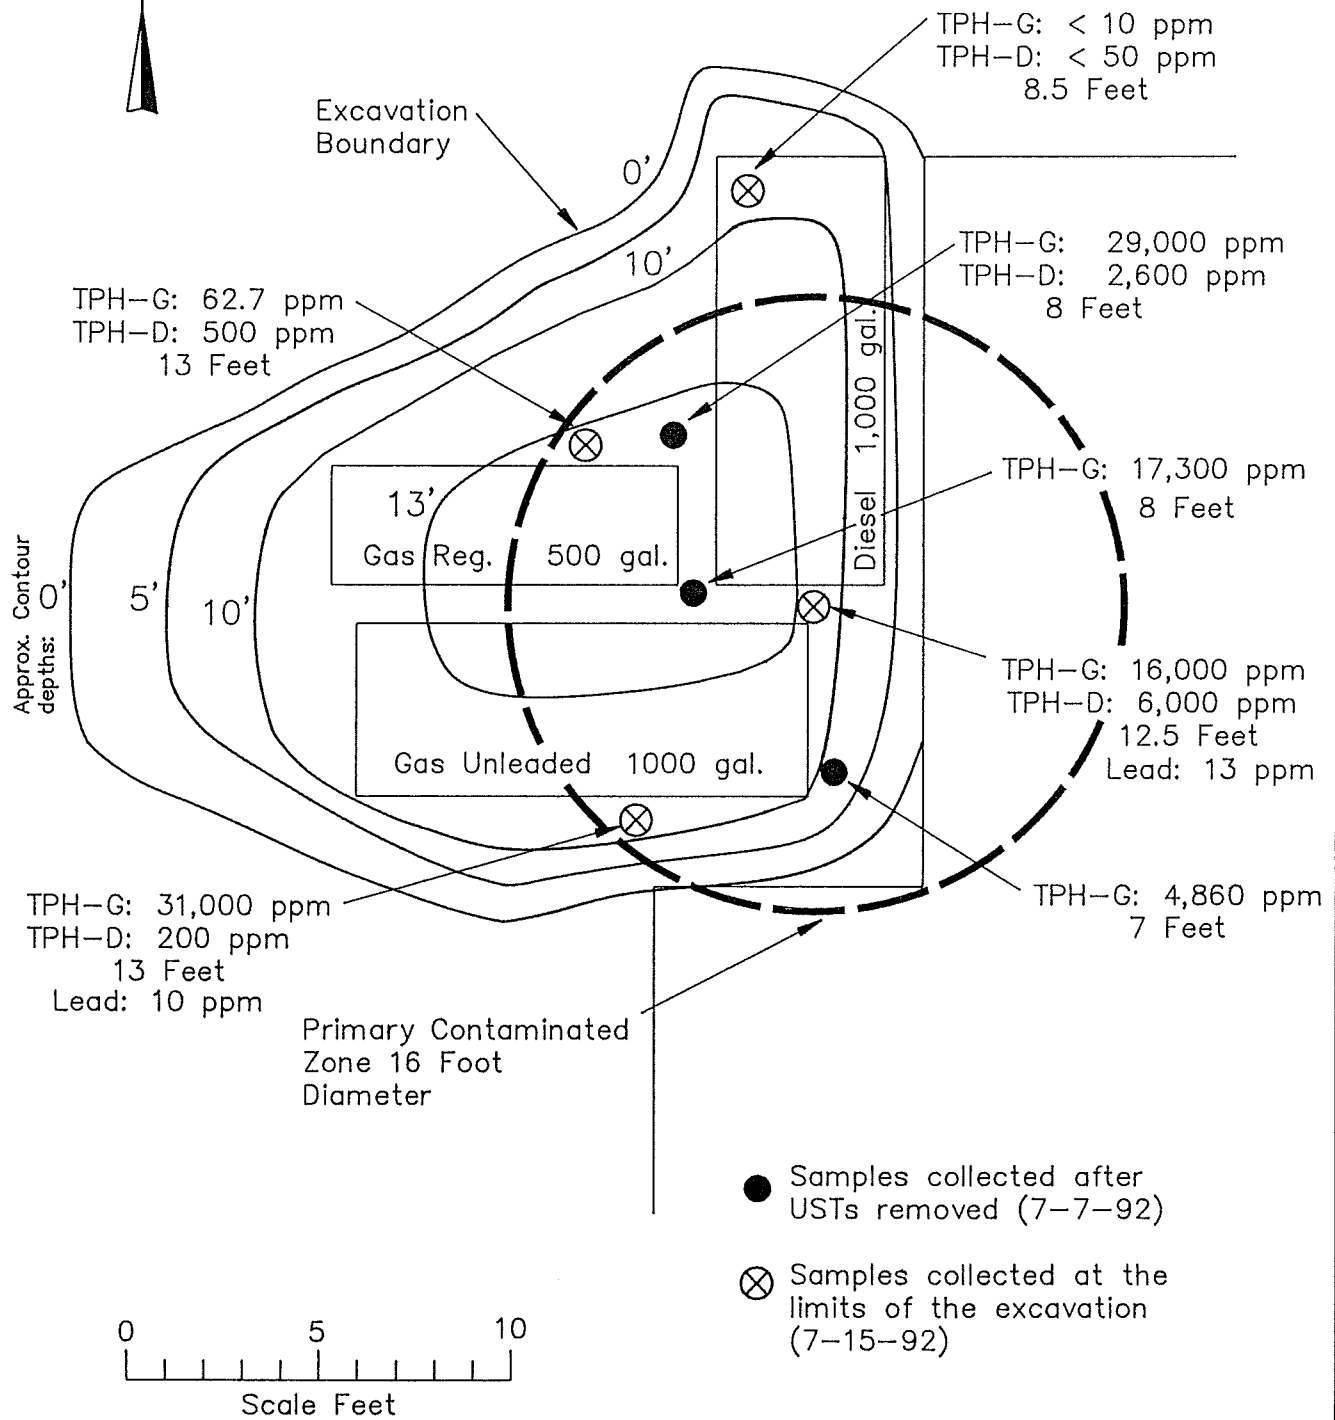
FIGURE # 3

The locations, depths, and analytic results of soil samples collected in the excavated area are shown in Figure 3. These samples were collected primarily in the contaminated zone. Samples collected north and west of the primary contaminated zone show a sharp decrease in TPH levels.

The excavation soil sample locations, depths, and analytic results are shown in Figure 3. Contamination in the excavated area was found to decrease rapidly to the west and north. An area of primary contamination appeared to be centered on the east side of the excavation south of the diesel tank. This primary contaminated zone appears to be approximately 16 feet in diameter and shows relatively consistent levels of TPH-G contamination from the bottom of the tanks to the bottom of the excavated area. Using these data, the zone of primary contamination was divided into a 3-foot thick uncontaminated surface zone-1; a 4-foot thick zone-2 including the USTs and localized areas of contamination; and an 8-foot thick zone-3 containing the primary dispersed gasoline and diesel contamination. Figure 6 shows an attempt to estimate the volume of product released using the primary contaminated zones as a model. The analysis required estimating the average TPH-D and TPH-G for soil zones 2 and 3; calculating the soil volume and weight in each zone; and estimating the volume of diesel and gasoline. Estimates are only an approximation based on observations of product distribution in the field and utilizing the limited analytic data available. The primary contaminated zones are plotted in Figures 2 and 3 as a perimeter of the zone and in cross-section Figure 5 to show the vertical extent of the zones. Based on this analysis, approximately 140 gallons of diesel and 800 gallons of gasoline

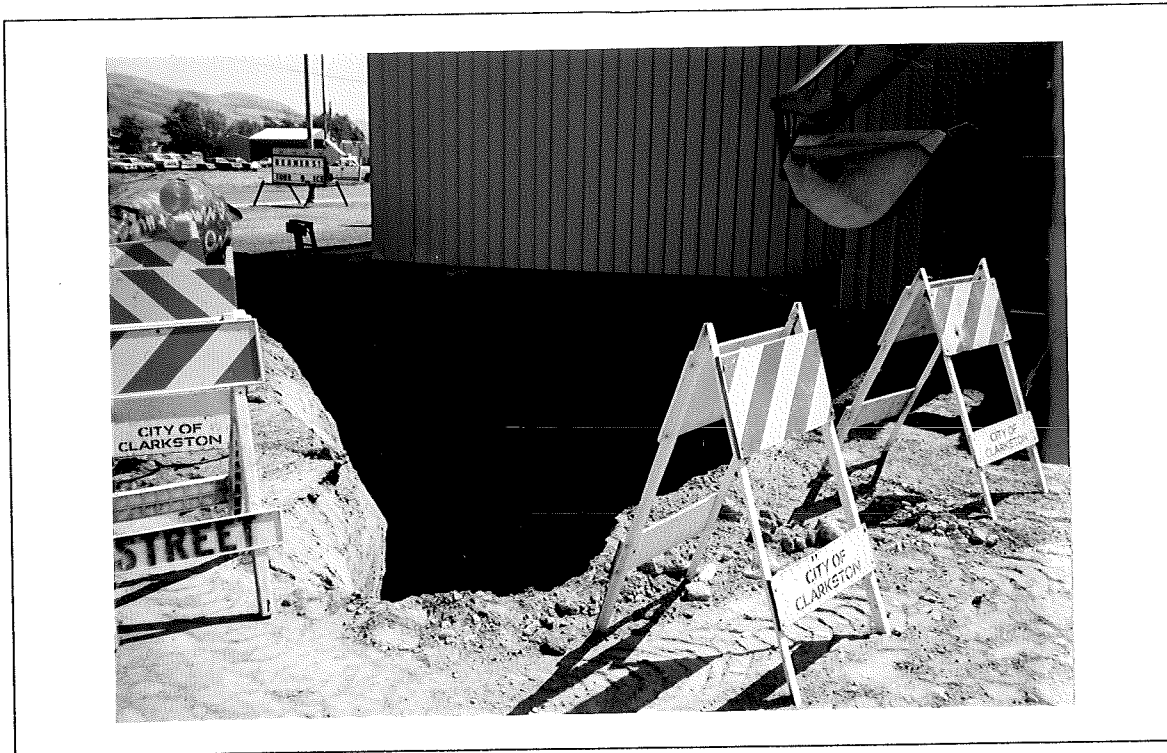
VIEW OF THE EXCAVATION LOOKING NORTHEAST WITH THE SHOP BUILDING AND BRIDGE STREET IN THE BACKGROUND.

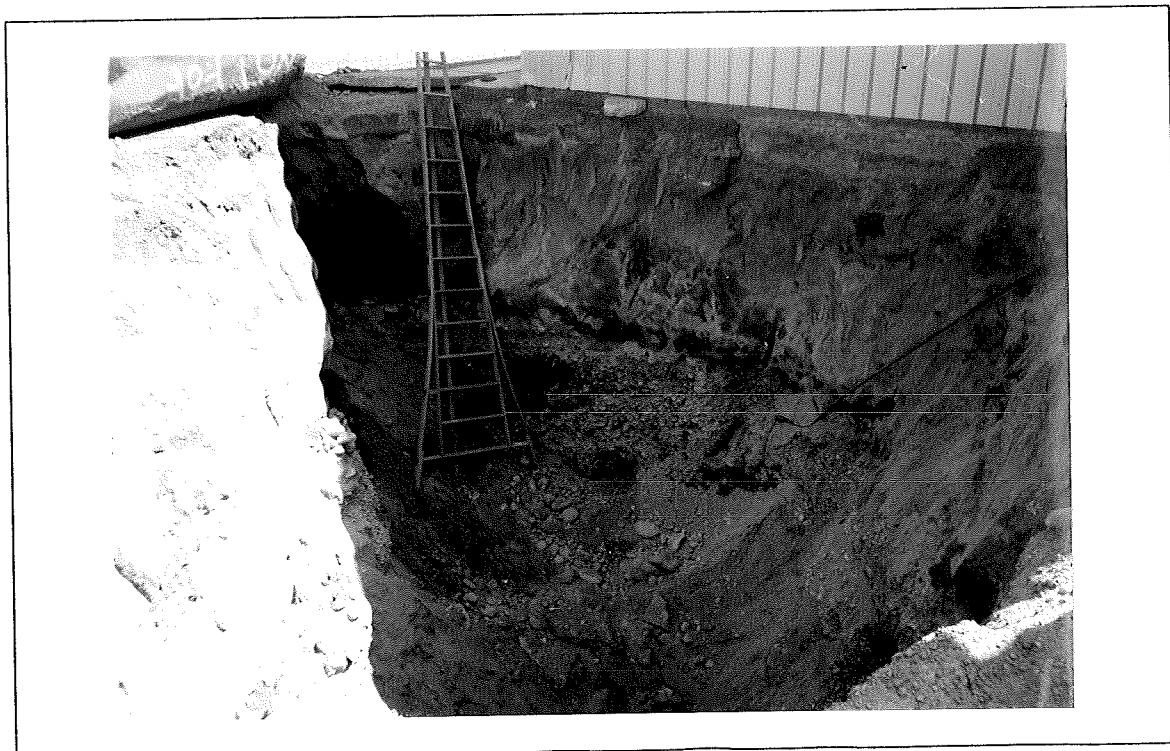
VIEW INTO THE EXCAVATION SHOWING THE SILTY SAND OVERLAYING THE GRAVEL.

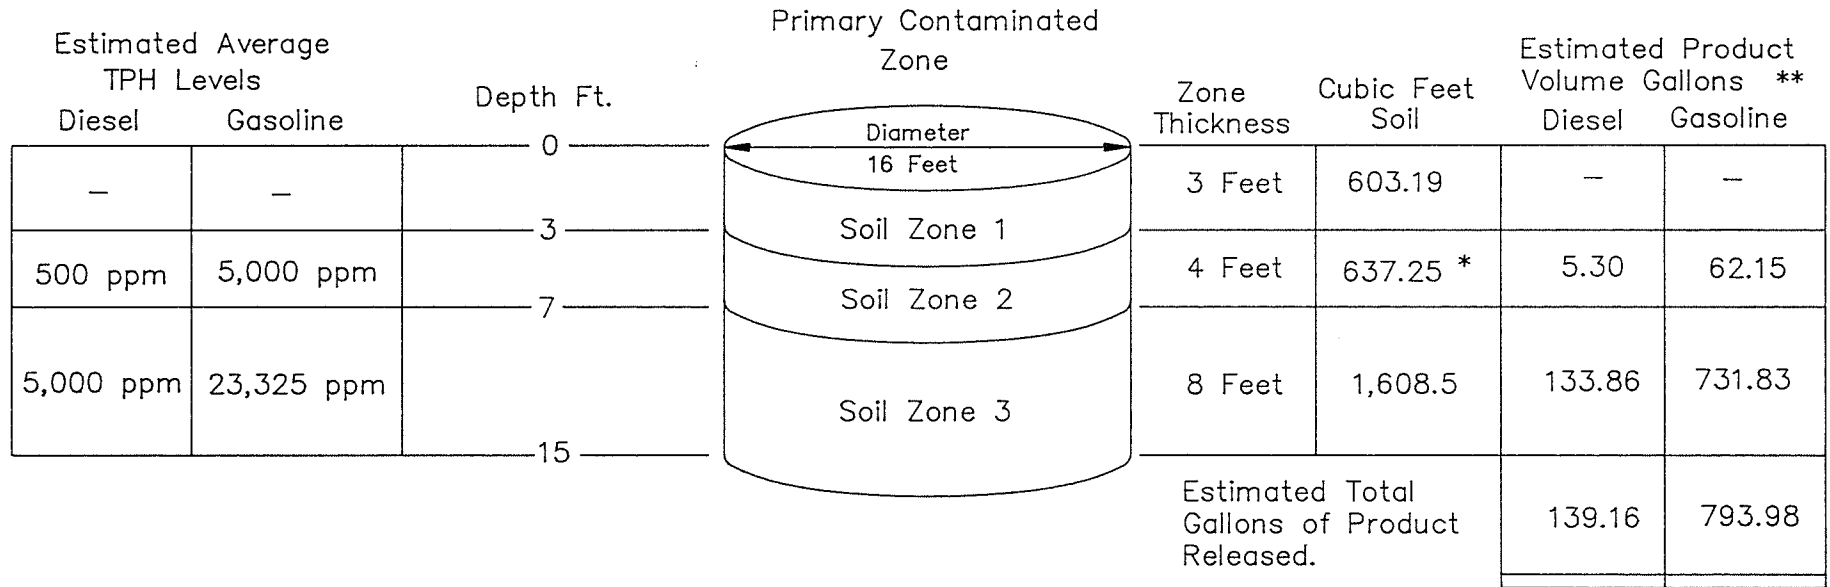
FIGURE # 6

* Soil Zone 2 volume has been adjusted for including approximately 167 cubic feet of USTs.

** Product volume based on Diesel = 7.21 lbs./gal.
and gasoline = 6.152 lbs./gal.

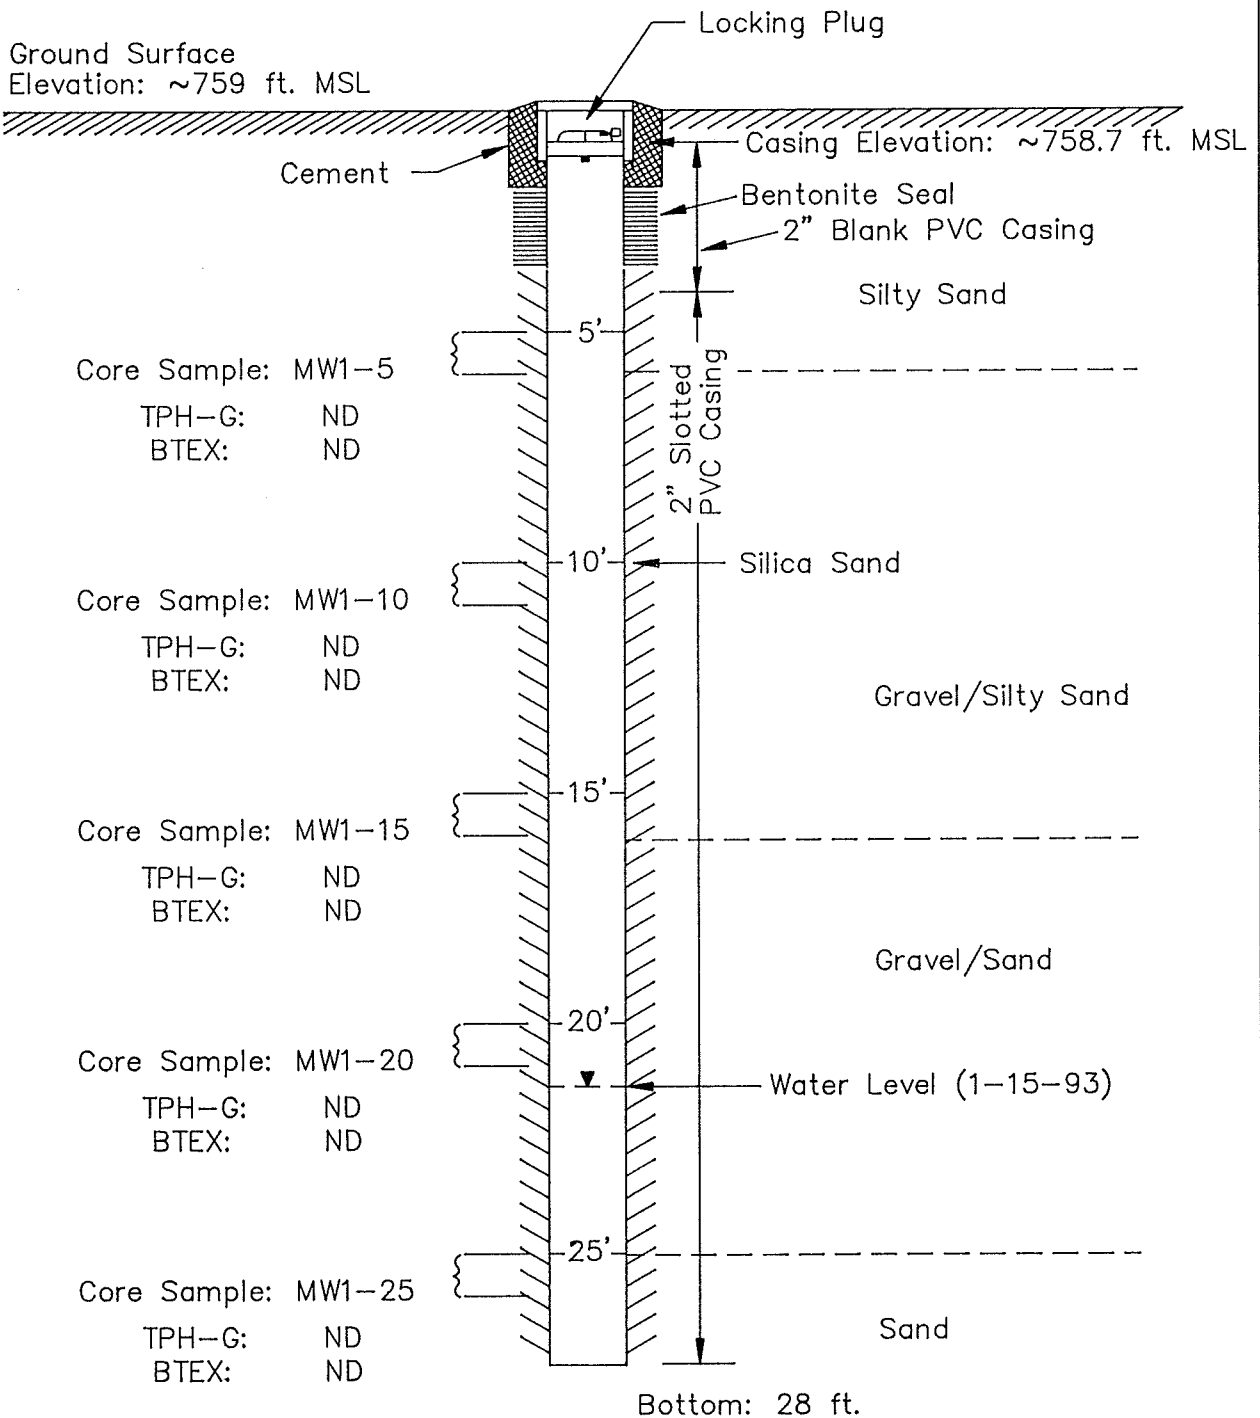
FIGURE #7

Soil samples were collected to a depth of 25 feet at 5-foot intervals during drilling of MW-1 located 20 feet north of the excavation, see Figure 7. These samples were collected with a split spoon sampler and were analyzed for TPH-G and BTEX. No soil contamination above the analytic detection limit was observed. Ground water sampled from MW-1 had a TPH-G level of 1.05 ppm, which is just slightly above the analytic detection limit of 1.0 ppm. BTEX components in the ground water were all below the detection limits. These results and the estimated ground water flow velocity of 40 ft./yr. suggest that only trace amounts of the contamination have reached the ground water at this site.

Groundwater Results (12-30-92)

TPH-G: 1.05 ppm
 BTEX: ND

We recommend collecting quarterly ground water samples from MW-1 and monitoring the temperature, oxygen, and carbon dioxide levels in the dry well and MW-1. These data over the next year should provide adequate monitoring of both the ground water quality and effectiveness of this passive in situ remediation technique. If the oxygen level decreases or the contamination level in the ground water increases significantly, the bioactivity can be enhanced by adding a fan to force an additional volume of air into the contaminated zone. This technique is now being used to remediate a site in North Lewiston, Idaho, where there was no opportunity to create the natural barometric pumping system that is provided by the pea gravel backfill at this site. The gasoline contamination at the North Lewiston site has been significantly decreased in both the vadose zone and in the ground water over the past year of operation.
