PHASE I ENVIRONMENTAL SITE ASSESSMENT

Dental Office
Parcel 1222000089
116 Southwest 160th Street
Burien, Washington 98166

RUDEY ORTHODONTICS

Rudey Orthodontics
November 25, 2008

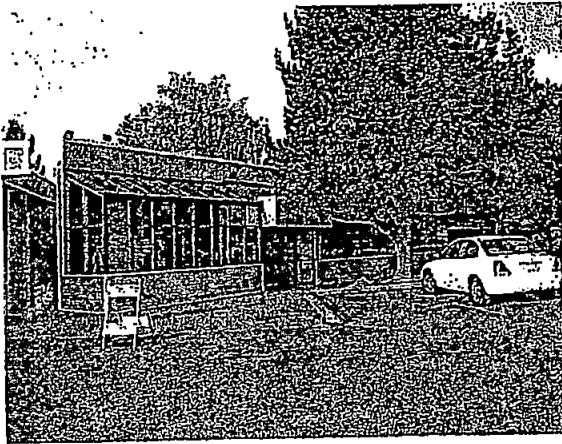
Eastern exterior of dental offices (subject building).

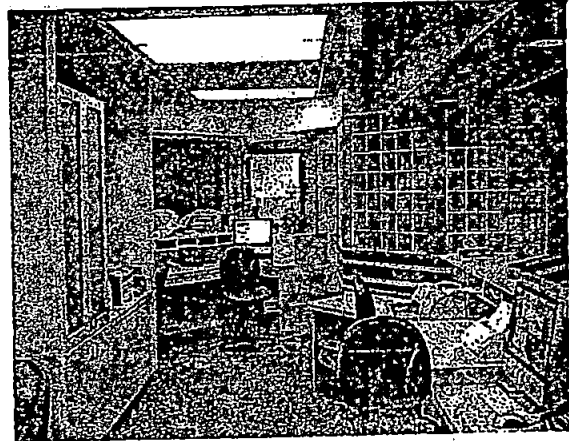
Typical office interior.

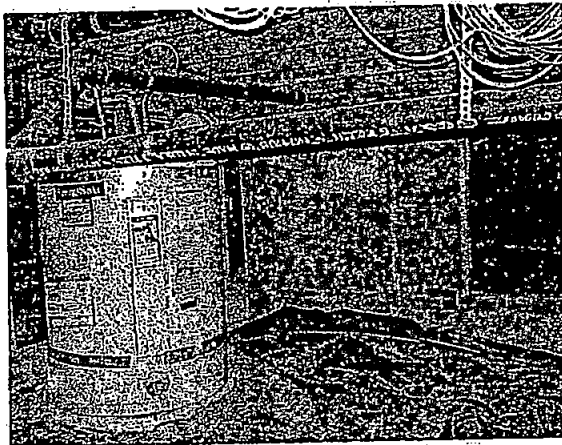
Crawlspace of subject building.

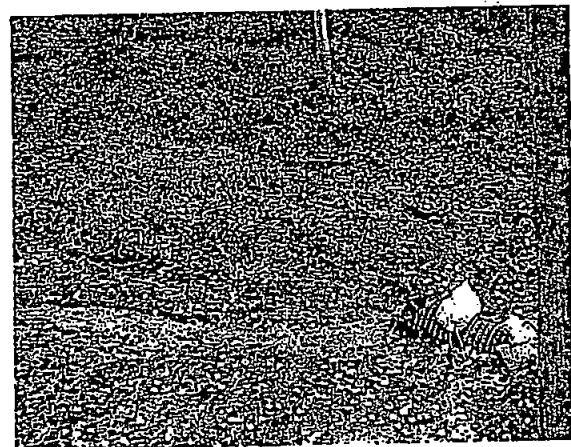
With respect to surface water resources, referring to the lower right-hand photo panel of Plate 3, a small drainage creek is located along the western boundary of the site. This surface water course flows in a southerly direction.

Drainage creek on western edge of the subject site.
