February 17, 2015

Subject: Conceptual Cleanup Action and Request for NFA-Likely Opinion Letter
Seattle Marriott AC
739 9th Avenue North
Seattle, Washington
GeoEngineers File No. 20776-003-00

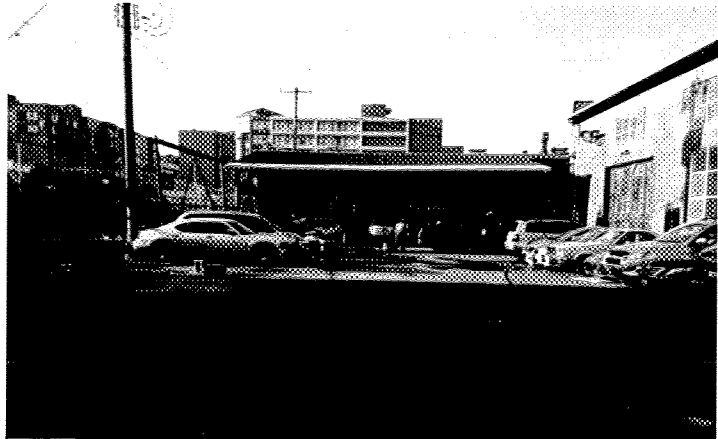
Photo 1: Current property use as a MAACO Auto Body and Repair facility - looking north.

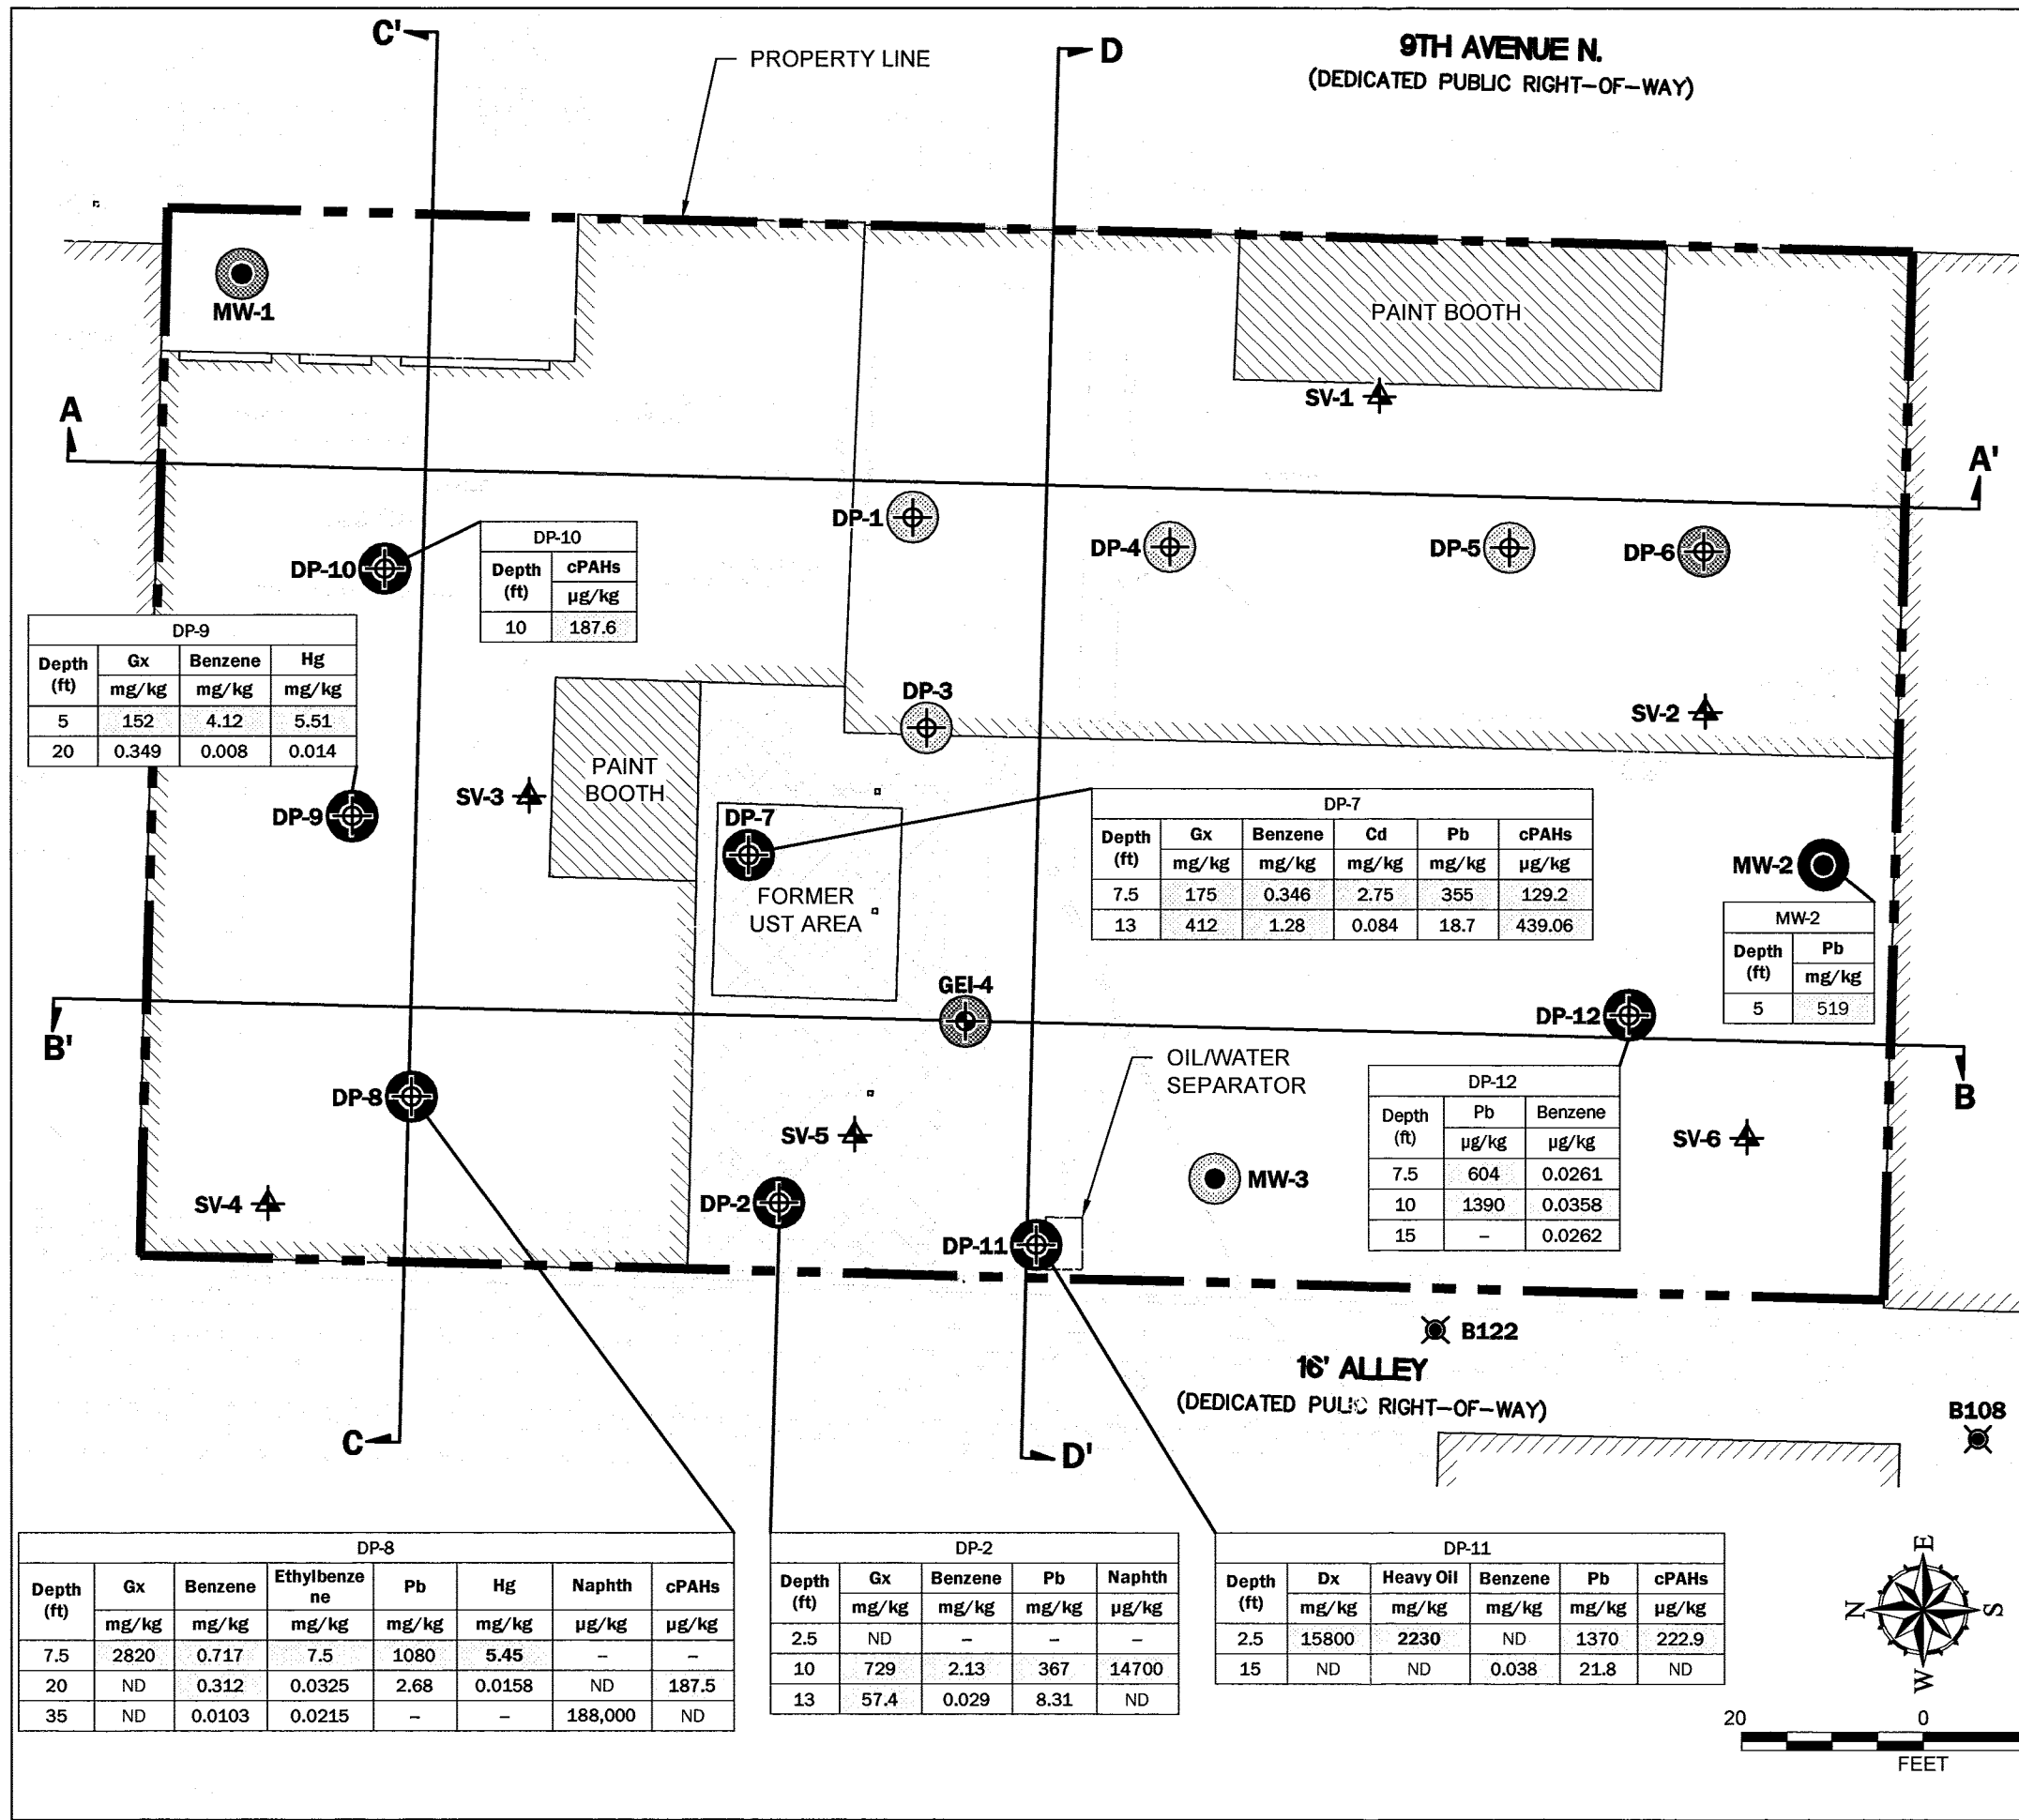
Boring Locations and Soil Chemical Analytical Results	
South Lake Union Marriott AC Seattle, Washington	
GEOENGINEERS	Figure 3

- **Contaminated and dangerous waste soil.** Petroleum, metals, benzene, ethylbenzene, naphthalene and/or polycyclic aromatic hydrocarbon (PAH)-contaminated soil exceeding MTCA cleanup levels is present on the subject property and lead is present at one location (DP-2) at a concentration that exceeds the dangerous waste threshold. Additionally, a significant amount of debris (plastic, wood, glass, metal, and other unidentifiable garbage) was encountered on the western portion of the property in borings MW-3, GEI-4, DP-2, DP-8, DP-9, DP-11 and DP-12 between approximately 5 and 15 feet below the ground surface. The approximate locations of the borings as well as a visual summary of the chemical analytical results of the soil samples obtained from the borings are shown on Figure 3.

- **Remedial Excavation of Contaminated Soil.** A remedial excavation will be conducted to remove soil with contaminants of concern at concentrations greater than the MTCA Method A Cleanup level. Contaminated soil is generally located on the western portion of the property. The remedial excavation will extend approximately 15 feet below the ground surface (direct contact point of compliance for protection of human exposure via direct contact (WAC 173-340-70 (6)(d)), which will remove the contaminated soil at the property with the exception of localized benzene-contaminated soil identified in the northwest portion of the property.

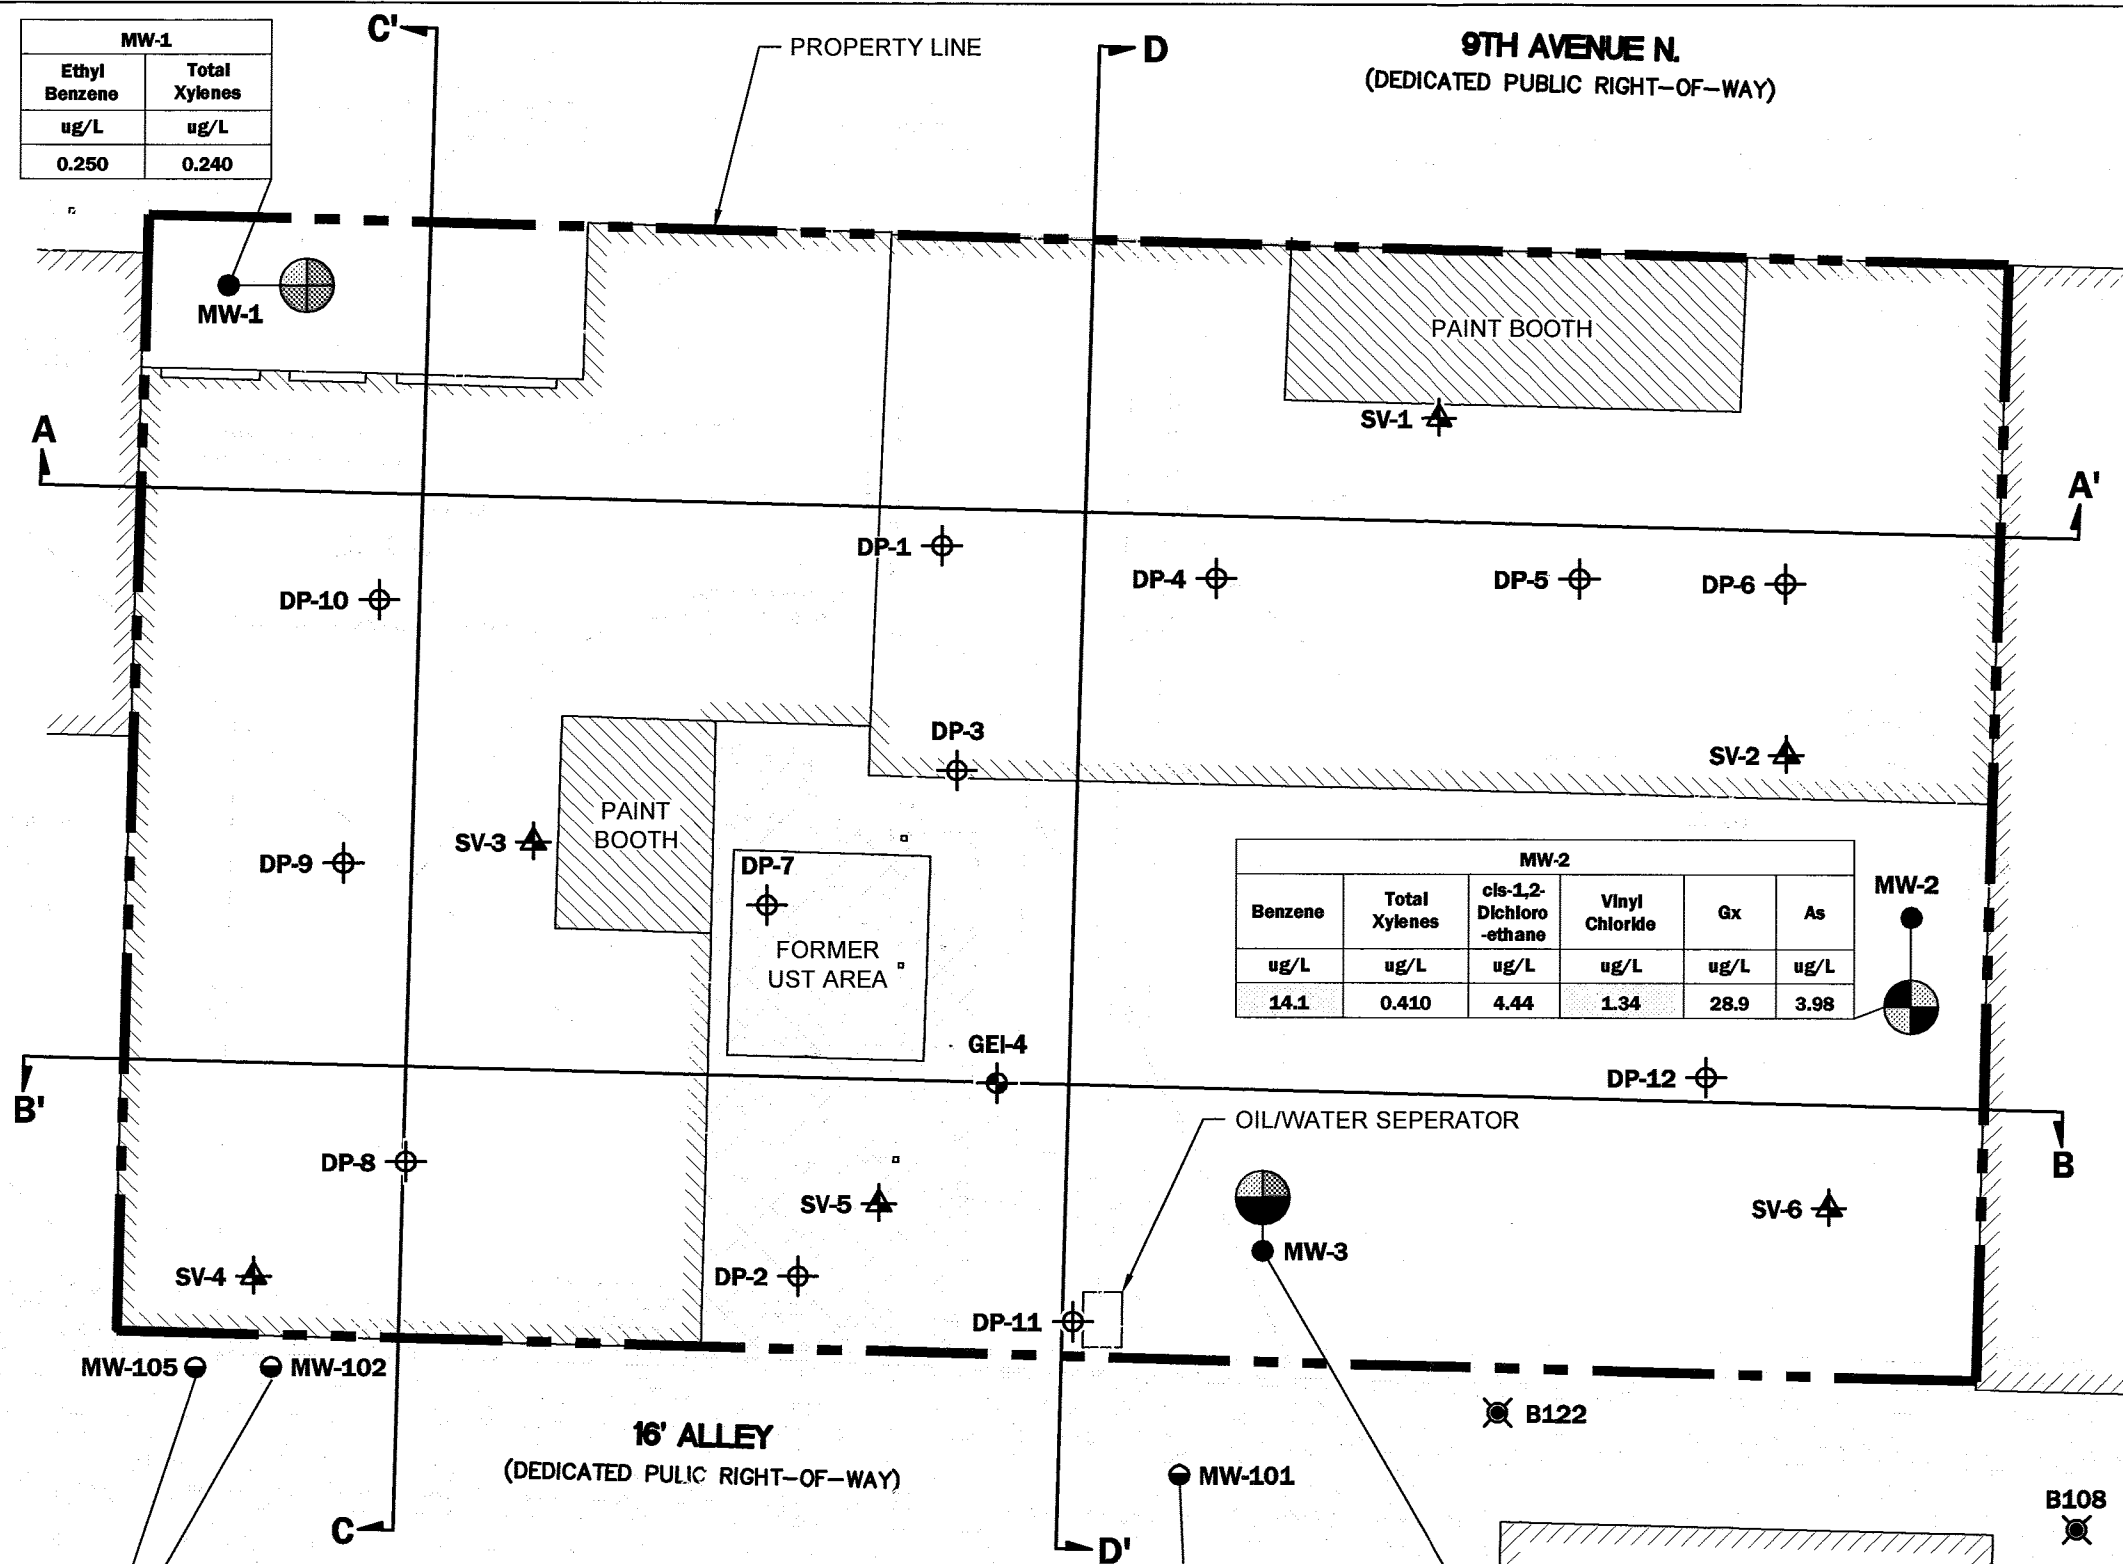
Groundwater Chemical Analytical Results

- **Groundwater.** Groundwater samples were obtained from the three monitoring wells (MW-1, MW-2, and MW-3) for chemical analysis. Benzene, vinyl chloride, and/or arsenic were detected at concentrations greater than their respective MTCA Method A Cleanup levels in monitoring wells MW-2 and/or MW-3. No contaminants of concern were detected at concentrations greater than MTCA cleanup levels in monitoring well MW-1 (at the northeast quadrant of the property [furthest downgradient well]) (Figure 4). There are multiple potential sources of benzene-contaminated groundwater beneath the subject property, however, the most likely source is the Roy Street Shops site because gasoline- and benzene- contaminated groundwater was confirmed in monitoring wells located in the alley immediately adjacent and upgradient of the subject property (see Figure 4). The presence of arsenic at the subject property could be related to background conditions, reducing conditions associated with petroleum hydrocarbons, and/or related to a degrading debris layer at the property. The source of the vinyl chloride-contaminated groundwater is likely the solvent release at American Linen, as described above and presented in Appendix B. Additionally, halogenated volatile organic compounds (HVOCs) were not detected in soil samples obtained from the subject property, but vinyl chloride was detected in groundwater, so the most likely source is the significant solvent release from the upgradient American Linen site.

MW-102				
Benzene	Ethyl Benzene	Toluene	Total Xylenes	Gx
ug/L	ug/L	ug/L	ug/L	ug/L
970	280	200	1,300	10,000

MW-101				
Benzene	Ethyl Benzene	Toluene	Total Xylenes	Gx
ug/L	ug/L	ug/L	ug/L	ug/L
810	1,200	100	1,700	19,000

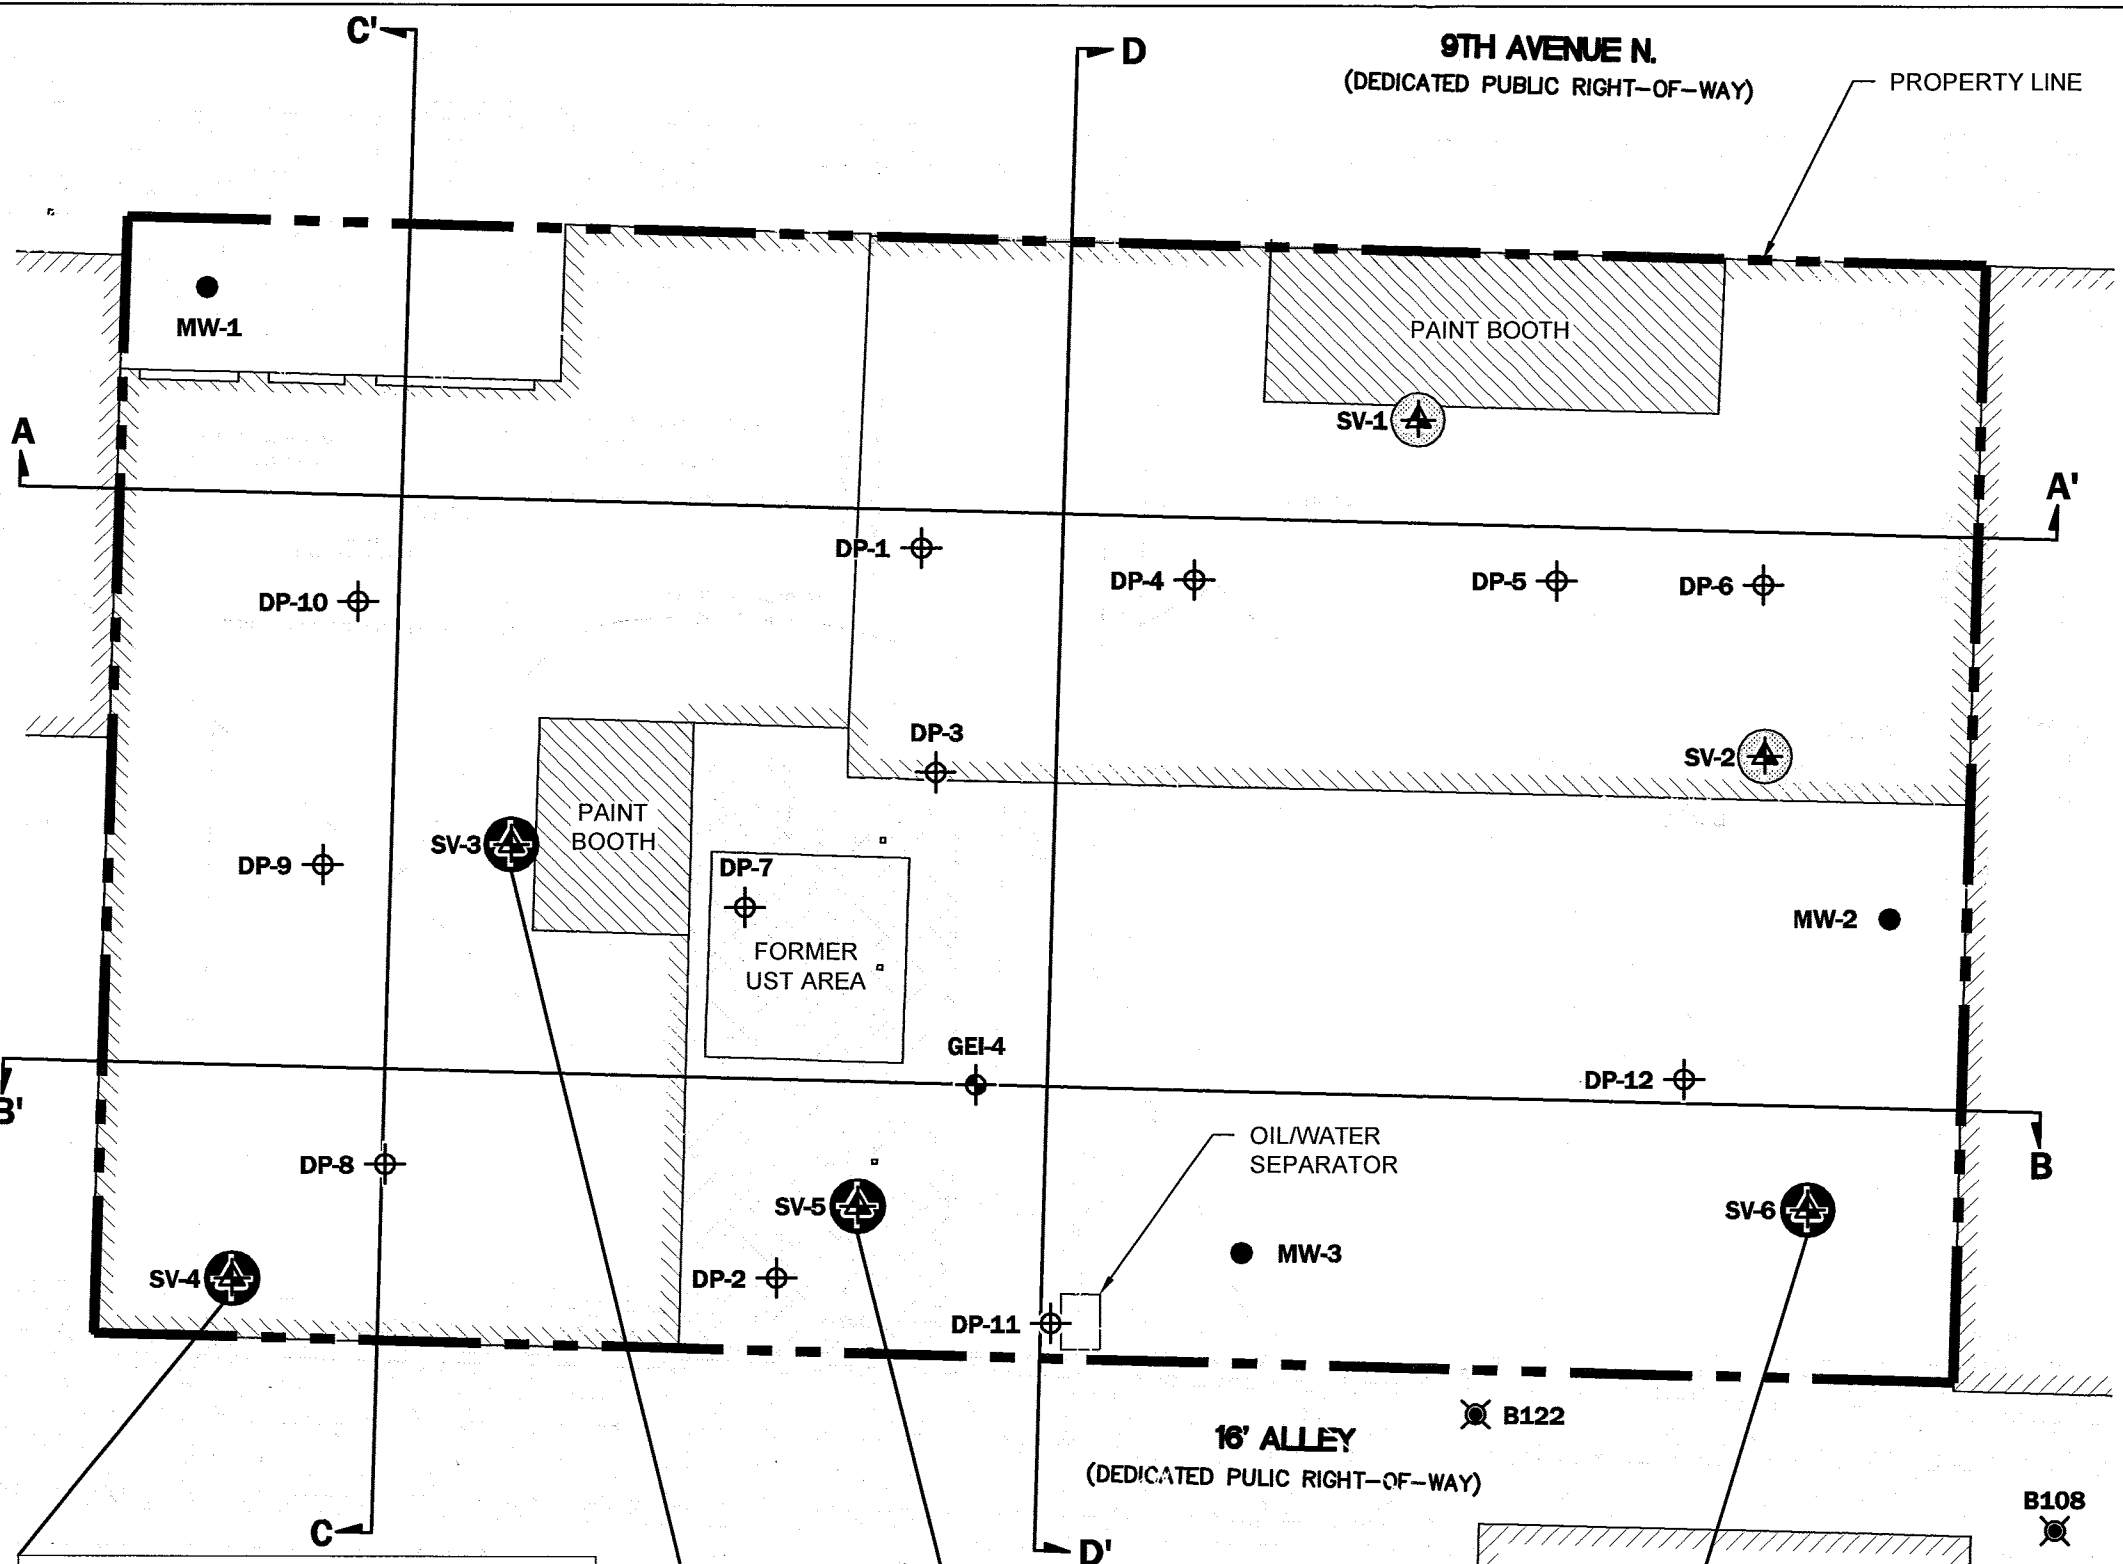
Soil Vapor Chemical Analytical Results	
South Lake Union Marriott AC Seattle, Washington	
	Figure 5

- **Soil vapor.** Benzene, low fraction total petroleum hydrocarbons, naphthalene, xylenes, 1,4-dioxane and/or tetrachloroethylene (PCE) were detected at concentrations greater than the MTCA Method B soil vapor screening levels in four of the soil vapor samples, which indicates there is a potential vapor intrusion threat at the subject property (Figure 5). The potential soil vapor sources include gasoline and benzene-contaminated soil on the subject property as well as the solvent-contaminated groundwater beneath the subject property.

SV-4				
TPH (low fraction)	Benzene	1,4-Dioxane	Naphthalene	1,2,4-Trimethylbenzene
µg/m3	µg/m3	µg/m3	µg/m3	µg/m3
4,100	54	18	94	54

SV-3					
TPH (low fraction)	Benzene	Naphthalene	1,2,4-Trimethylbenzene	m&p-Xylene	o-Xylene
µg/m3	µg/m3	µg/m3	µg/m3	µg/m3	µg/m3
16,000	25	520	130	1,800	780

SV-5			
TPH (low fraction)	Benzene	1,4-Dioxane	Tetrachloroethylene
µg/m3	µg/m3	µg/m3	µg/m3
3,600	15	40	2,400

- **Installation of a Chemical Vapor Barrier.** Volatile-contaminated groundwater, including PCE and vinyl chloride from the American Linen site and BTEX from the Roy Street Shops site, will remain beneath the subject property following the completion of the remedial excavation and in-situ chemical oxidation. During construction, a chemical vapor barrier will be installed beneath the entire building footprint to prevent vapor intrusion issues. Additionally, new utilities will be placed above the high groundwater table and low permeability dams will be constructed to preferential pathways will not be developed.

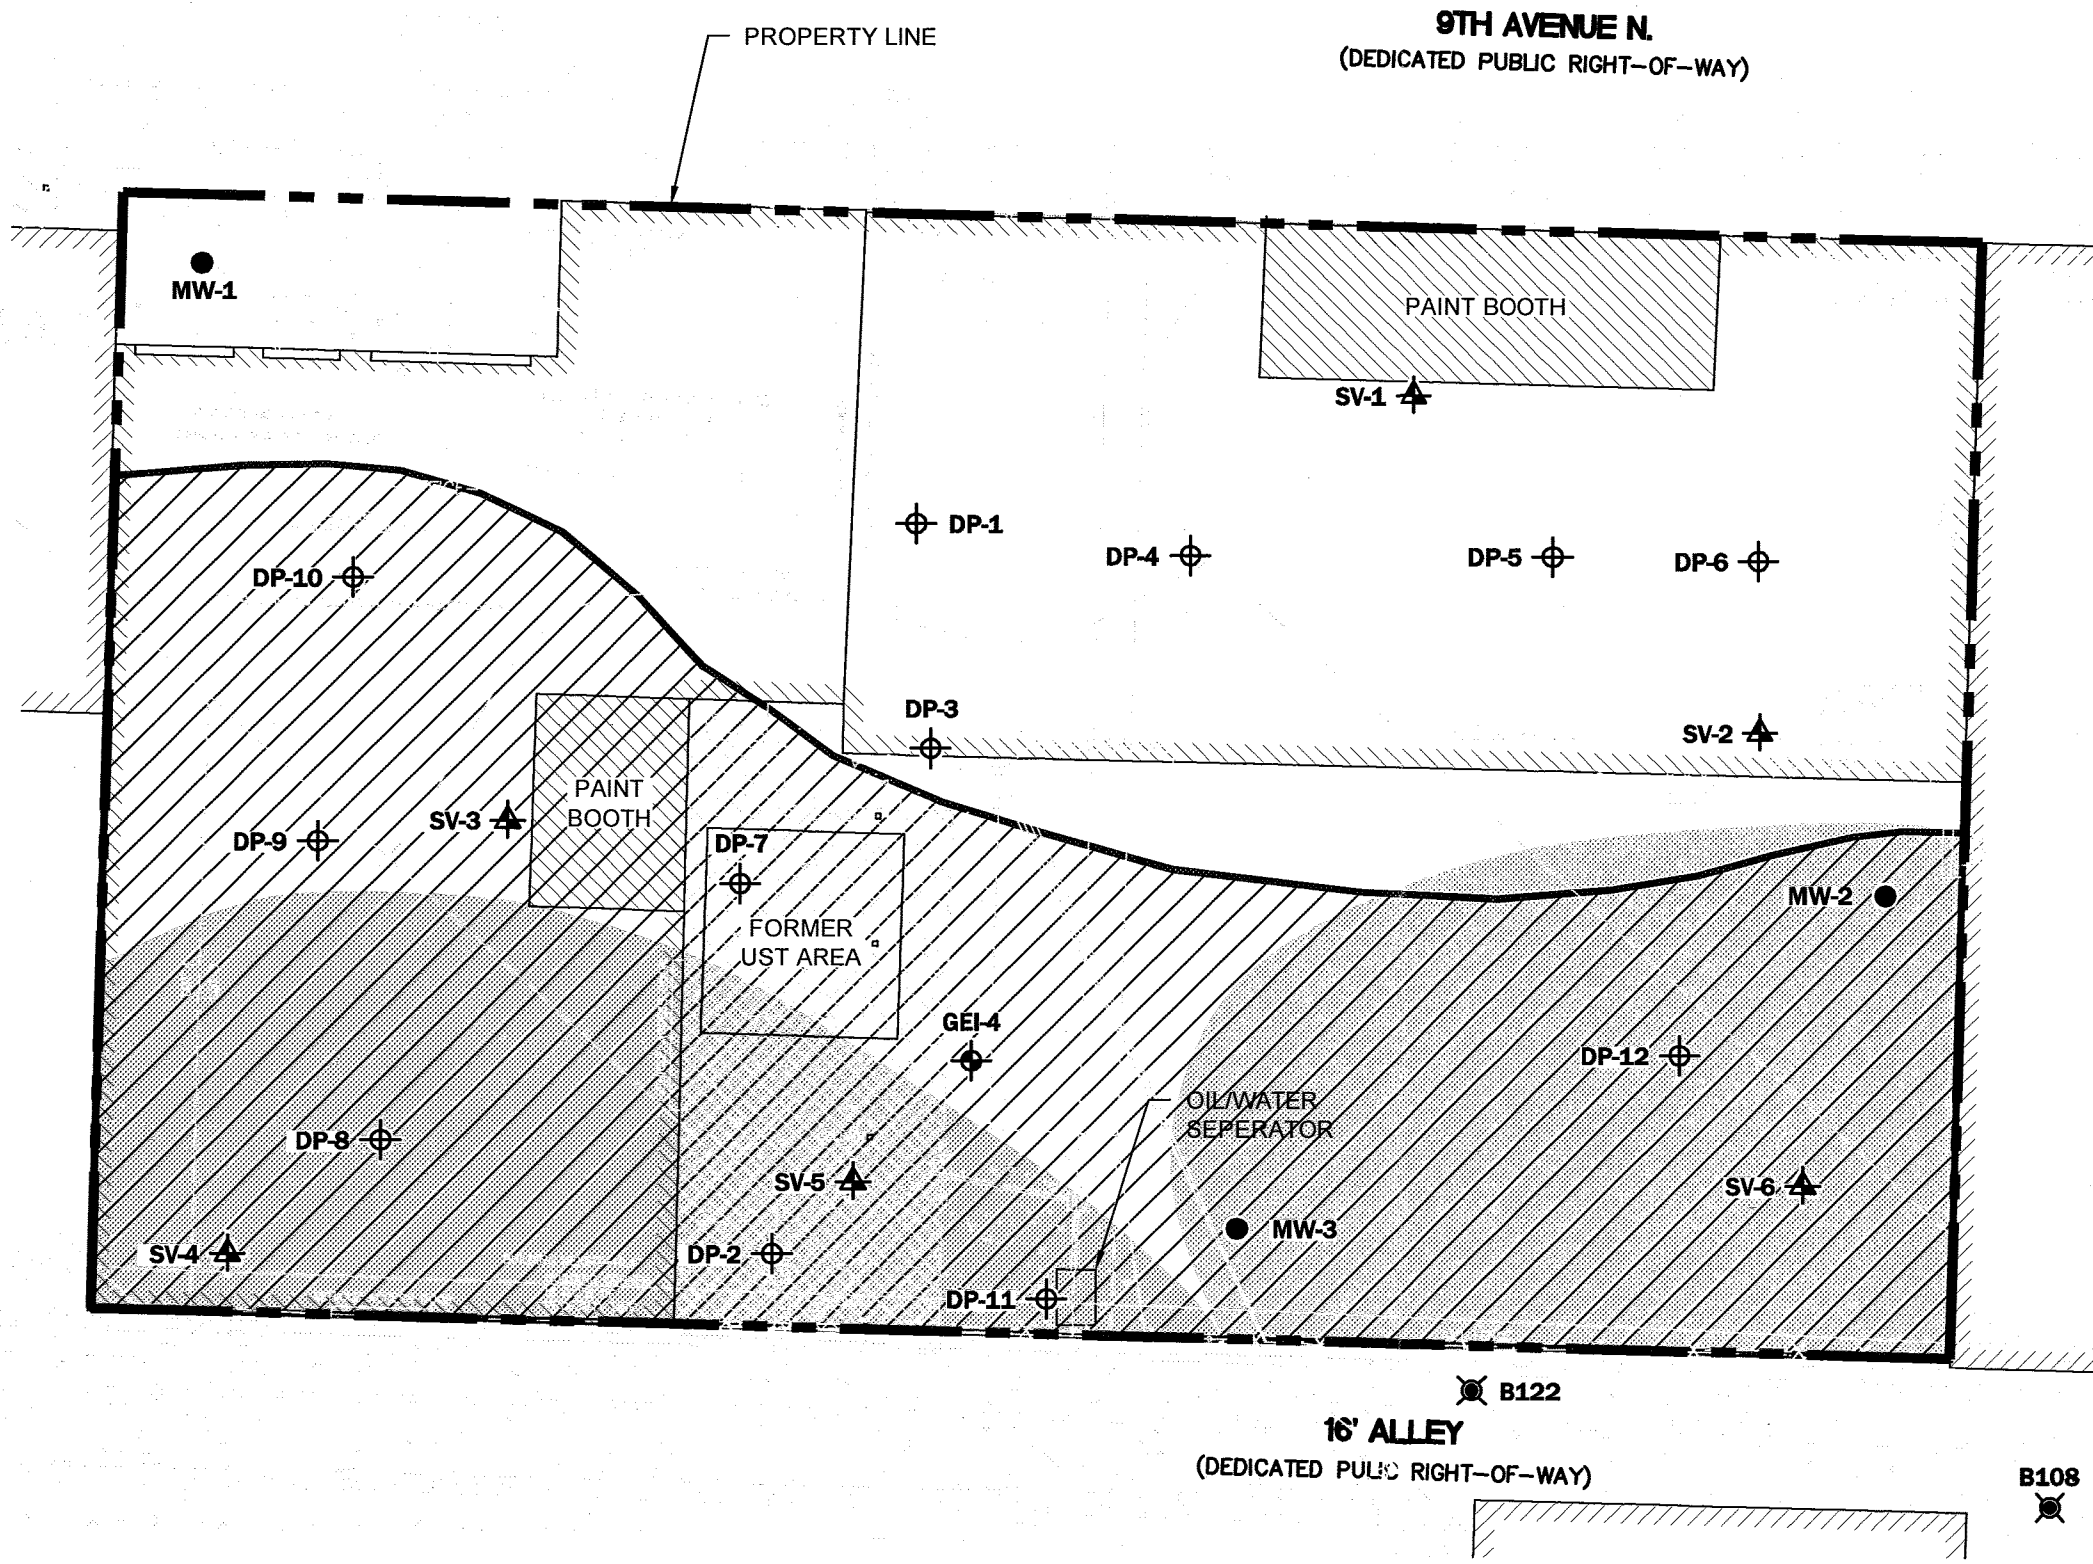
Site Designation	
South Lake Union Marriott AC Seattle, Washington	
	Figure 6

Based on the results of our Phase I and II ESA (RI), we have identified three “hazardous waste sites” (as defined in WAC 173-340-200) present on the subject property, as described below and presented in the attached Figure 6.

- **Site #1: Benzene-, gasoline- PAHs- and metals- contaminated Soil Site;** located on the western portion of the subject property generally between approximately ground surface and 15 feet below the ground surface. The contaminated soil resulted from current and former use of the property, including auto repair and maintenance, former USTs and a leaking oil/water separator.
- **Site #2: Vinyl Chloride-Contaminated Groundwater Site;** migrating onto the southeast portion of the subject property sourced from the American Linen site.
- **Site #3: Benzene-Contaminated Groundwater Site;** migrating onto the western portion of the subject property sourced from the Roy Street Shops site.

During property redevelopment, Site #1 will be remediated through excavation, according to the conceptual cleanup described in the section below. The data suggest that groundwater contamination identified as Sites #1 and #2 beneath the subject property originated from two off-site sources: the BETX and petroleum release from the adjacent Roy Street Shops site and the solvent release from the nearby American Linen site. Additionally, due to the presence of volatile-contaminants in groundwater migrating onto the site from adjacent properties, vapor mitigation, as described below, will likely be needed on the subject property.

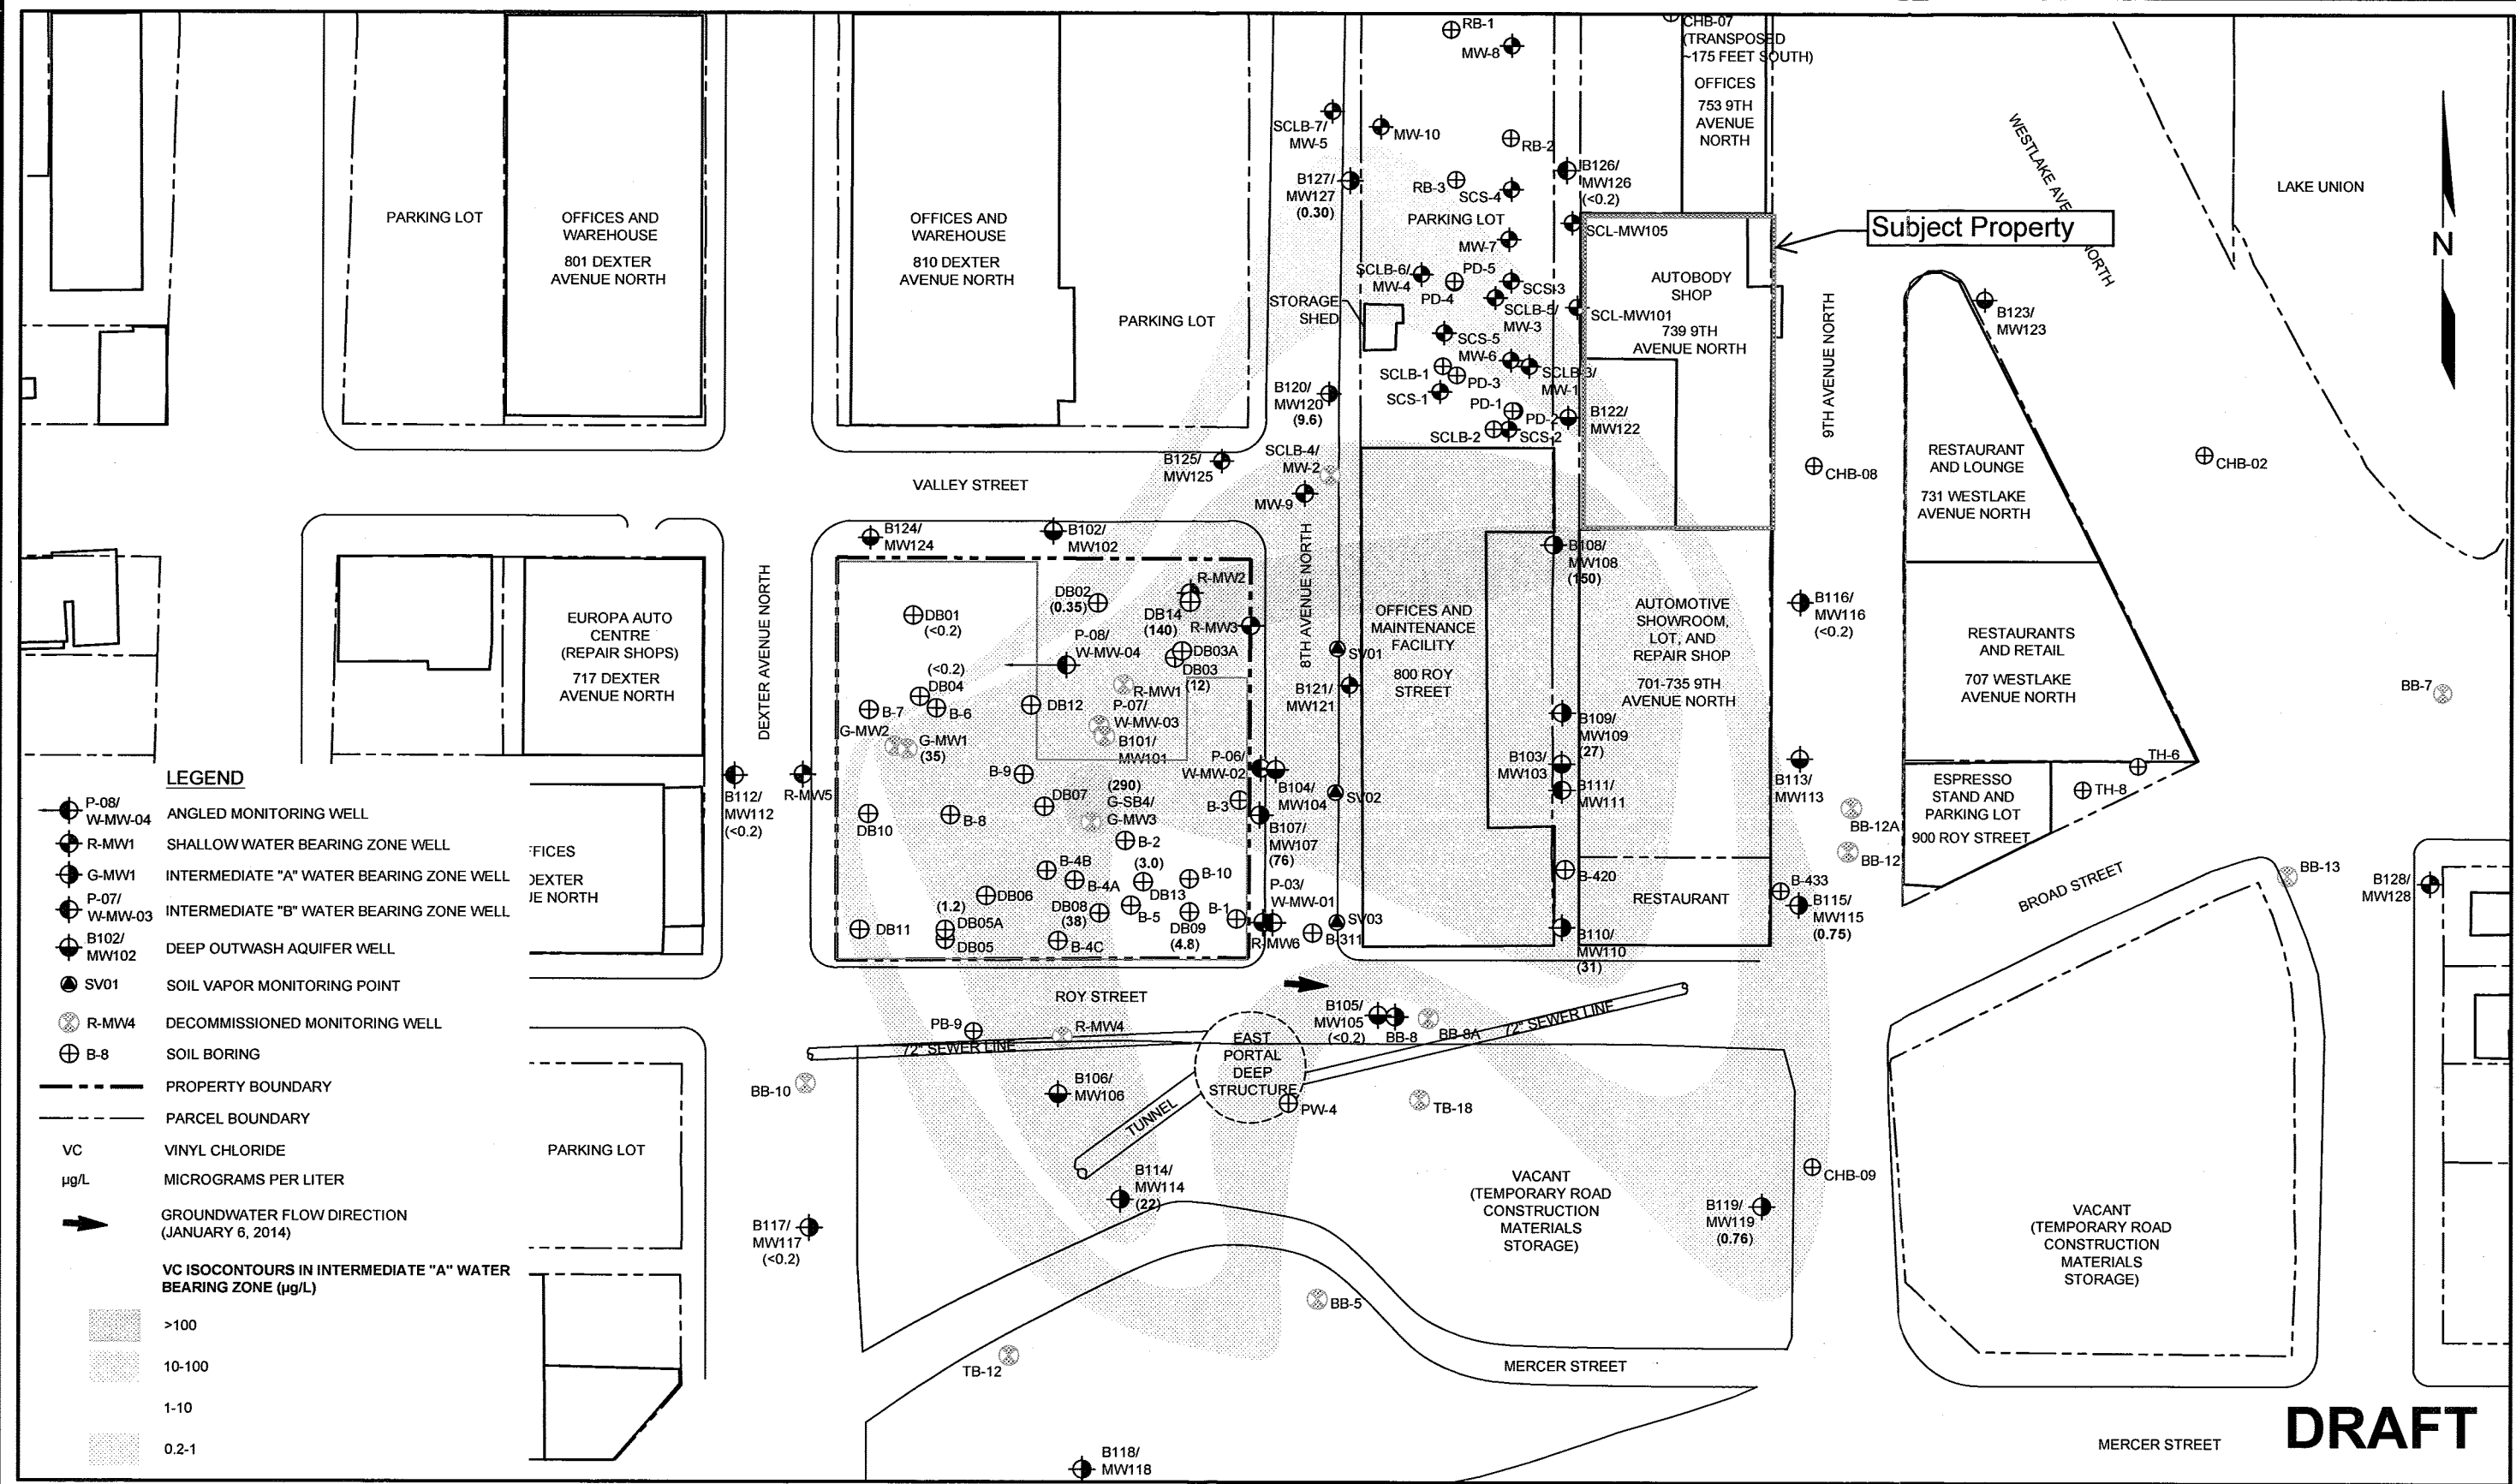
FIGURE 24
 VC ISOCONTOURS IN
 INTERMEDIATE "A" WATER-BEARING ZONE

Based on our recent experience and review of Ecology documents for nearby sites, a large solvent-contaminated groundwater plume sourced from the American Linen is present beneath much of this part of the South Lake Union neighborhood. Our proposed cleanup action addresses soil and soil vapor contamination sourced from the subject property (Site #1), but does not attempt to remediate other parties' contaminated-groundwater plume extending onto the subject property from the large area-wide solvent-plume or the benzene-contaminated groundwater plumes. However, the proposed cleanup action and property redevelopment (at grade or one-level of below grade structure) does allow for the liable parties to monitor and clean up the contaminated groundwater plumes that extend onto the subject property.

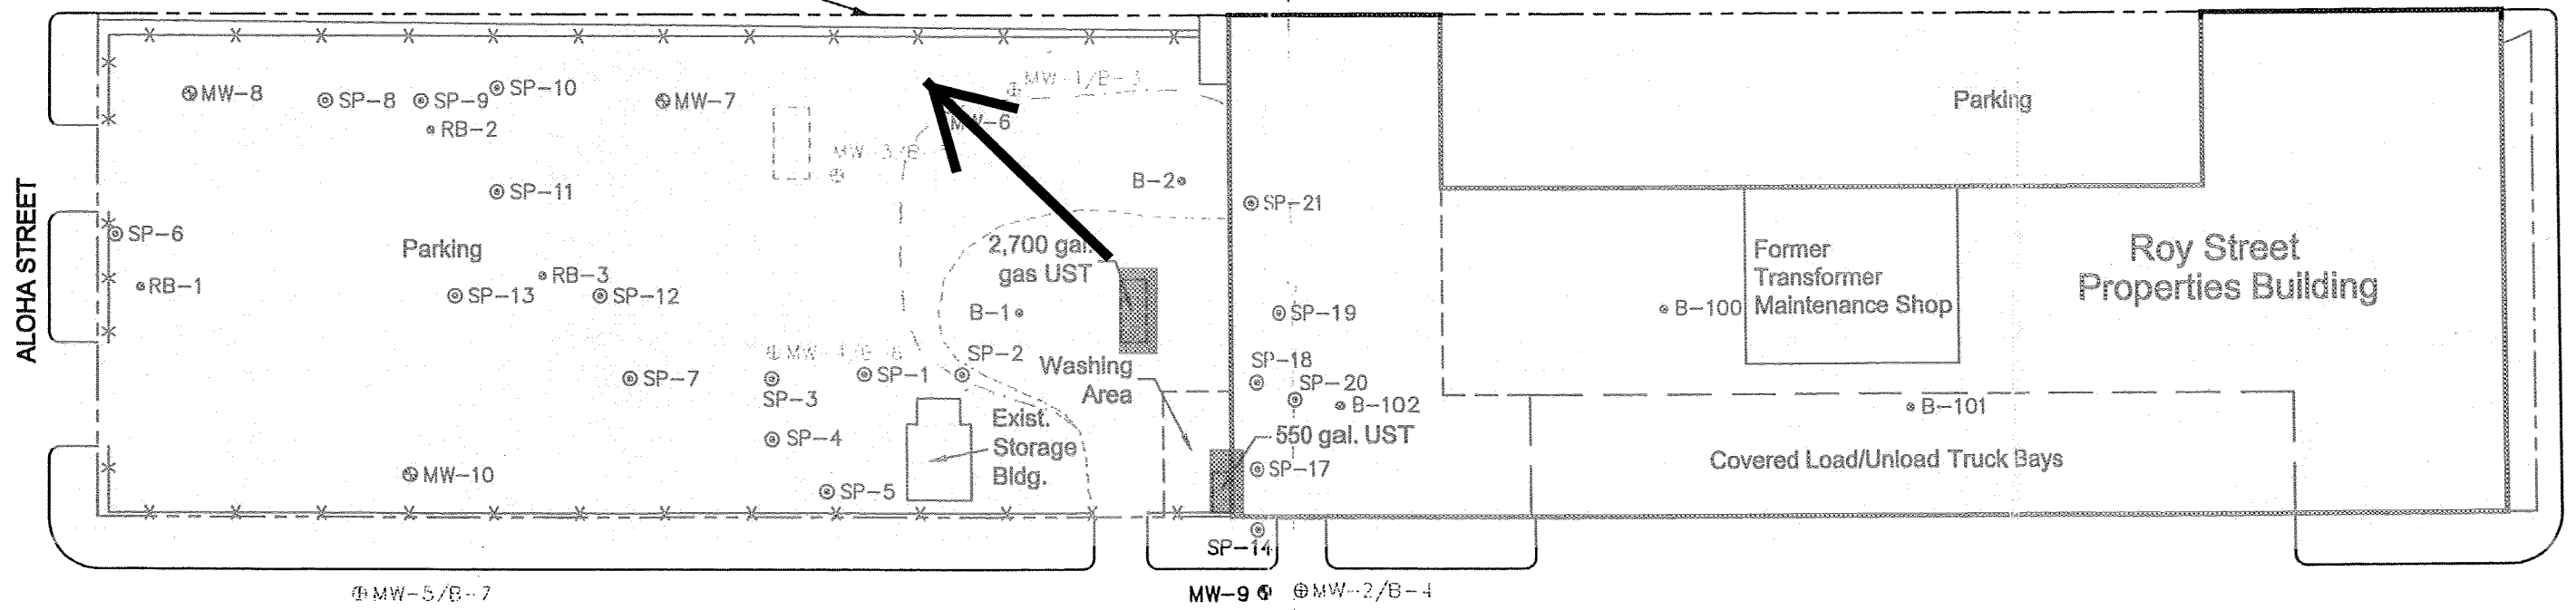
Figure 1
Site Features and Exploration Plan

Roy St. Shops site. Source of benzene- and gasoline-contaminated groundwater migrating onto the MAACO property.

USTs reportedly installed by Puget Power and Light prior to 1955. The 2,700-gal. UST is reportedly the source of the groundwater contamination extending onto the MAACO property.
