**APPENDIX D**  
**PIT LAKE DAM STABILITY ANALYSIS**

This appendix documents the results of Hart Crowser's geotechnical subsurface investigations and slope stability analysis, and provides preliminary geotechnical recommendations for the Pit Lake Dam (AOI-1) at the Van Stone Mine. Hart Crowser is completing a Remedial Investigation (RI) for the mine, which includes analyzing the stability of the Pit Lake Dam. The purpose of the analysis is to determine the current condition and stability of the dam.

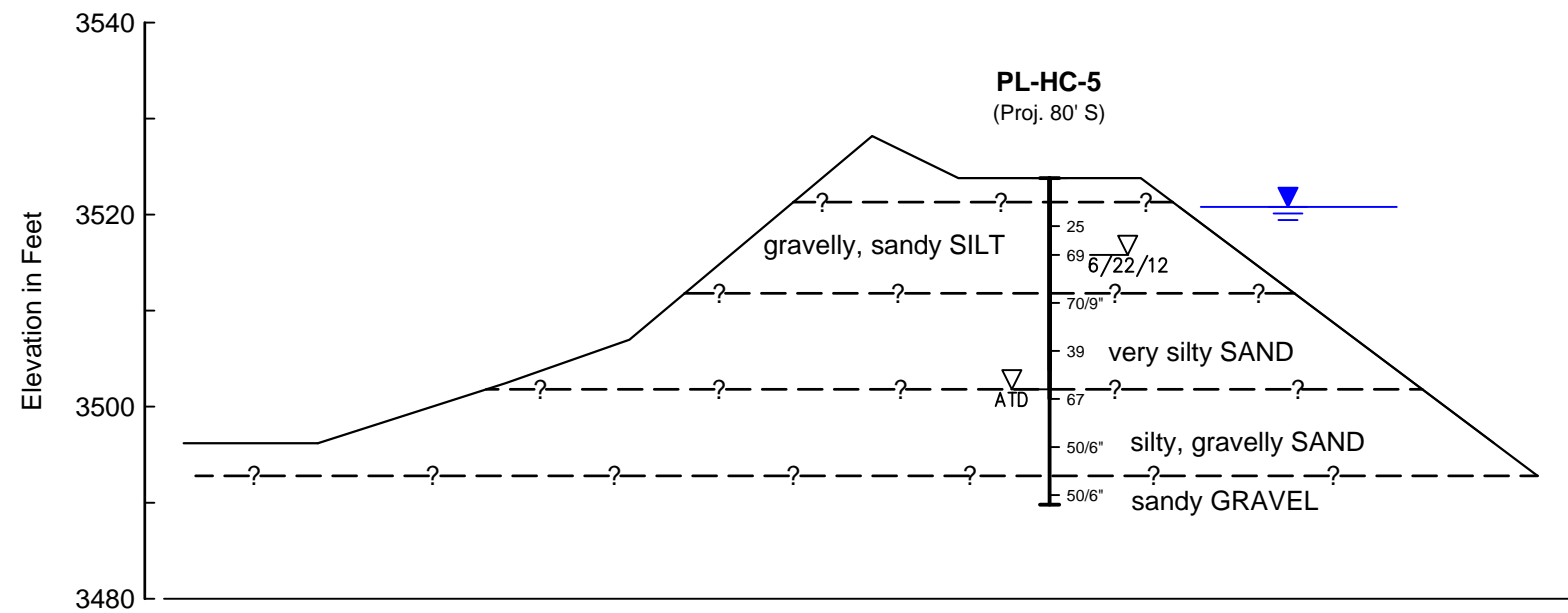
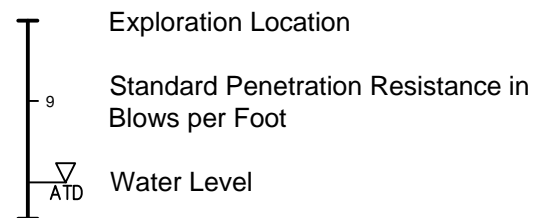
Van Stone Mine Onion Creek, WA	
<b>Generalized Subsurface Profile Along Pit Lake Dam</b>	
17800-11	2/13
	Figure <b>D-2</b>

Figure D-2 illustrates the generalized subsurface soil conditions at the critical cross-section for the Pit Lake Dam.

During drilling, groundwater was observed in PL-HC-5 approximately 23 feet below ground surface. Groundwater levels observed in the exploration are indicated on the boring log in Appendix A and on the generalized subsurface cross section (Figure D-2).

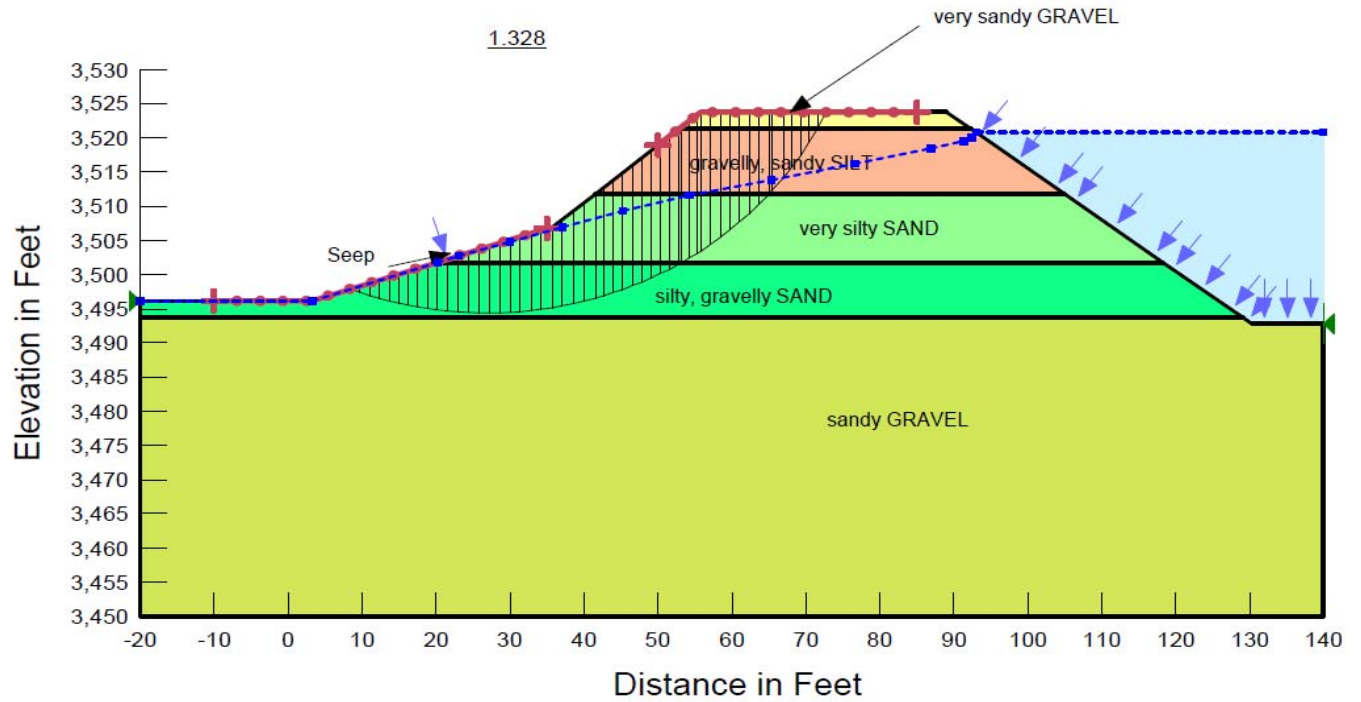
Figure <b>D-3</b>

The results of the slope stability analysis indicate that the Pit Lake Dam is below Ecology's target factor of safety for static long-term loading conditions with factors of safety (FS) less than 1.0 for shallow failure surfaces (5 feet or less); and between 1.0 and 1.5 for failure surfaces less than 10 feet thick. This supports the assumed strength criteria for the embankment are conservative, but the degree of conservatism is unknown. Although factors of safety for post-earthquake conditions exceed the minimum criteria for failure surfaces at least 20 feet thick, factors of safety are below the minimum criteria for potentially significant failures at least 10 feet thick.

Pit Lake Dam  
 Long Term (b)2  
 Minimum Slip Surface Depth: 20 ft  
 Entry and Exit

Instability of the Pit Lake Dam could cause downstream flooding. These conditions do not satisfy Ecology's dam safety requirements for static or seismic stability. Improved stability or other hazard elimination should be addressed in the Feasibility Study for Van Stone Mine.
