**APPENDIX E
LIMITED STRUCTURAL RECONNAISSANCE AND
PRELIMINARY PIT HIGH WALL STABILITY ASSESSMENT**

Van Stone Mine
Onion Creek, WA

Rock Structures and Pit Stability Site Map

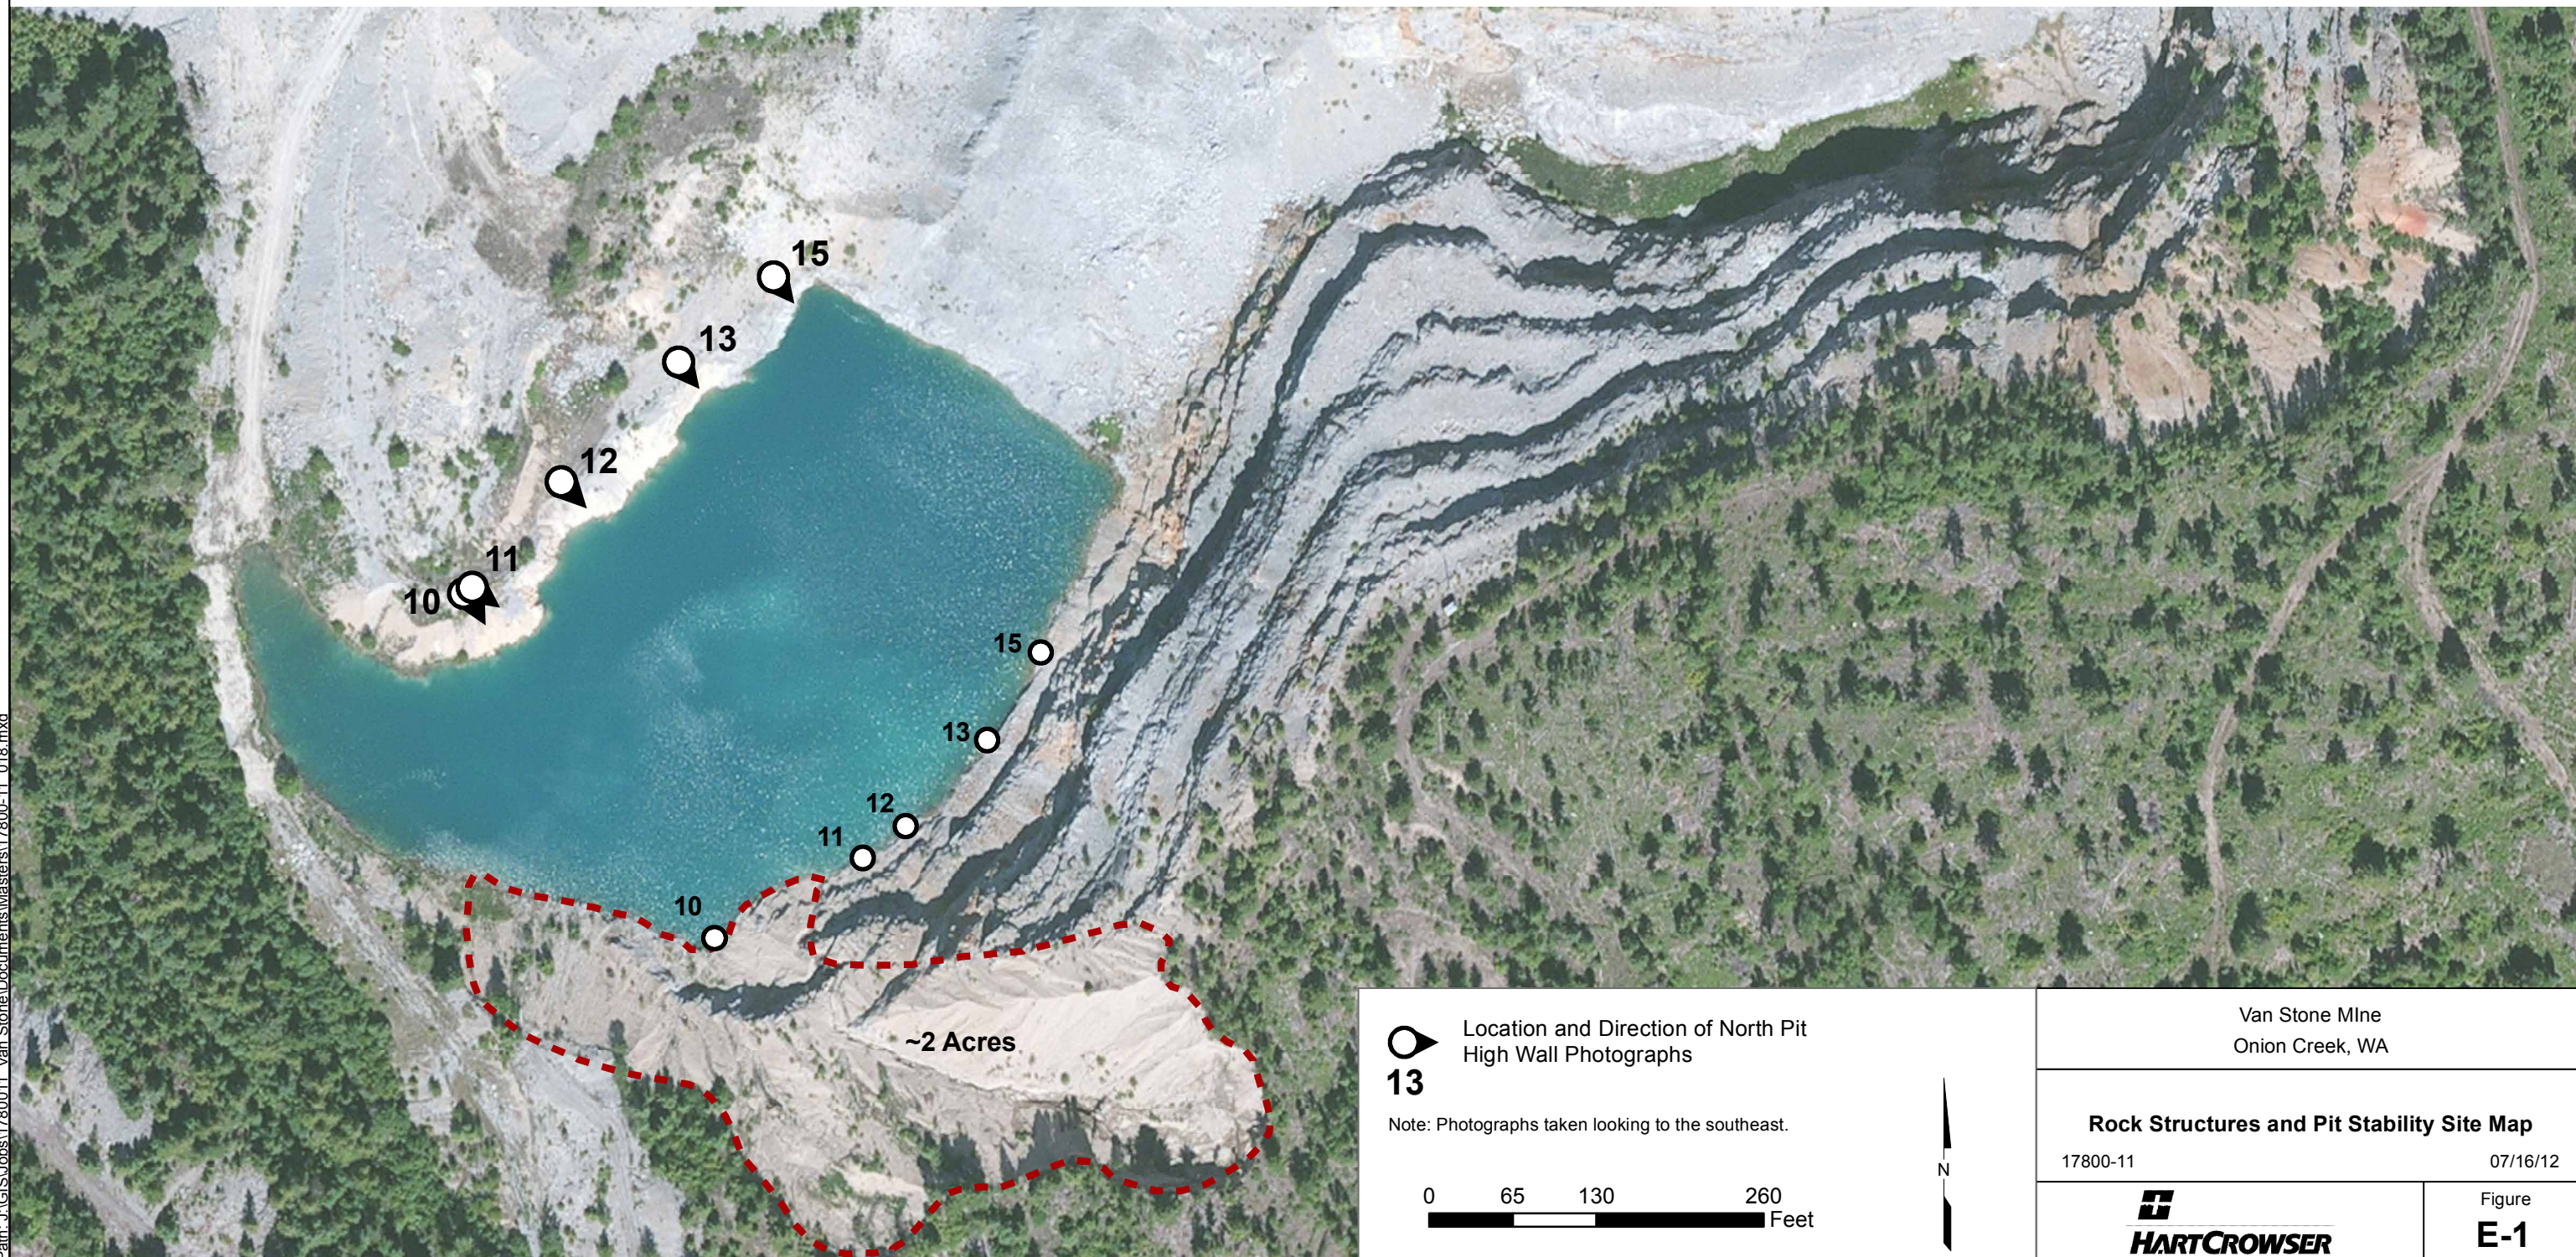
Figure
E-1

Soils in the North and South Pit areas (Area of Interest 1, or AOI-1) are of variable thickness and overlie Paleozoic metasedimentary rocks. A small amount of glacial overburden was removed to expose the ore deposits, but most of the overburden consisted of dolomitic limestone. Photographic documentation of rock structures and open pit configuration of AOI-1 are shown on Figure E-1.

In June 2012, a field geologist walked around the perimeter of the approximately 2 acres of actively eroded exposed soils in the southwest corner of the North Pit, as shown on Figure E-1. Residual soil and glacial overburden overlie Paleozoic metasedimentary rocks (primarily dolomitic limestone) within the study area.

Soil in this area consisted of very loose to loose, damp, gravelly silty sand with occasional boulders. The exposed slopes were steep, sloping west to northwest to the North Pit Lake, with little to no vegetation as shown in Photograph 9 on Figure E-1. During the June 2012 visit, surface water was flowing into the North Pit Lake in this area.

Although the average slope angle of the high wall is about 45 to 50 degrees, the benched configuration of the high wall results in near-vertical segments up to about 30 feet maximum height. These benched segments are steeper than the plunge angle of the wedge failures, so would be prone to such failures, although their extent would be limited by the bench height and the moderate persistence of the fractures. Based on the geometries of the fractures, we estimate maximum failure volumes of about 10 cubic yards in a single event. Such small volume failures are supported by wedge-shaped vacated areas in the steep benches and rock debris on the surfaces of the benches, as exhibited on Figure E-1.

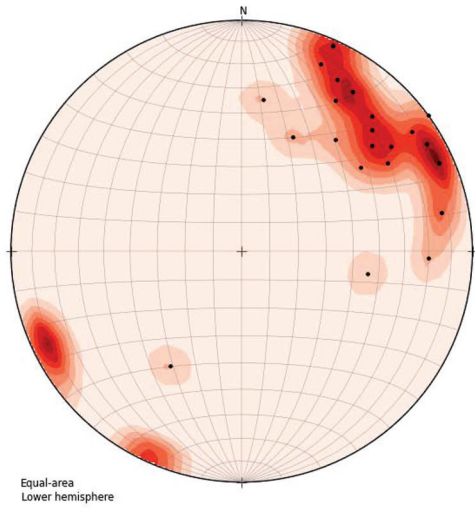
A. Poles from NP-T1

very pronounced along Transect NP-T1 with abundant fractured brucite fill, some residual soil, and moss within the fractures. The average fracture orientation along this transect was S40°E (140° azimuth), dipping 73° southwest. Orientations for transect NP-T1 are provided in Table E-2. A stereonet constructed from 28 recorded fractures along Transect NP-T1 is included as Figure E-3.

These joint orientations were plotted on stereonet along with the orientation of the high wall face (at the North Pit) and rock strength data to evaluate wedge failure potential. The stereonet plots are included on Figure E-3. Based on the stereonet evaluations, wedge failures are possible from these joint sets and would occur at:

- NP T-1: a dip direction of 298 degrees along a 68 degrees plunge line.
- NP T-2: a dip direction of 310 degrees along a 74 degrees plunge line.

Estimating rock strength along the fracture surface as at least 30 degrees plus a joint roughness of 10 degrees, 68- and 74-degree plunges are steeper than the rock strength and less than the high wall slope, so wedge failure is a hazard.

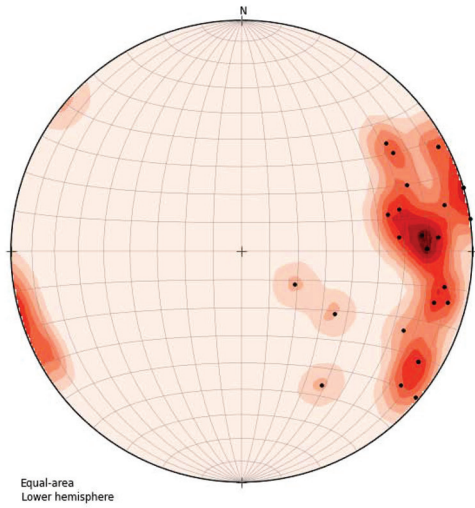
B. Poles from NP-T2

Fractures along Transect NP-T2 were typically slightly to moderately weathered, had very low to moderate persistence (<1 to 3-10 m), tight to moderately open fracture separation (0.1-0.5 to 0.5-2.5 mm), and slightly rough surfaces. Fractures were very pronounced along Transect NP-T2 with abundant brucite fill, some residual soil, and moss within fractures. In the middle of transect NP-T2, groundwater seepage was observed in a 6-foot section with some evidence of oxidized minerals associated with the seep. The average fracture orientation along this transect was S3°W (183° azimuth), dipping 72° northwest. Field orientations for transect NP-T2 are provided in Table E-2. A stereonet constructed from 27 observed fractures along Transect NP-T2 is included on Figure E-3.

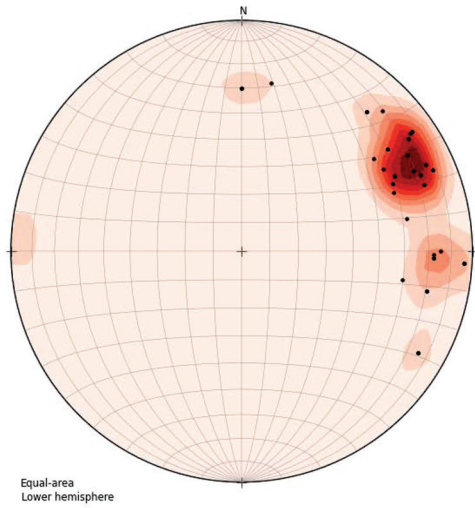
C. Poles from SP-T1

Fractures along Transect SP-T1 were typically fresh to moderately weathered, had very low to low persistence (<1 to 1-3 m), had moderately open to open fracture separation (0.5-2.5 to 2.5-10mm), and slightly rough surfaces (Table E-1). Fractures were very pronounced and prevalent along Transect SP-T1 with abundant brucite fill, residual soil, and moss within fractures. Transect SP-T1 was extended due to abundant soil and moss covering the open pit high wall. The average fracture orientation for this transect was S22°E (158° azimuth), dipping 72° southwest. Field orientations for transect SP-T1 are provided in Table E-2. A stereonet constructed from 61 observed fractures along Transect SP-T1 is included on Figure E-3.
