**APPENDIX F
TAILINGS PILE STABILITY ANALYSIS**

This appendix documents the results of Hart Crowser's geotechnical subsurface investigations and slope stability analyses, and provides preliminary geotechnical recommendations for the Upper and Lower Tailings Piles (AOI-2 and -3) of the Van Stone Mine. Hart Crowser is completing a Remedial Investigation (RI) for the mine, which includes analyzing the stability of the Upper and Lower Tailings Piles. The purpose of the analysis is to determine the current condition and stability of the tailings piles.

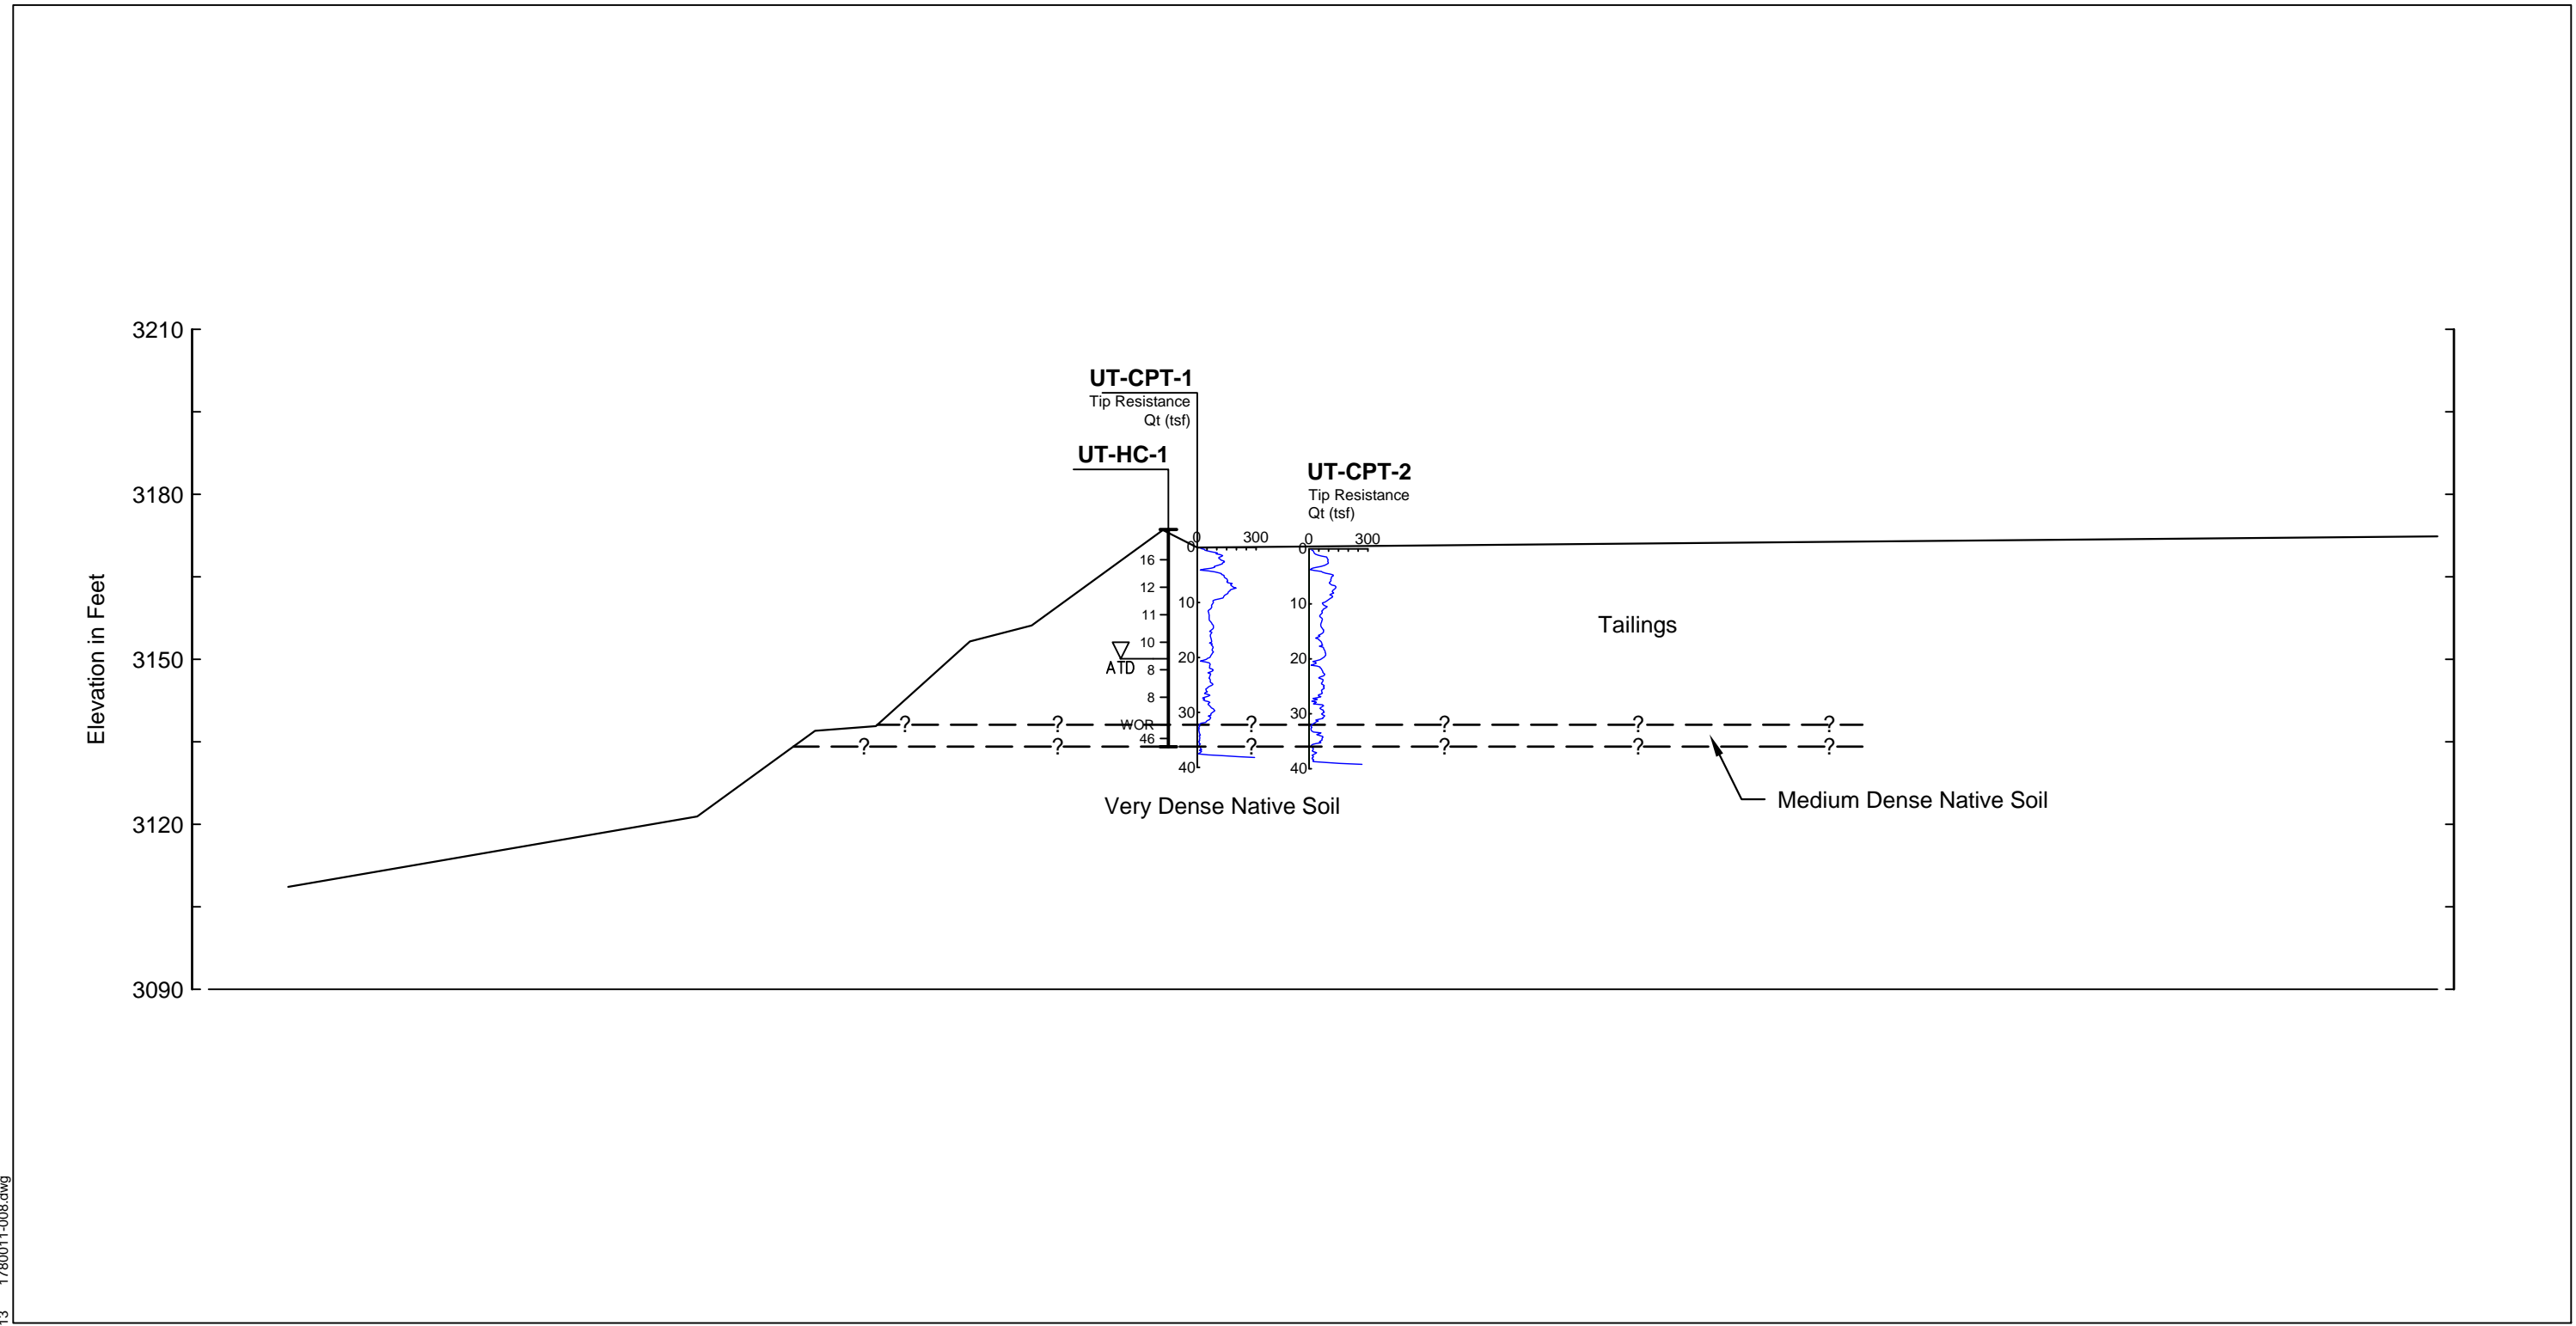
Generalized Subsurface Profile Along Upper Tailings Pile Cross Section 1
Van Stone Mine

During drilling, groundwater was observed in UT-HC-1 within the tailings approximately 12 feet above the contact with native soil. Groundwater was observed in UT-HC-2 within the tailings approximately two feet above the contact with native soil. Perched groundwater was observed in LT-HC-3 within the tailings approximately 42 feet above the contact with native soil. Groundwater was observed in LT-HC-4 at the contact between tailings and native soil. Groundwater levels observed in the explorations are indicated on the logs in Appendix A and on the generalized subsurface profiles (Figures F-3 thru F-6).

The Upper Tailings Pile slopes are marginally stable for static long-term loading conditions with factors of safety generally greater than 1.0 and less than 1.5. Although stability factors of safety for failure surfaces at least 20 feet thick with groundwater at the base of the tailings pile meet Ecology's minimum requirements, factors of safety are below the minimum requirements for all other cases analyzed.

Factors of safety for post-earthquake conditions exceed minimum requirements for failure surfaces greater than 10 feet thick with groundwater at the base of the tailings piles. Factors of safety do not meet minimum requirements for failure surfaces less than 10 feet thick or failure surfaces of any thickness with groundwater above the base of the tailings piles.

As long as the groundwater table remains below the base of the pile, the estimated seismic displacements are unlikely to cause overall instability of the Upper Tailings Pile. However, if the groundwater rises 2 feet, the estimated displacements are likely to affect overall slope stability and could cause catastrophic failure. For failure surfaces 10 feet deep and greater with the groundwater at least 2 feet above the base of the tailings pile, displacements could not be calculated because the pseudostatic factor of safety was less than 1.0 before applying a seismic acceleration. For these cases, it is assumed that displacements will be significant.

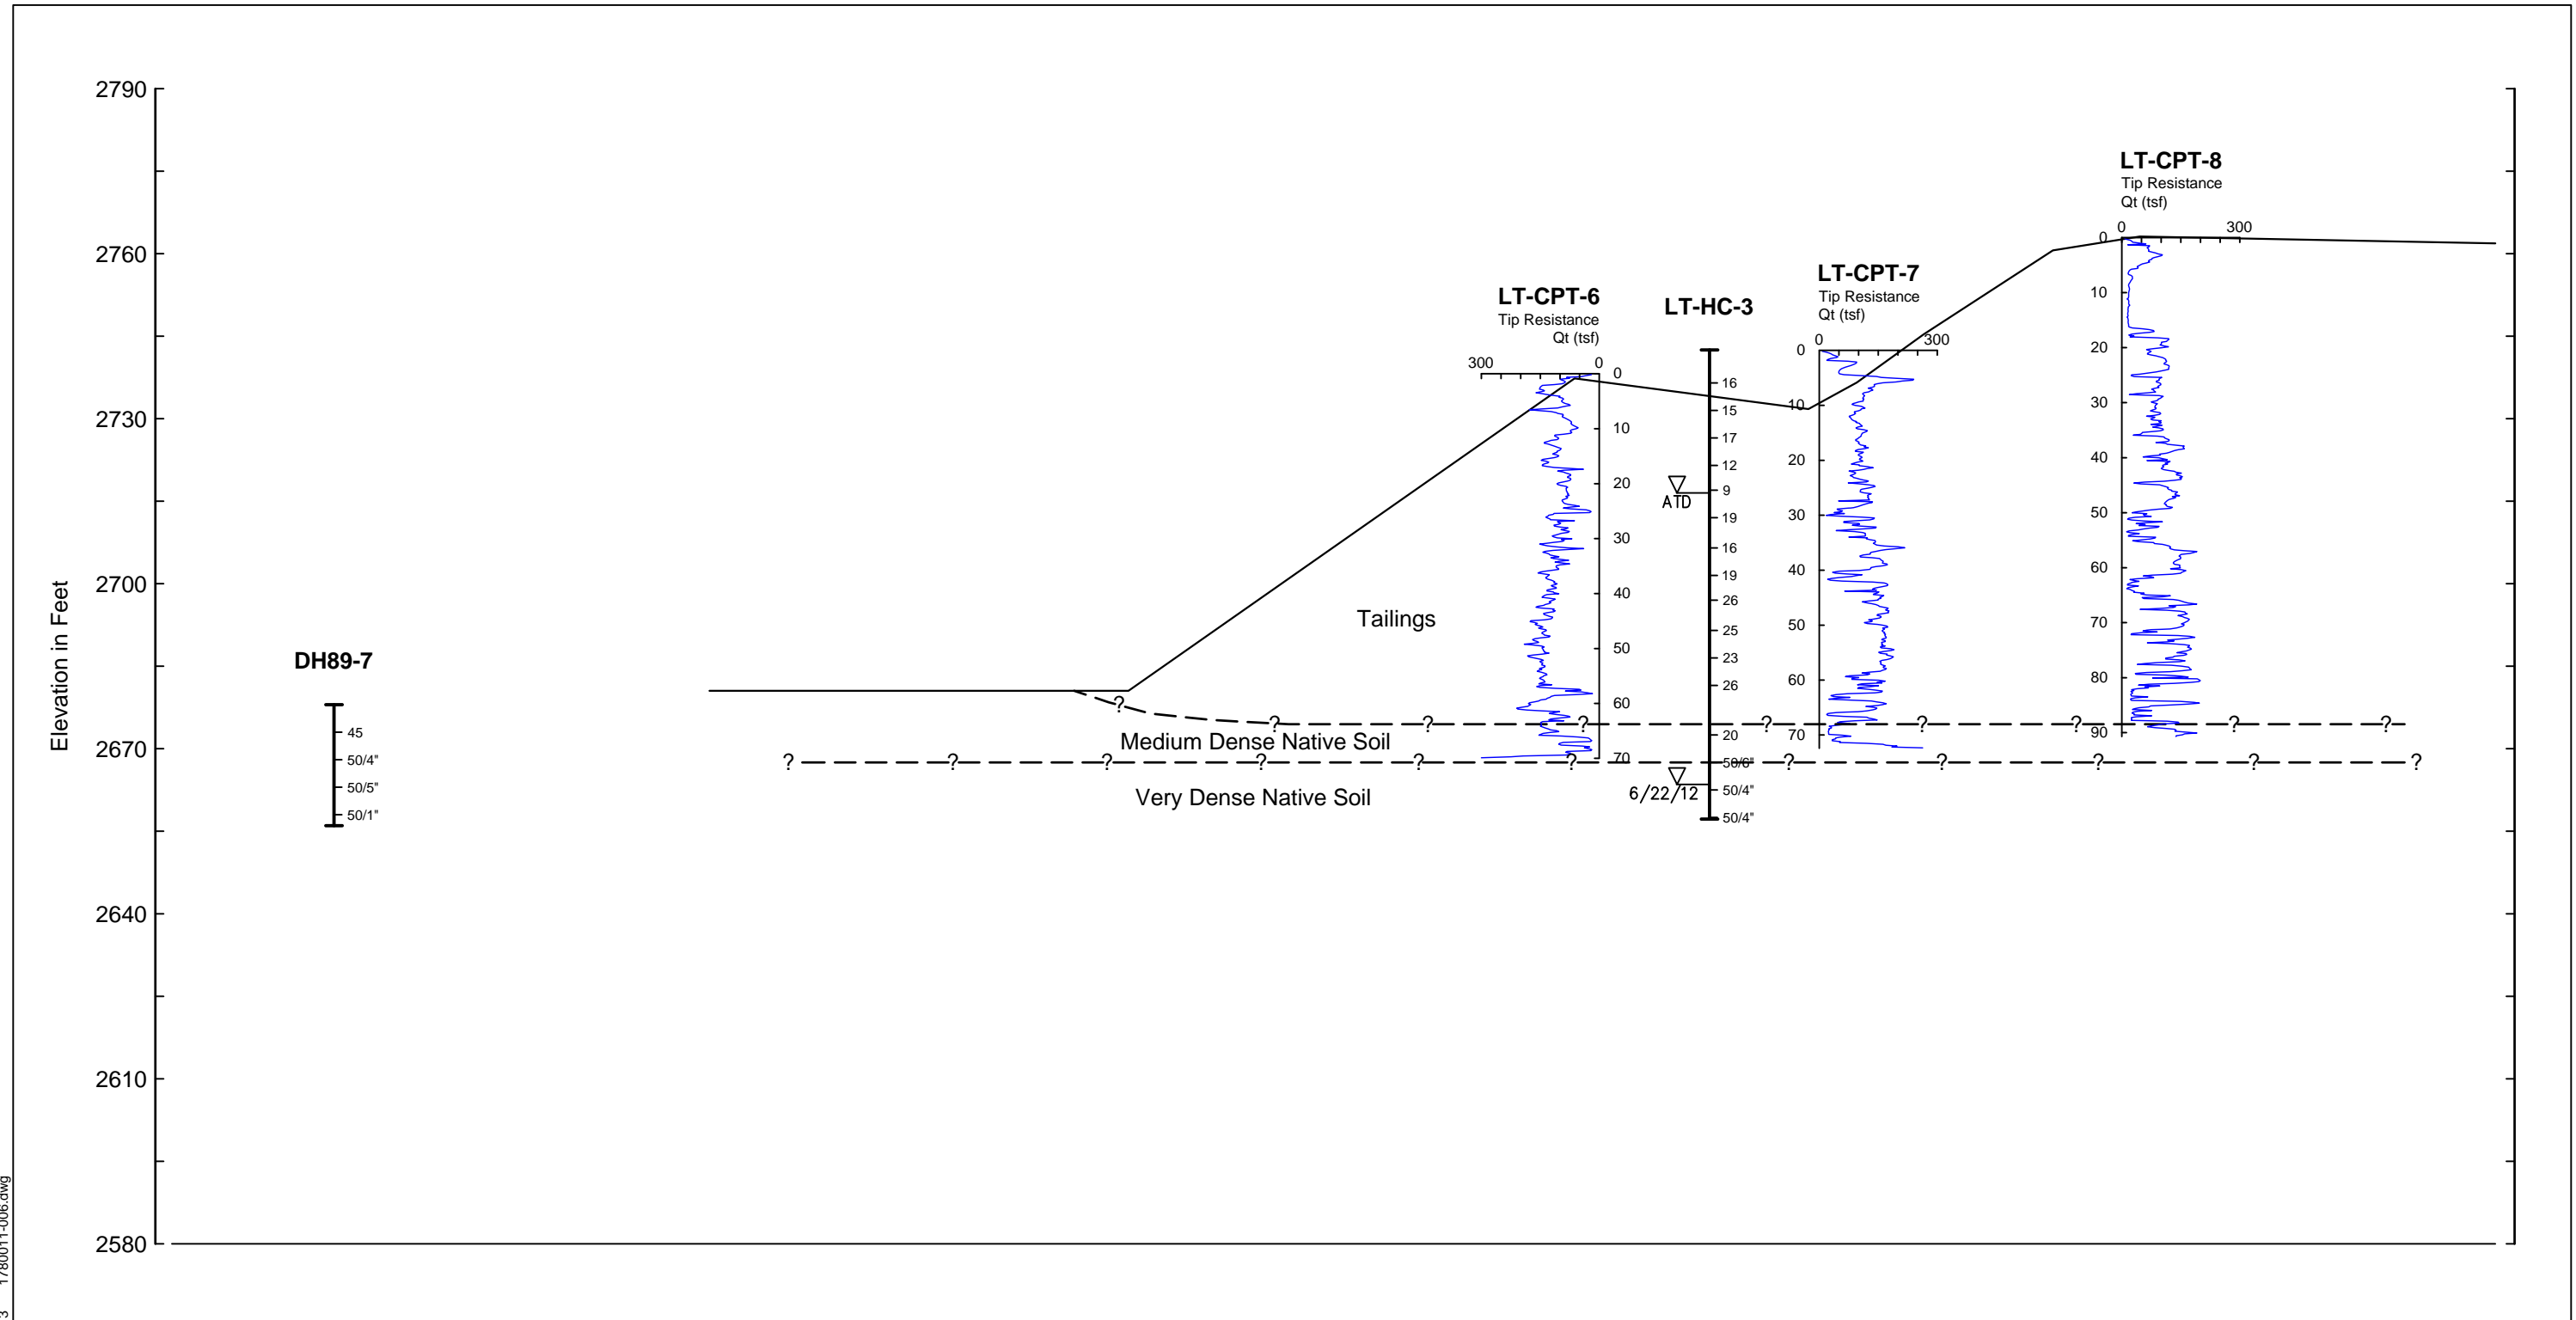
Generalized Subsurface Profile Along Lower Tailings Pile Cross Section 3
Van Stone Mine

The results of the slope stability analyses indicate that the Lower Tailings Pile slopes are marginally stable for static long-term loading conditions with factors of safety generally greater than 1.0 and less than 1.5. None of the static cases analyzed met Ecology's minimum factor of safety requirements.

Factors of safety for post-earthquake conditions exceed the minimum requirements, for failure surfaces at least 20 feet thick and groundwater less than

2 feet above the base of the tailings piles, and for failure surfaces at least 30 feet thick and groundwater less than 4 feet above the base of the tailings pile.

If the groundwater table remains below the base of the pile, the estimated seismic displacements are unlikely to cause overall instability of the Lower Tailings Pile. However, if the groundwater rises two feet or more, the estimated displacements are likely to affect overall slope stability and could cause catastrophic failure. Displacements could not be calculated for some of the scenarios analyzed because the pseudo-static factor of safety was less than one prior to applying a seismic acceleration. For these cases, it is assumed that displacements will be significant.
