Periodic Review

Metro Lake Union

**1602 North Northlake Way
Seattle, Washington 98103**

April 2023

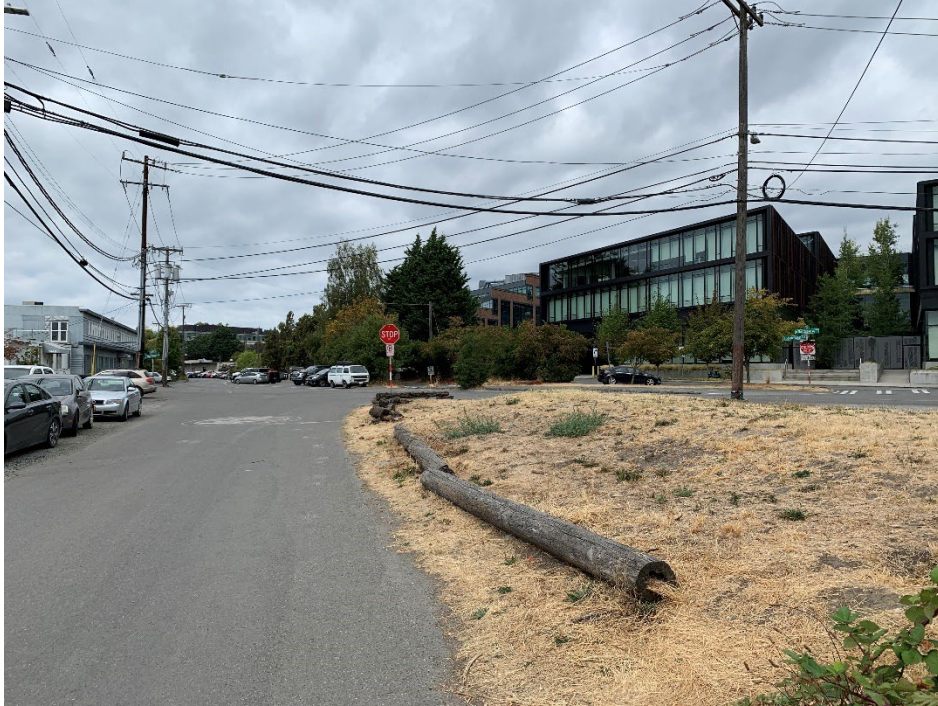
Photo 1: Right-of-way area between North and South Yards with North Yard beyond.

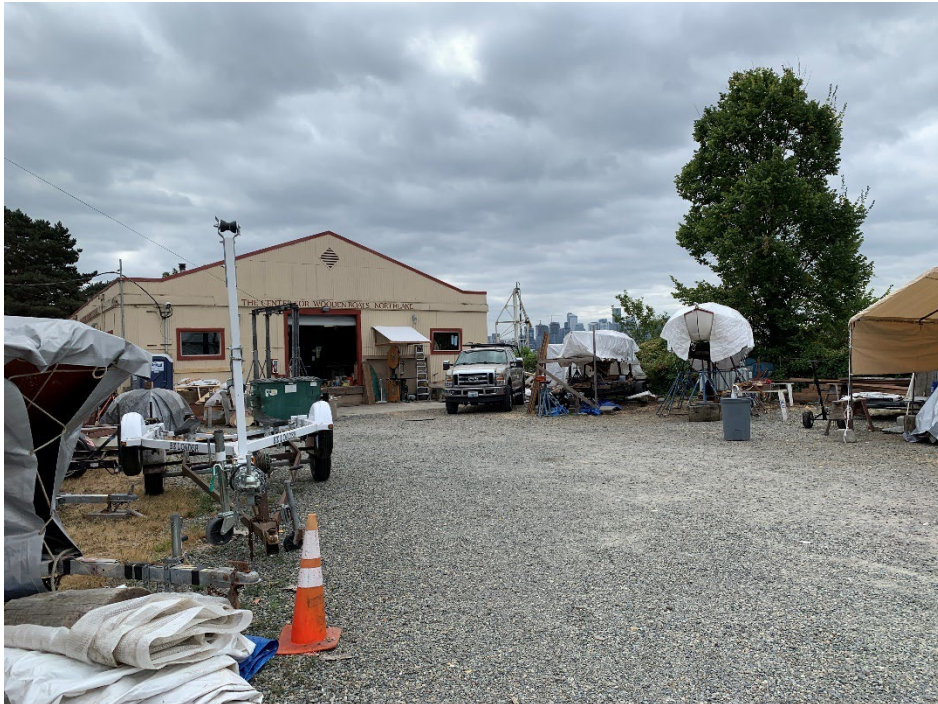
Photo 2: South Yard from entrance gate.

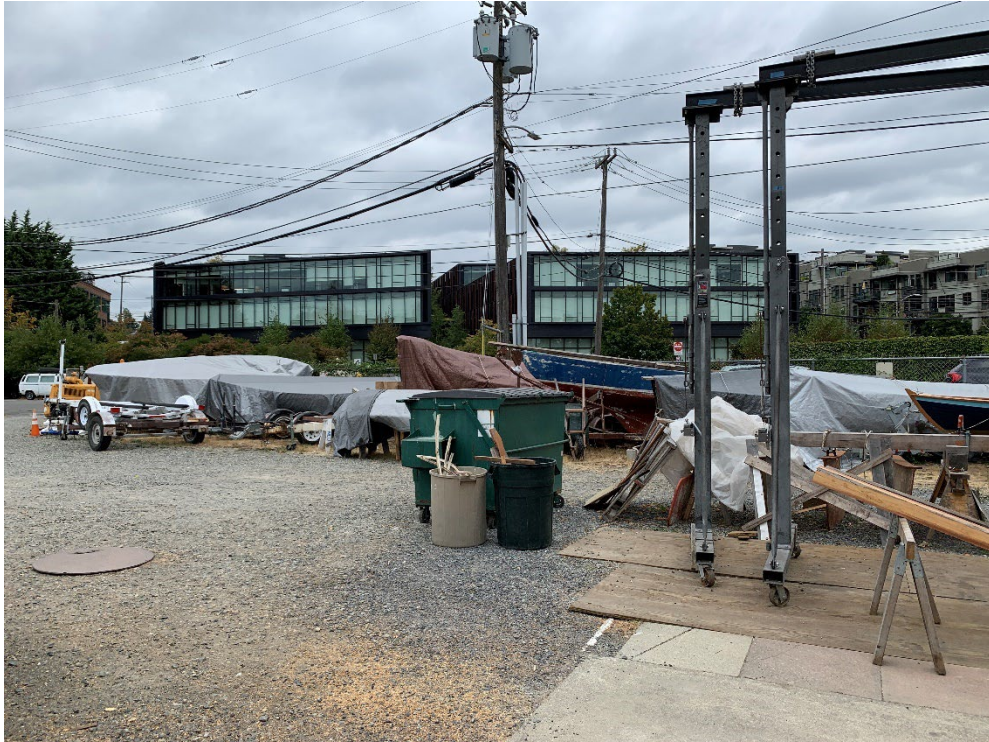
Photo 3: North Yard buildings viewed from the South Yard.

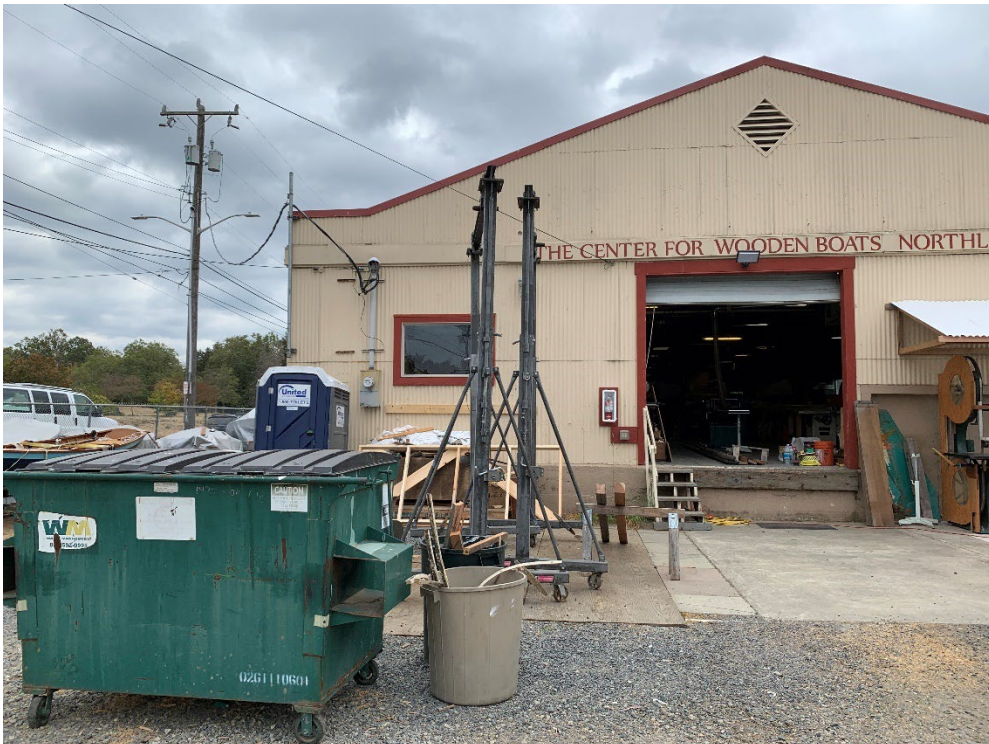
Photo 4: South Yard building from the west.

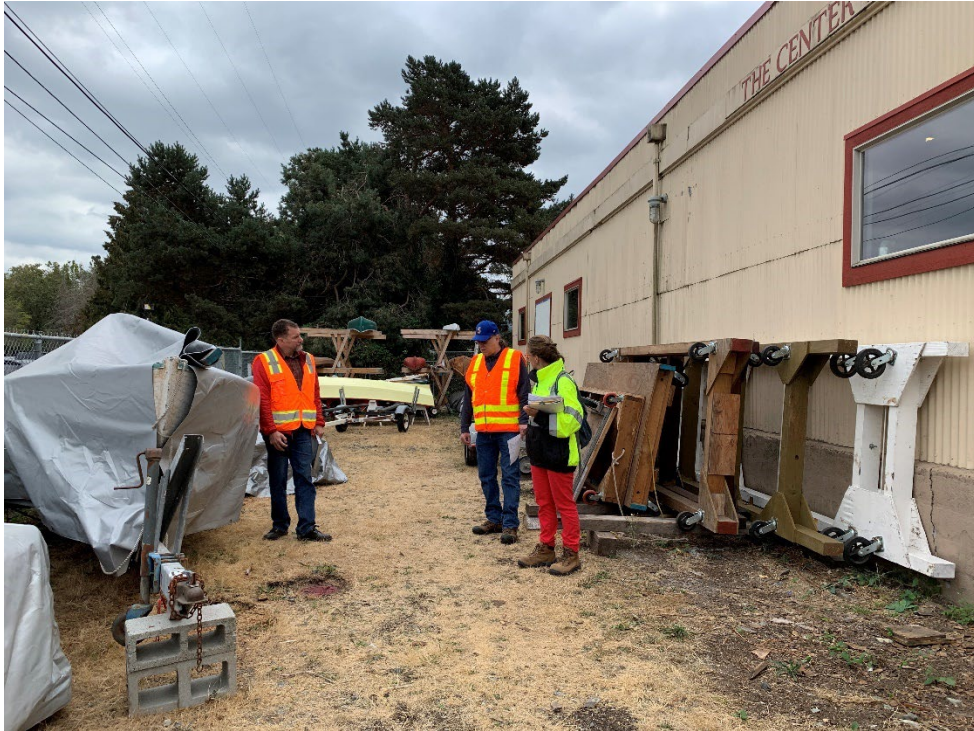
Benzene and naphthalene are present in groundwater from well MW-7, which is within 30 feet of the building on the South Yard. In January 2022, MW-7 contained 18.2 µg/L of benzene and 137 µg/L of naphthalene. The concentration of benzene is less than 5 mg/L (5,000 µg/L), so based on the initial PVI assessment, a vertical separation distance of 6 feet is needed. During the last 5 monitoring events, groundwater at MW-7 has generally been between 12.2 and 14.1 feet bgs, which is greater than the recommended 6 foot vertical separation. Therefore, additional PVI assessment is not warranted for the South Yard.

Photo 5: MW-7 (red monument in the lower left corner) and the South Yard building.

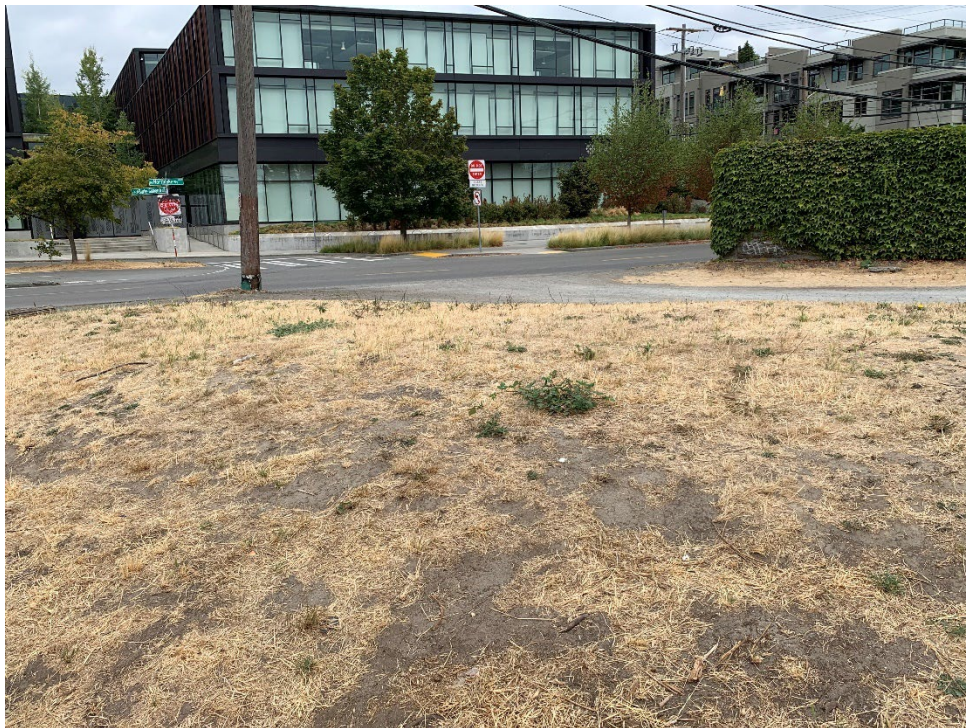
Photo 6: Right-of-way area between the North and South Yards, facing the North Yard.

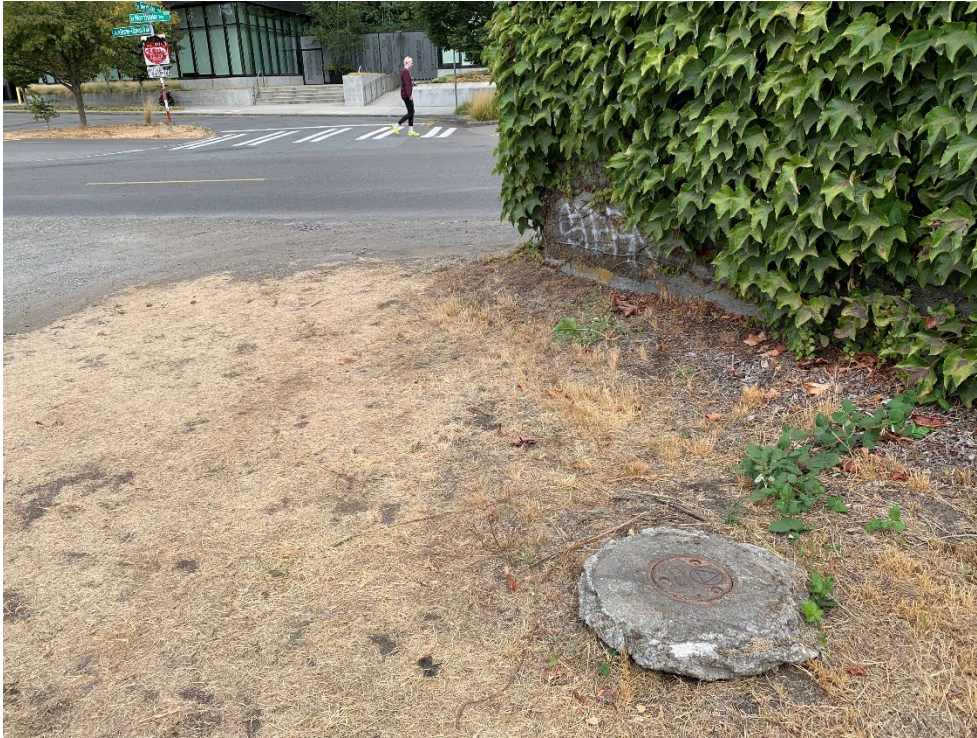
Monitoring wells were generally in good condition; however, the surface conditions at well MW-22 appear to have changed since installation and a new surface housing is needed since in its current condition, the top of the well casing could be easily exposed or damaged. This well should be repaired by a licensed driller.

Photo 7: MW-22 within the right-of-way area.

- Well conditions at the Site should be reviewed by the PLPs at least annually and any issues should be repaired or the well replaced. At a minimum, the condition and location of well MW-14 should be verified during the next sampling event and the surface monument of well MW-22 must be repaired.

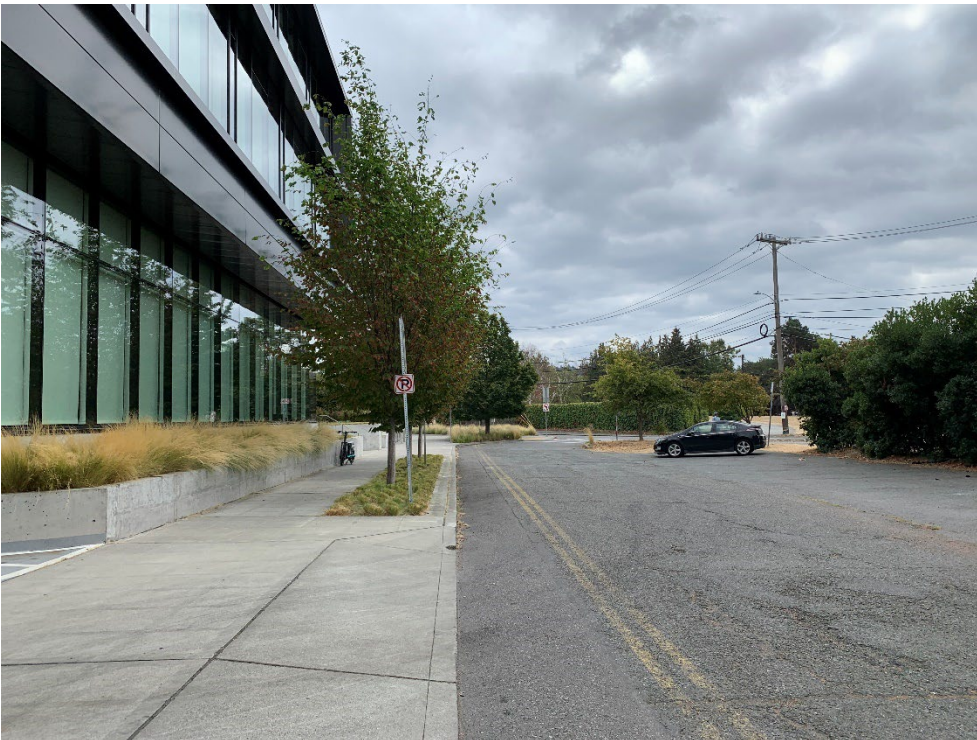
Photo 8: South side of the North Yard buildings and right-of-way area.

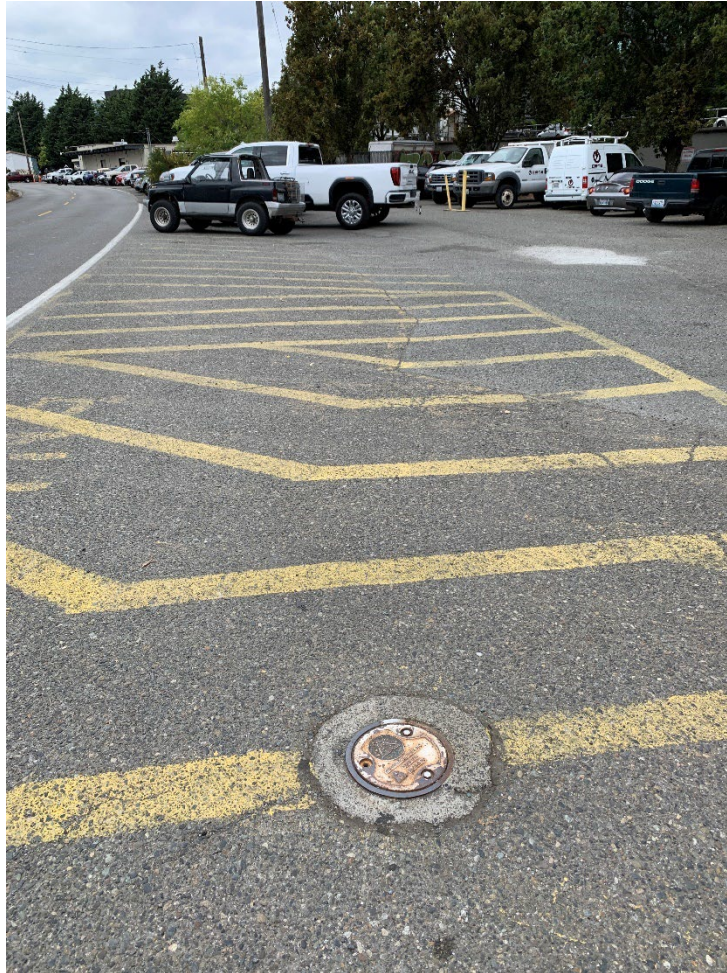
Photo 9: Monitoring well and pavement within the right-of-way area.
